## Ignition Woes – an endemic modern problem?

by David Bolton

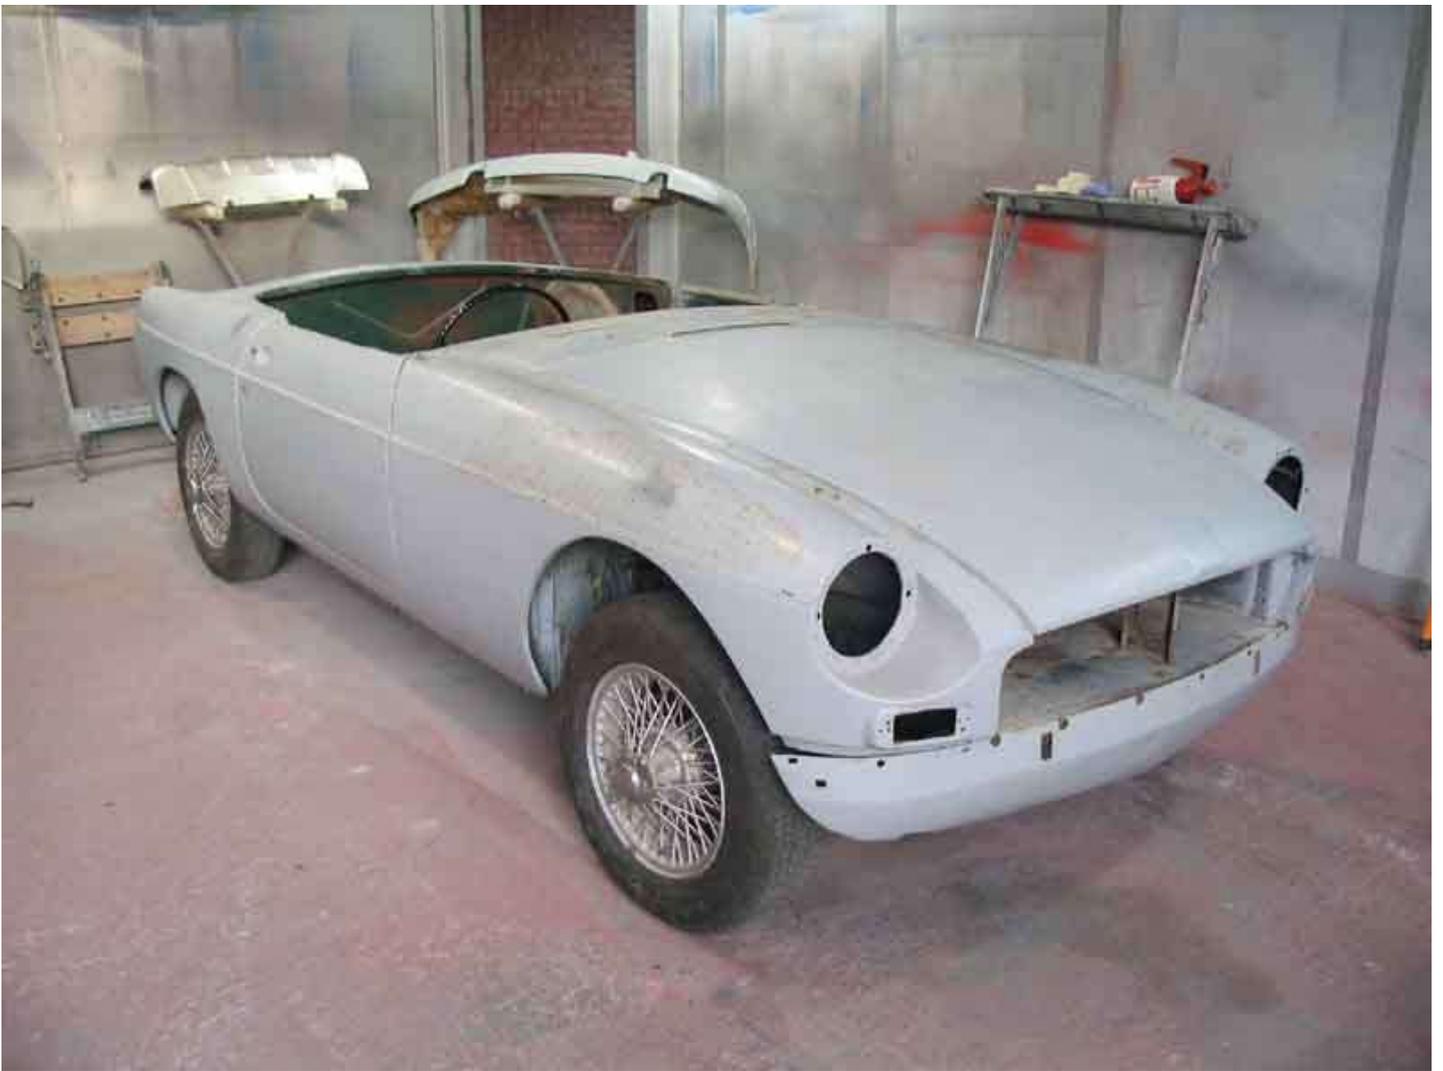
As received it didn't look too bad, the external panels seemed sound and had been primed, although a long time previously as rust spots were coming through.

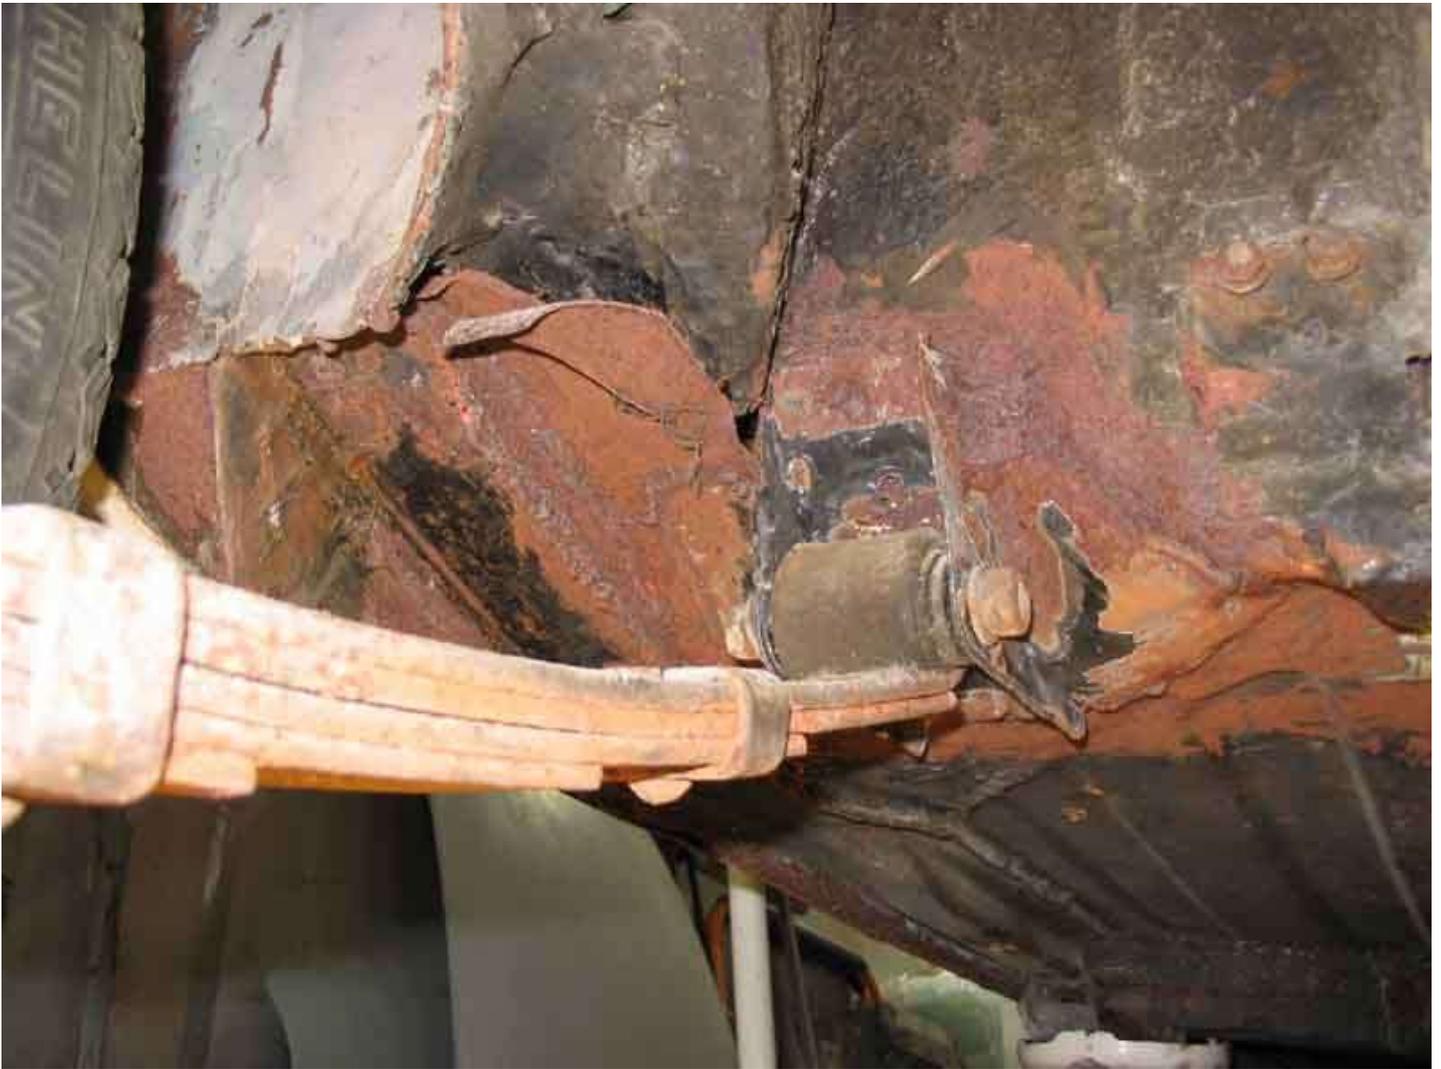
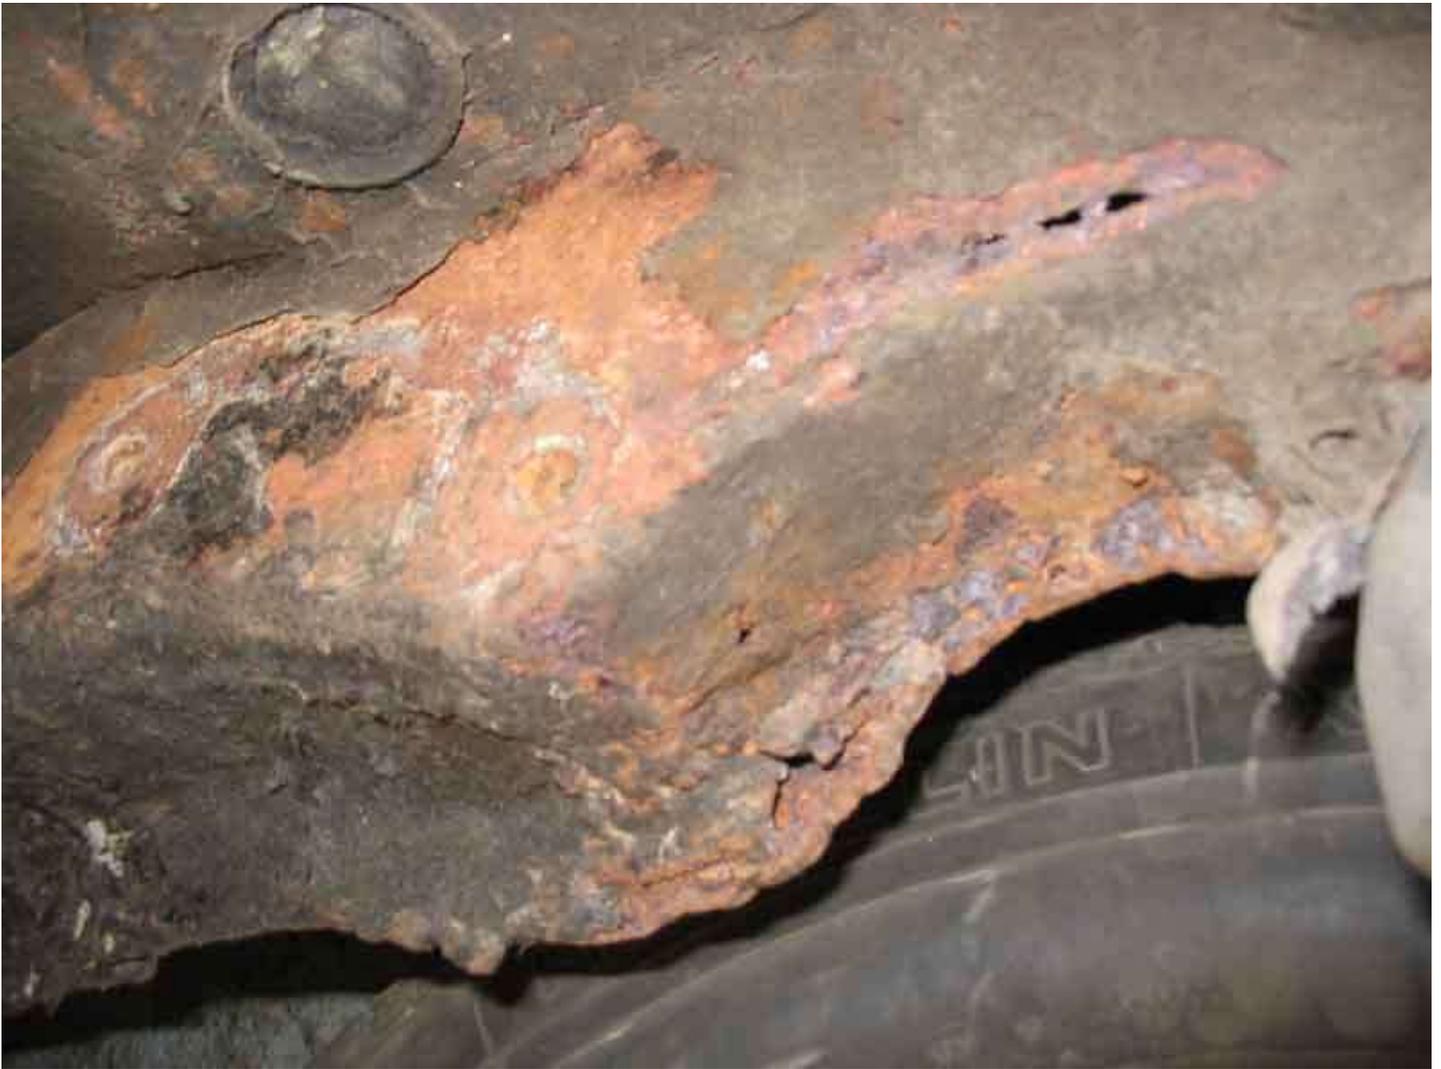
But underneath it was a horror story, with bodes and serious rot in a lot of places, and significant surface rusting. It looked like it had been abandoned outside for very many years.

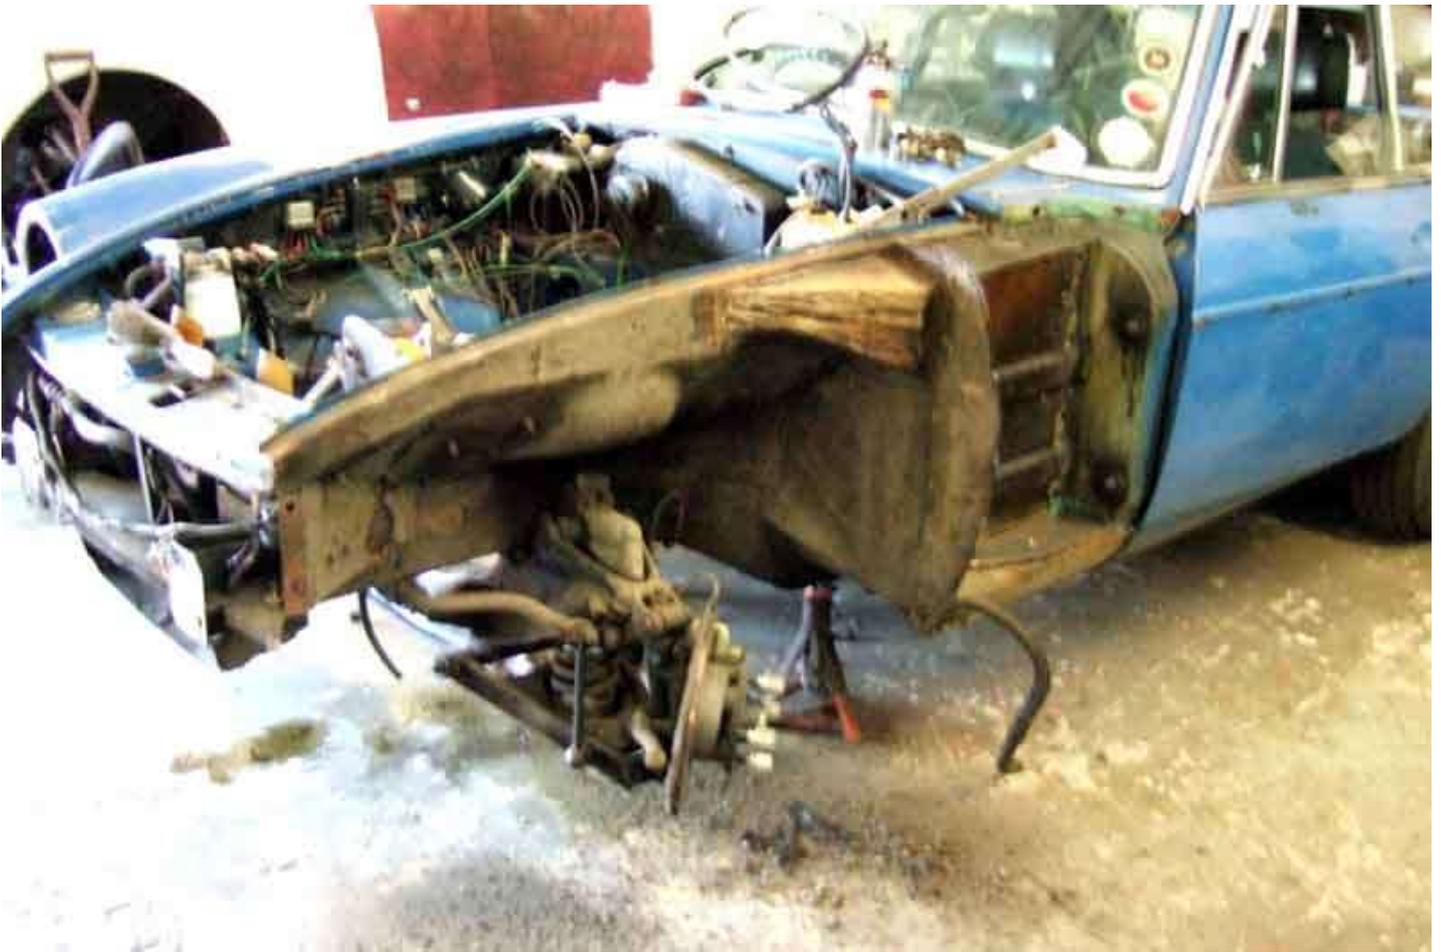
... A little bit of rot in the top of the (previously replaced) trumpet section, duly cut out and replaced.

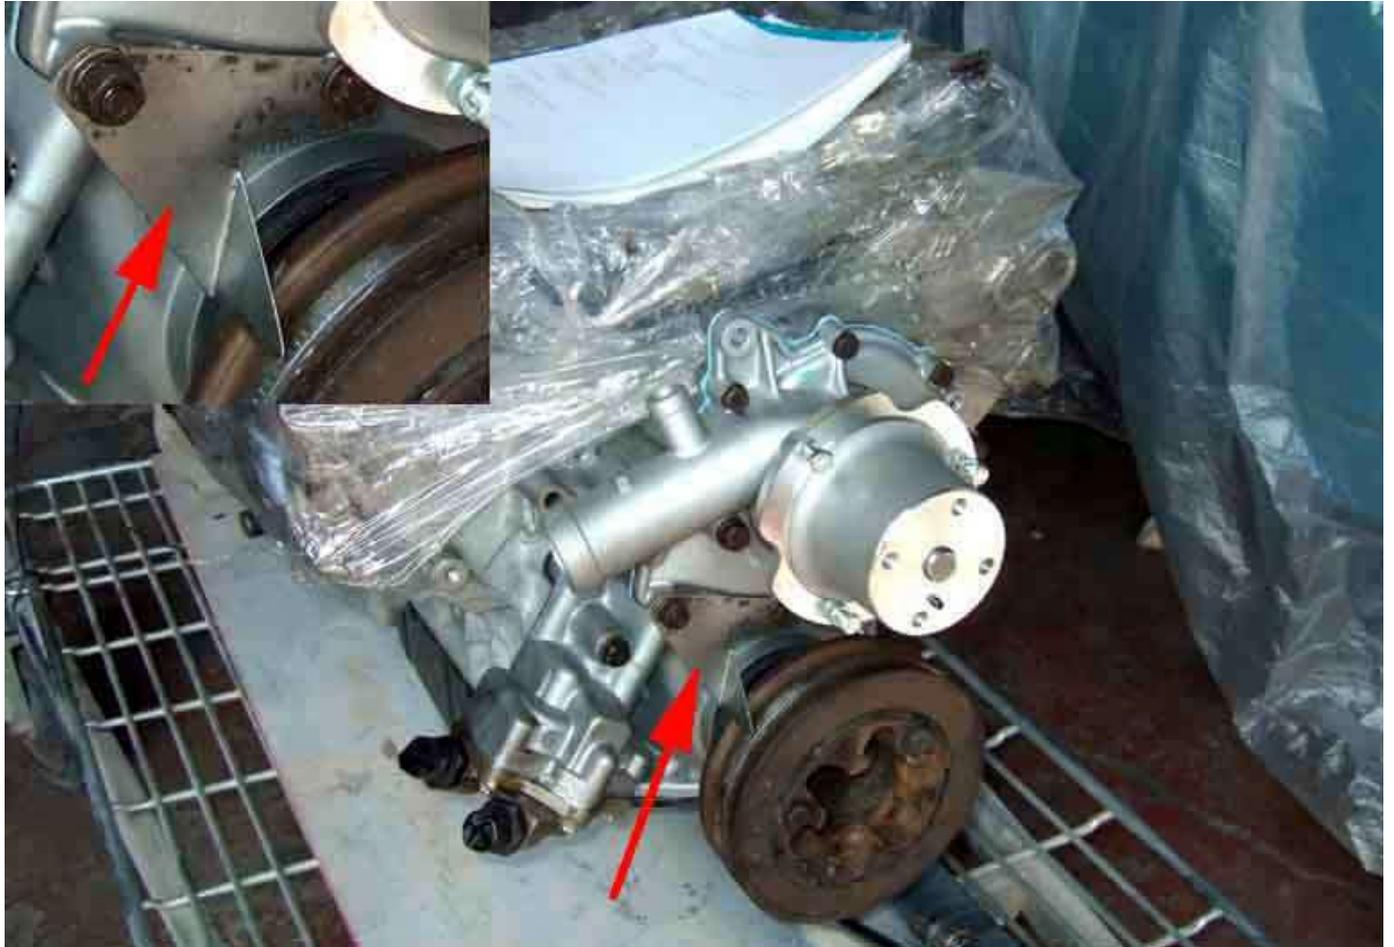
Engine mounts fitted. Only discovered then that the upper bolt had sheared off in the block, so flush it was almost invisible. The mounts were the only things I didn't trial-fit to the block. But using the mount plate - held by the lower bolt as a guide - I drilled and retapped. Also found one of the block drain taps damaged, but I had taken a couple of spares taken from the old block and another I had and replacement only took moments, although the off-side one tripped me up later on.

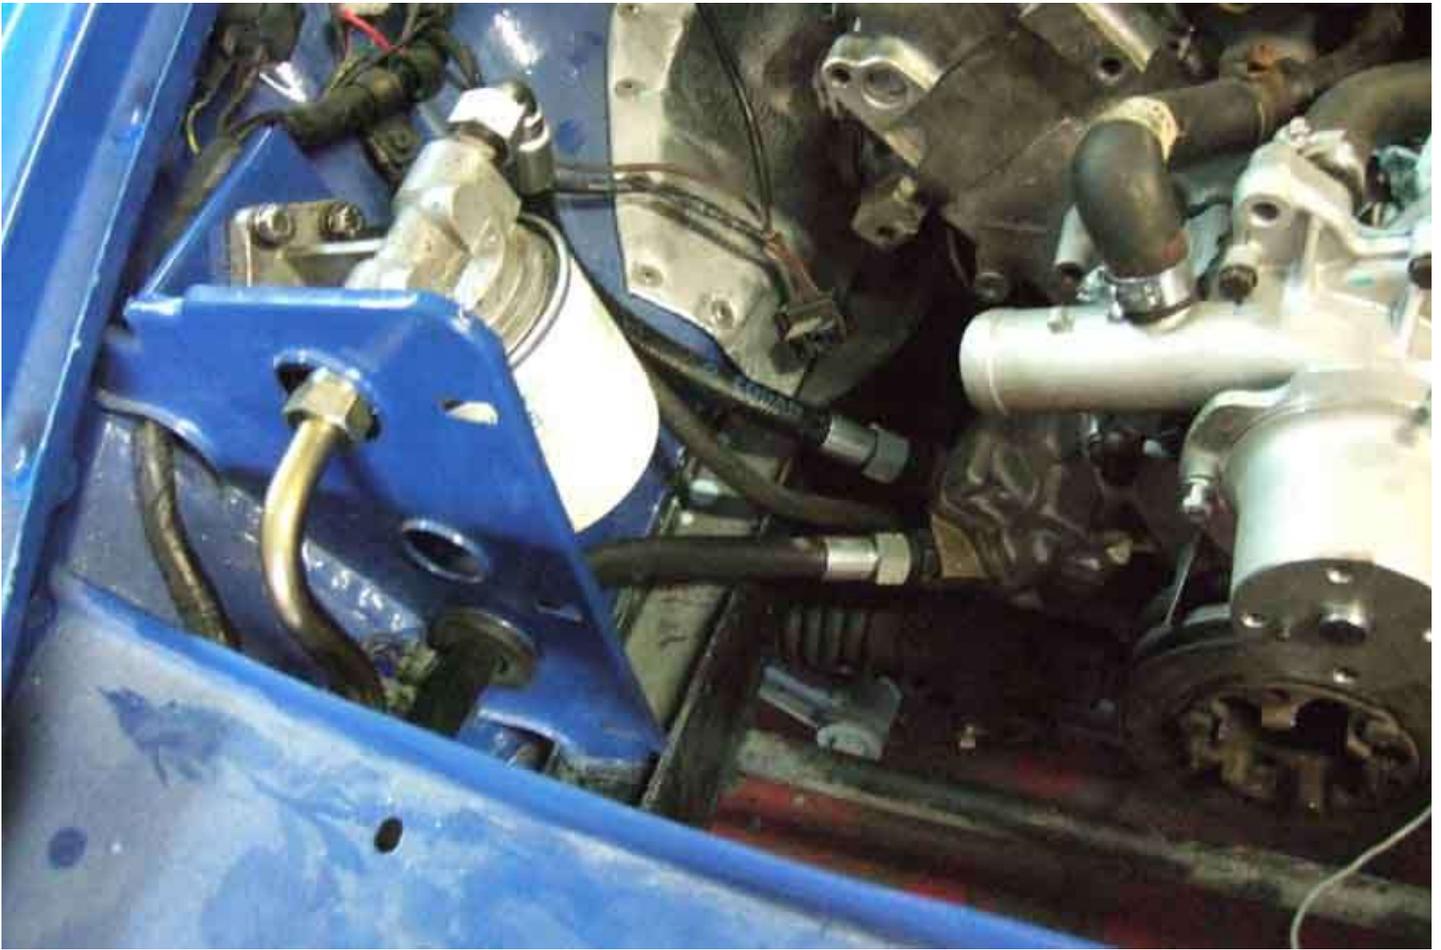
However the clearance on the front hose is very small, about 1/8", and the gauge hose is close too. Give the amount I know the engine has rocked in the past with the exhaust manifolds hitting the inner wings, I think it is too small. Rather than grinding and welding straight off, I think I'll try battering the lip over first, to present a smooth face as well as being lower.

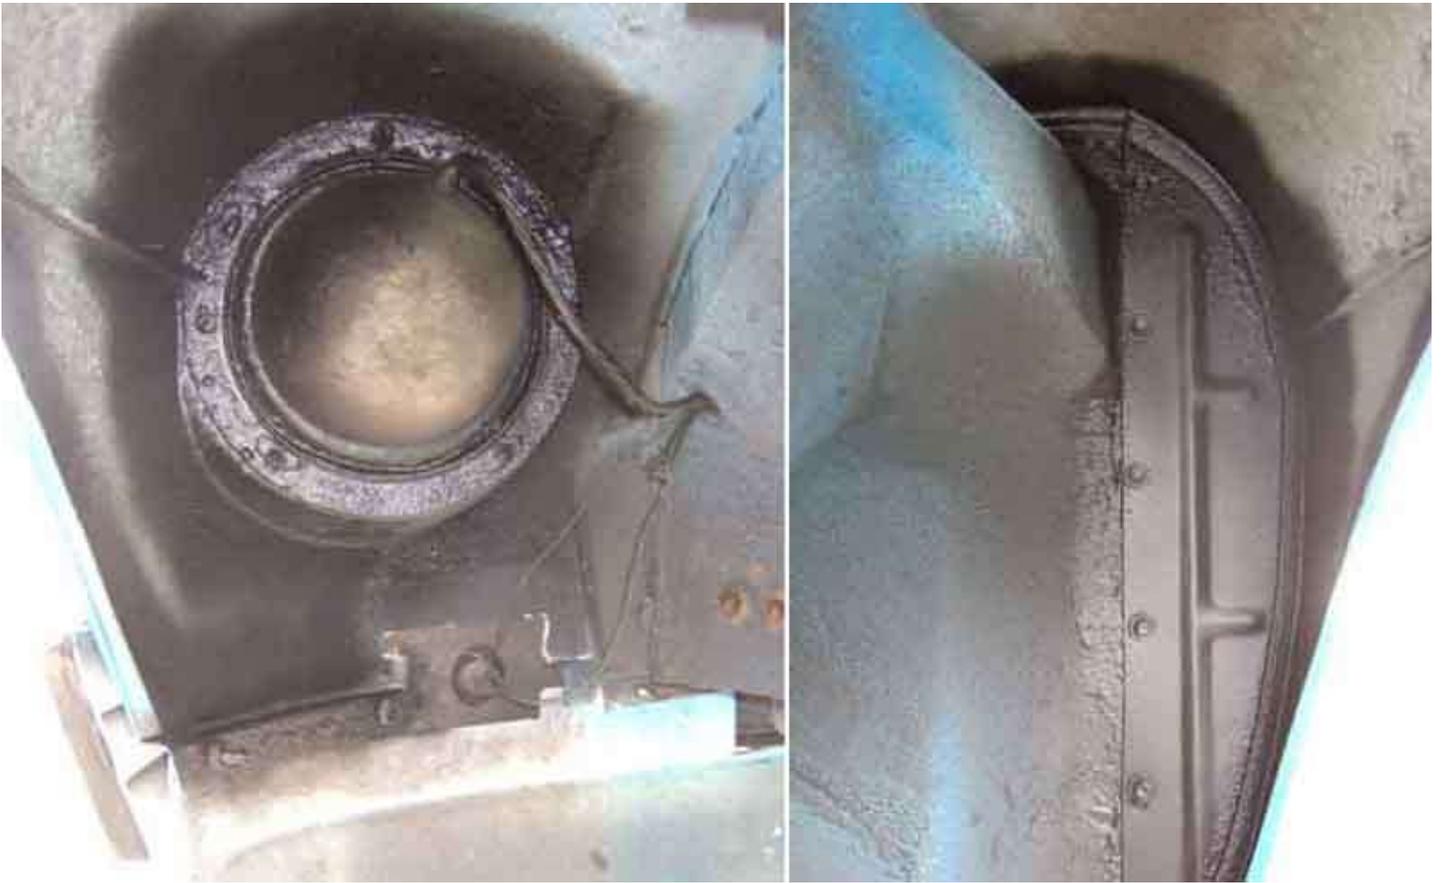
The old off-side panel was looking like Swiss cheese in the lower half.
