Bee's Clutch Change 2016

Last updated 22-Dec-2023

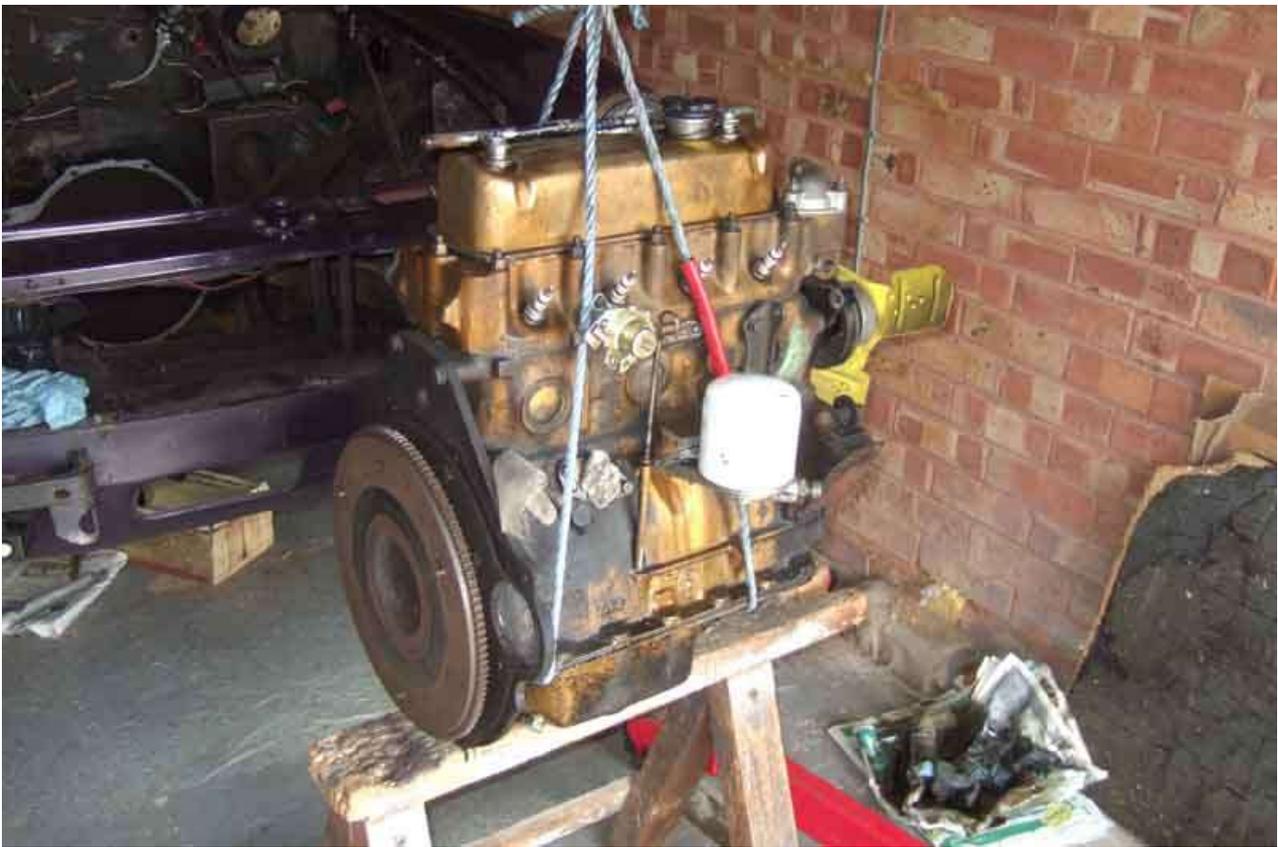
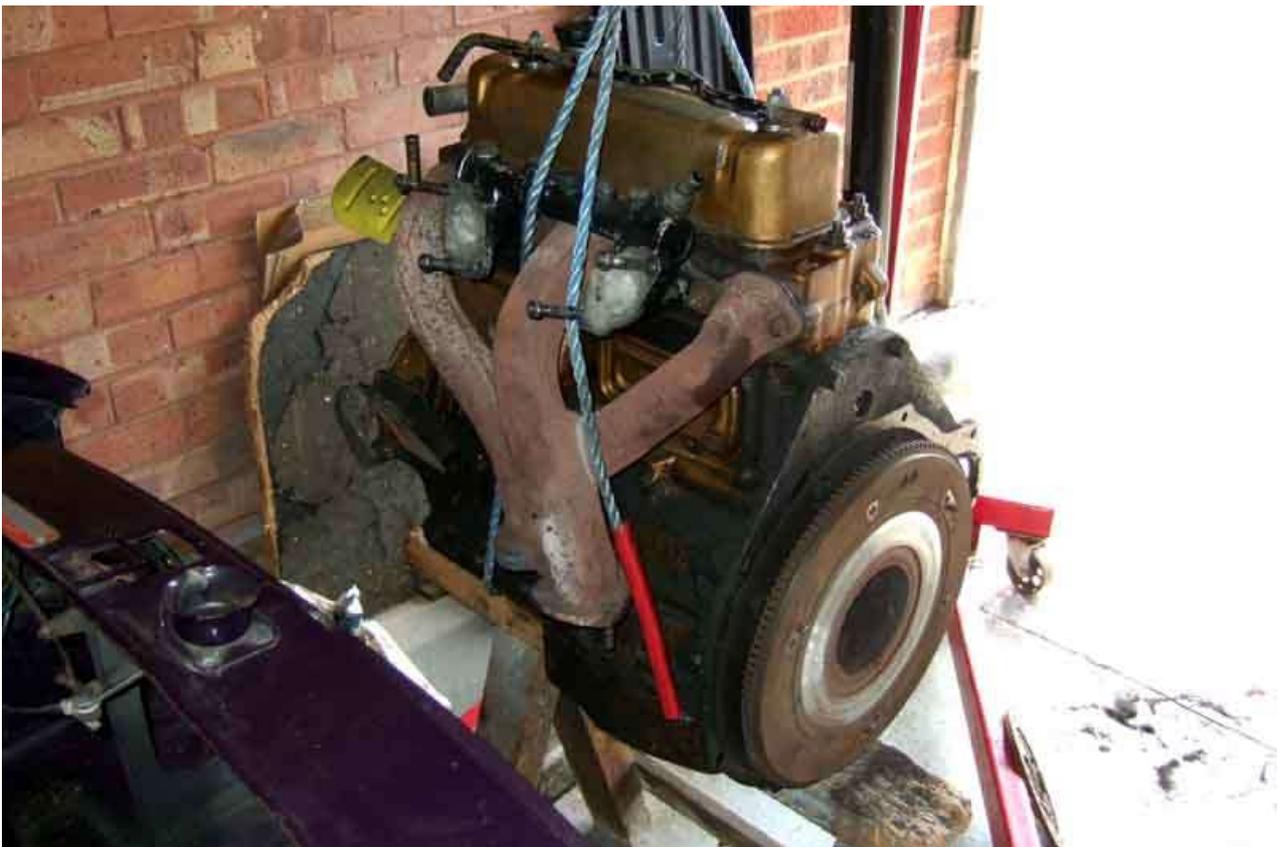
First sight of the release bearing and cover plate - and it is shocking! Bearing completely knackered with balls jammed and them and the housing ground down, the boss on the cover plate practically worn right through, and the ends of the diaphragm springs showing blue from excessive heat, and some partially cut through from the outer corners of the release bearing fork. No-one could accuse me of not getting the maximum life out of it! The air-gun gets the cover-plate bolts undone without having to jam the crankshaft in some way, to reveal the friction plate, which is barely worn. If it hadn't been for that damned release bearing the clutch itself would almost certainly have lasted another 50k and 15 years or so. The flywheel does have a slight wear groove, from a previous friction plate having worn down to the rivets, but as it's been like that for the past 22 years I'll leave it as it is, not worth removing it and getting it skimmed. The inside of the bell-housing is well mucky of course, but dull dry dirt rather than the shiny wet-look of the previous two, so again I just check the gearbox front-cover nuts for tightness.

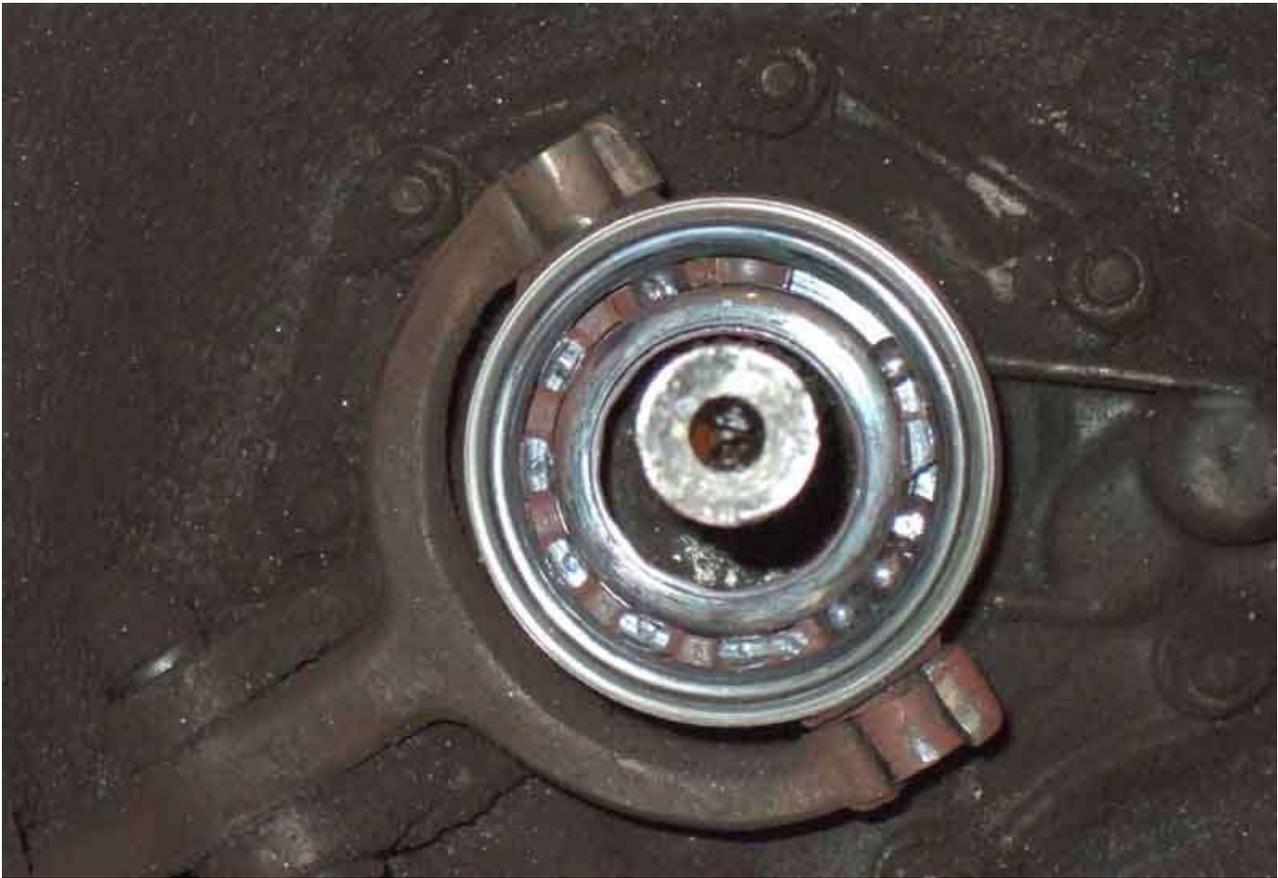
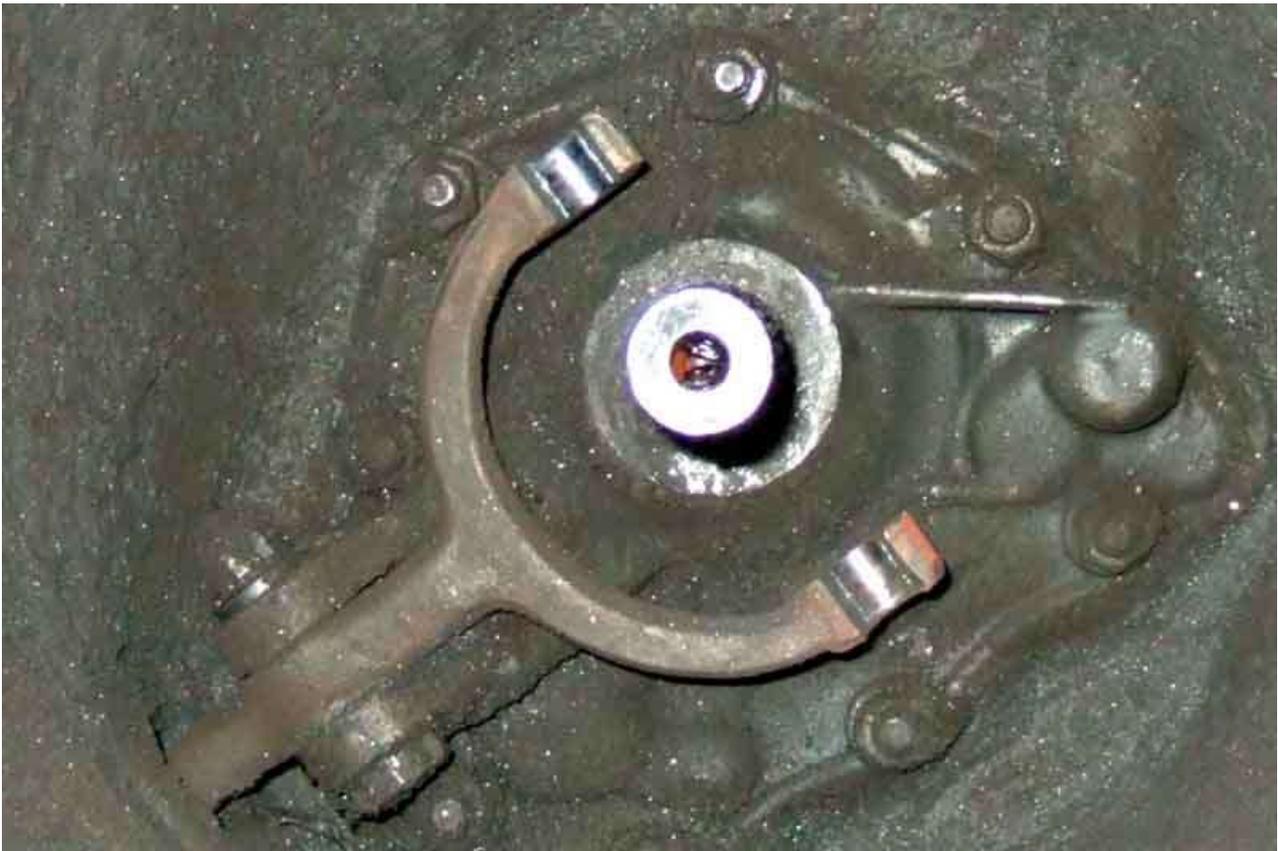
The other thing I notice is how offset the release bearing is to the first-motion shaft - sideways relative to the orientation of the release arm pivot bolt, getting on for 3/16". Even with the bearing removed the forks are still offset, and removing the arm and turning it over is just the same. I.e. it isn't the arm that is bent, but the pivot bolt bracket is not in line with the shaft. That's almost certainly what has caused the roller bearing to fail, which is why John Twist says roller bearings have a high rate of premature failure when used on a gearbox not designed for them. OEM applications like the Midget 1500, MGB GT V8 and modern cars, have a special carrier that keeps the bearing concentric with the shaft, compensating for any misalignment between arm and shaft.

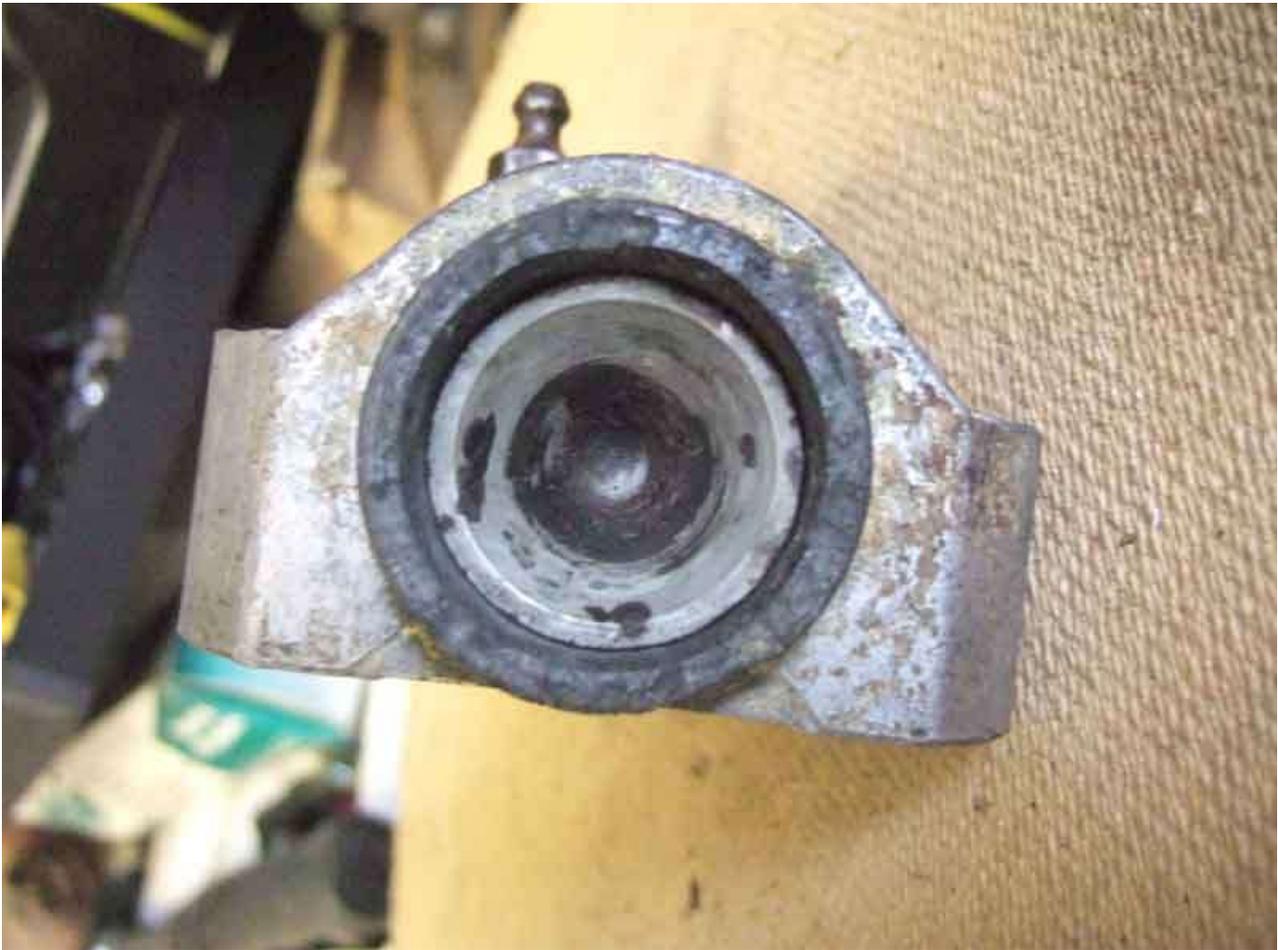
Showing the very close fit between piston and cylinder wall. I have read one claim where so much wear had taken place that the piston got 'cocked' in the bore and jammed. I can't really see this, the seal would have become so loose it wouldn't seal at all long before that, more likely an under-sized piston had been used.

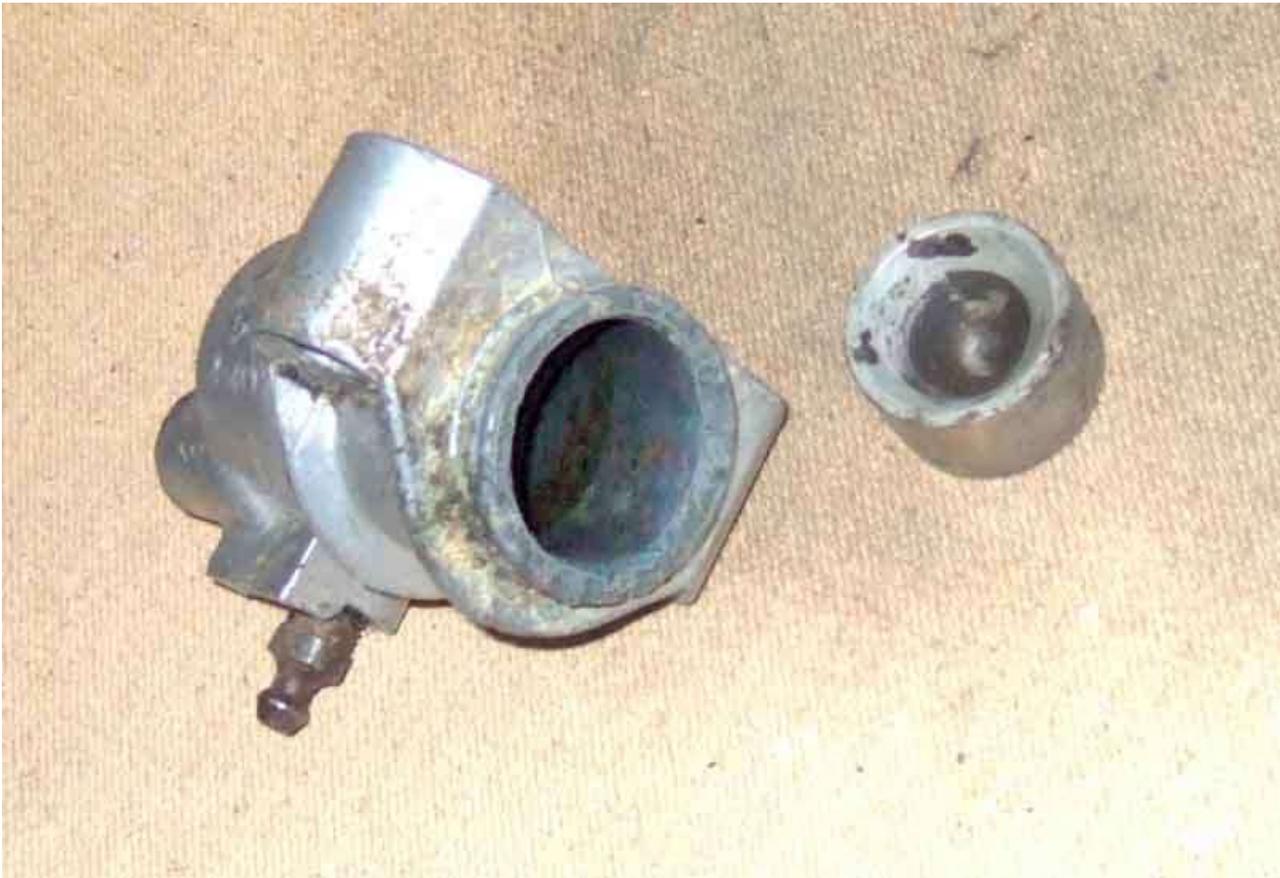
Showing the bleed hole (circled) drilled along the line of the join of the cylinder wall to the back wall, in an arc at the top of the cylinder, normally at the highest point of the cylinder when the car is on its wheels or has the front raised.

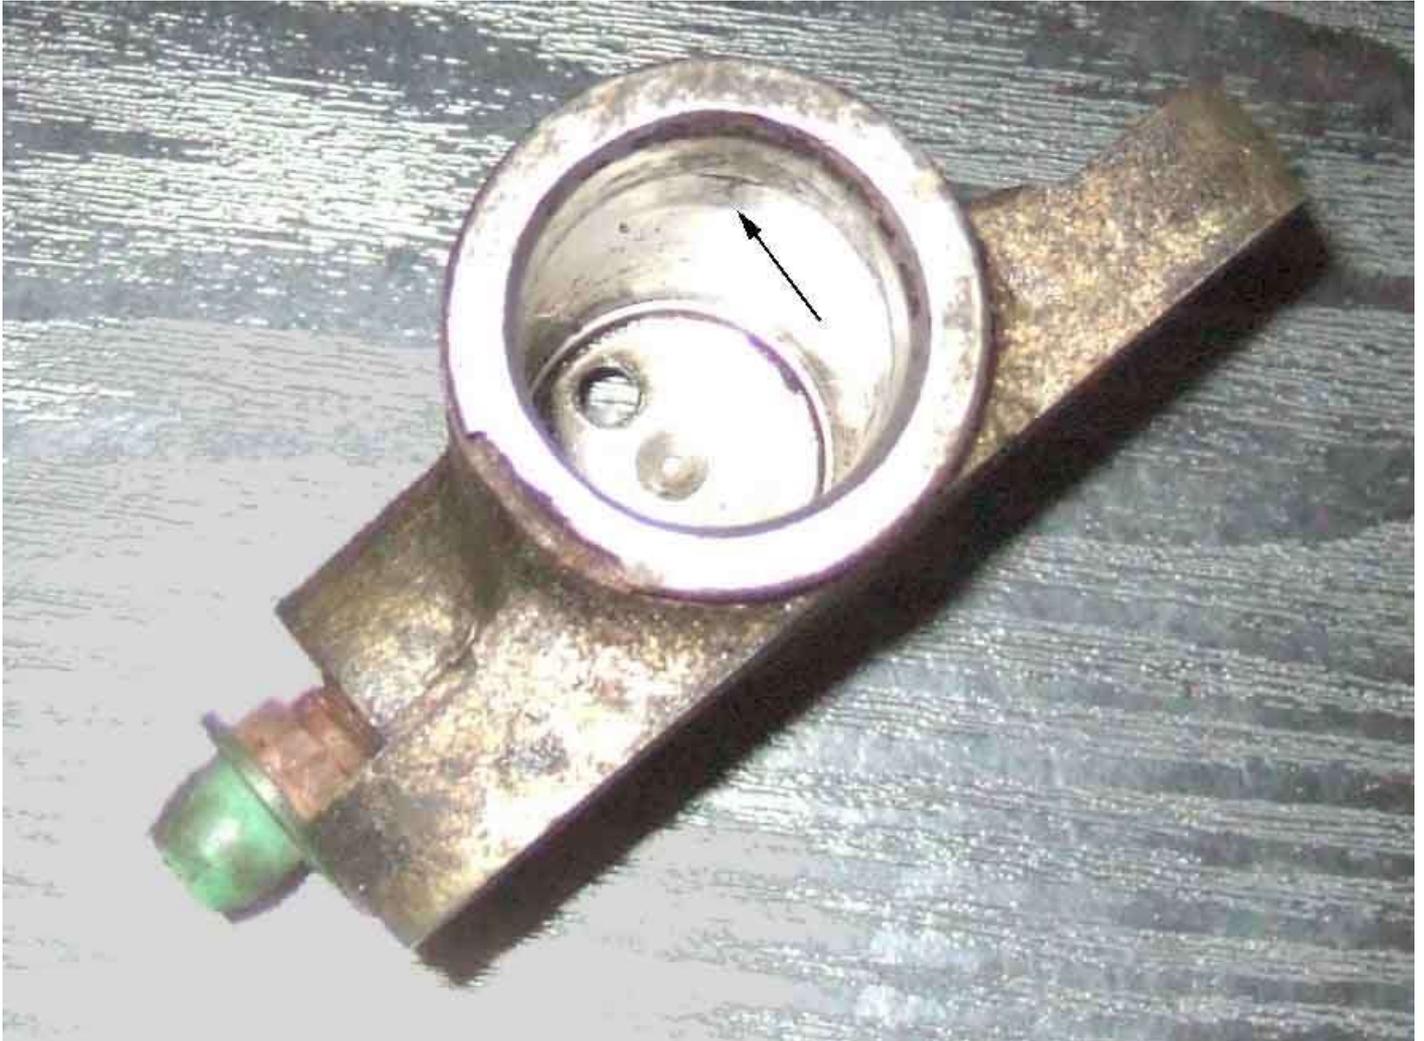
The lower half, showing a larger area of corrosion where water may have been laying. The problem is that as the clutch wears down the seal will move out bit by bit to take up the wear. The further it moves, the more it encroaches onto areas

that have never been used. If any dampness has got into the boot, the risk of rusting and seal moving more and more onto it increases. Not only is this rough making for a poor seal, but it can also damage the rubber.

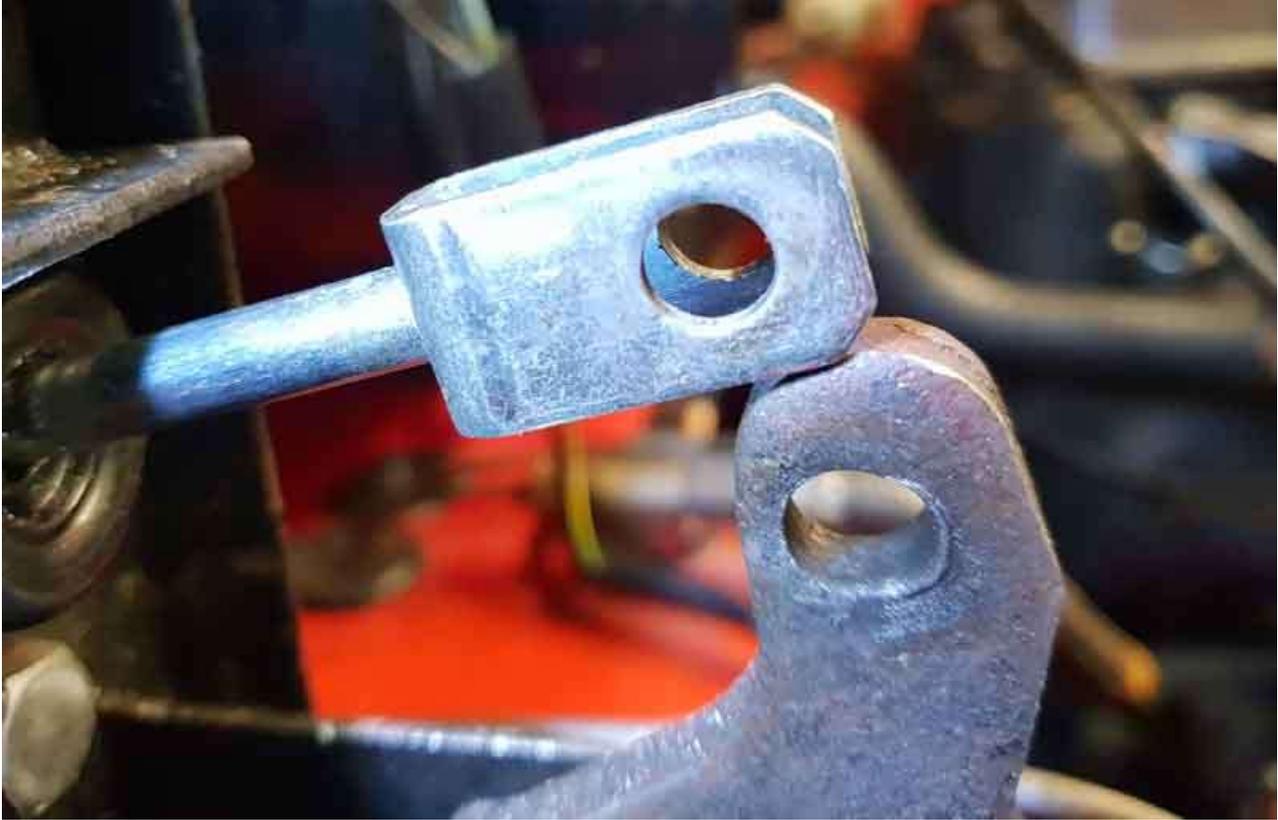
Steve's clevis pin as badly worn as Bee's was:

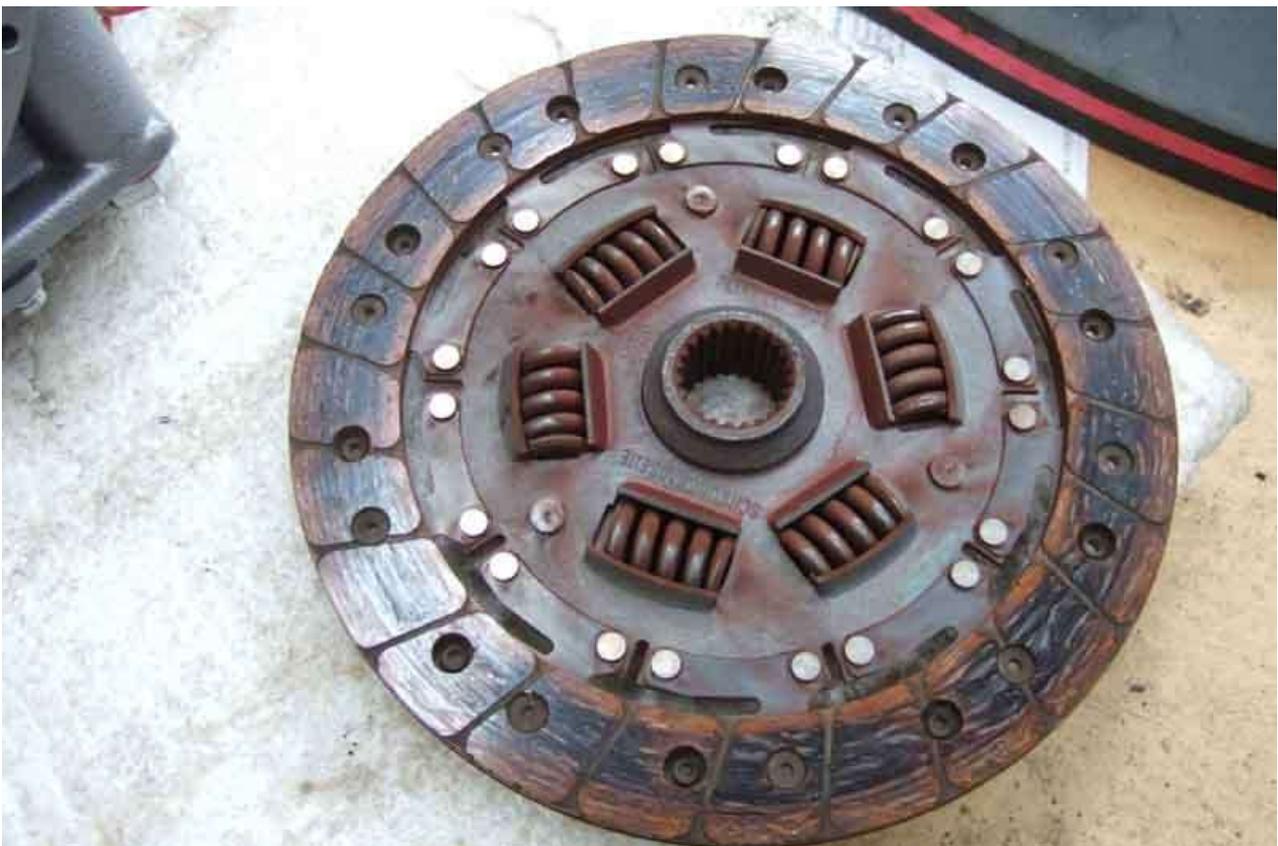
Witness marks as the rivets pass by, but no grooves on the flywheel, which could have happened with any previously worn-out clutch

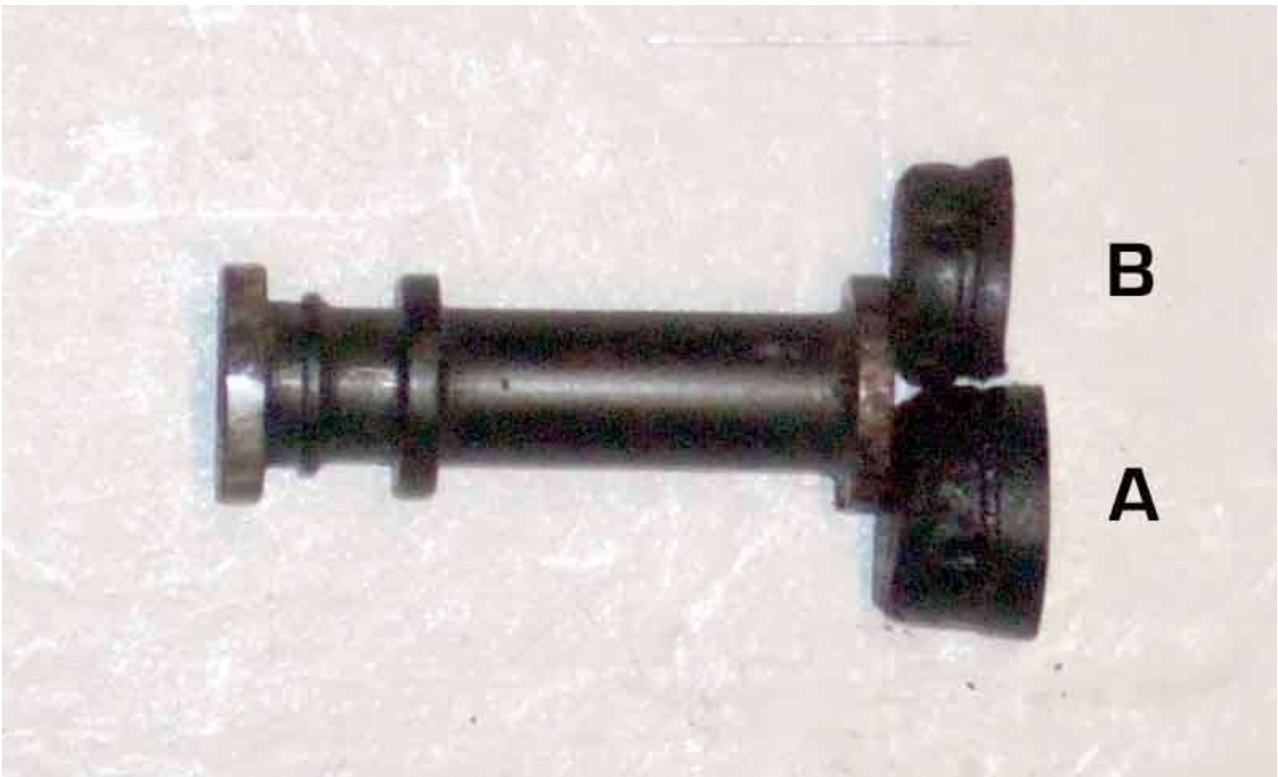
The cup-type seal removed from Bee's clutch (A) significantly longer than a similar seal from another cylinder (B). If the replacement seal is like B, that would explain why the biting point is now lower.

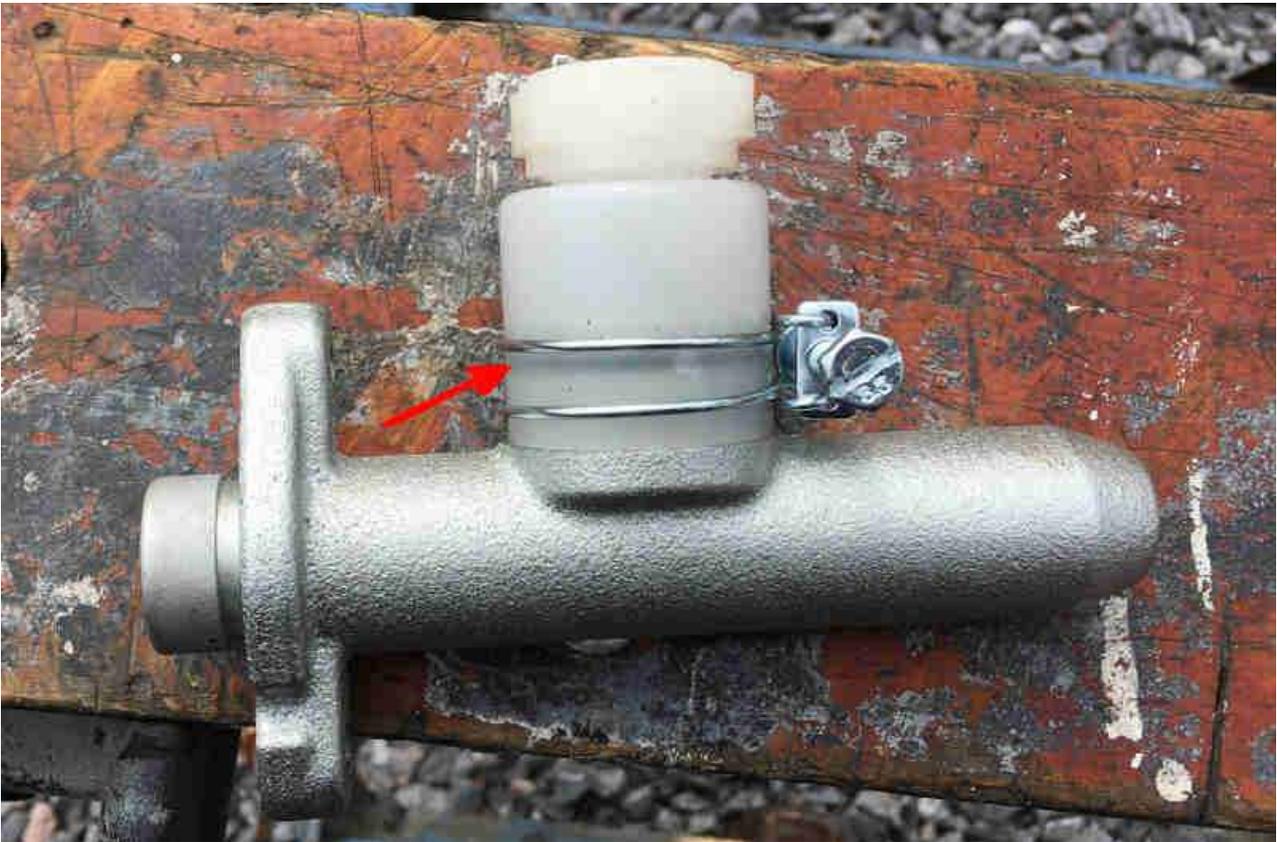
This cylinder had a leak from between the reservoir and the casting which could have the upper wire clip above the casting and so tending to distort the plastic reservoir rather than seal it: (*Richard Massey*)

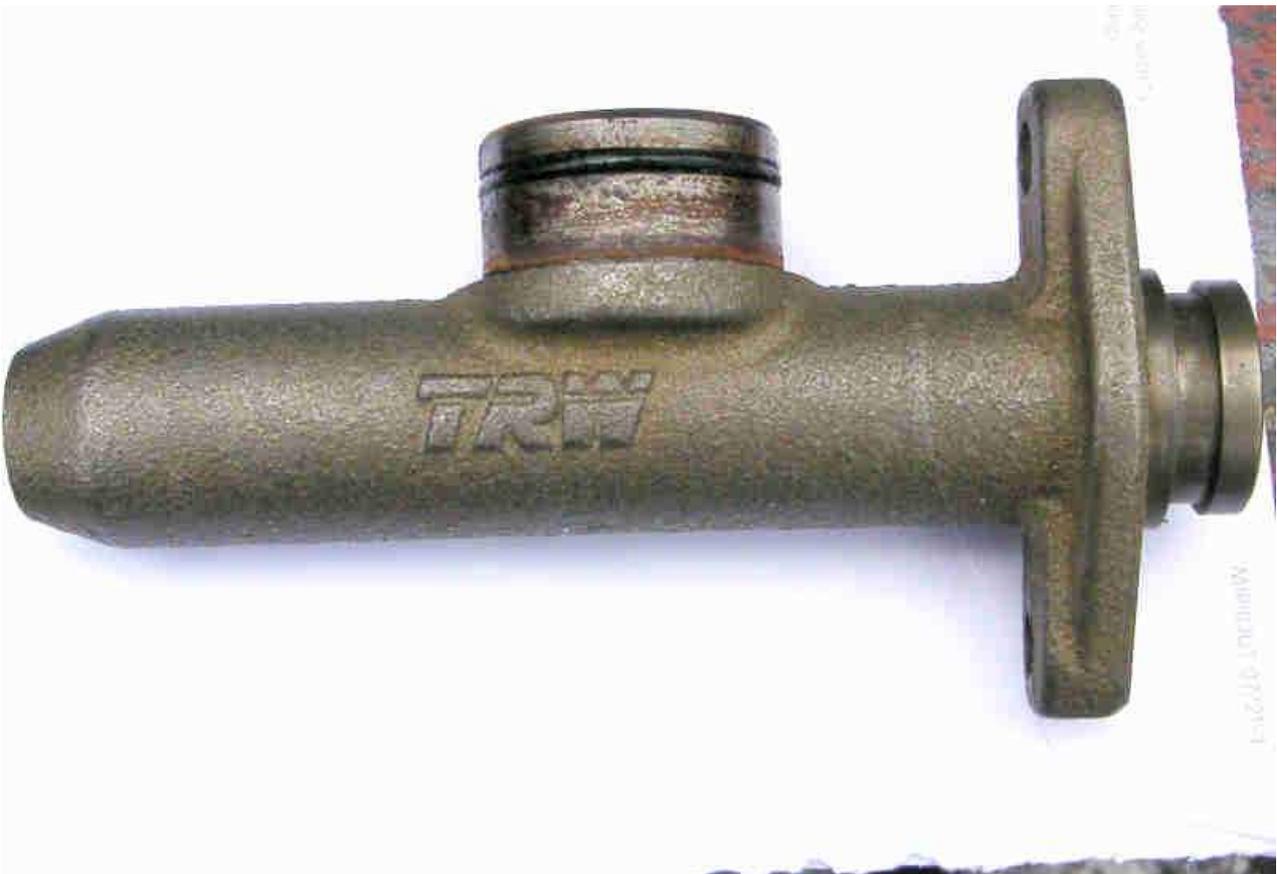
A previously failed master showing the position of an O-ring seal in relation to the top of the casting. Not much scope to get the upper wire above the O-ring but still on the casting: (*Richard Massey*)

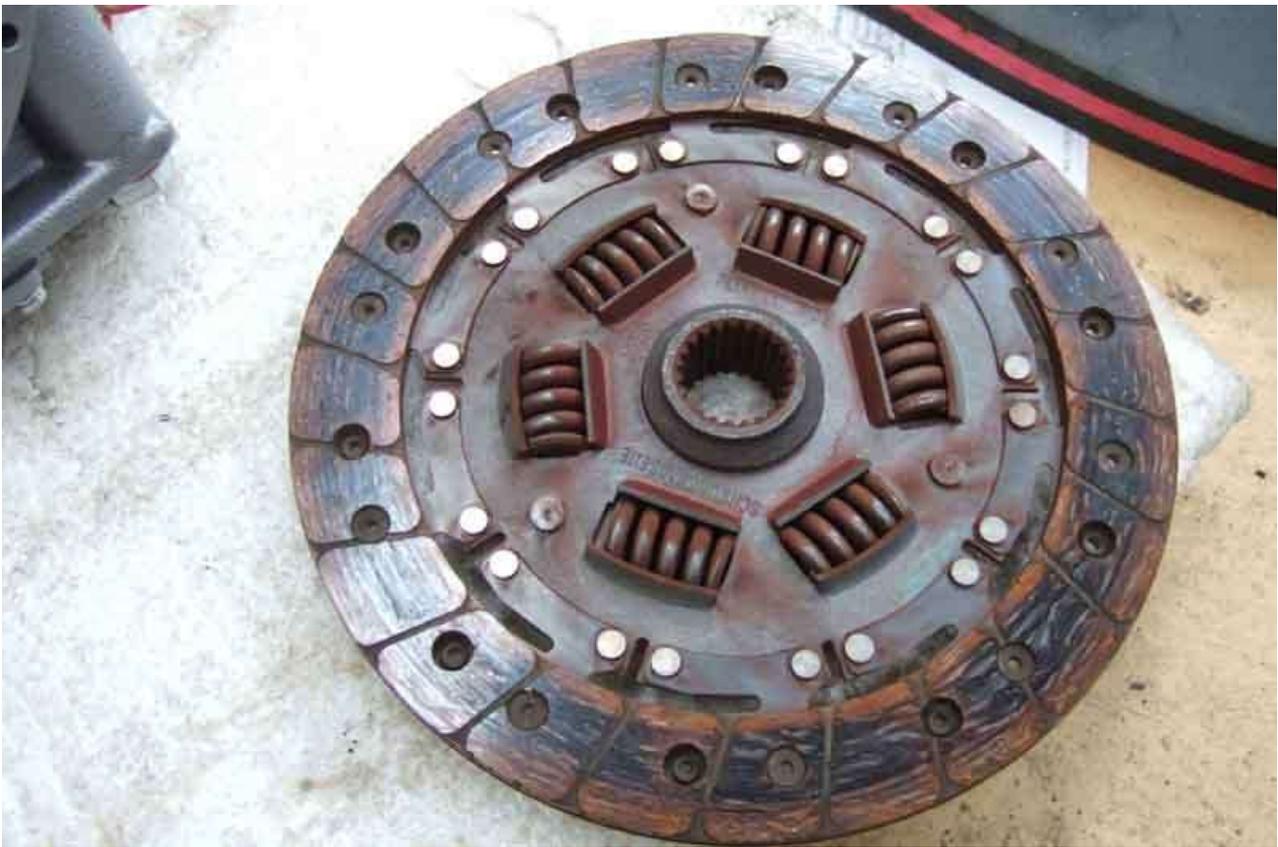
Witness marks as the rivets pass by, but no grooves on the flywheel, which could have happened with any previously worn-out clutch
