## Gearbox and Overdrive

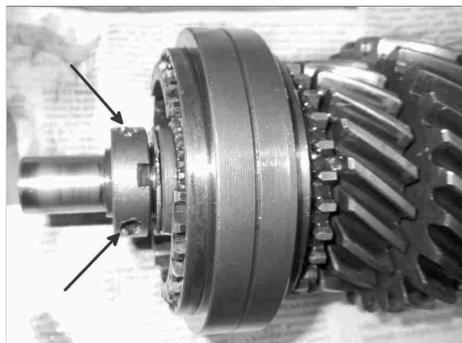
I could immediately see what was wrong - the (reused at least once if not twice) lock washer had not been staked down into any of the three recesses in the mainshaft nut and it was coming unscrewed! That was allowing the gears and selectors to move up and down the main-shaft. All that stress, effort and £5k for a replacement gearbox because of a £3 lock-washer. Talk about 'For want of a nail ...'!

I'd already been looking for the thrust washer 22H276 as initially I had felt that would be the culprit but it was NLA. So now I started looking for the lock-washer 22H773 and that was the same as far as eBay and all the usual suspects went. It's basically a flat washer with two tabs that lock into the main-shaft then you tap the flat part into three angled recesses on the circular nut. Dimensions are fairly critical as it has to be at least the same diameter as the nut but not much wider as the 3/4 selector hub has to be able to pass over them. I reckoned I could make one at a pinch given a flat washer of about 1/5" OD and 1" OD, cutting two tabs at 180 degrees, then clamping it in a nut and bolt in a drill and grinding down the excess diameter. Googling nothing of that size same up, but one with a large enough OD but a smaller ID could be opened up. Then on the advice of Roger Parker as a last resort (based on past experience ...) I

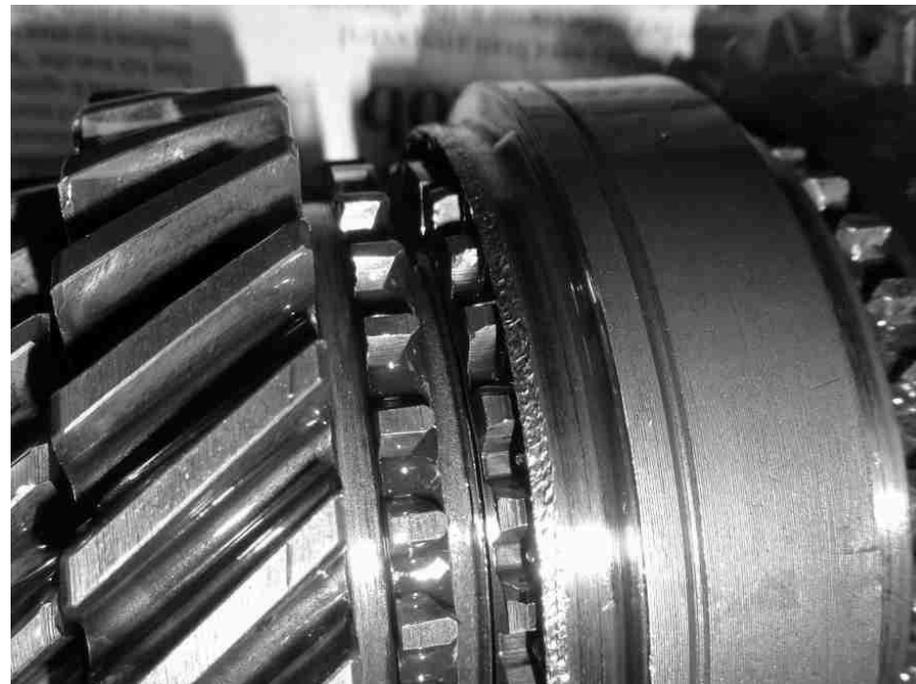
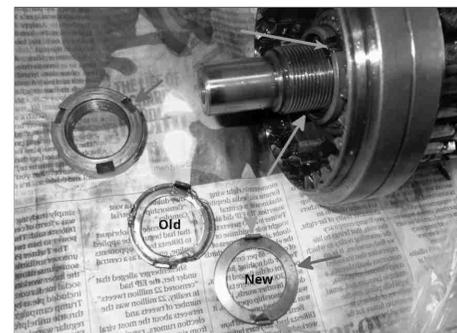
Not only that but I could also see some nibbling in the 2nd gear selector/synchroniser assembly, so because the gears were moving down the main-shaft the selector had moved far enough to come into contact with the edge of the 2nd gear part of the laygear:
