Braking System

Last updated 03-Feb-2026

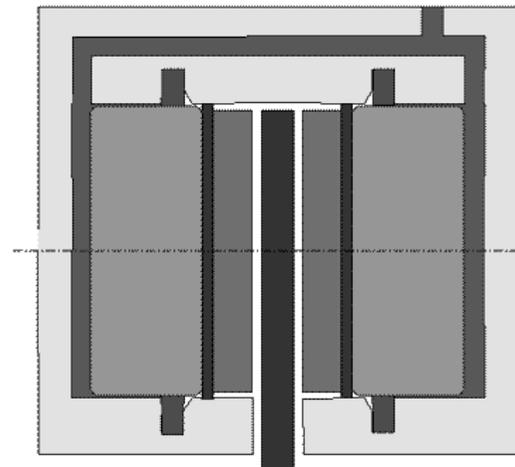
Source: [Motor Vehicle Maintenance & Repair Stack Exchange](#)

December 2017: Someone has just asked 'how do brakes work' in terms of what releases the brakes after they have been applied. They also asked if it was the pedal being released that pulled the fluid back and so pulled the brakes off, but that definitely isn't the case. The design of both master cylinders is such that when the pedal is released and pulls the push-rod back, a spring inside the master cylinder pushes the piston and its seals back. Normally all the fluid that flows out of the master cylinder when the brakes are applied flows back in when they are released to release the pressure in the calipers and wheel cylinders. But if for any reason it doesn't, for example when pedal bleeding (can be done but not ideal) and some fluid has been expelled from a bleed nipple, then as the piston comes back more fluid flows from behind the pressure seal and the reservoir so the system remains full of fluid and at zero pressure, positive or negative. See the [description of the master cylinder](#) for how this happens. But even when all the fluid does come back, on single-circuit masters at least it does so through a [restrictor](#), which only gradually releases the pressure in the pipes etc. As the master piston comes fully back straight away some fluid is always pulled from the master into the cylinder, to be pushed back into the reservoir again as all the fluid comes back through the restrictor.

So how are the brakes released? Rear brakes with drums and shoes have [return springs](#) to pull the shoes away from the drum, and pushes the wheel cylinder pistons back into the cylinders, which pushes fluid back towards the master cylinder. But caliper pistons don't have return springs. They are self adjusting, and in normal use the pads sit just fractionally off the discs, maybe rubbing very slightly. As the brakes are applied fluid pushes the pistons out, past the seals, which pulls on the seals very slightly. When fluid pressure is released the seals will tend to return to their former shape and position, pulling the pistons back into the caliper very slightly, taking the pressure of the pads off the discs. There is a secondary effect on cars like the MGB in that there is a small amount of [end-float at the front hubs](#). This end-float allows the hub and disc to rock from side to side very slightly when driving, which also tends to push the pads and hence the pistons back a little. Some pooh-pooh this secondary effect saying not all cars have this end-float. That's true, and the intention of end-float isn't to push the pads and pistons back, but nevertheless it does happen. If you Google 'pad knock back' you can find many descriptions of the same effect caused by worn wheel bearings.
