## Ignition Woes – an endemic modern problem?

by David Bolton

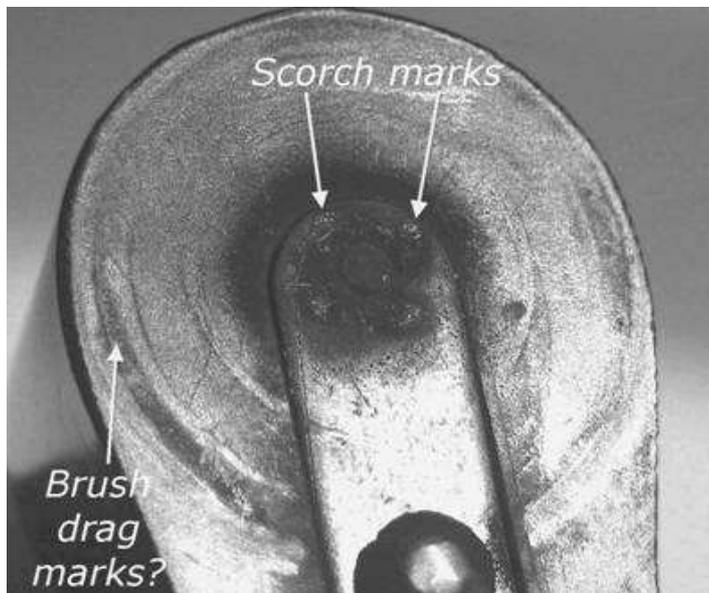
*Rotor top showing scorch & drag marks*

The interior of the distributor did not show any signs of pulverised carbon so where was the brush – on the

floor or still within the body? The remnants of a broken spring were found within the cap.

Interestingly the newer caps appear to have a considerably larger channel for the carbon brush & spring – the original pattern ones were a snugger fit – indicating a possible mechanism for the brush to have escaped. A new distributor cap, with spring & brush and a new standard rotor were fitted. All seemed well.

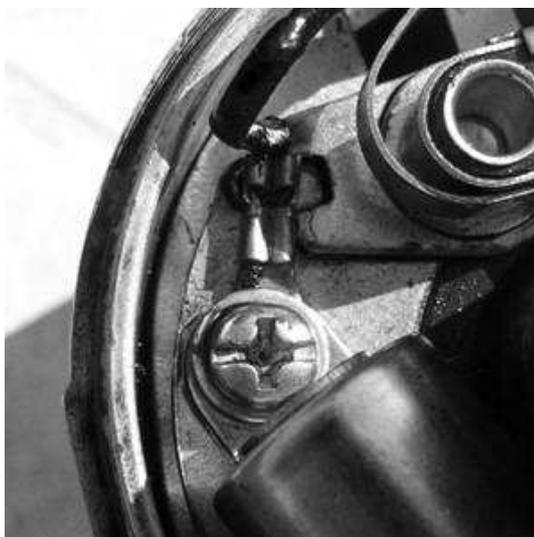
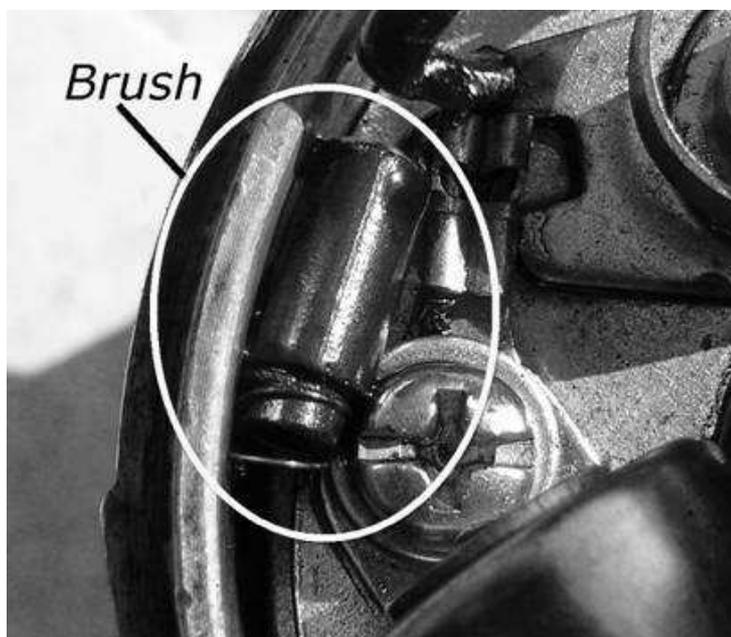
While checking the points gap with the distributor out, the missing carbon brush was found intact and lying loose on the 45D4 base plate – was this the cause of some of the problems?

Two new “uprated” red rotors were then obtained – one for the active 45D4 and one for the reserve 25D4 as well as “uprated” condensers for both (unfortunately the two are not compatible so spares for each have to be carried).

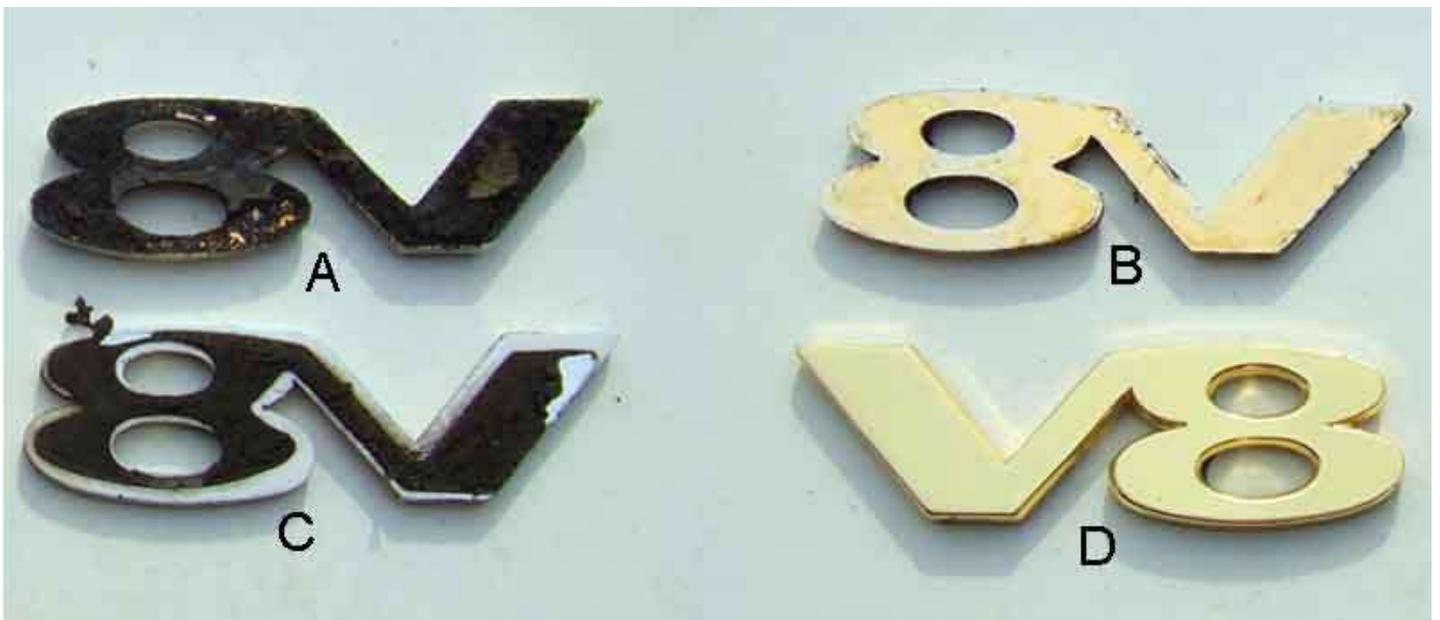
The tailgate 'V8' badges were originally curved in two planes, whereas the wing badges are flat. Tailgate at the top, wing at the bottom. Only the flat badges are available now, but being alloy are relatively easy to curve along their length, at least.

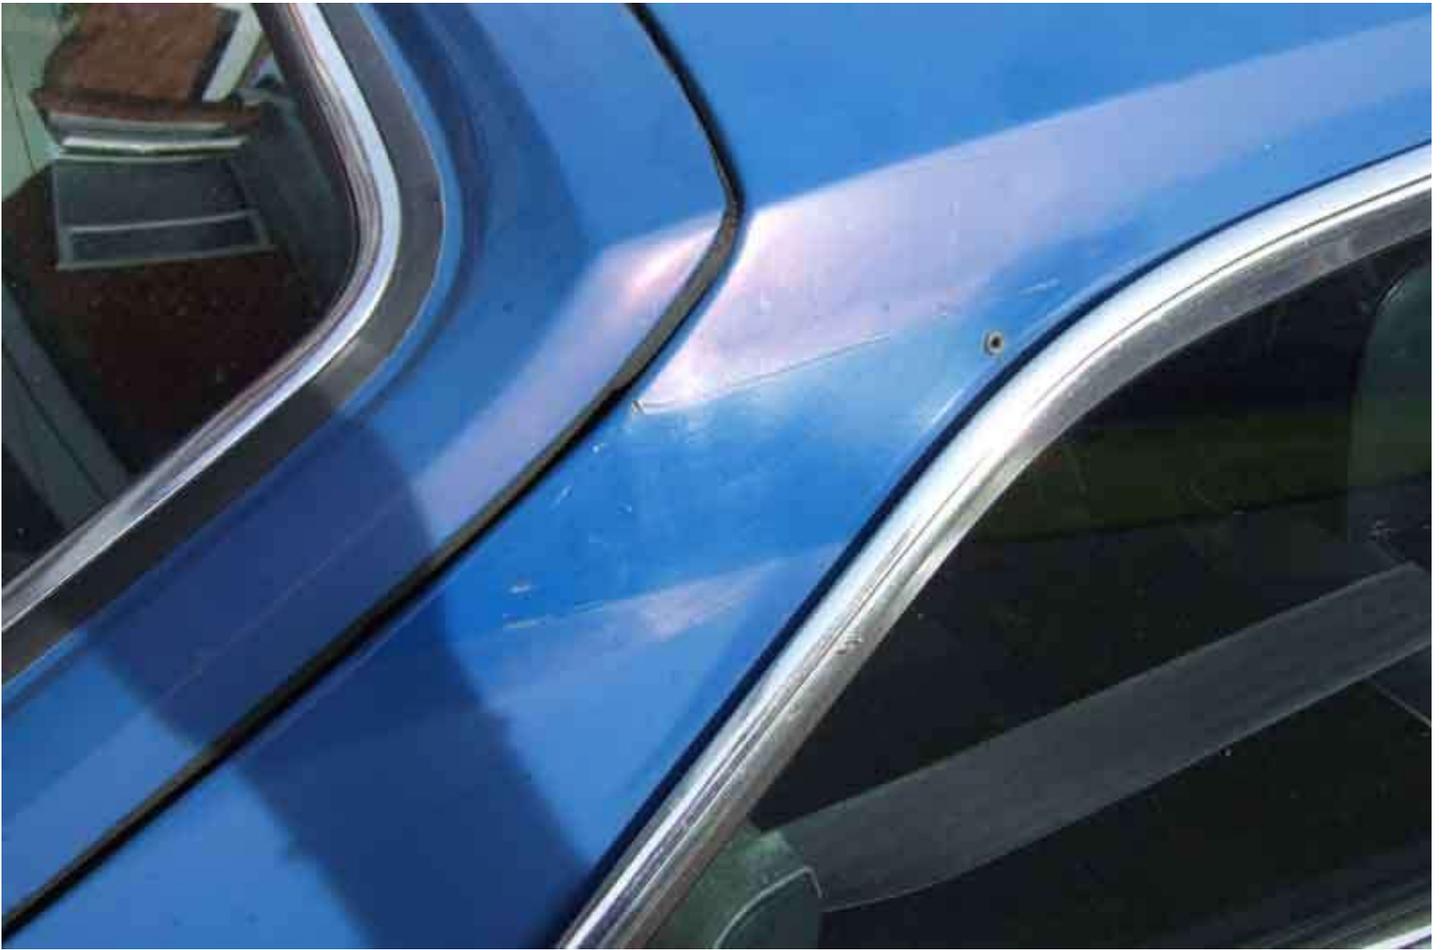
C-panel to roof seams are lead-loading and not filled ...

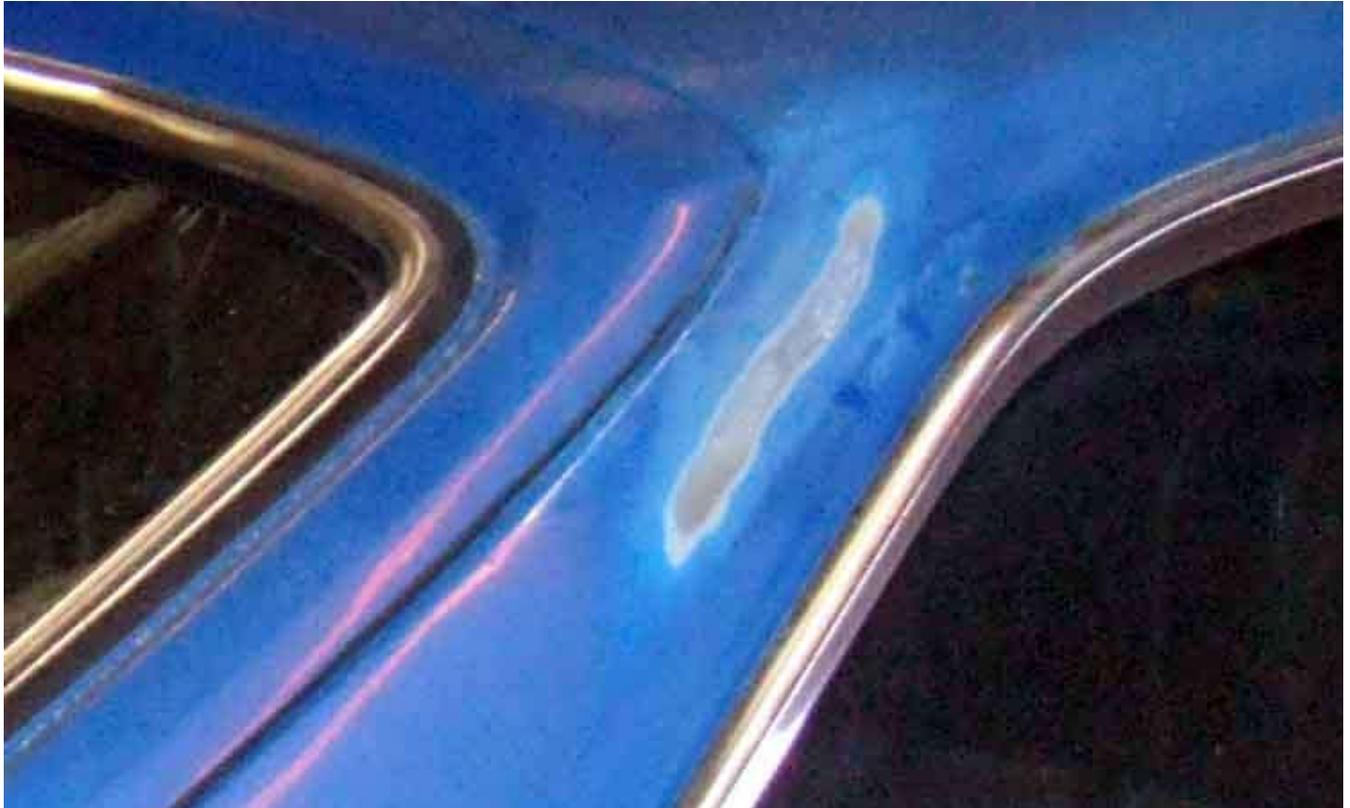
... but the rear panel seams are visible, and in the positions they were while lead-loading was being carried out. It's not a replacement panel as the body-man says it is all original. I've decided to do-away with the 'Spocks ears' as they were never made in gold and they won't match the rest of the badging ... or will I?

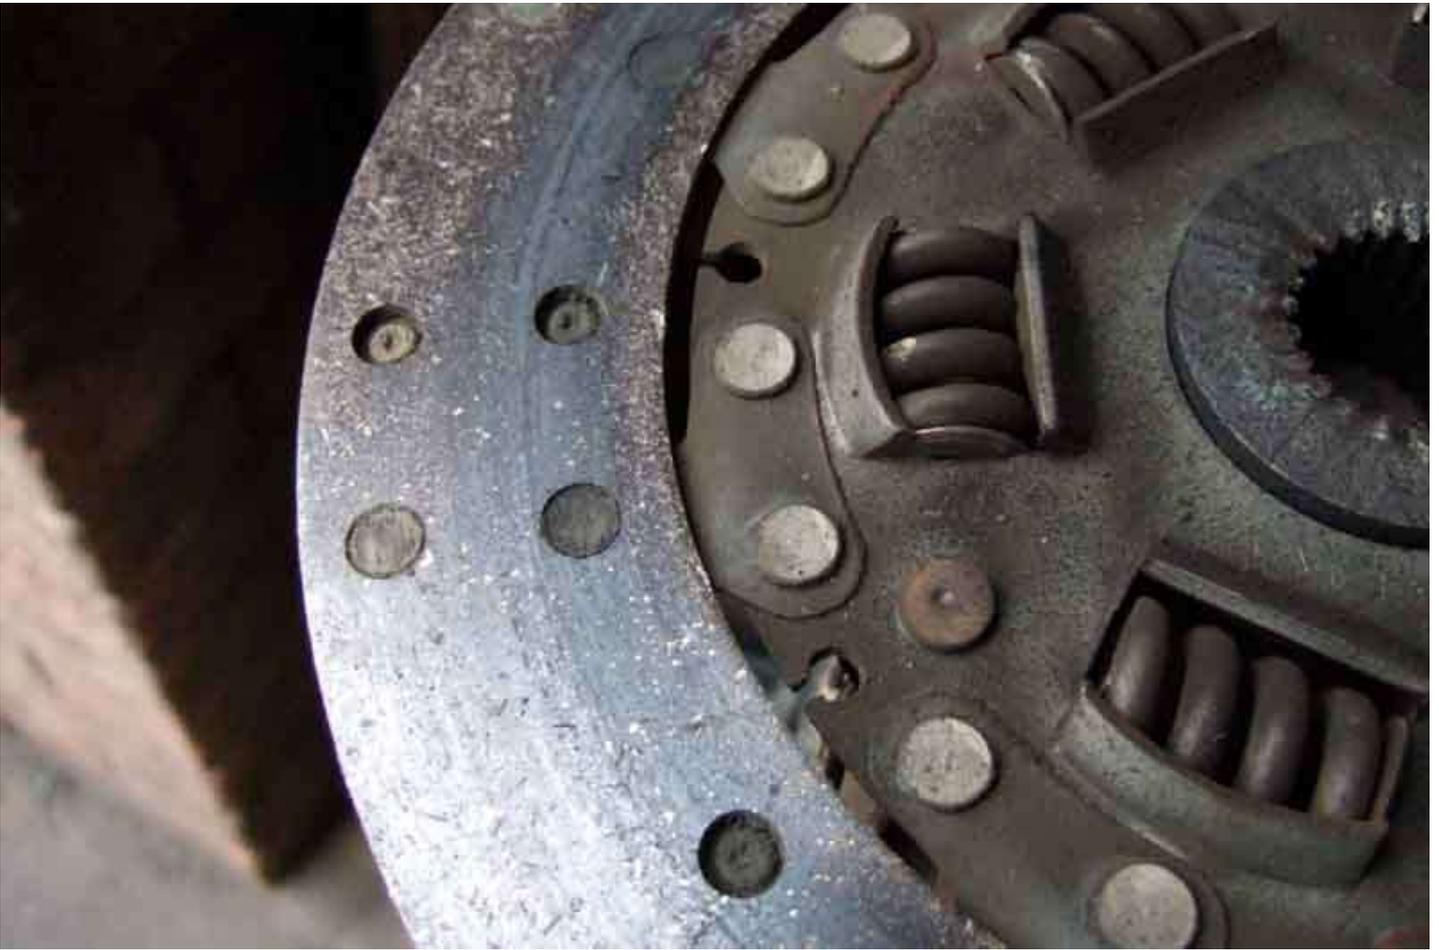
... a bit more meat on the pressure-plate side, but an odd mark in the middle of the friction material. Oil? There had been no sign of oil anywhere else on the clutch or bellhousing. Whatever it is, I wonder if it has been causing the clutch-drag after not being used for a bit.

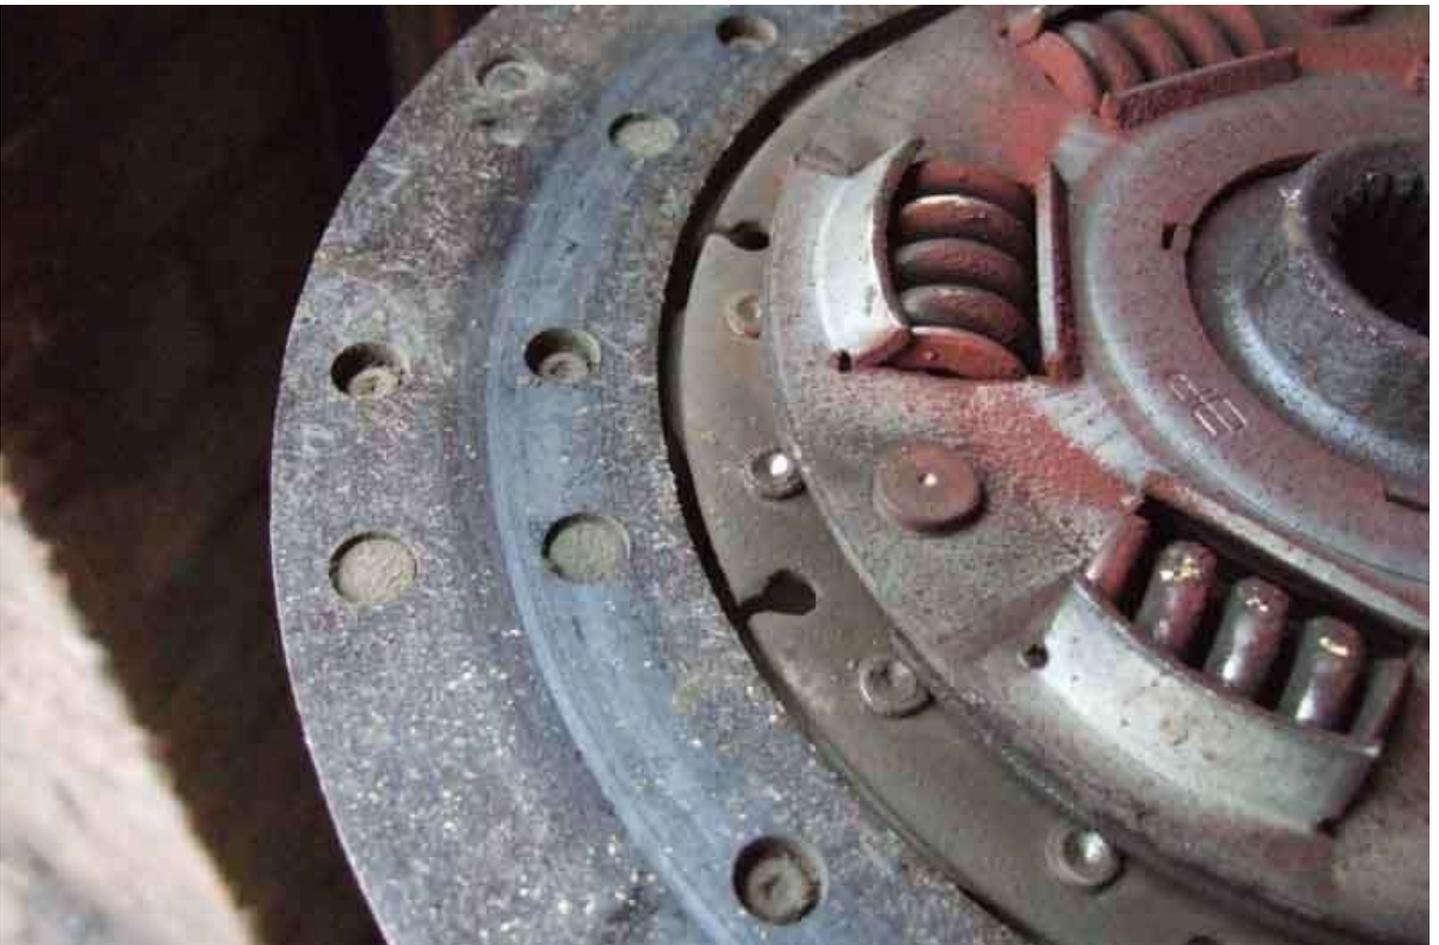
However the flywheel will still need a skim.

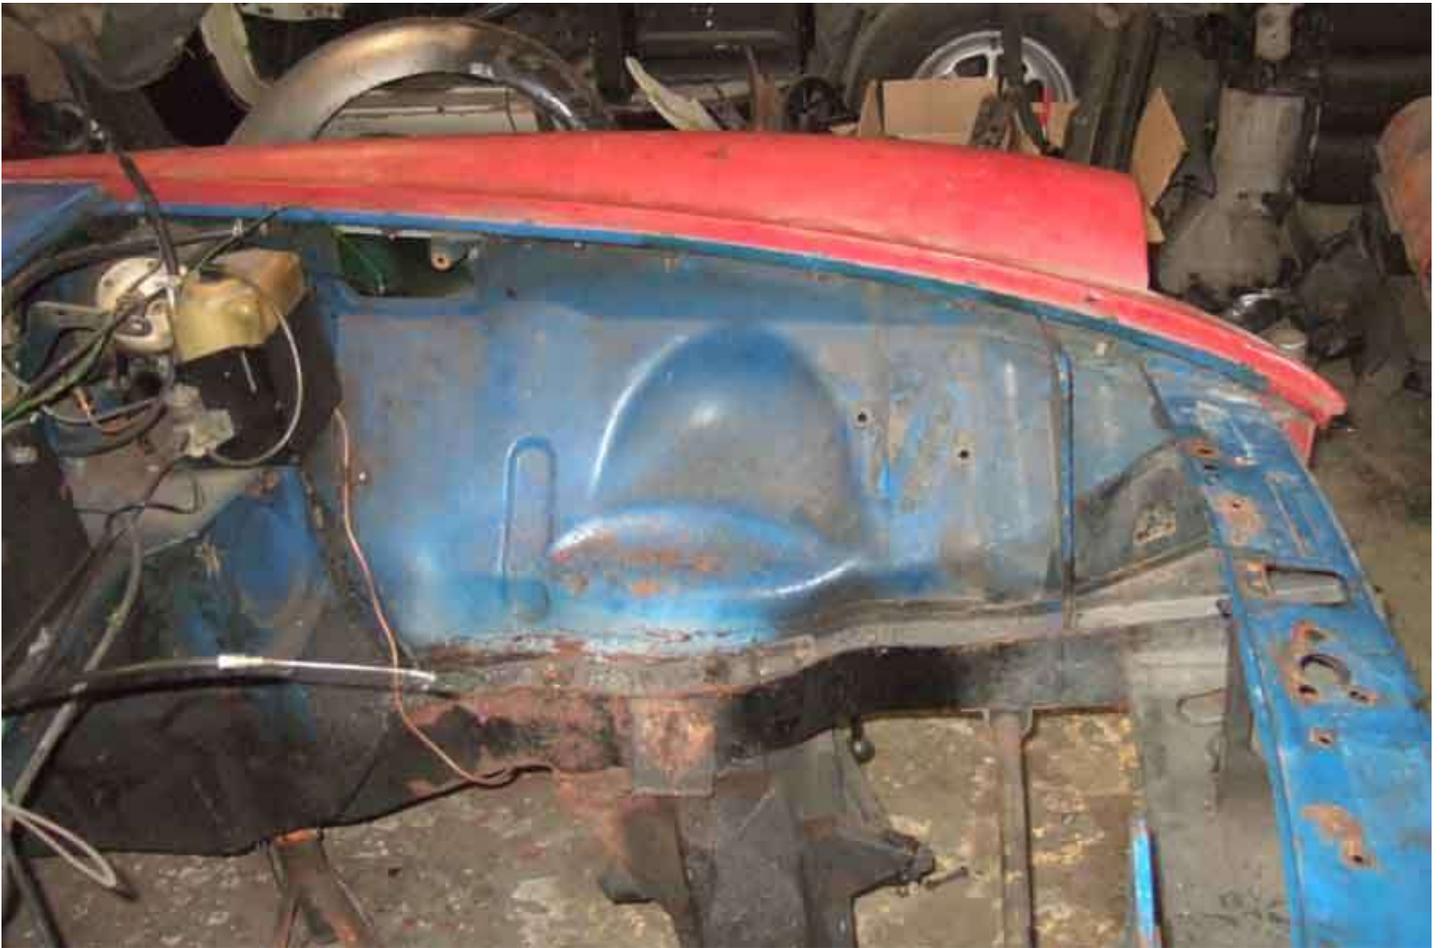
Next day the panels were cleaned, de-rusted, primed, and the chassis rails painted. The panels just above the engine mounts were also dressed back a bit to give more clearance for the tubular manifolds, which had been hitting them despite a 5mm spacer albeit only on the drivers side. I made a second spacer for the passenger side to increase clearance even more.

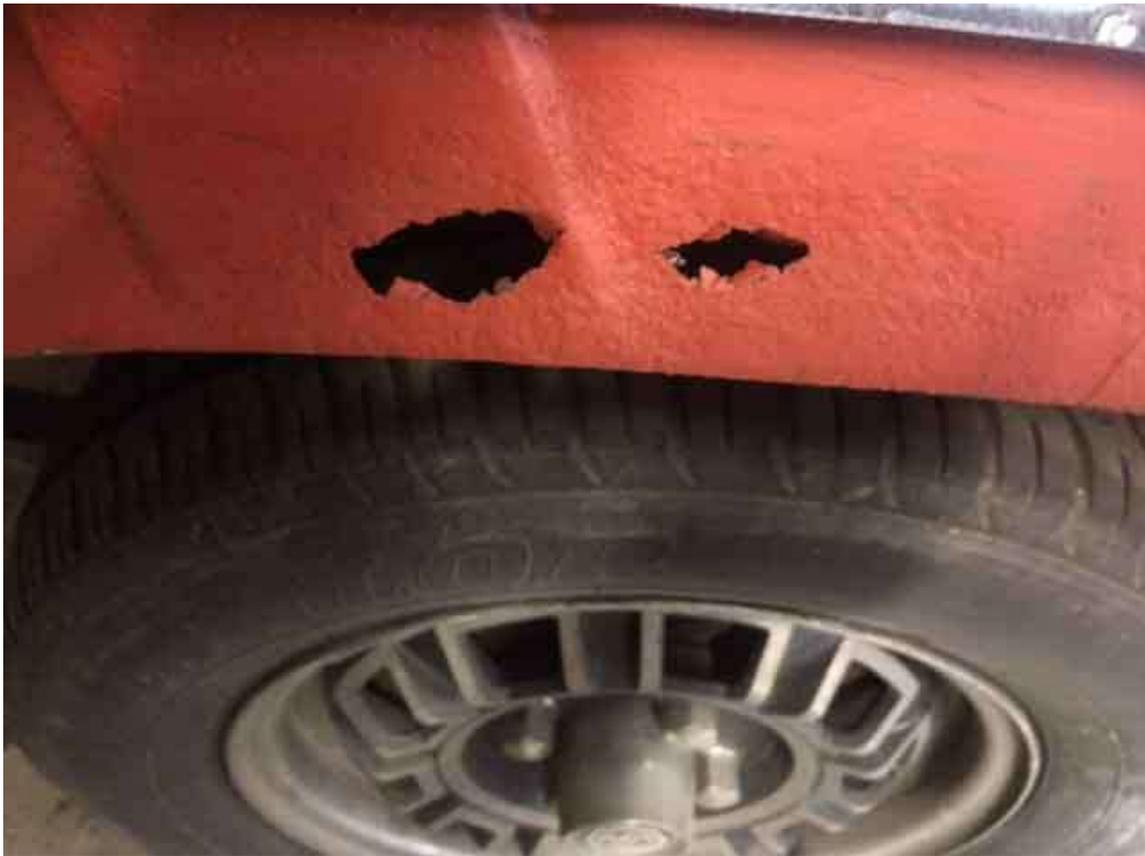
The repair panel even has the crease :o)

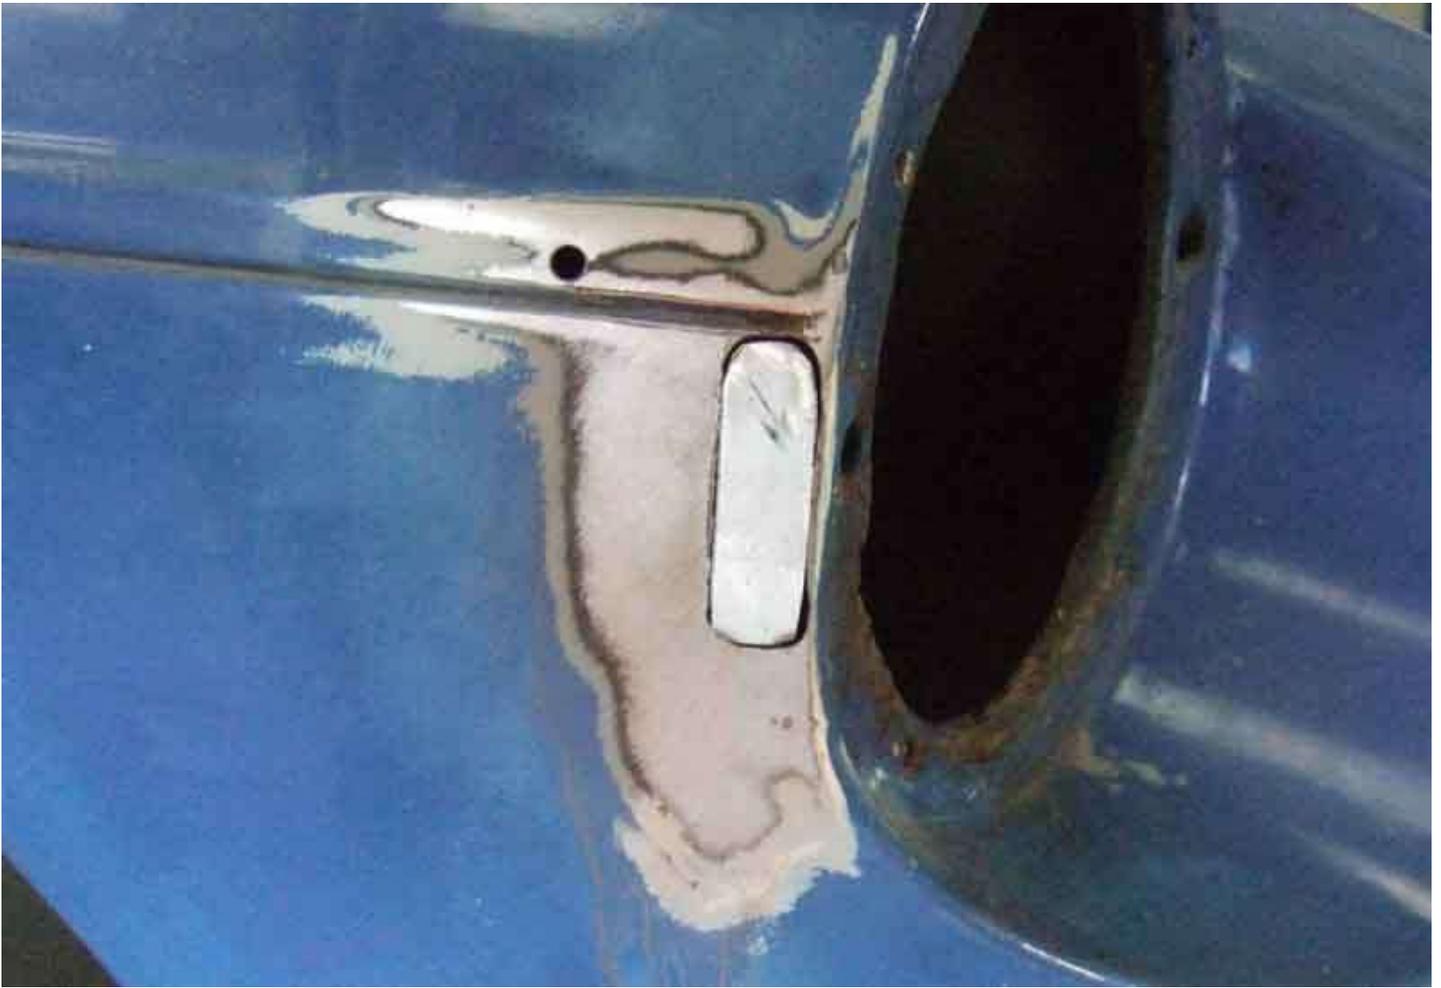
What started off as a pinhole by the OS headlight ended up as a patch a couple of inches square

Invisible mending.

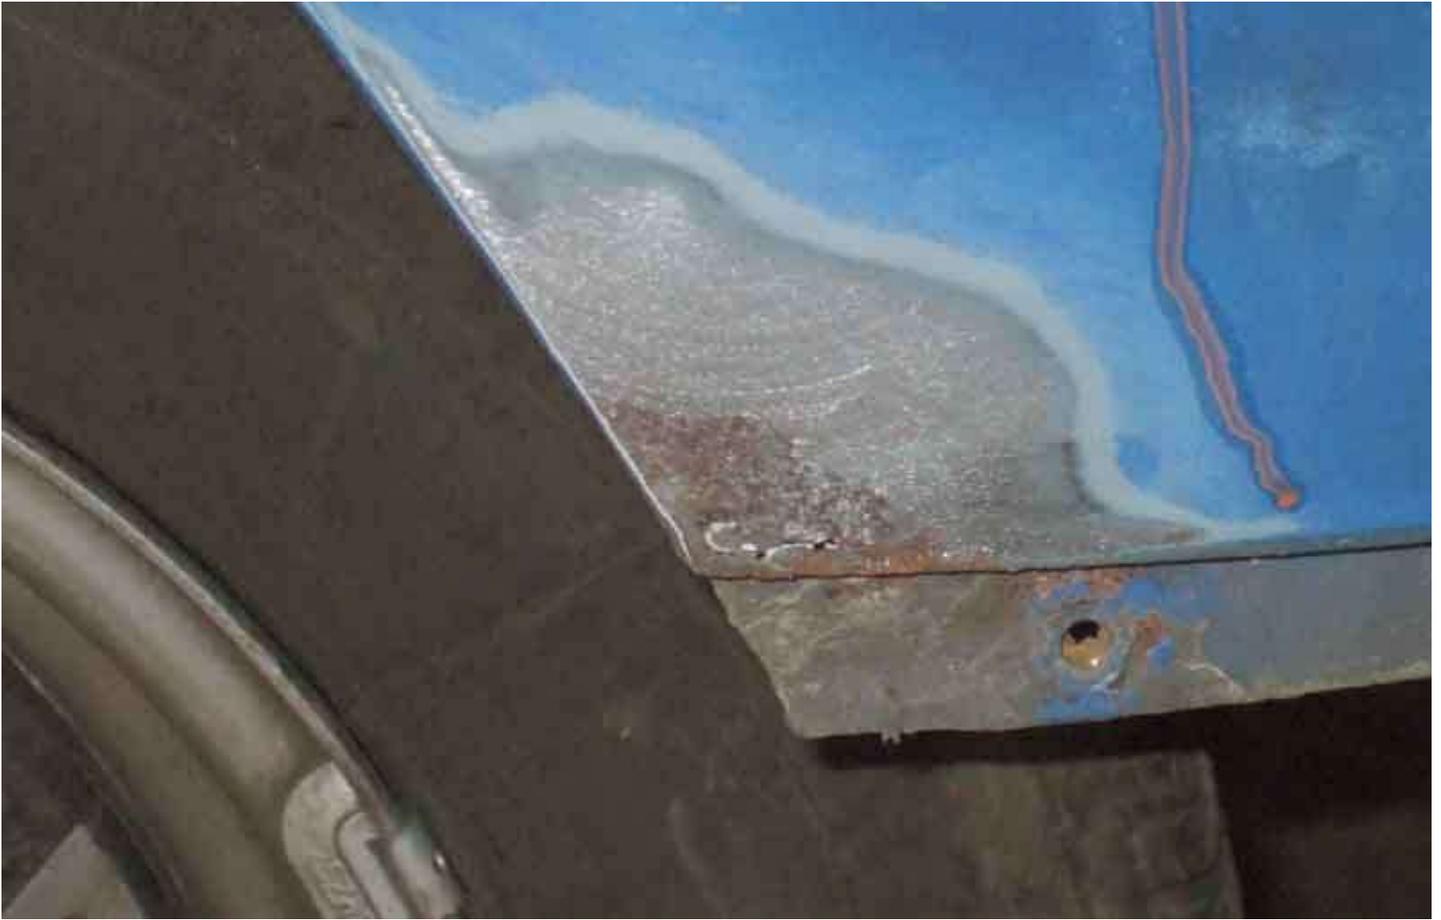
A couple more at the lower corner ...

... but a smaller patch required.

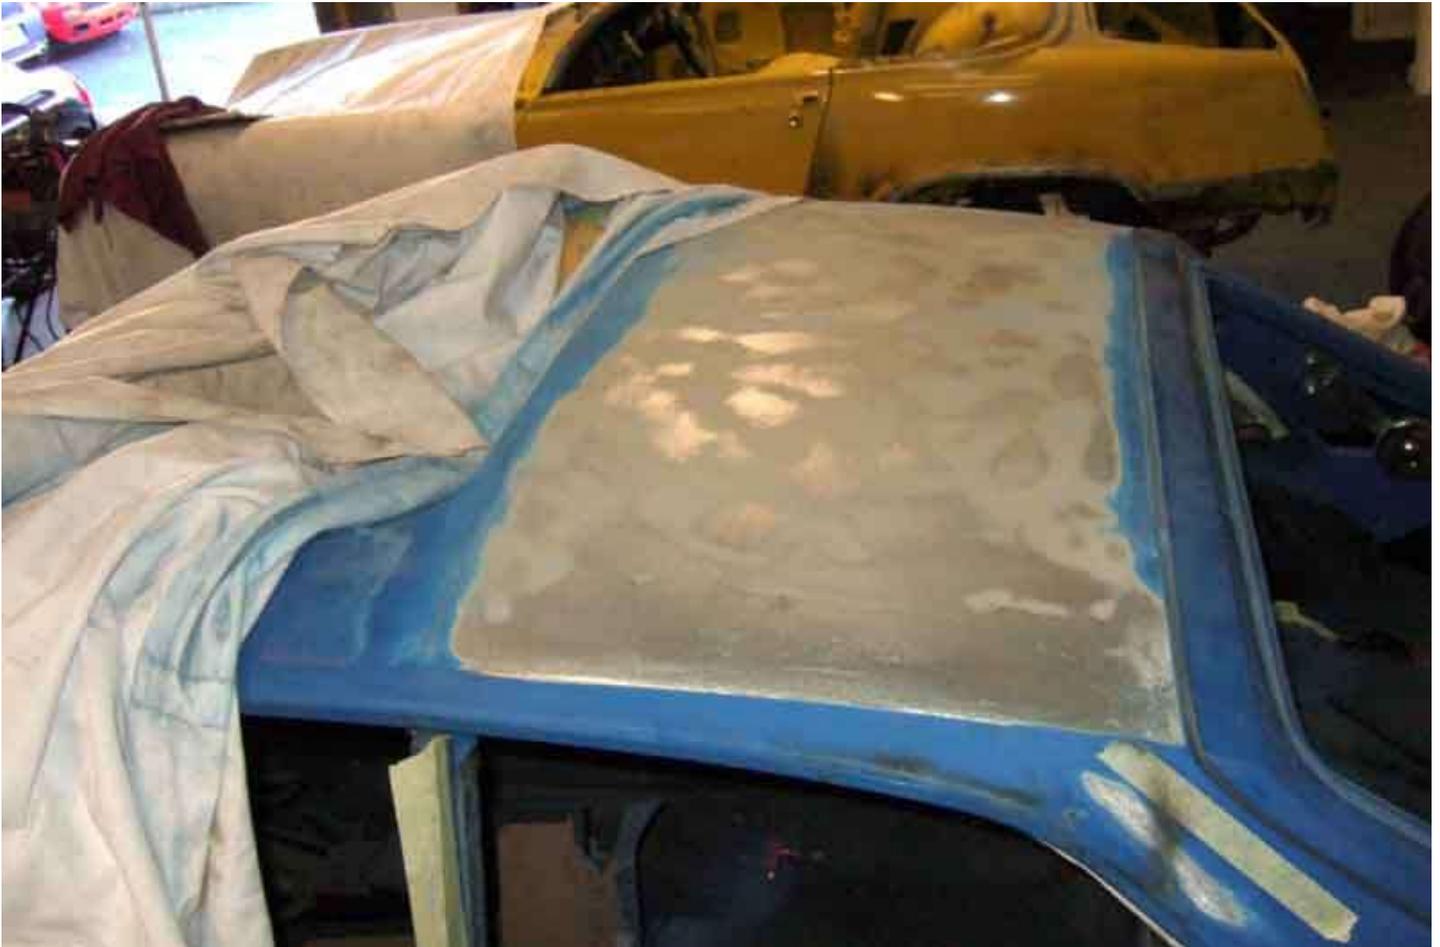
Rear half of the roof stripped back to metal. The paint was cracking and beginning to form scabs where cracks joined when I had the car 22 years ago. I'd treated the scabs which stayed sound, but others had been forming very slowly. When I had the roadster painted he advised me to go back to bare metal, because with multiple repaints the underlying layers can crack as each layer above it progressively shrinks. Certainly paint does shrink over time, on the scabs I'd painted I left them level but after a while they were visibly recessed, and it looked like that is what had happened here.

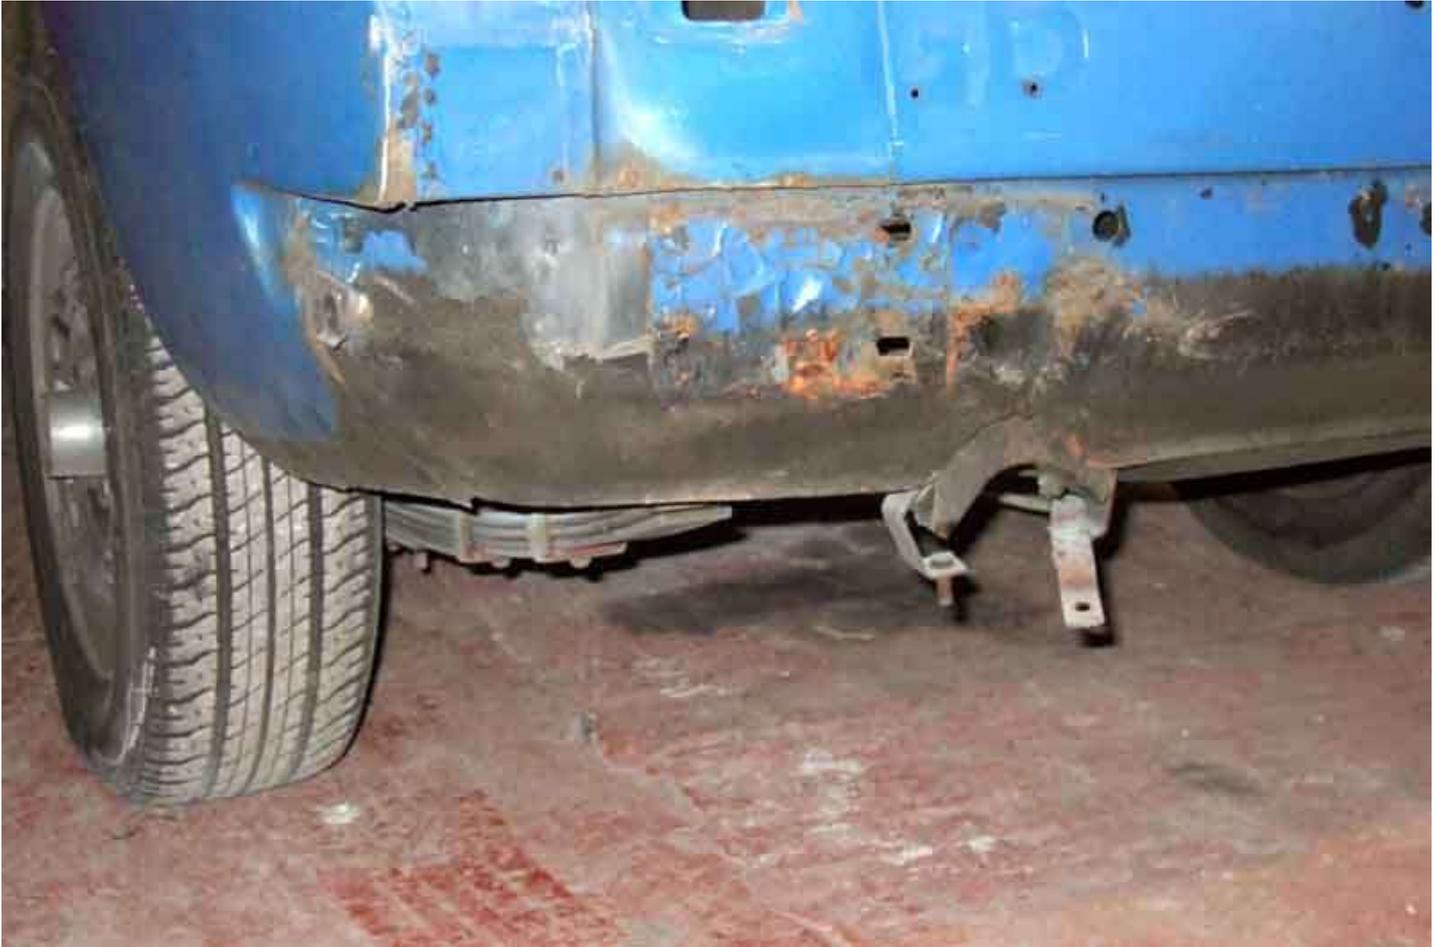
Rear valance to be replaced - at least that was the plan following a visual inspection, but on attacking it with a needle gun de-scaler only two small sections near the bumper mounting holes need to be patched.

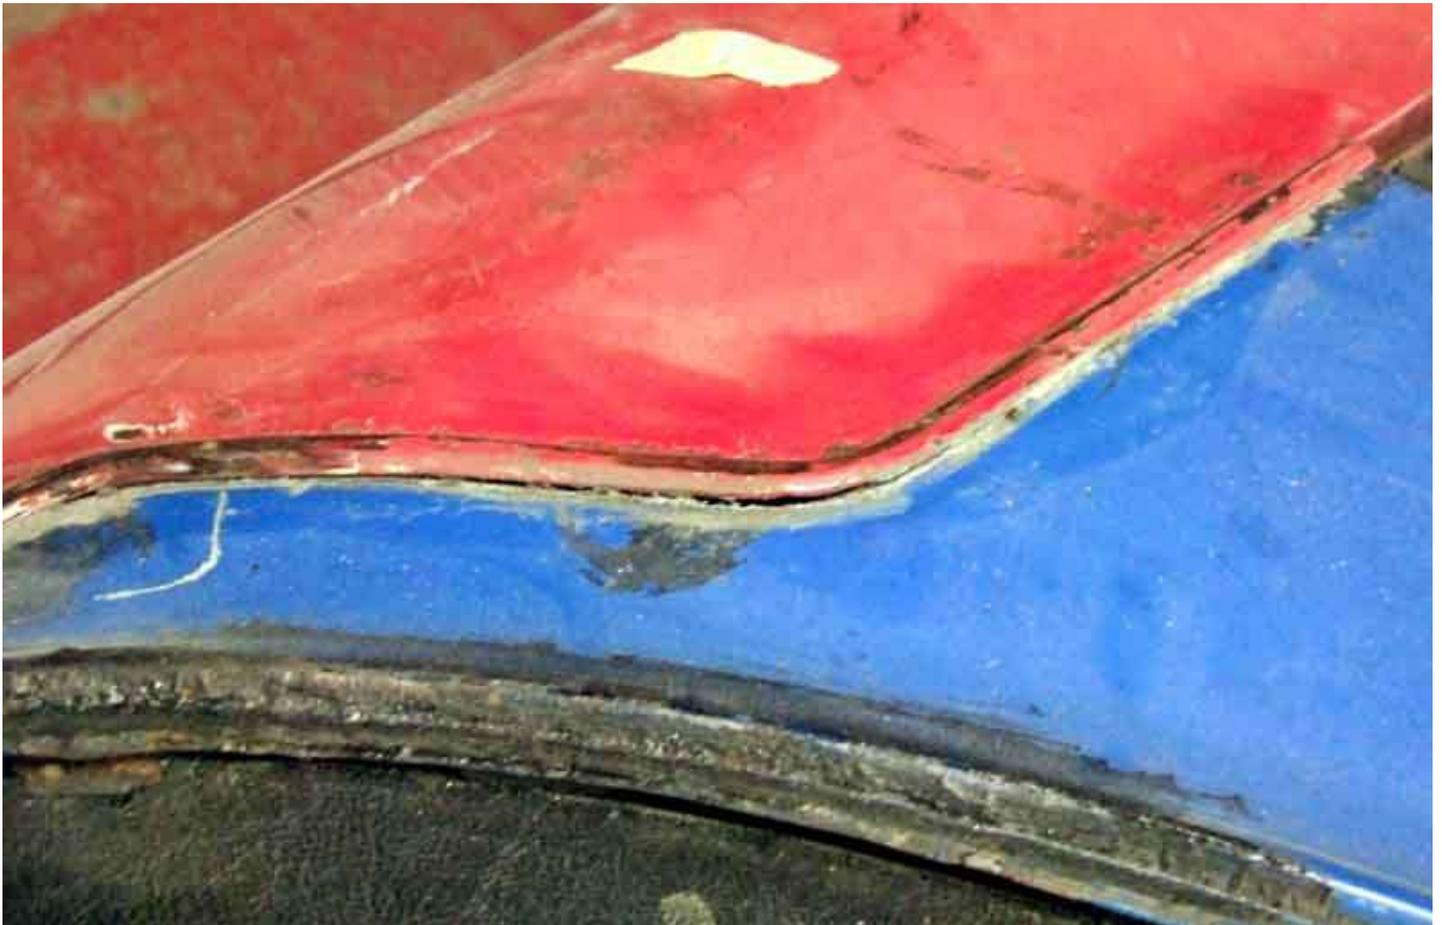
A gap has opened up between the 'new' wing and the panel at the base of the screen, so that will have to be removed and refitted.

Wing removed again for refitting - correctly this time.

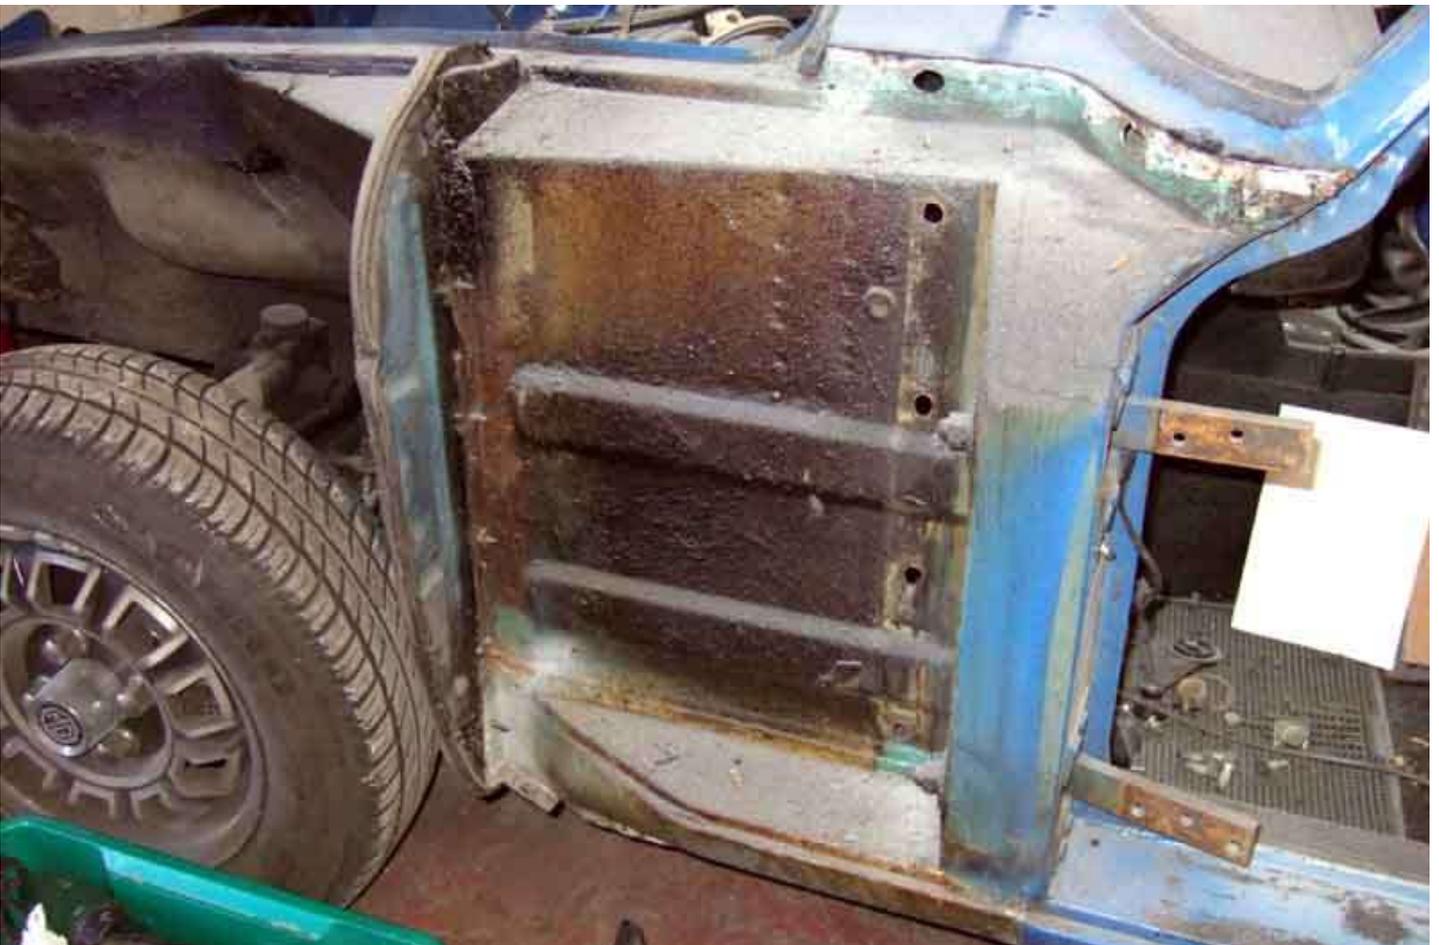
Comprehensively Waxoyled at some time in the past, painter said "That's why the body is so good". It was Waxoyled before my time, but even after 22 years, if summer sun is shining direct on the tailgate for any length of time, Waxoyl drips out of the latch aperture.

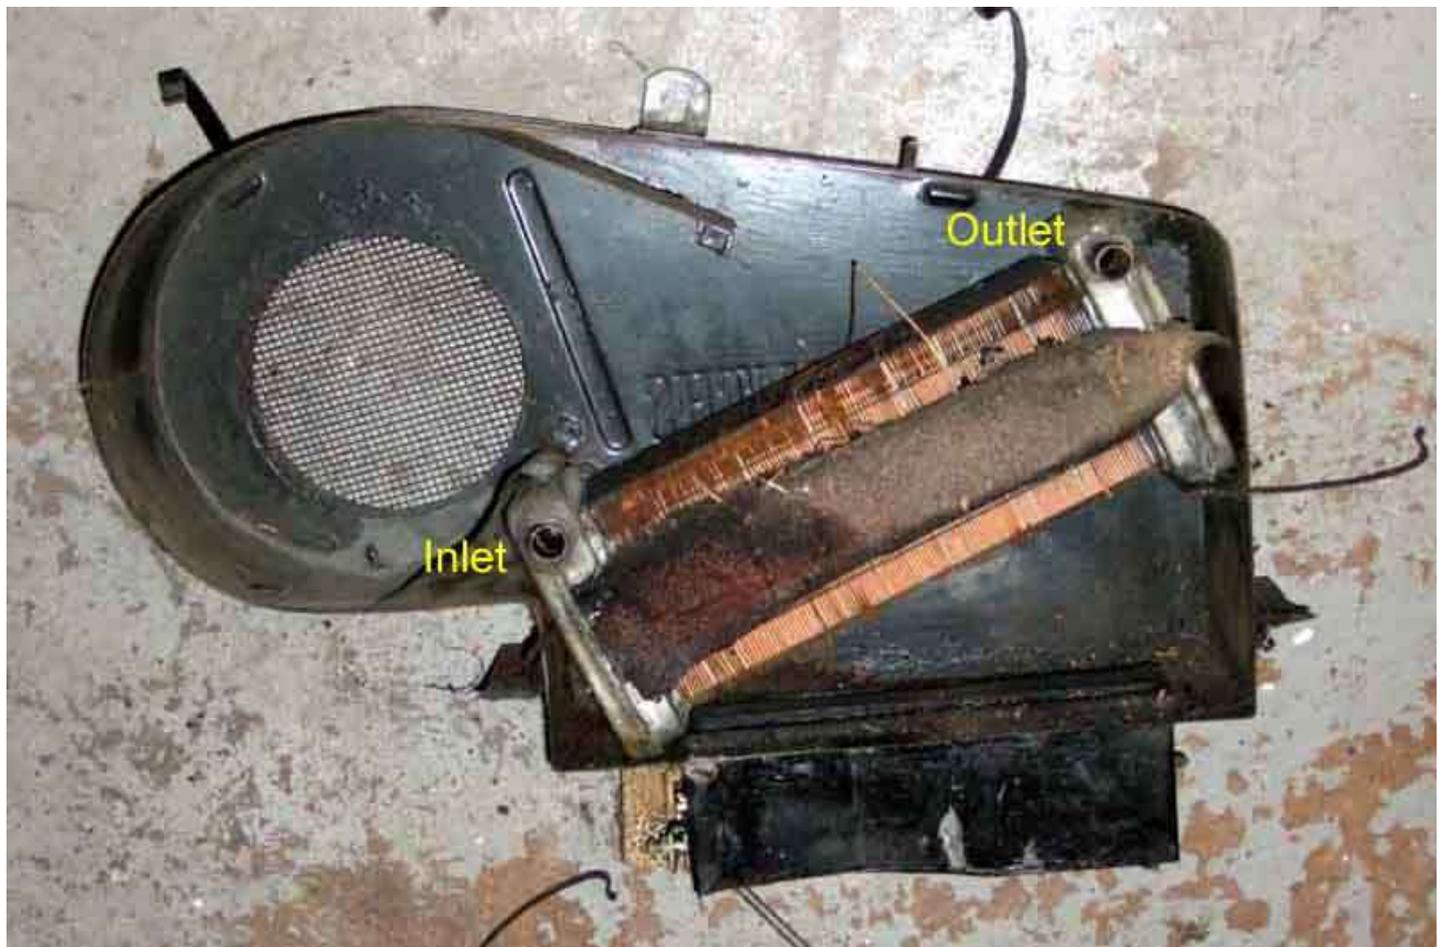
Heater cover removed, manky foam on top of the matrix ...

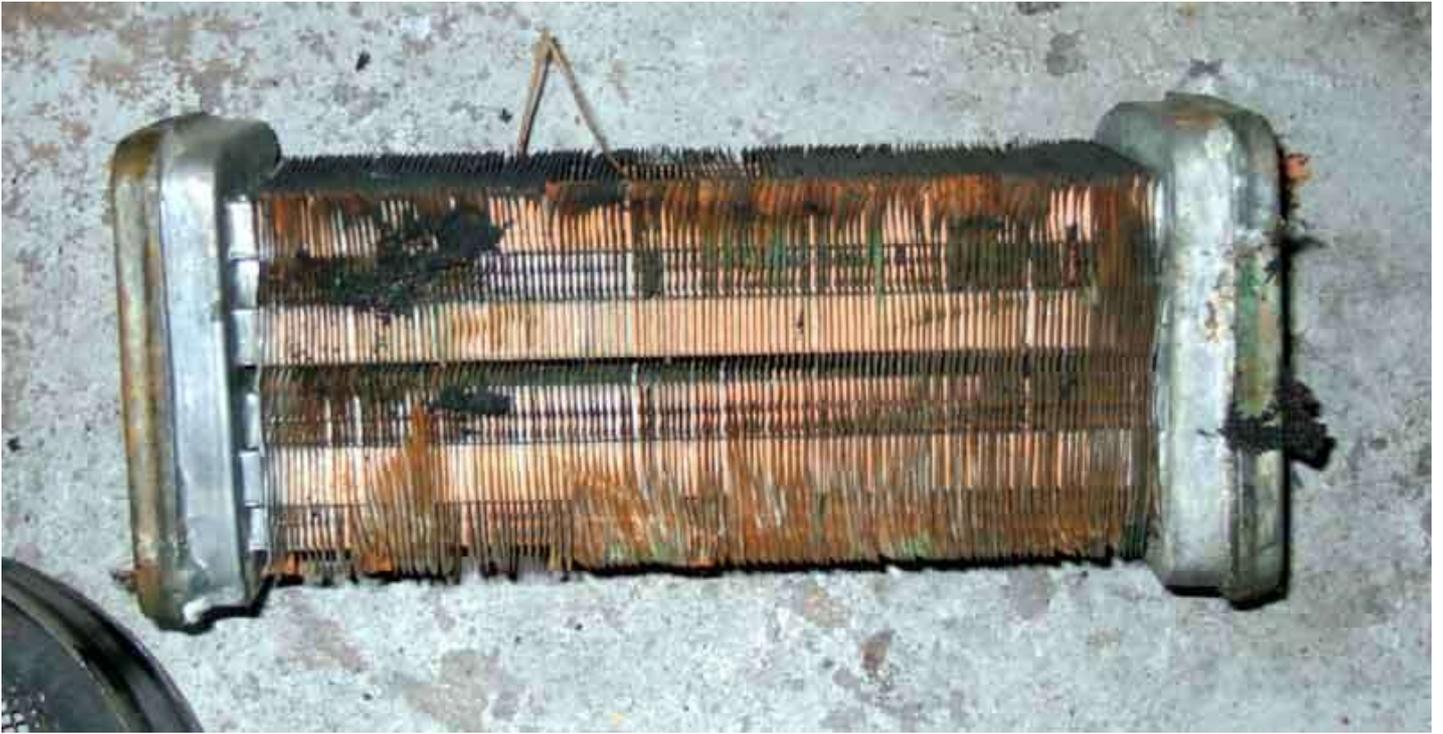
... and no foam at all on the other side ...

... just lying in the bottom. This means that a significant amount of air would have been able to bypass the matrix, reducing its output. I'm not surprised, in the past I've noticed little bits of old foam blowing out of the vents from time to time, and it's never been as effective as Bee's heater.

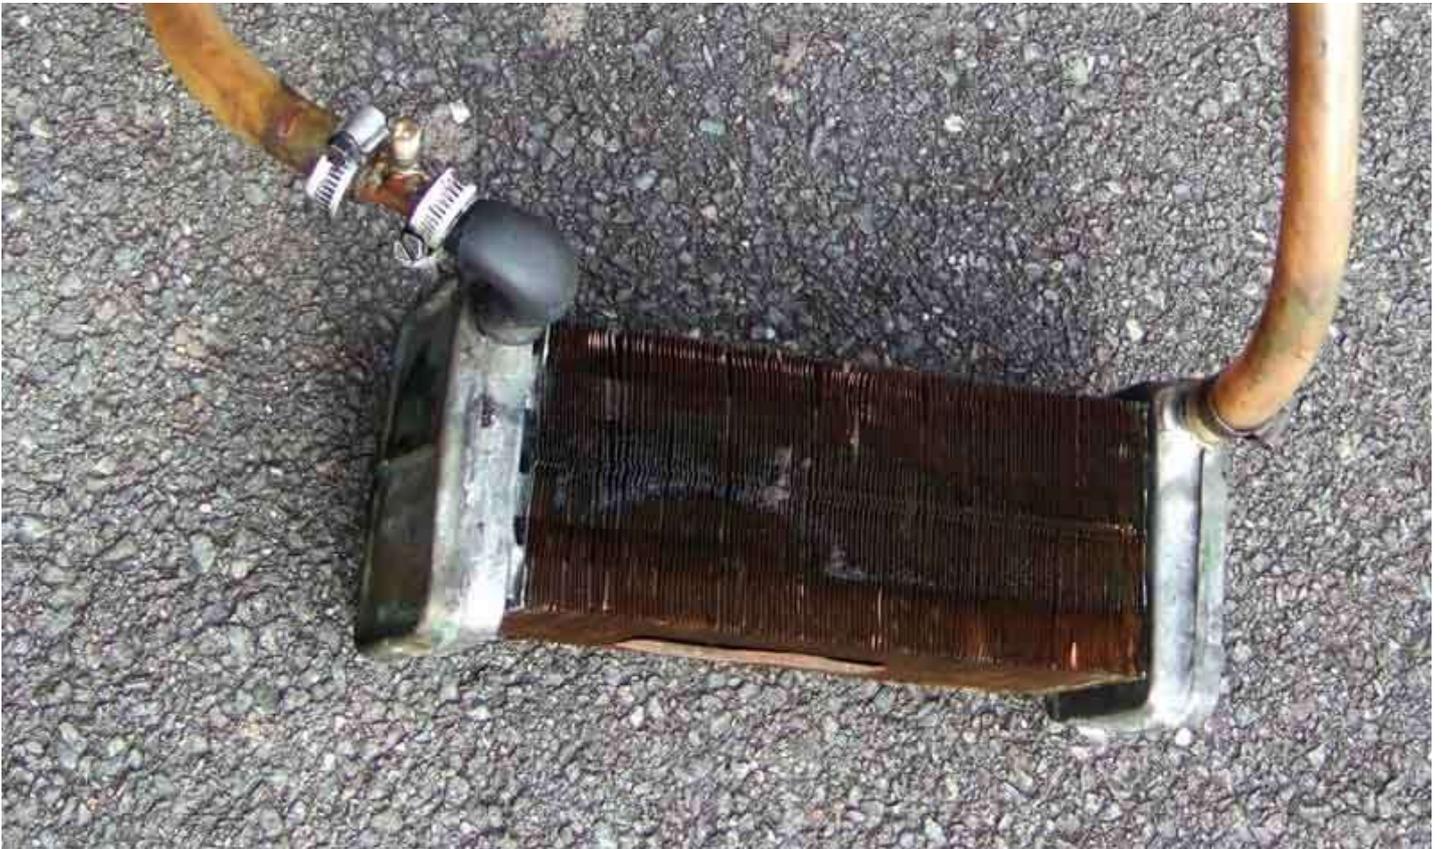
The heater casing is in quite good condition, but a rough (to the touch) area on the top proved to be very slight rusting under the paint, so the case and cover gets rubbed down to clean metal, two coats of zinc primer and two of satin black to-coat. I decide to pressure-test the matrix. In the past I'd made a Tee with a Schrader valve to insert in the small remote header tank hose to pressure-test a pals late-model system, so wrapped duct-tape round that to build up the size to fit a length of hose that would fit in the matrix spigots, and used one of the rocker-cover breather hoses on the other matrix spigot. Used my foot pump to build up some pressure to prove it was air-tight, then poured water into the matrix to a level just above the tops of the spigots, then pressurised it to 20psi. Left it overnight, still some pressure left next morning, but more importantly no water on the vinyl-topped workbench, so the matrix is fine.
