## Ignition Woes – an endemic modern problem?

by David Bolton

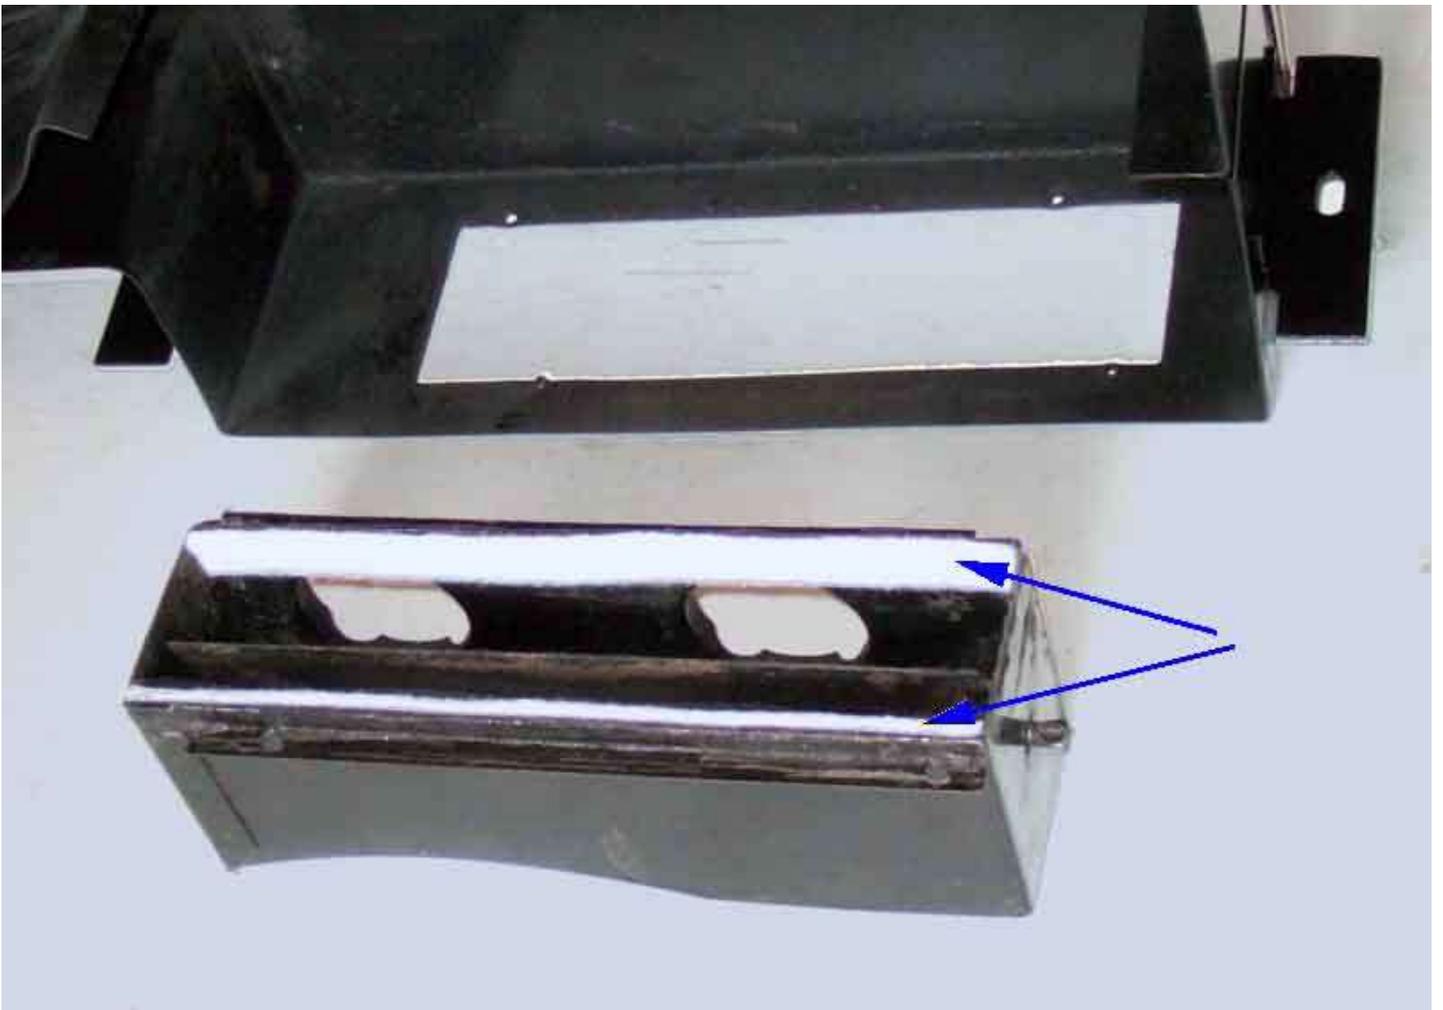
The section that contains the air-direction flap is screwed to the bottom of the main case, so can be removed making cleaning and replacing the felt easier. Originally there seemed to be strips stuck to both sides of the top and bottom of the air channel, plus two or three stuck to the movable flap as well, i.e. about seven altogether. I used 3mm felt from a hobby-shop and felt (ho ho) that four pieces stuck to the channel top and bottom and both sides was thick enough to form a seal with the moveable flap at either of its extremities of movement.

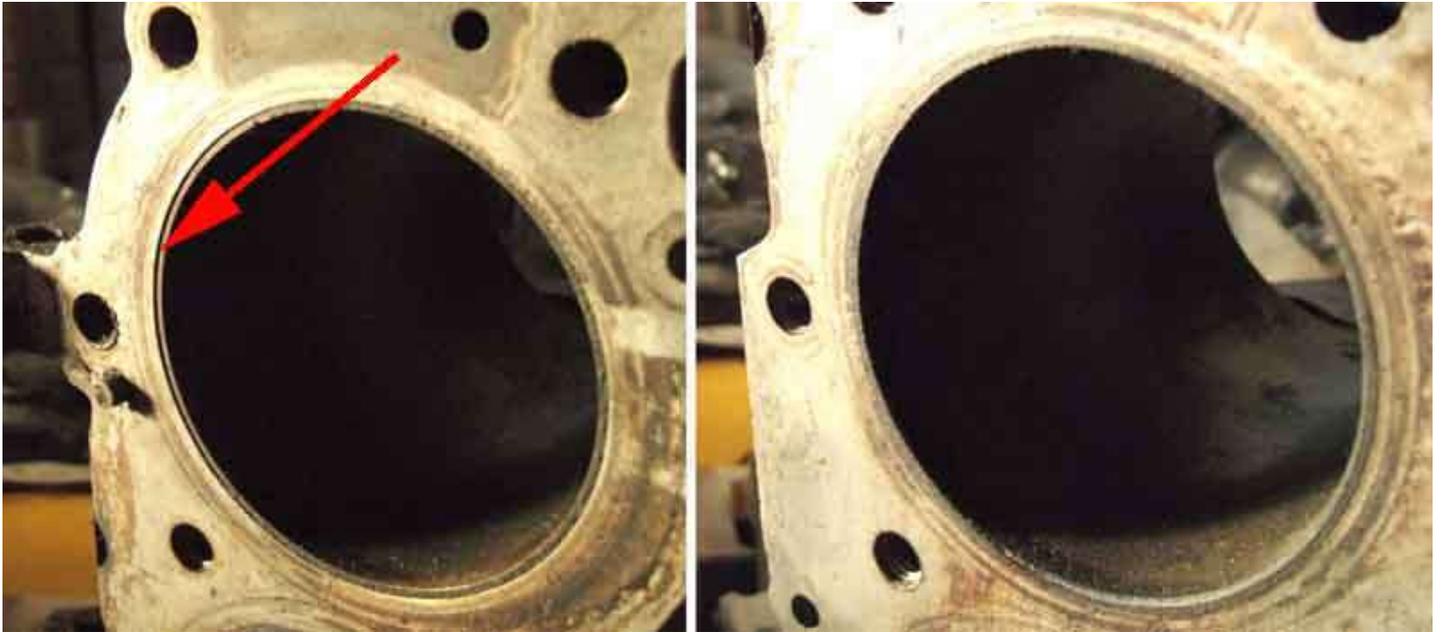
He also had a look at the old block and said it was no good as the liners were slipping, and indeed you can see that it has for No.1 cylinder on the left here, all the others are flush, as with No.3 on the right. Lit from the left clearly shows the recession:

The noise has certainly been coming from the front, less easy to decide which side, and it seemed to be coming from both top and bottom. It certainly wasn't like that when I had the heads off over 10 years ago as I was looking for it. Nor was there a gap to the 'lip' at the bottom when I had the sump off a few years later. And more recently when I had both the sump off and one of the heads it was the other head. But of course, it would be typical of the Law of Sod that when looking at the top it would be up, and when looking at the bottom on another occasion it would be down.

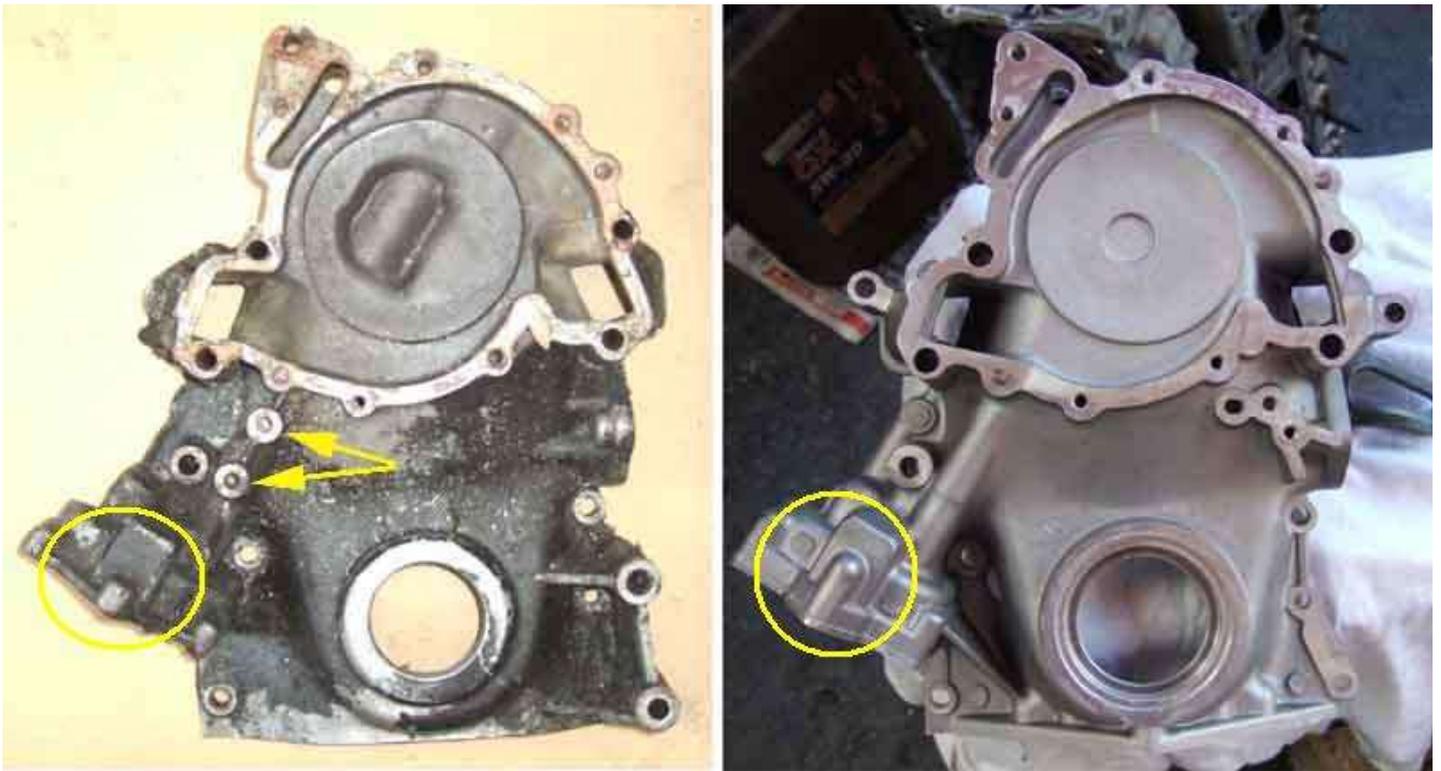
Original (left) and replacement (from Clive Wheatley, right) front/timing covers. No mounting points for the original timing pointer (arrowed) on the new cover, but Rimmers have a modified pointer (£45 inc P&P!) which hopefully will mount to the new cover somewhere. Deeper oil pump gears (circled) should maintain oil pressure at hot idle.

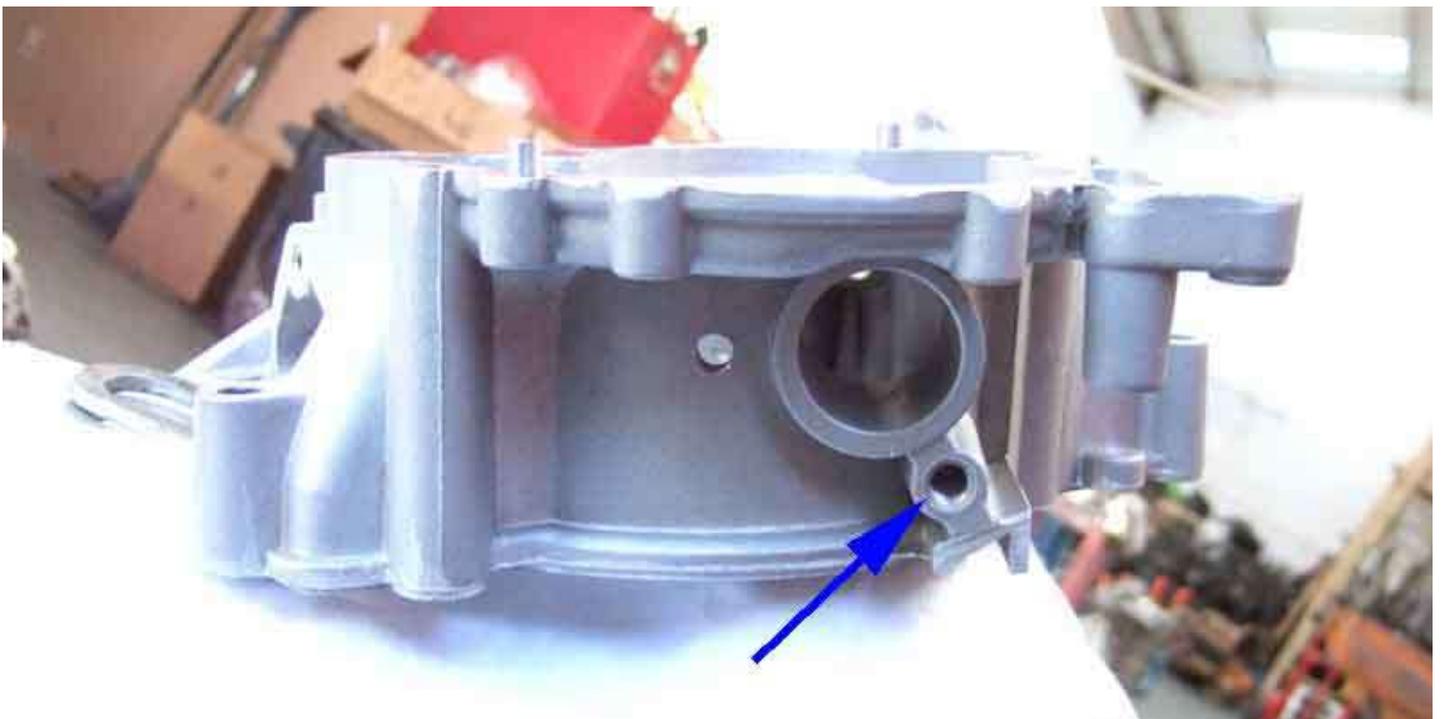
These covers also have another tapping under the distributor (arrowed, the other hole is for the distributor clamp bolt), which has to be plugged for this application - I'll be using a 3/8" x 3/4" UNC button screw. A grub screw has been mentioned but you don't want that screwing itself into the cover and hitting the timing gears. Also Clive's remanufactured water pumps have metric tappings for the pulley despite him having asked for - and got - Imperial in the past, taking an M6 x 16mm fully-threaded set screw in place of the original UNC.

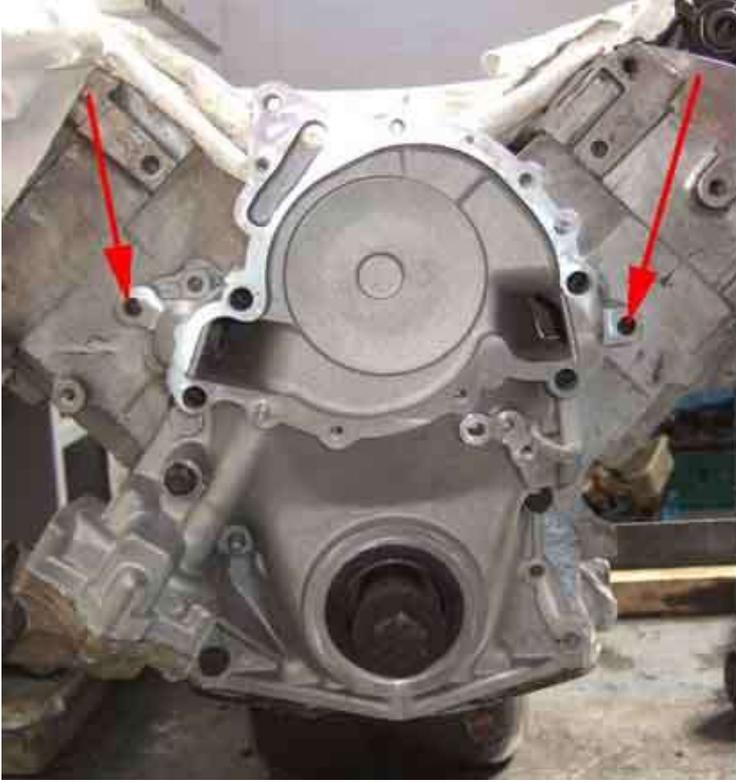
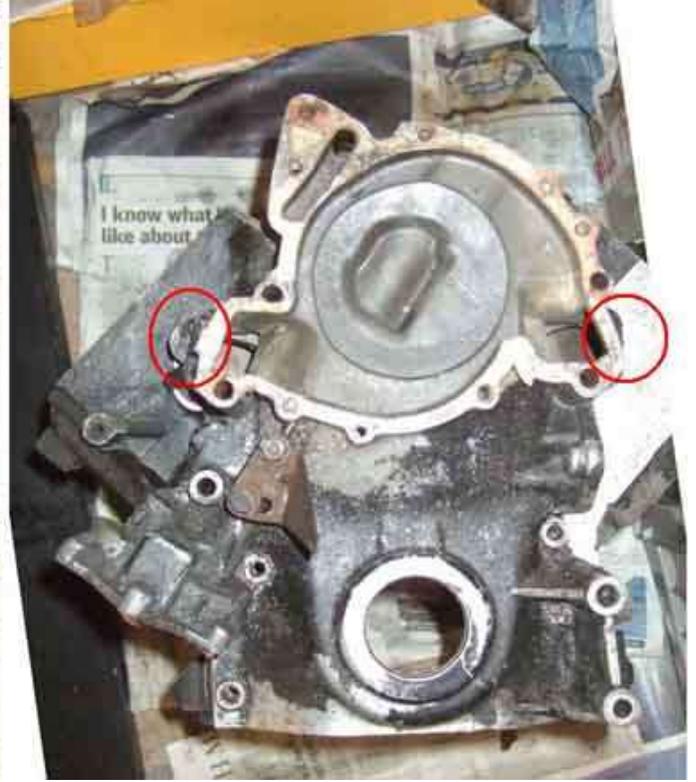
Tuesday came and went and it was only when I phoned to ask what was happening that he informed me there was a problem with the front cover, something about bolt holes not lining up, but as usual he gabbles away, talks in half-sentences, and ends up saying "but it's up to you". So another trip over there after a night stressing about how big the problem was, only to find that there isn't a problem at all. This modified cover has two extra lugs with bolt-holes, that have nowhere to go on this block. But they have all the original bolt-holes as well, so these can simply be left. One would think he would have had enough experience to know that, but there we are.

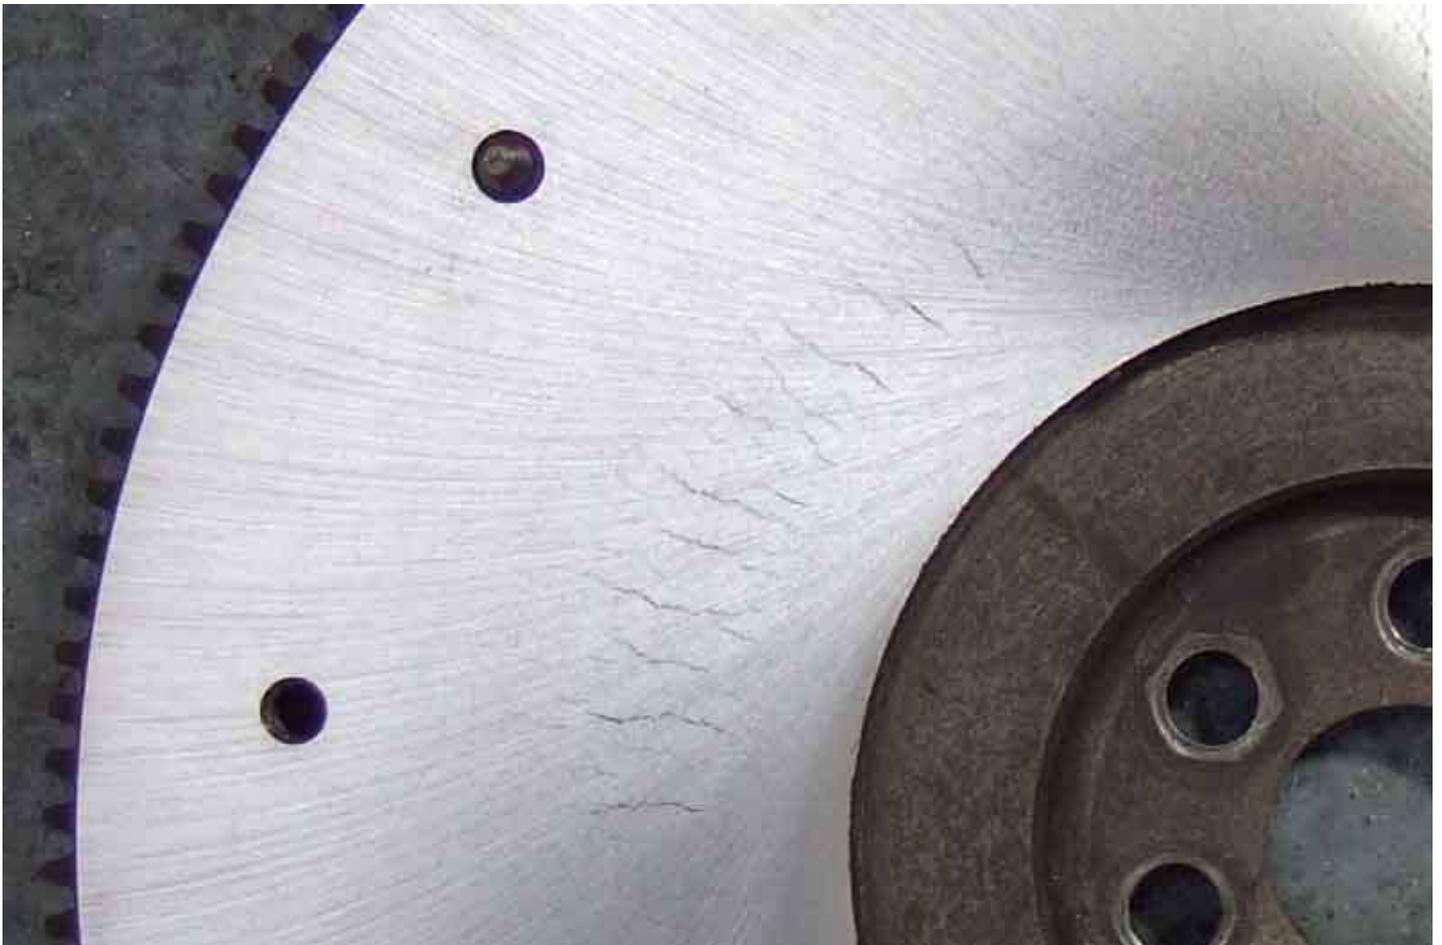
... he said it was pretty bad, and hasn't been able to machine all the surface cracking out.

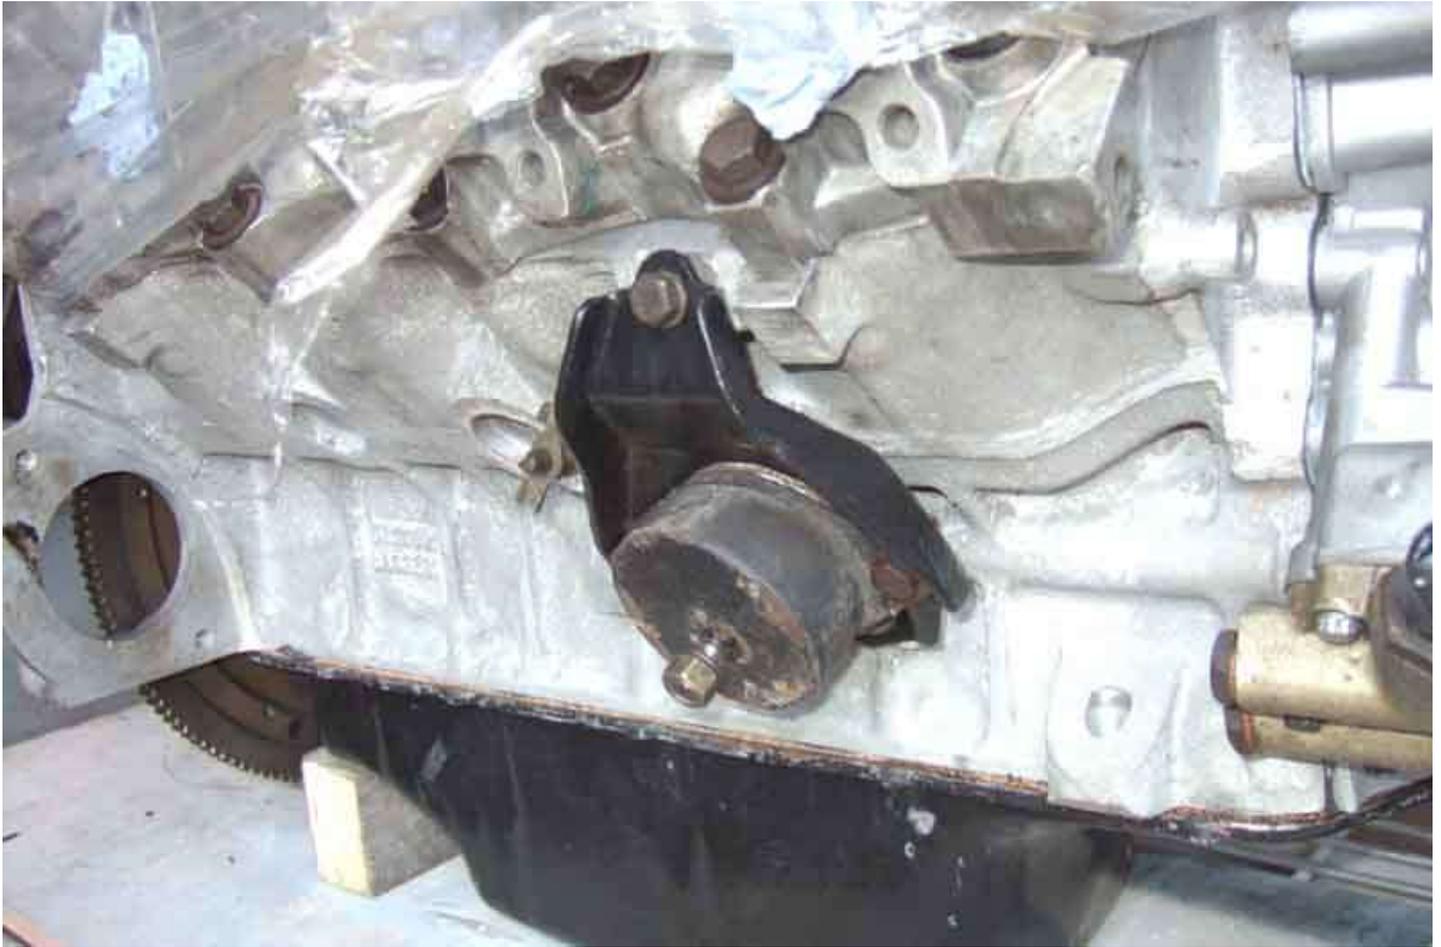
Engine mounts fitted. Only discovered then that the upper bolt had sheared off in the block, so flush it was almost invisible. The mounts were the only things I didn't trial-fit to the block. But using the mount plate - held by the lower bolt as a guide - I drilled and retapped. Also found one of the block drain taps damaged, but I had taken a couple of spares taken from the old block and another I had and replacement only took moments, although the off-side one tripped me up later on.

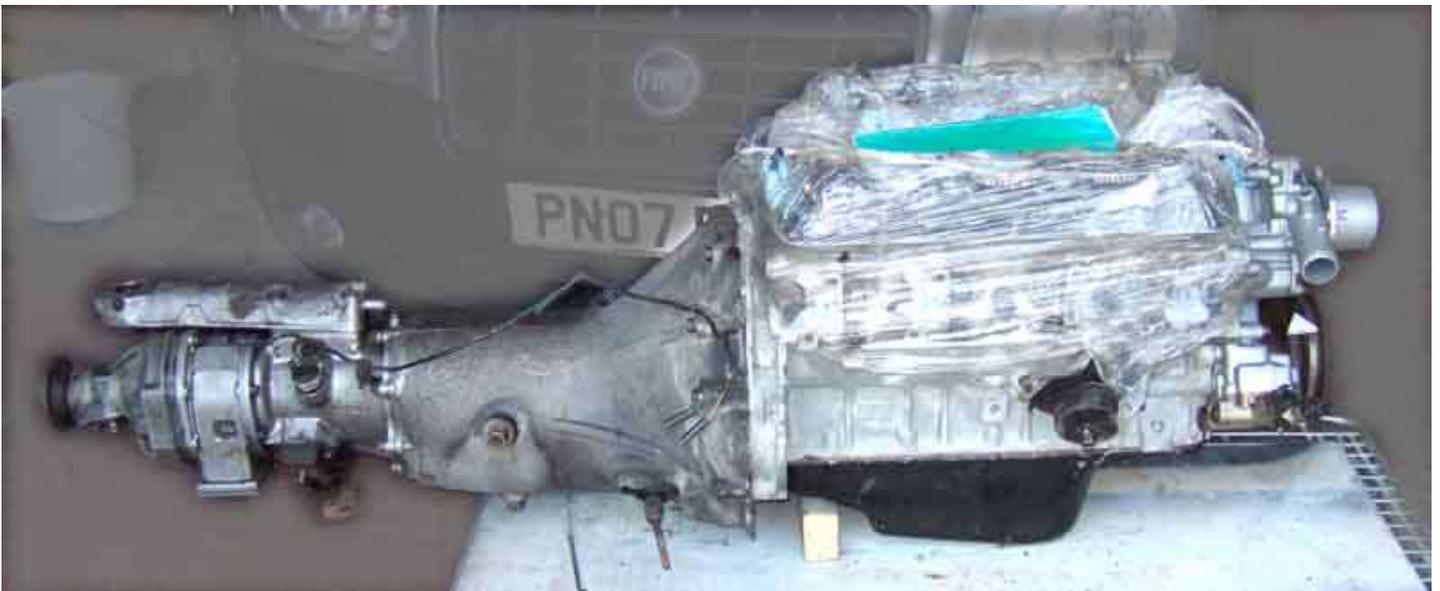
Gearbox fitted and ready to install. However big problem with the release bearing - it wouldn't fit as it was a completely different design! [Details here](#), I had to reuse the old one.

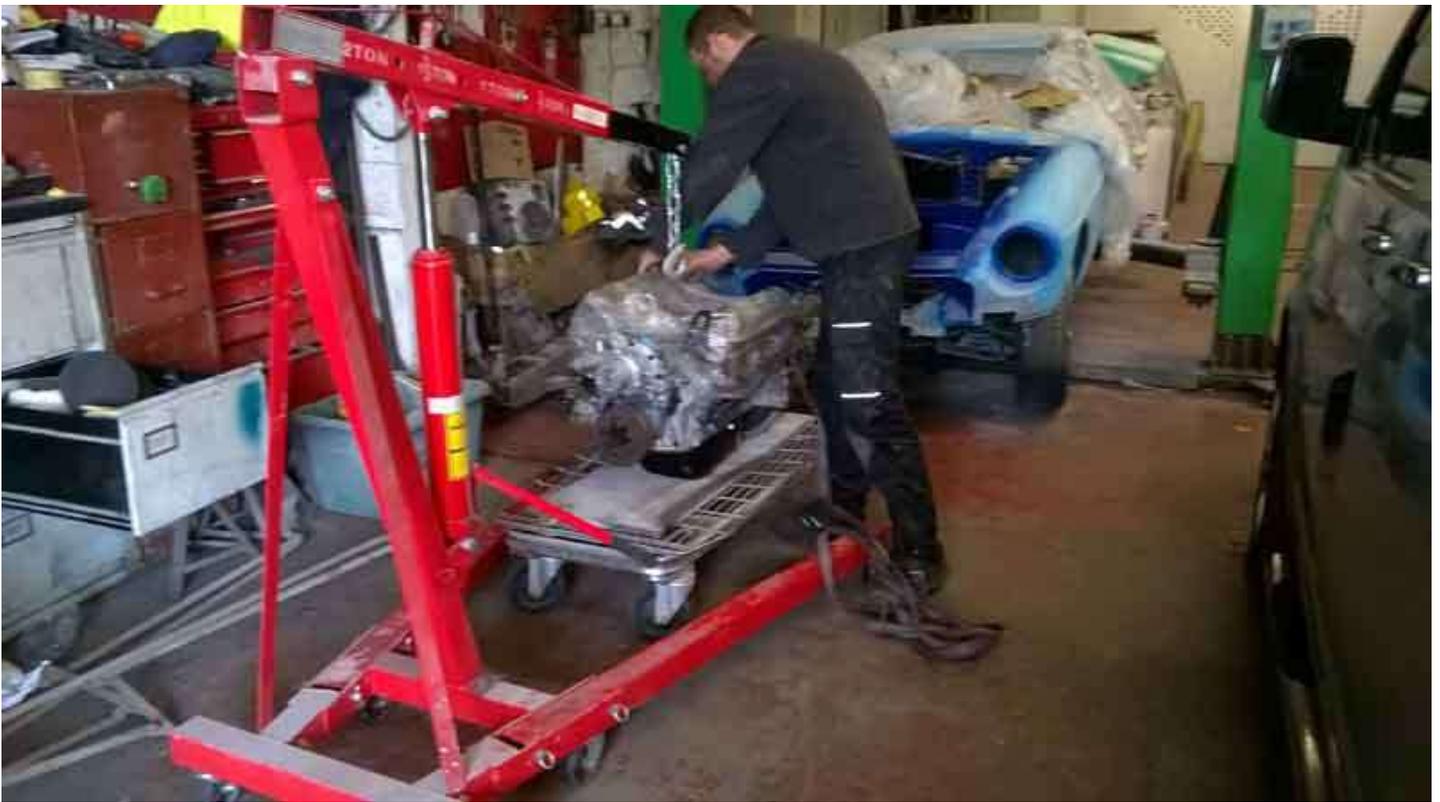
It was only after looking at these pictures I realised the engine mounting plates were on the wrong sides, despite what I thought was careful consideration beforehand. They are handed, fit either side, but make a fore and aft difference in the position of the engine by about an inch. Vee came to me with them on the wrong sides, only discovered when the sump wore through from rubbing on the front crossmember. Changing them over at that time with the engine in-situ was challenging! Next day I confirmed they were on the wrong sides, so swapped them over. You also have to be careful to get the chassis studs in the lower of the two possible positions. Getting ready for installation, rear of the car raised on the lift.

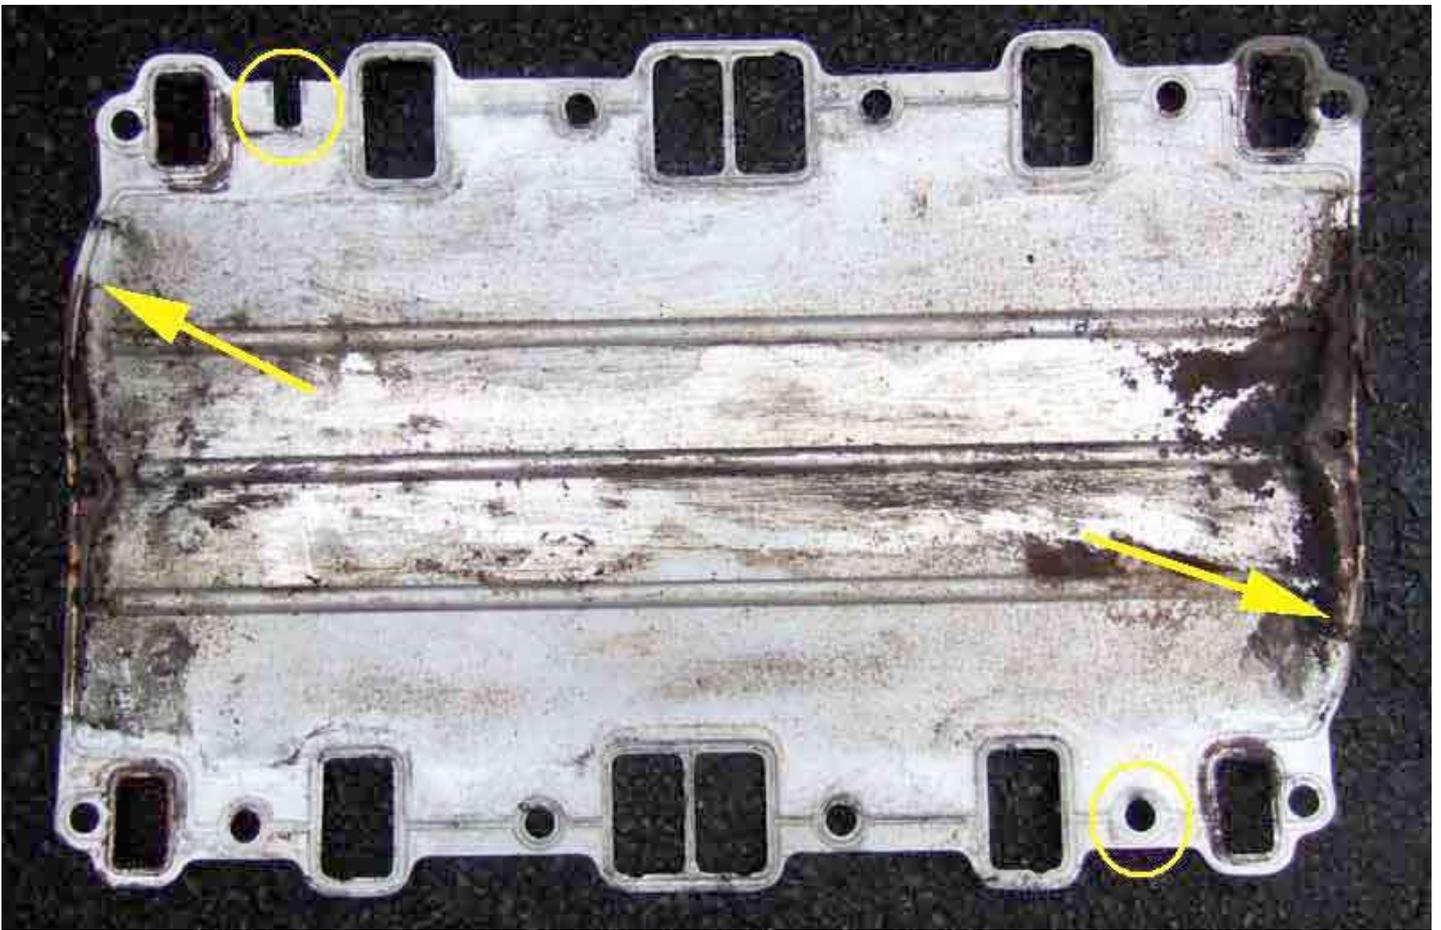
The inlet manifold gasket was a pain. The WSM says they are marked 'FRONT' and one of the bolt holes near the front on the right (off-side) is 'open' i.e. slotted. The new gasket has neither, also there are sealing rings round all the holes on one side of the gasket only, and it is flat so not obvious which way up it goes let alone which way round. I ring the supplier and he doesn't know, so he rings his supplier who says the sealing rings face downwards i.e. into the heads. Fine. However when I compare it with an old tin gasket, I realise that it can only go up one way, as the right bank is offset relative to the rear, and that puts the sealing rings uppermost! Still no info regarding which way round it goes, but careful comparison indicates that the two ends are identical, so it doesn't matter. Old tin gasket, with circles round two bolt-holes only one of which is 'open', and arrows where each bank is offset relative to the other.

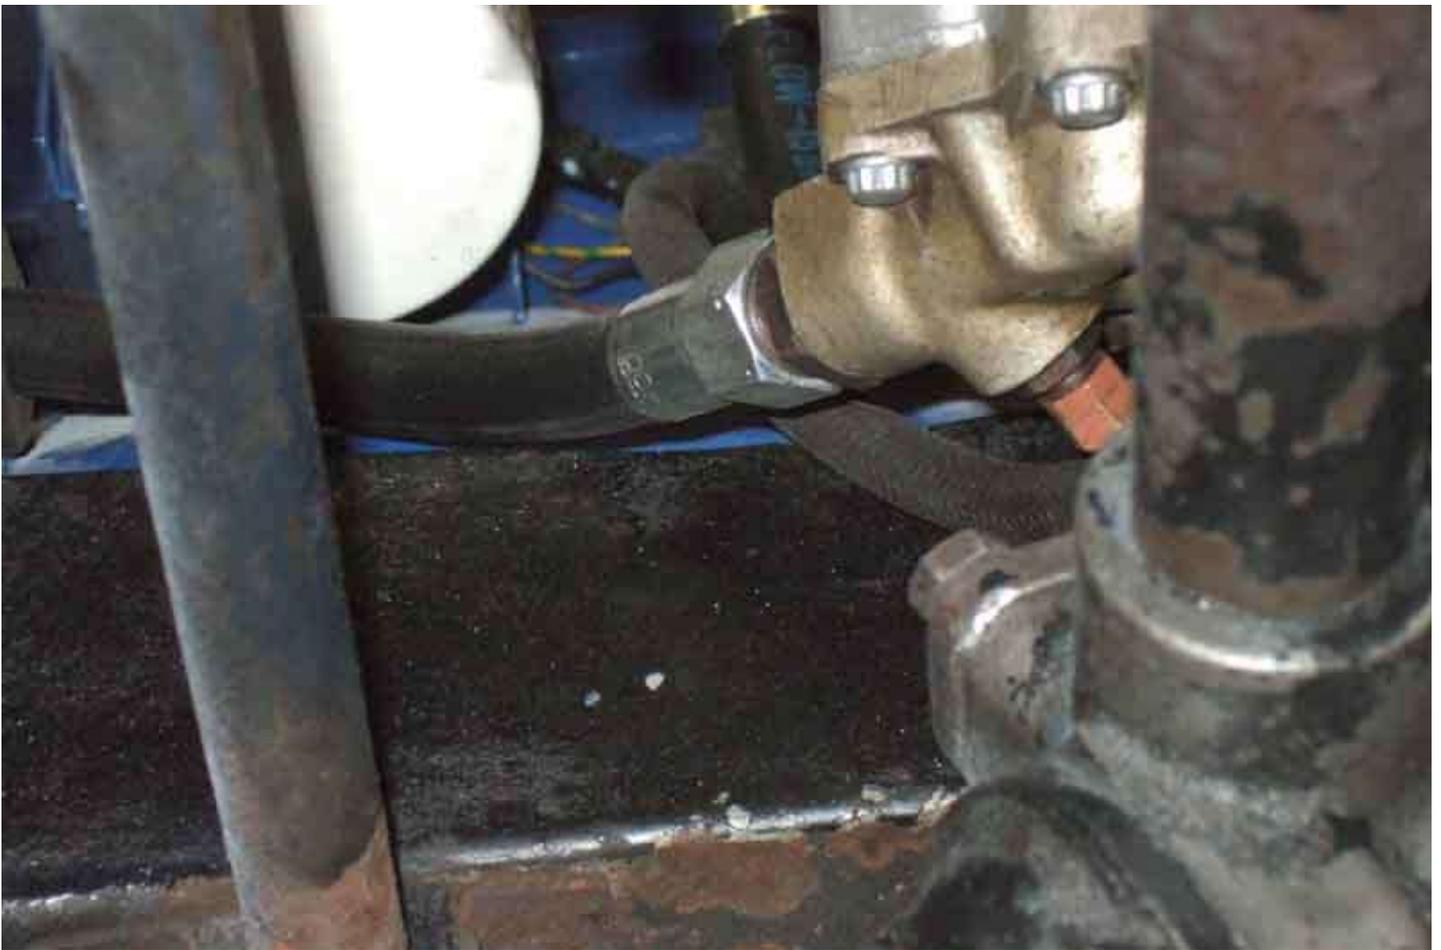
However the clearance on the front hose is very small, about 1/8", and the gauge hose is close too. Give the amount I know the engine has rocked in the past with the exhaust manifolds hitting the inner wings, I think it is too small. Rather than grinding and welding straight off, I think I'll try battering the lip over first, to present a smooth face as well as being lower.

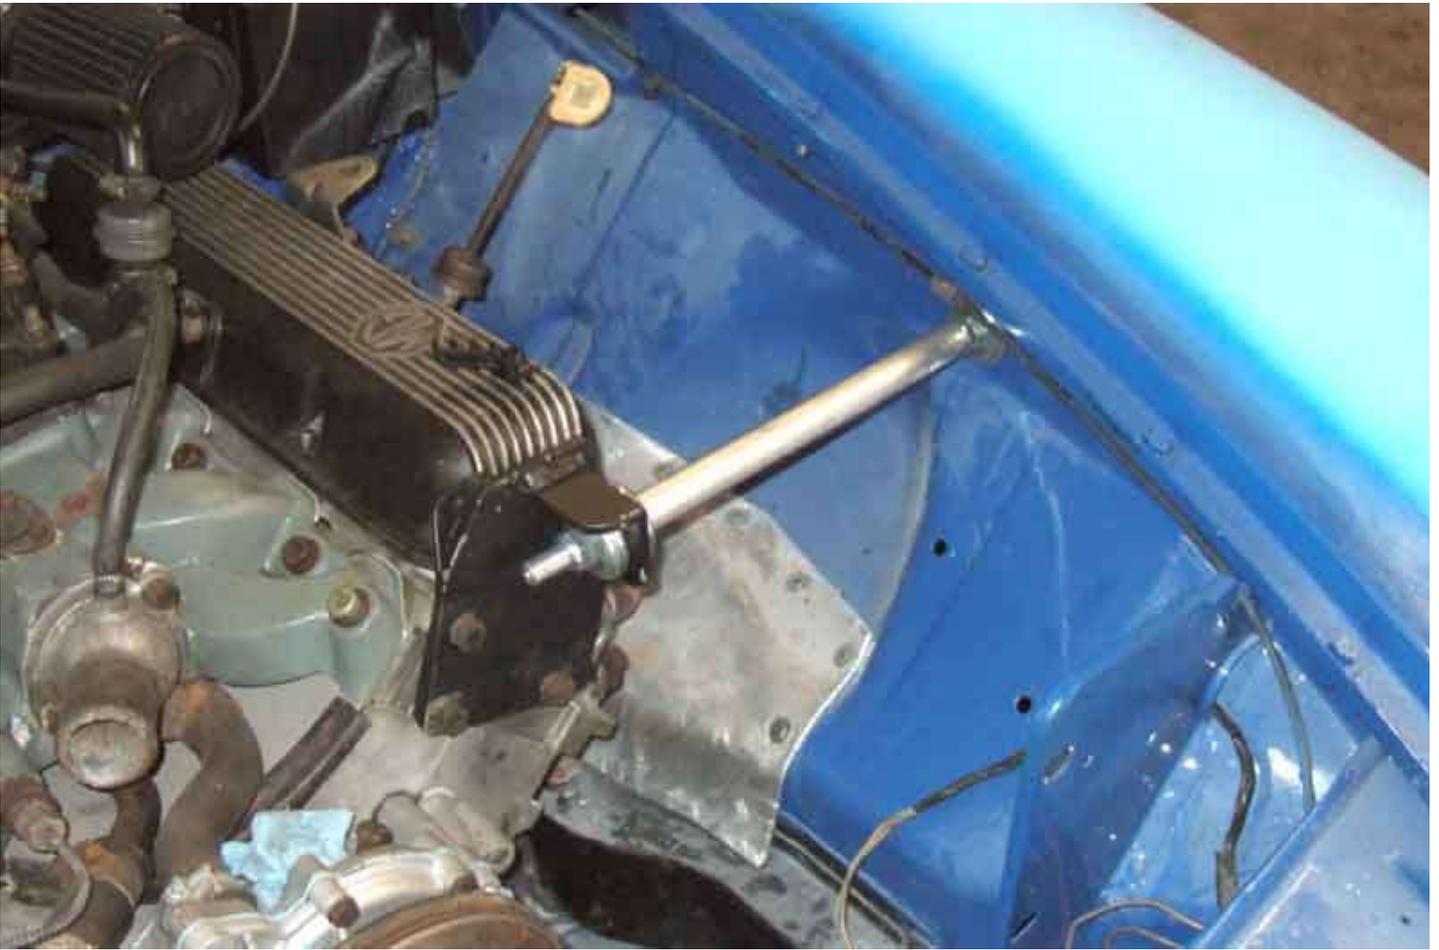
Clive Wheatley engine steady bar. Battering the chassis rail lip over gave me enough clearance to insert the end of a forefinger, and that together with the steady bar should be enough. Bar installation needed some thought to get the engine bracket holes to line up with the head. There are rear shackle rubber mount rubbers between a pair of cup-washers, and a set of those both sides of the engine bracket and both sides of the inner wing and strengthening plate under the wing. There are also adjuster nuts on the inner-wing end of the bar, which should initially be screwed all the way onto the bar. Tighten the engine bracket nut using a spanner on the inner adjuster nut, to compress the rubber bushes that end so that the slightly smaller cup-washers fit inside the larger ones. Then tighten the nut under the wing to compress the bushes that end, which will pull the engine bracket across the end face of the head. Keep tightening the nuts until the holes in the engine bracket have come past the holes in the head. Then tighten the adjuster nuts onto the wing to compress those bushes more, until the engine bracket has moved far enough back across the face of the head for the holes to line up, and insert the bolts - including the engine lifting bracket on the inside so it doesn't get lost - and tighten the adjuster locknut. This ensures the engine is sitting in its 'natural' position, and not pulled or pushed to one side by the steady bar. Of course if you find you need more clearance one side, then that can be set with the adjuster nuts.

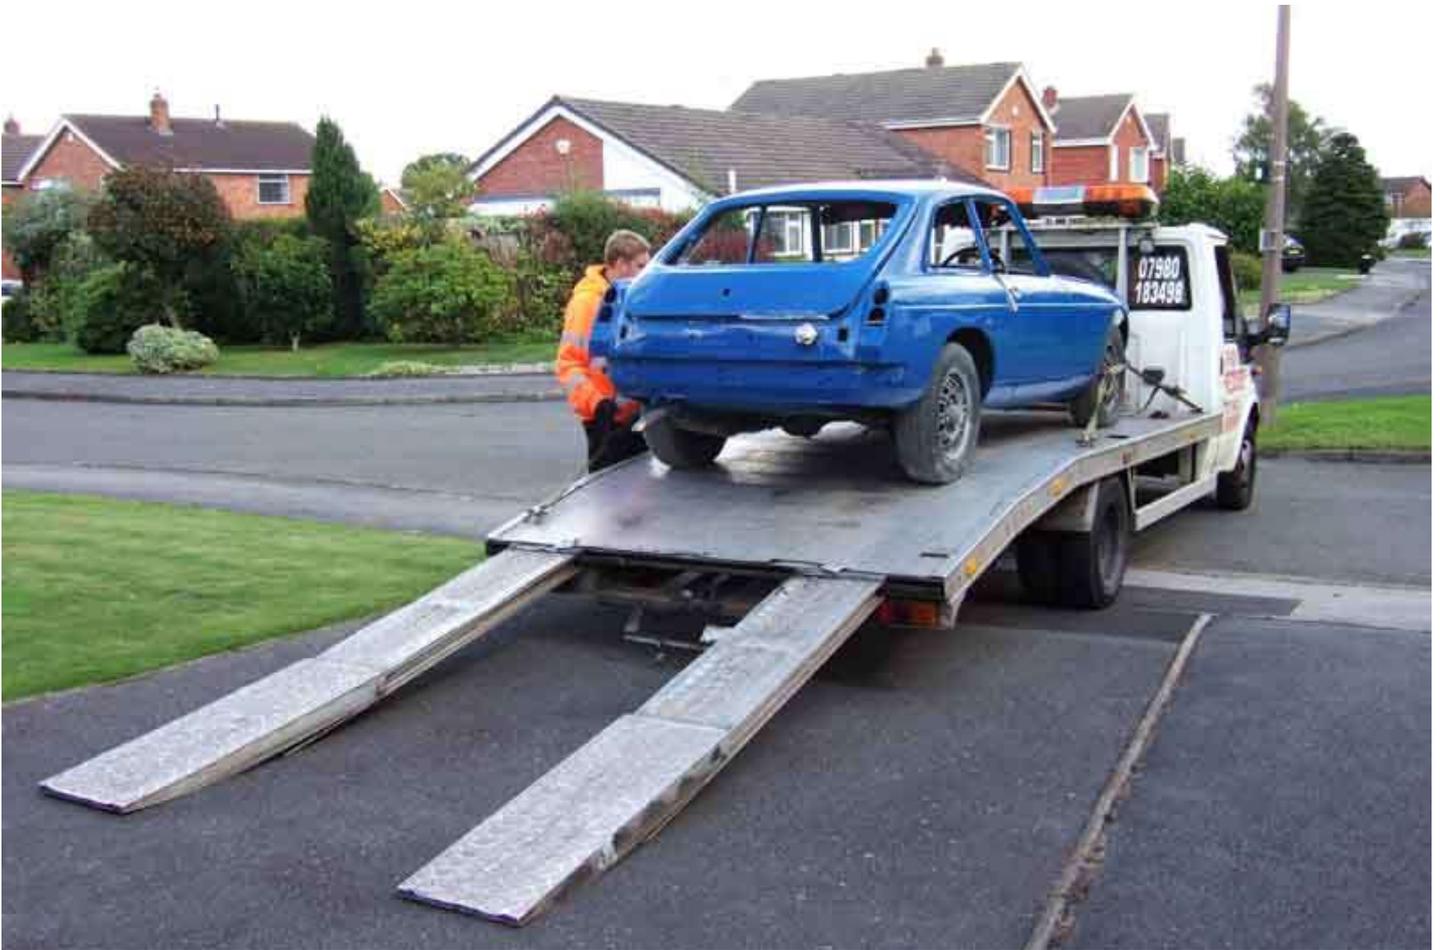
10 months and two weeks after going away, and a lot of trauma. Very annoying when backing her into the garage to find she had dropped oil all the way up the drive, seeping from the oil pump cover. I'd previously run her for twenty minutes or so on two occasions in the paint shop with no sign of this, not an auspicious return! The one screw I could get to at that time was barely finger-tight, and the leak seemed to stop with that tightened, but what about the others? First job next day was to pull the rack and investigate all the screws. There are six - five short grey ones and one long black one, and all the grey ones were slack. I decided to remove them all and re-insert with thread-lock if I was going to have any confidence against future leaks, and immediately noticed all the grey ones had what looked like a grey plastic washer under the head, which appeared to have extruded into the gap between the shank of the screws and the sides of the holes in the cover - hardly surprising they had lost torque! I didn't notice them when I bought them, the long black (tight, remember) one didn't have it, so I removed them all. used thread-lock, and refitted. Torque is a pain - being variously given as 13 ft lb in the GT V8 WSM supplement, but 3 or 9 in other manuals. Previously they didn't want to go as far as 13 so I stopped at 10, but this time only went to 9.

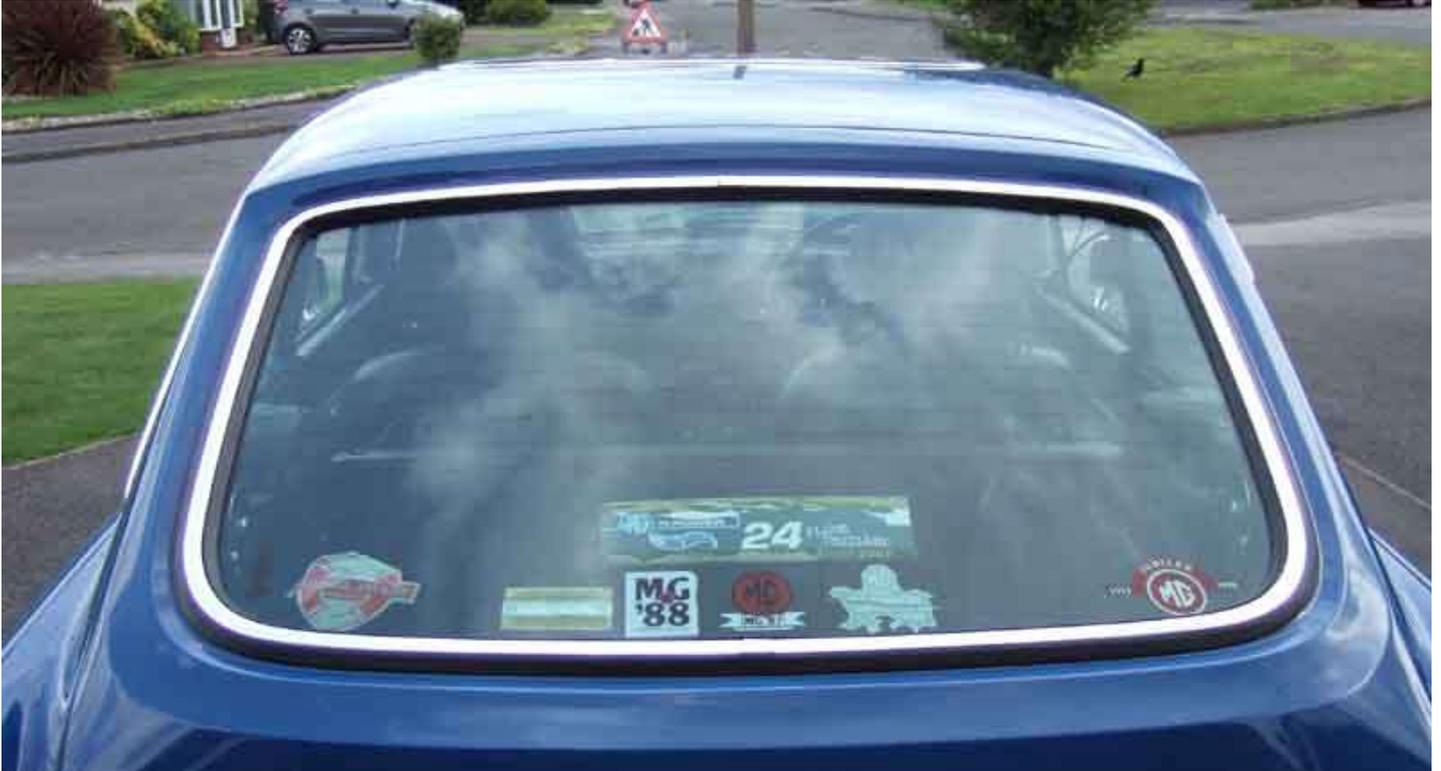
Wiper arms to be repainted.

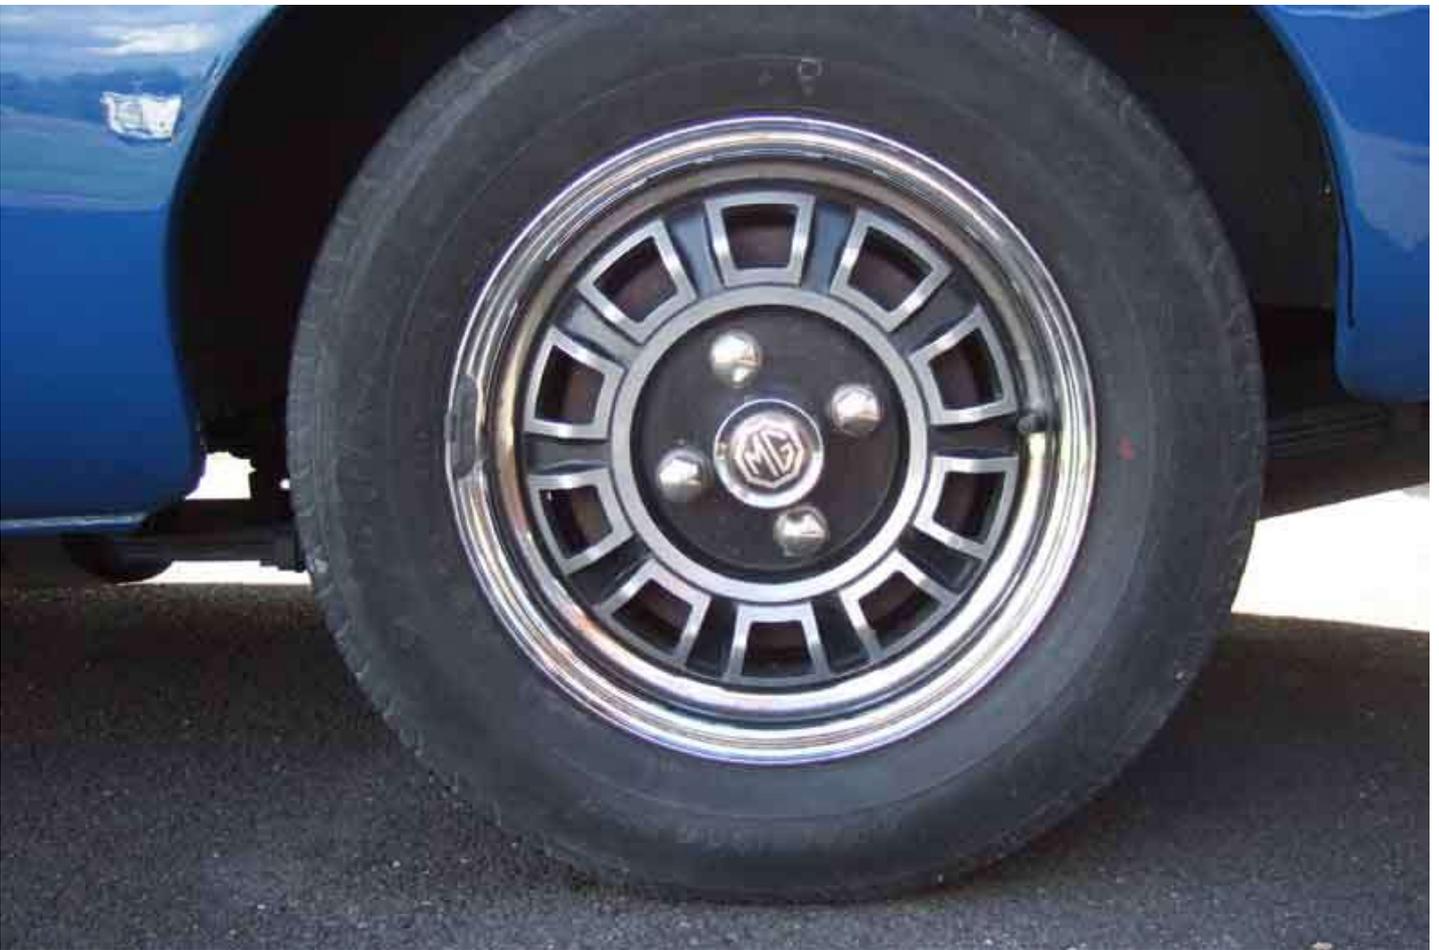
That doesn't take along at all, so I decide to have a go at [cleaning one of the rear wheels](#), and after that one of the fronts.

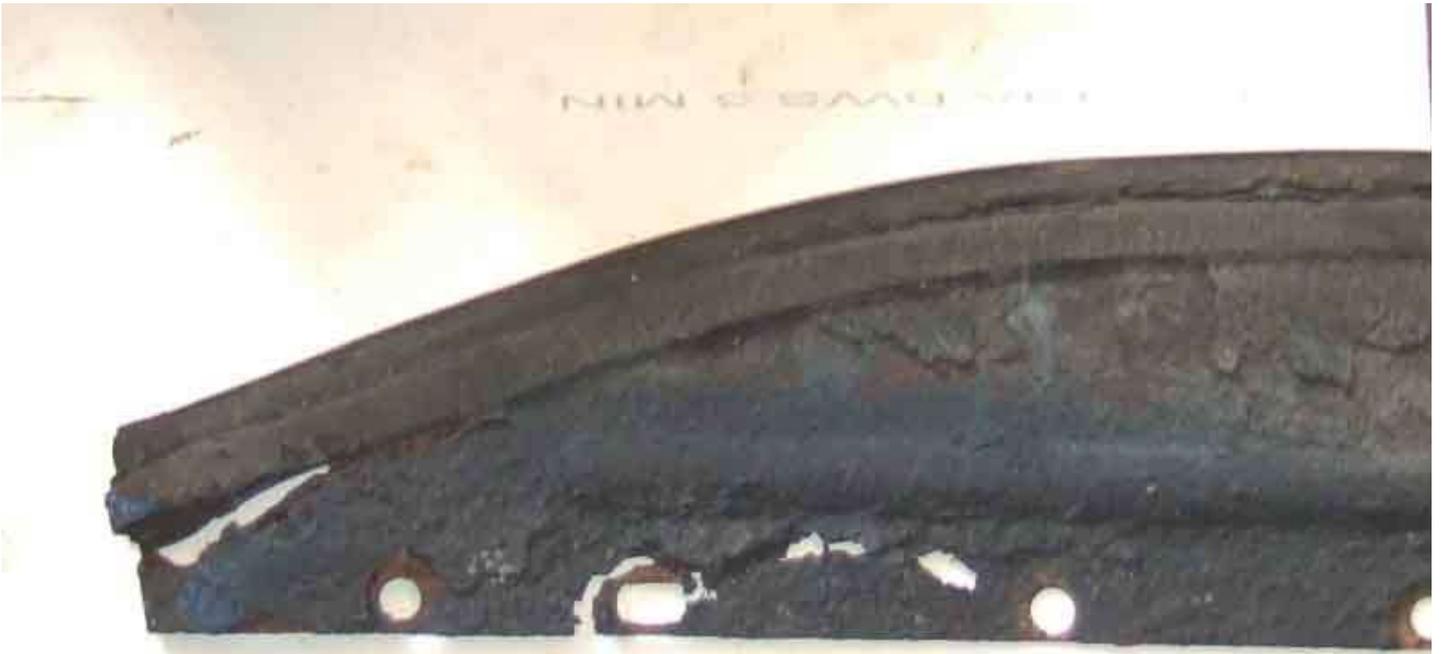
The old off-side panel was looking like Swiss cheese in the lower half.

Wednesday the front wings behind the splash-panels treated with Dinitrol, the new splash panels and seals fitted, Finnegan's underbody seal sprayed at the back of the wing by the headlight bowls (a mud trap and corrosion point), the new splash-panels and seals, and the backs of the wing and sill flanges.

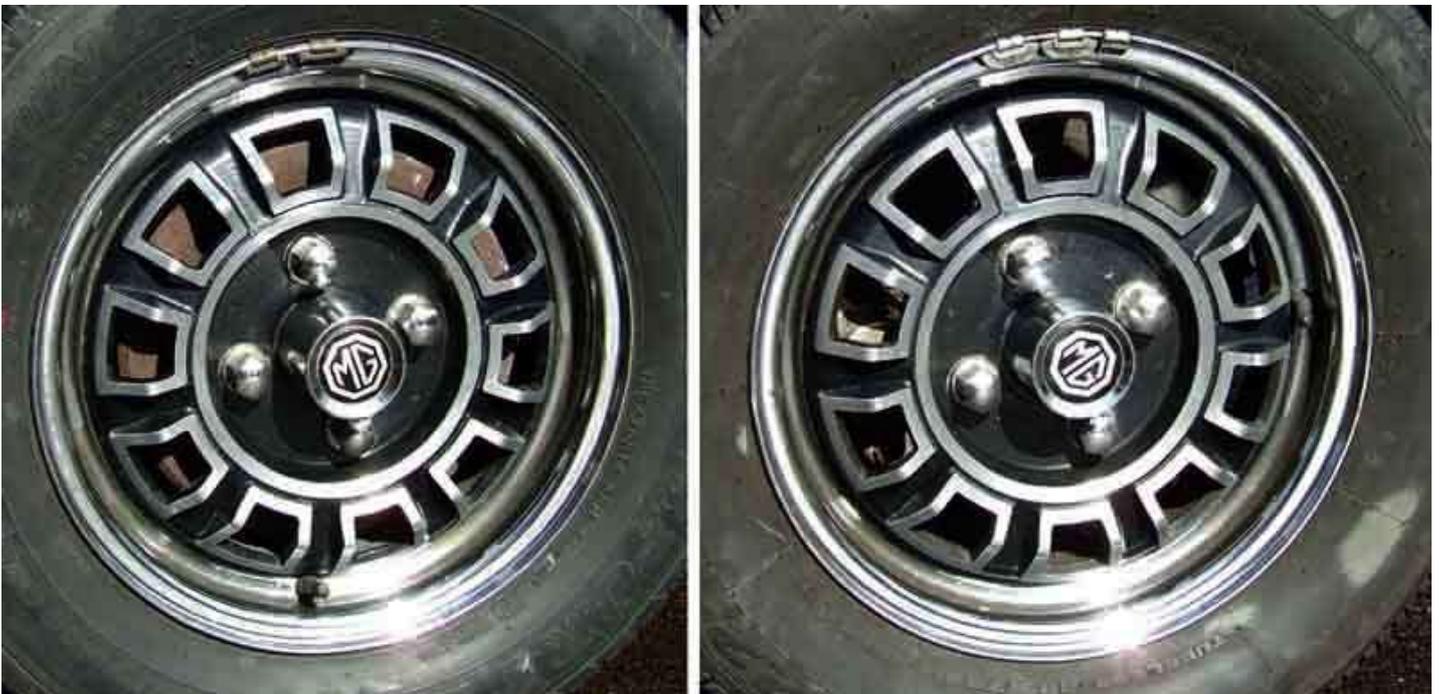
Thursday sees the other two wheels cleaned - the first rear took me an hour, the first front and the second rear about 90 mins, and the second front about 2 hours as it turned out to be the worst! If I'd started with that one I might not have carried on. Note to self: [Paint the brake drums!](#)
