## Ignition Woes – an endemic modern problem?

by David Bolton

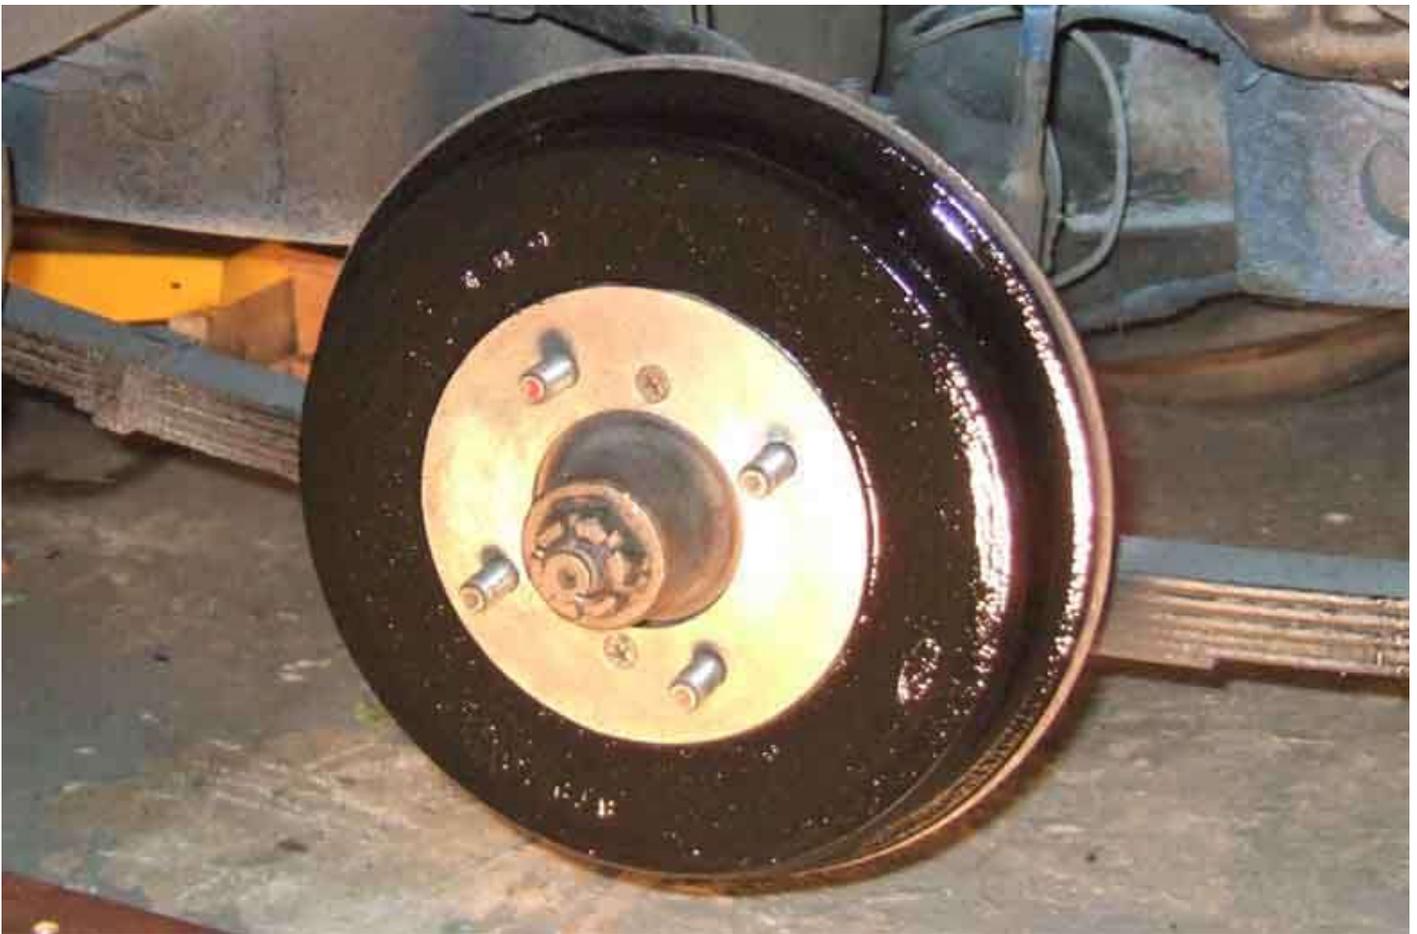
The final week of September sees another 40 miles to get the Sunday paper, the brake drums painted ...

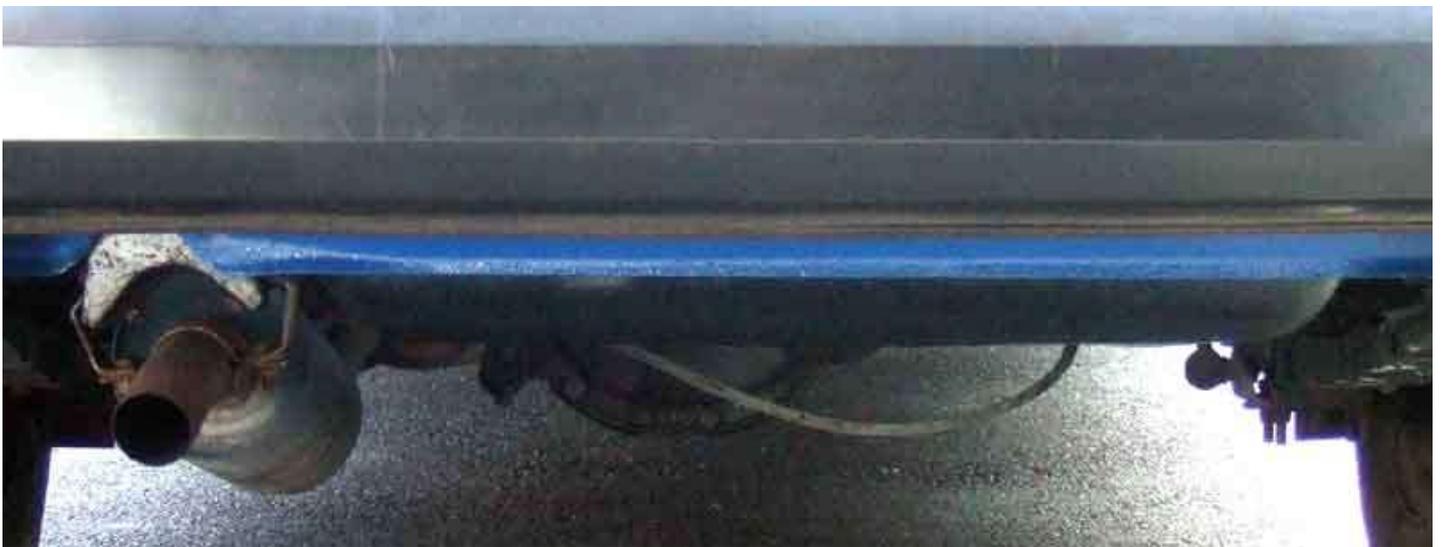
... the overspray removed from the tank and exhaust hangers ...
