Bee's Clutch Change 2016

Last updated 22-Dec-2023

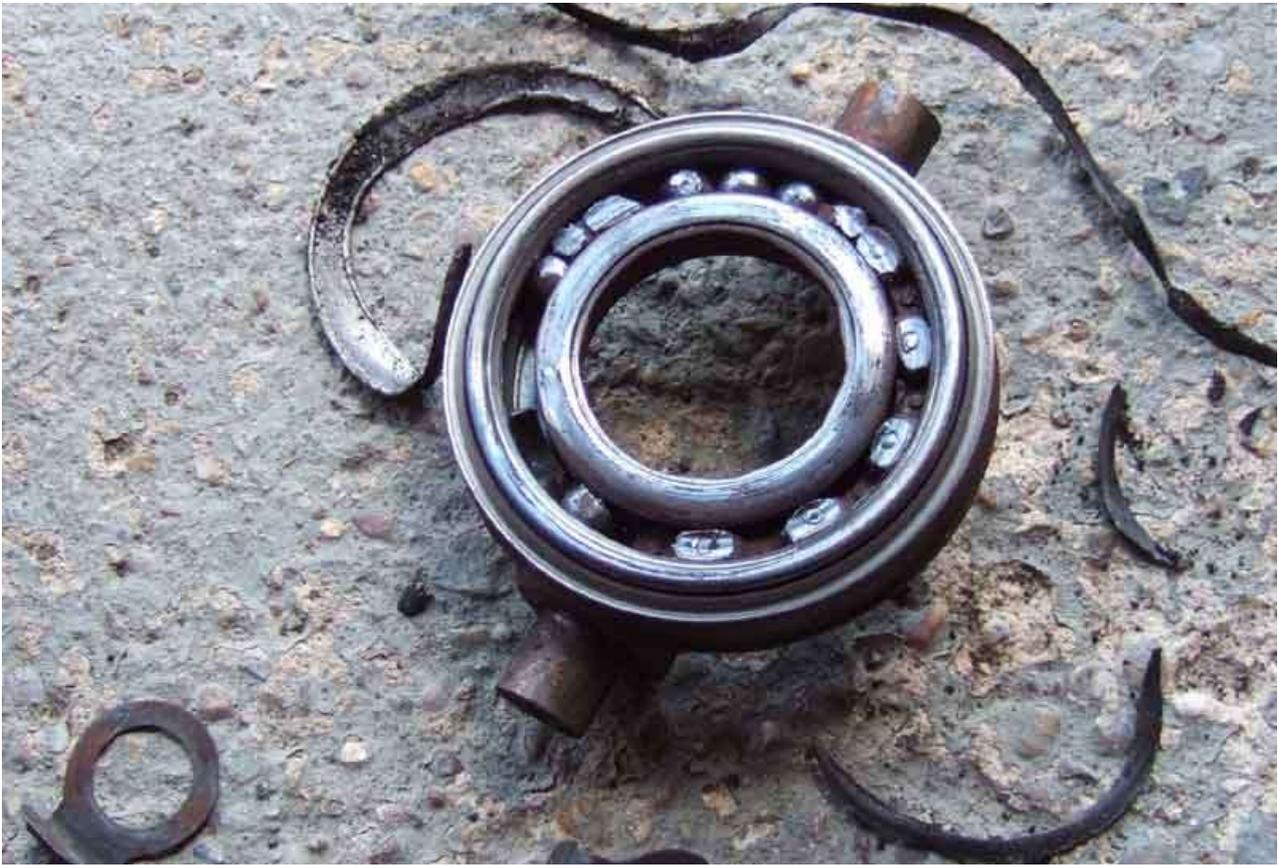
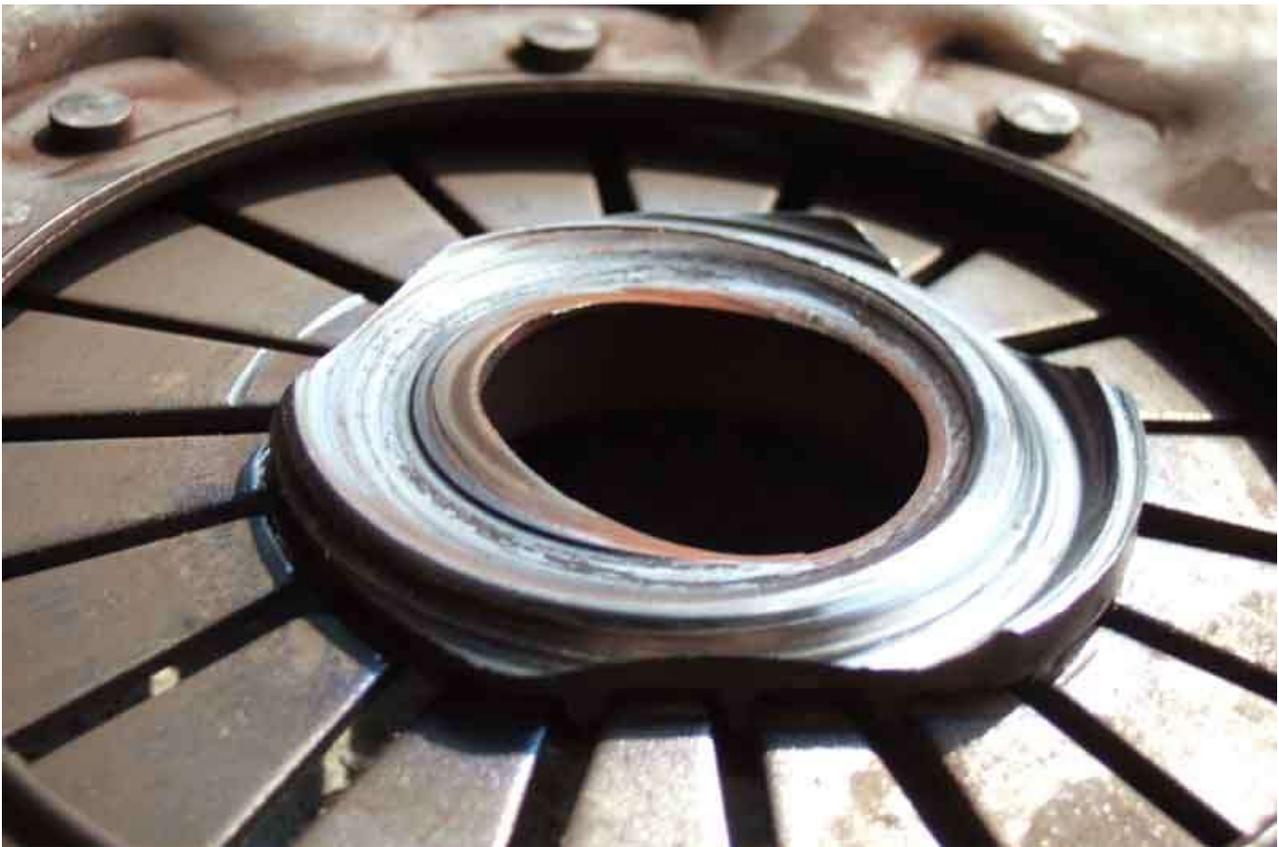
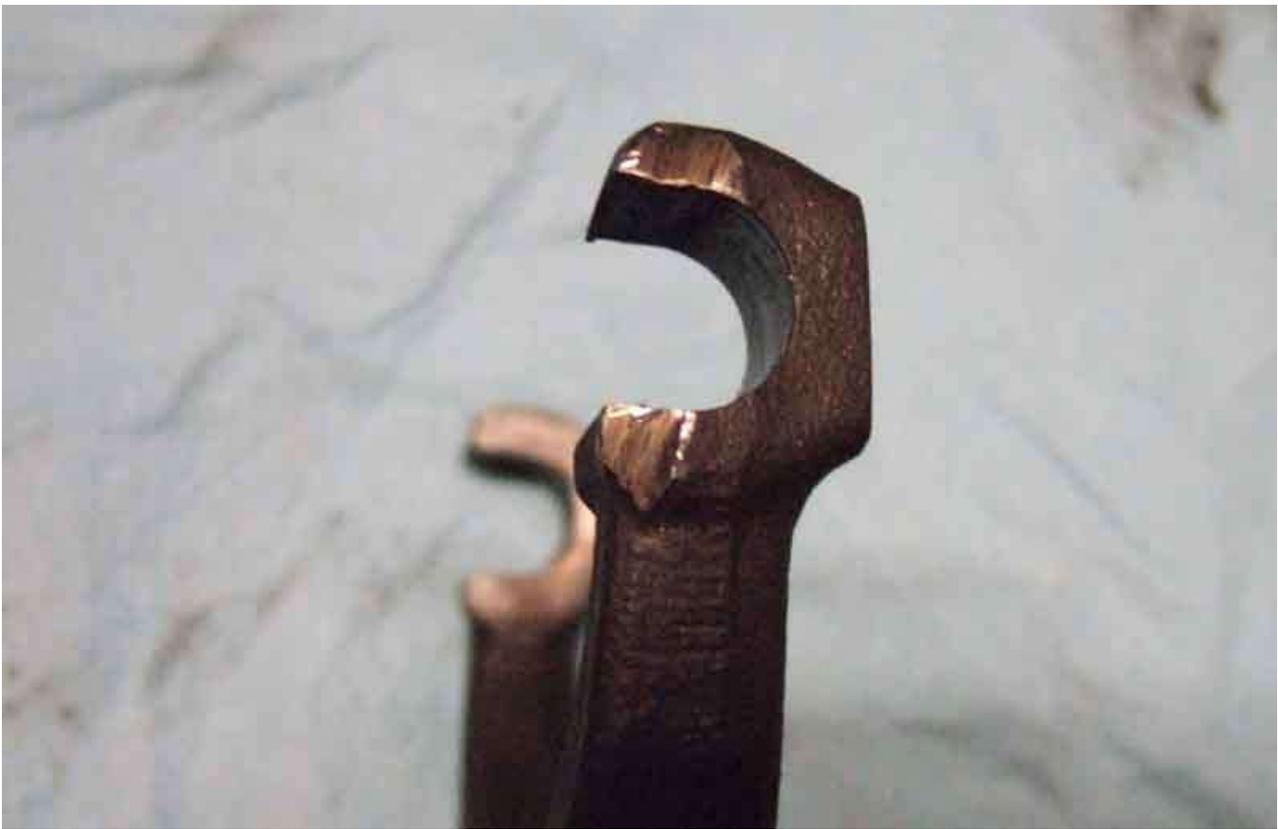
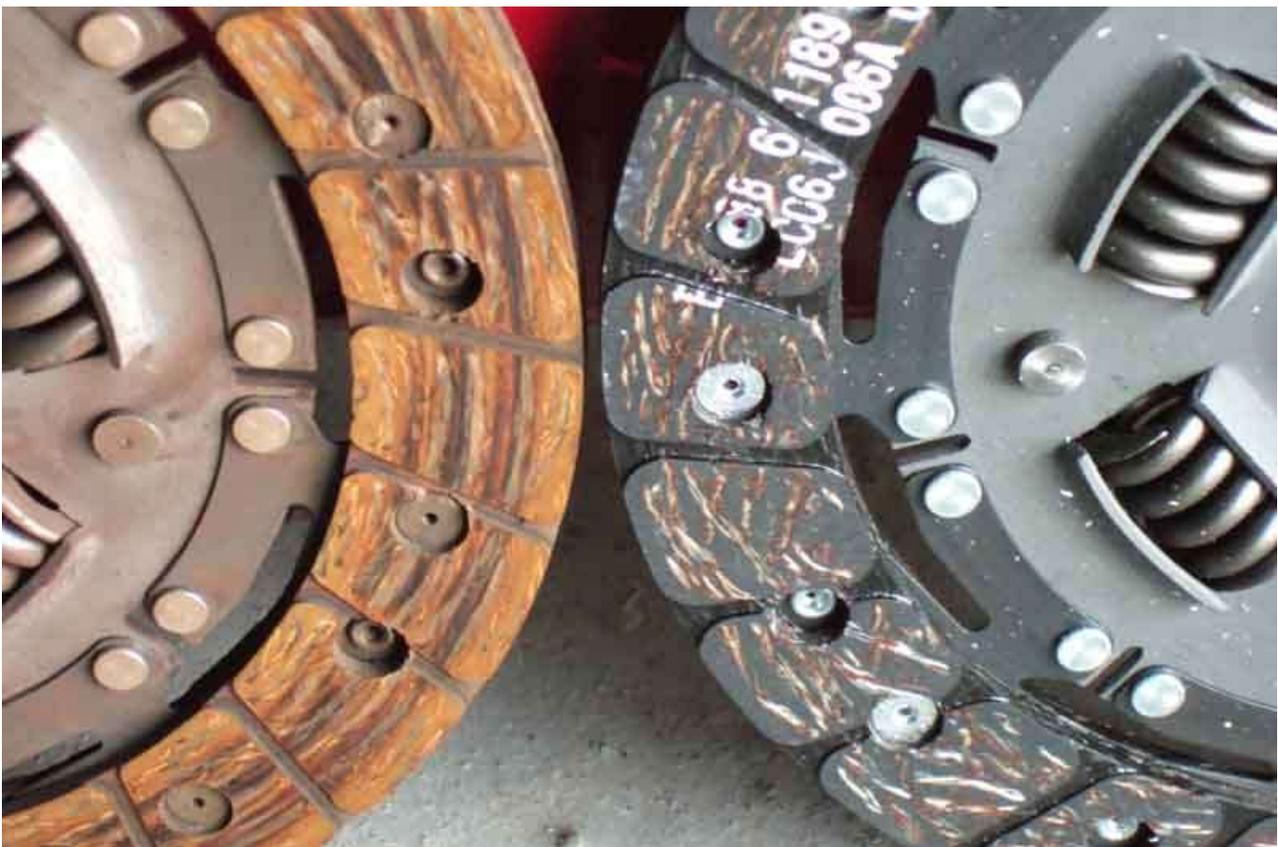
First sight of the release bearing and cover plate - and it is shocking! Bearing completely knackered with balls jammed and them and the housing ground down, the boss on the cover plate practically worn right through, and the ends of the diaphragm springs showing blue from excessive heat, and some partially cut through from the outer corners of the release bearing fork. No-one could accuse me of not getting the maximum life out of it! The air-gun gets the cover-plate bolts undone without having to jam the crankshaft in some way, to reveal the friction plate, which is barely worn. If it hadn't been for that damned release bearing the clutch itself would almost certainly have lasted another 50k and 15 years or so. The flywheel does have a slight wear groove, from a previous friction plate having worn down to the rivets, but as it's been like that for the past 22 years I'll leave it as it is, not worth removing it and getting it skimmed. The inside of the bell-housing is well mucky of course, but dull dry dirt rather than the shiny wet-look of the previous two, so again I just check the gearbox front-cover nuts for tightness.

The other thing I notice is how offset the release bearing is to the first-motion shaft - sideways relative to the orientation of the release arm pivot bolt, getting on for 3/16". Even with the bearing removed the forks are still offset, and removing the arm and turning it over is just the same. I.e. it isn't the arm that is bent, but the pivot bolt bracket is not in line with the shaft. That's almost certainly what has caused the roller bearing to fail, which is why John Twist says roller bearings have a high rate of premature failure when used on a gearbox not designed for them. OEM applications like the Midget 1500, MGB GT V8 and modern cars, have a special carrier that keeps the bearing concentric with the shaft, compensating for any misalignment between arm and shaft.

Not surprisingly I'm going to be using a standard graphite bearing this time, which are better able to cope with misalignment. However as the previous clutch replacement was caused by the release bearing casting wearing away and breaking, I'm wondering if the misalignment is so bad it caused that to fail, and so will cause the new bearing to fail. I find that with the pivot bolt nut slackened there is quite a bit of free-play between arm and bracket, and that tightening the nut would remove that free play to the point of the arm binding in the bracket, which was obviously too much. Adjusting the free-play in this way improved the alignment of the release forks to the shaft, but not enough to get an equal gap both sides. Note that this can only be done on CB gearboxes, RB gearboxes use a shouldered bolt which can only be tightened so far, leaving whatever free-play that exists between the brackets or in the bushing as slop.

Pondering some time, I decide to grind away the boss on one side of the pivot point of the arm, and fit a spacer washer underneath. But before removing the arm I remove the clevis pin between it and the push-rod, and the slave promptly evacuates its boot, piston, seal, seal spreader and spring and all its fluid ... onto the floor before I can get a container underneath it. The garage floor is painted concrete, and hydraulic fluid makes an excellent remover of that as well as cellulose! Modifying the arm probably takes most of a day grinding, flattening, checking the thickness with a dial caliper at six points around the pivot bolt hole, and trial fitting with a 0.2" washer. I'd previously ordered a new bush and pivot bolt in case the old ones were well worn, but to be honest there didn't seem much difference. Nevertheless I used them, driving the old bush out with the double-socket technique in a vice, and pressing the new one in with the bolt. Of course the new bush was now longer than thickness of the arm, so I opened up the hole in the spacer washer to fit over the protruding end of the bush rather than grind it off. It made refitting the arm much easier, than trying to line up the holes in the washer and the bush to get the bolt through. Finally I tightened the pivot bolt nut to bring the new release bearing into concentricity with the shaft, as judged by the shank of a 8mm (I think) drill bit which just fitted into both sides, checking that the arm was free over its full travel. Note that as the release arm is moved back and fore the alignment of bearing to shaft varies in a longitudinal direction i.e. in line with the arm, there is nothing you can do about that. However - it was only subsequently that I realised if I had done nothing, and simply put a new release bearing and clutch in and they lasted the same as before, I would probably be over 90 before it needed doing again! Oh well, it's done now.

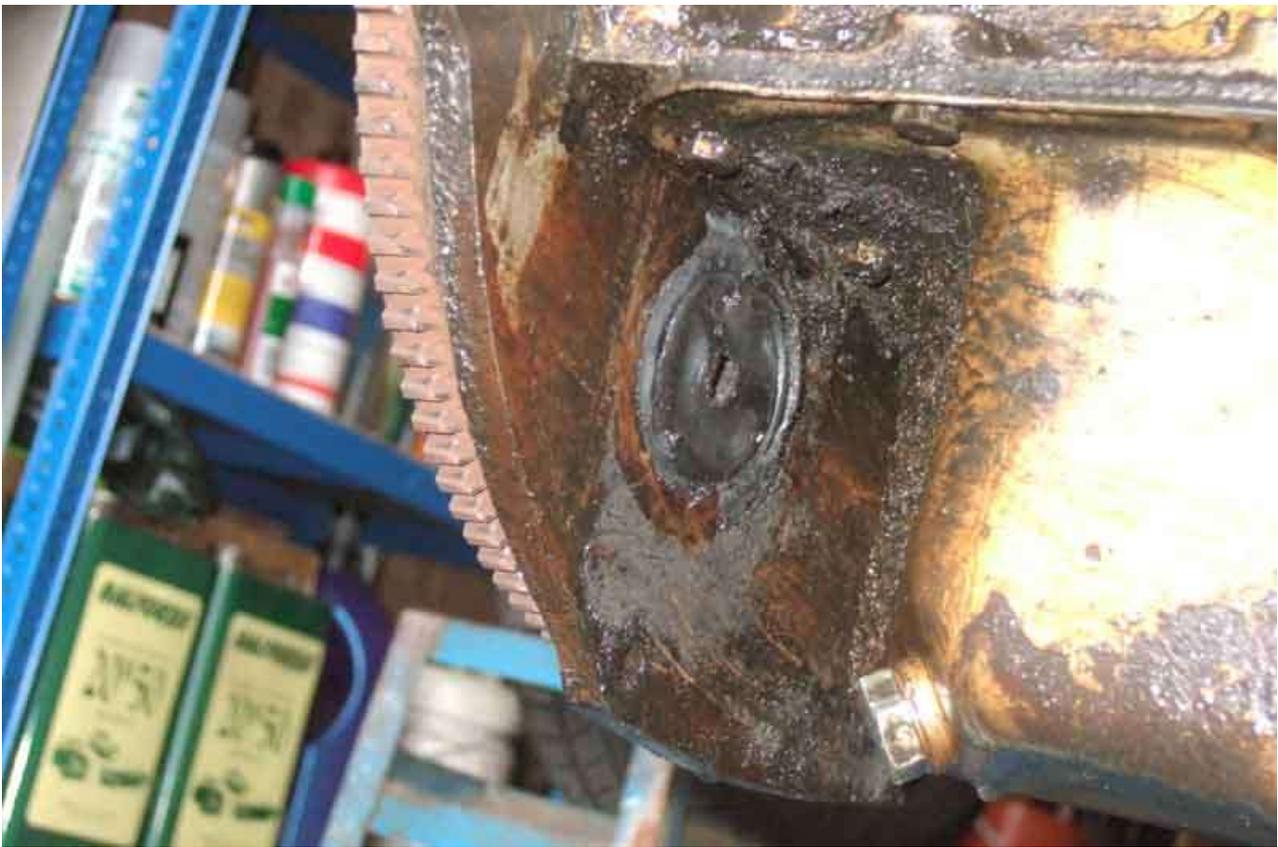
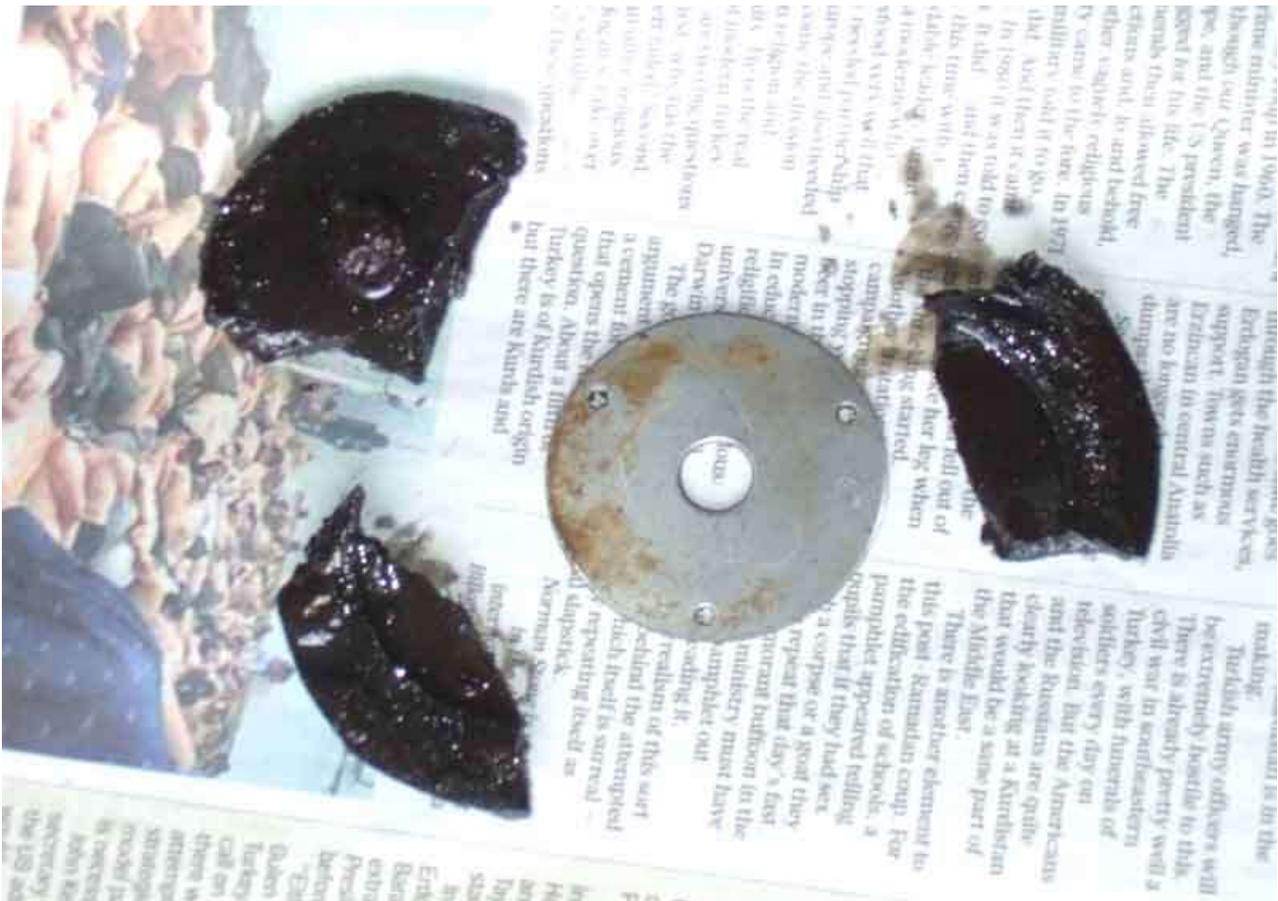
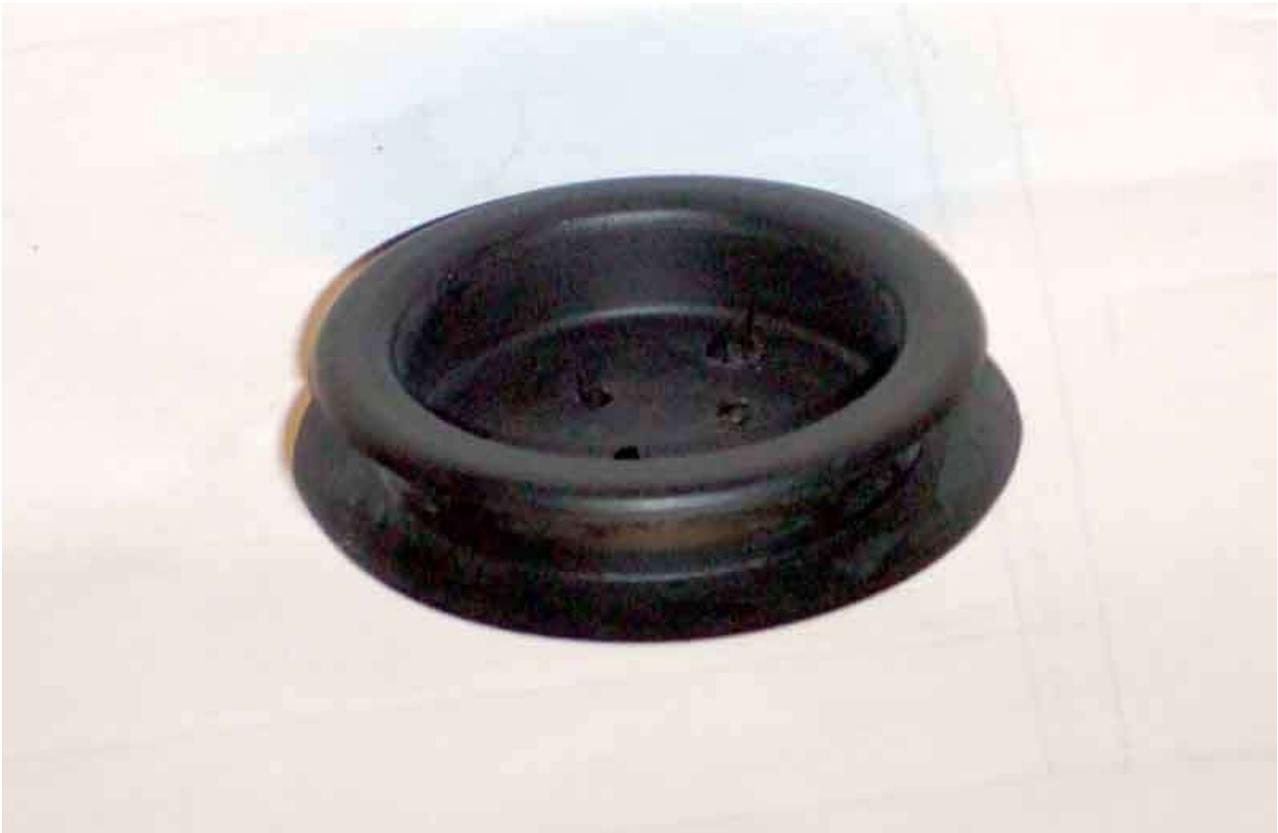
Whilst scraping the side of the engine back-plate that faces the sump, on the distributor side, some large lumps of what initially looked like underseal came off. Then I noticed it had revealed a large flat metal washer, and it turned out to be a very large grommet (12H 541) in a hole in the back-plate, the reason for which (the hole) [can only be guessed at](#). That'll have to be replaced, so goes on a list in case I find anything else along the way.

The engine back-plate grommet has arrived, I thought it might be a bit of a struggle sandwiched in the narrow gap between that and the sump, but it pops in quite easily. With that, the engine is ready to go back in.

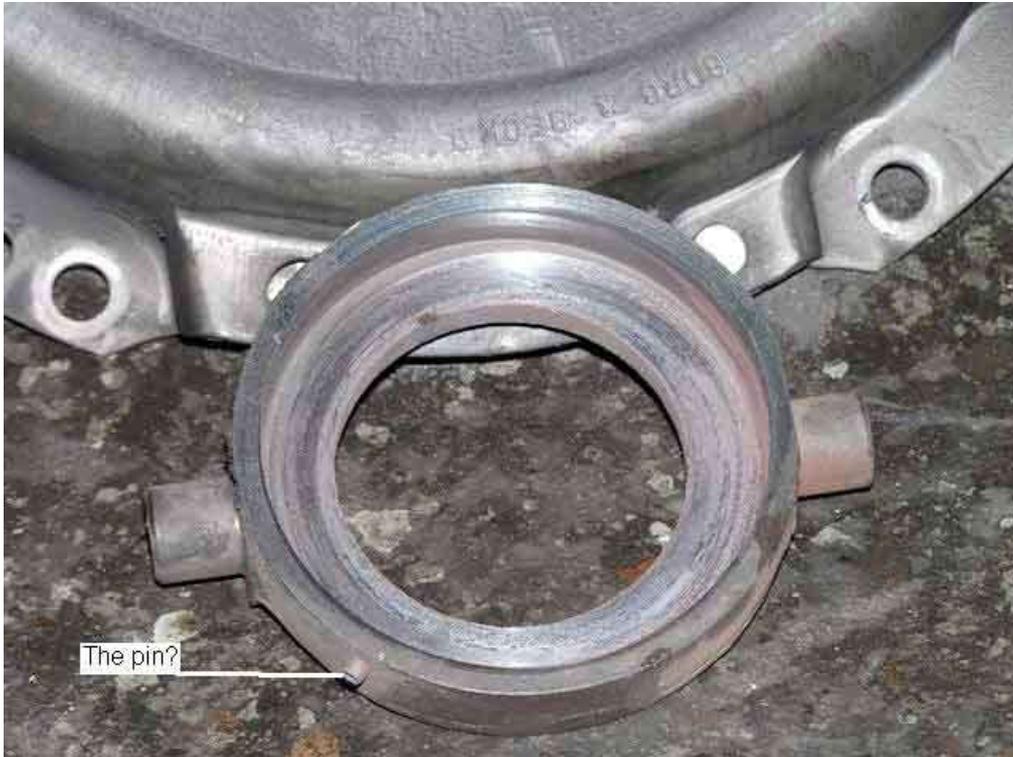
The 8000 mile release bearing. Not a trace of carbon left in it, or any pieces in the bell-housing, just a fine dust spread all round the inside. Note the roll-pin on the bottom left-hand side, is this the pin that causes the problem? (Photo: David Bolton)

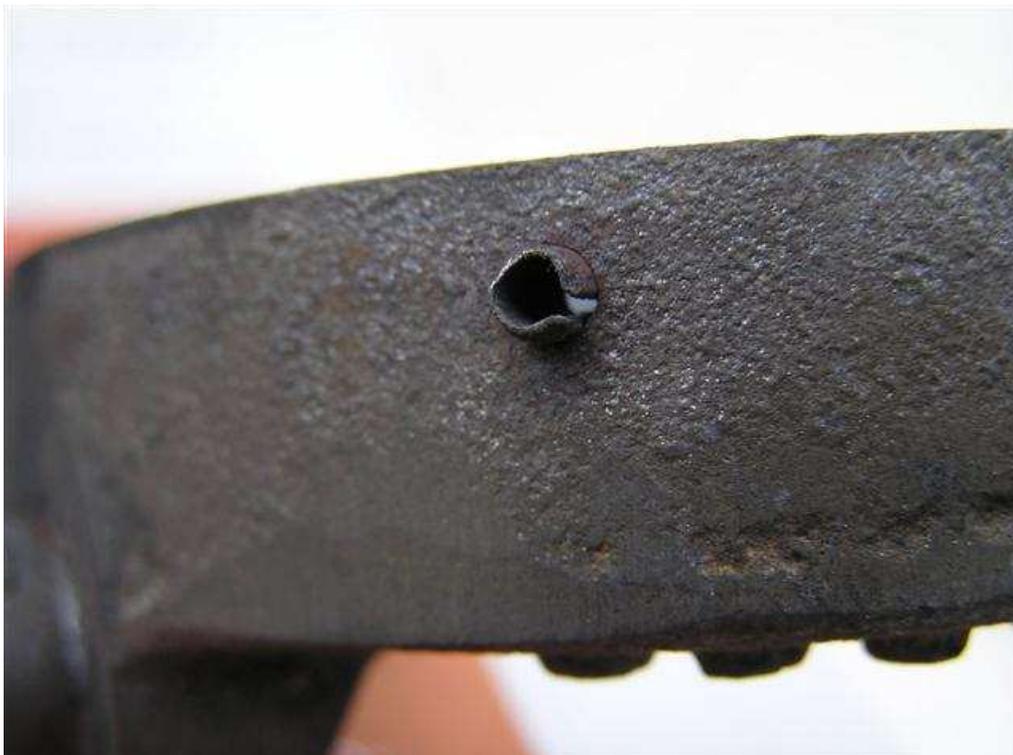
Two more pictures of the roll-pin in the old bearing. Is it supposed to be sticking out like this or flush? (Photo: David Bolton)

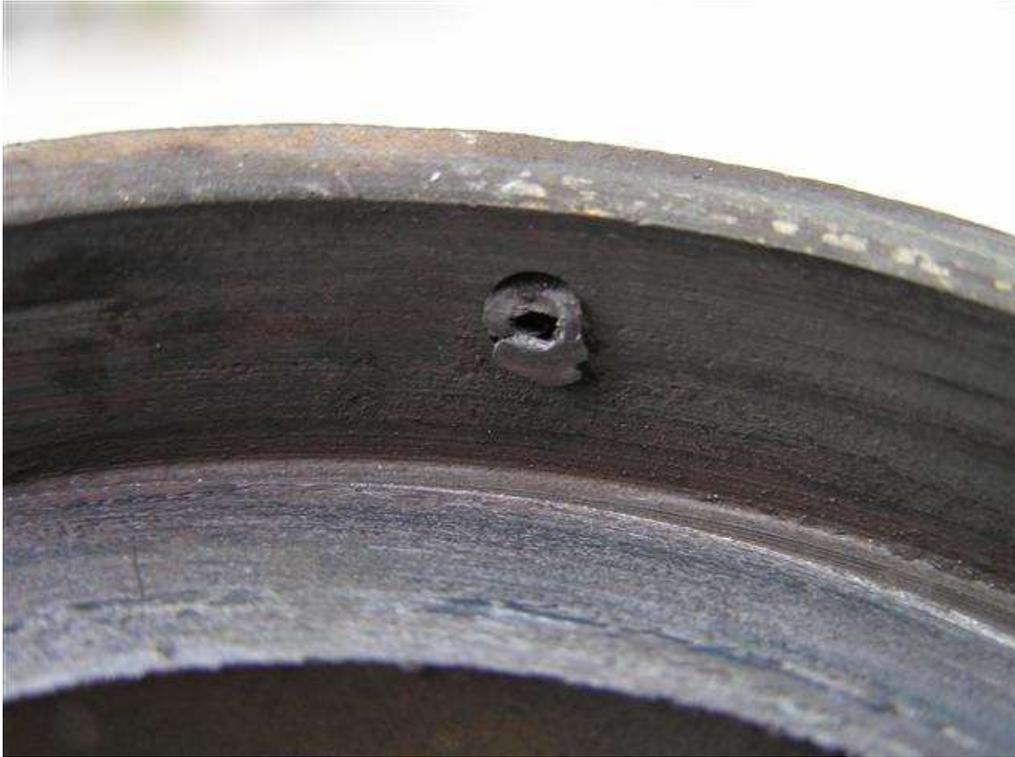
The inner end of the roll-pin. Part shows obvious signs of wear, but there is a recessed part that doesn't. It's not possible to determine whether the pin projected into a hole in the carbon ring and so has had quite a bit ground off by the boss on the

cover plate plus some broken away, or whether the pin only bears on the side of the carbon ring (so holding it slightly off-centre) so very little has been ground away. (Photo: David Bolton)

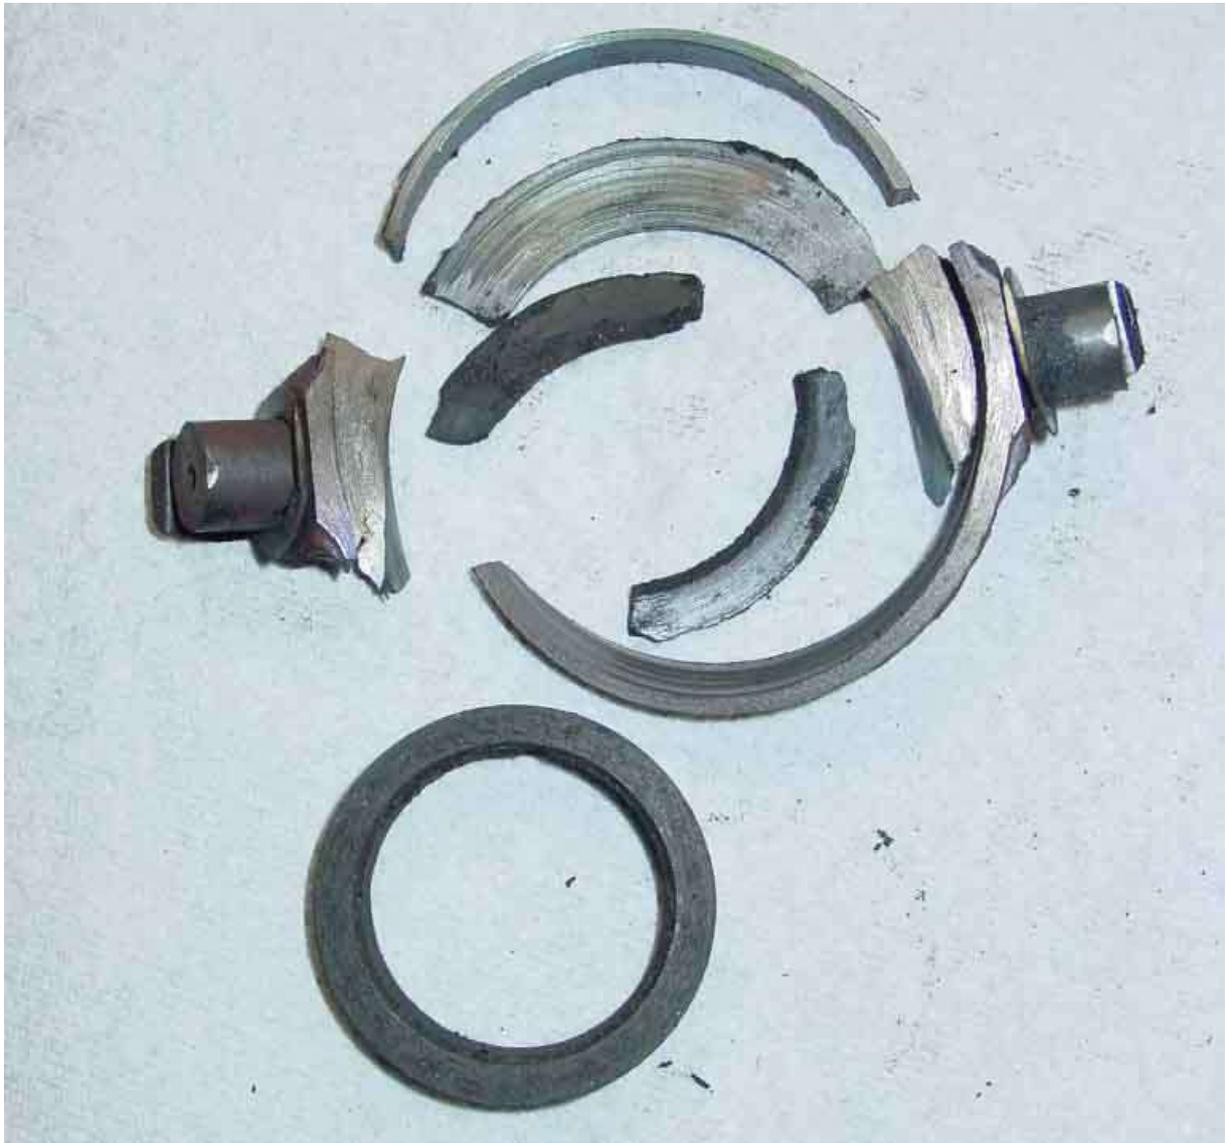
These four photos by Bob Muenchausen: Badly broken-up bearing but still a ring of carbon seems to be left. Probably once the boss on the cover plate had worn down the carbon to the top of the carrier there was a mis-match that meant it was bearing on the casting rather than the carbon ring, wearing that down instead, note the upper piece of the outer ring of casting is much thinner than the lower piece. Eventually it goes so thin it couldn't take the force of the clutch and it broke suddenly, further operations of the clutch pedal pushing the slave piston out of the end of the cylinder. This is very similar to what happened to the clutch on my roadster many years ago (mileage unknown), although on that the offset was worse and towards one of the pivots which snapped off leaving the rest of the bearing relatively undamaged.

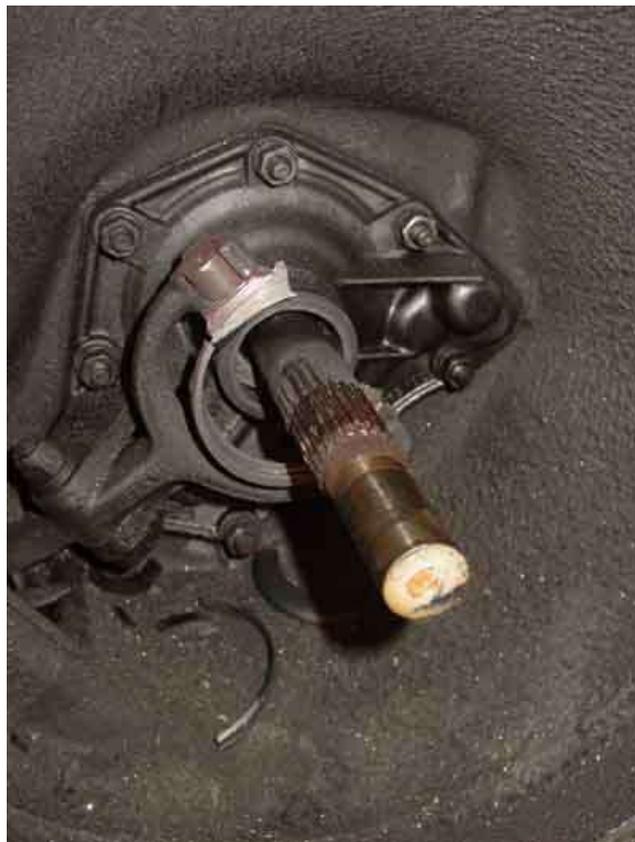
Inside of the bell-housing liberally coated with carbon.

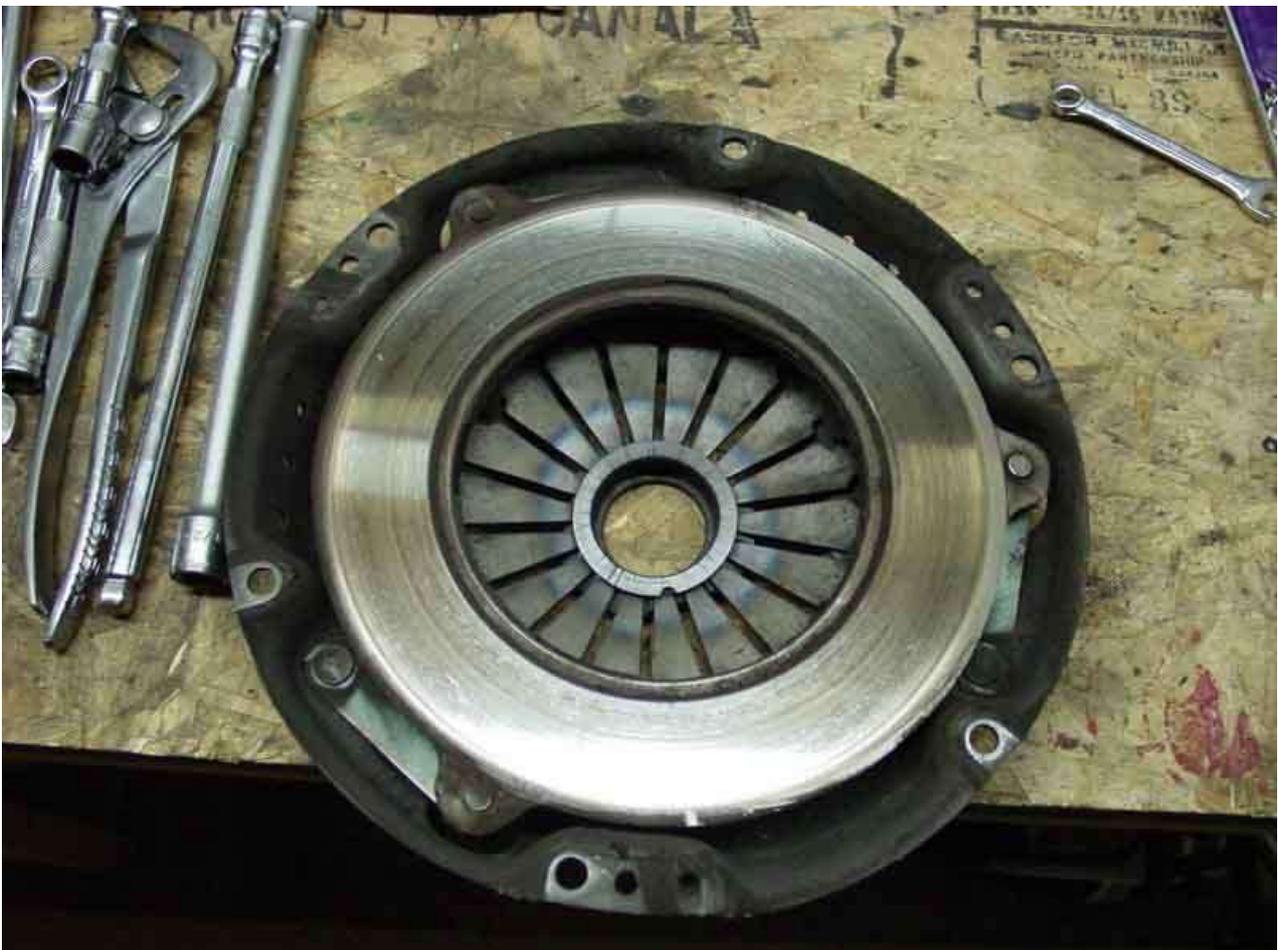
Deep wear groove in the cover-plate, although Bob reports that the flywheel itself was fine. I found much the same on the clutch change I did, perhaps deliberately dissimilar strength metals?

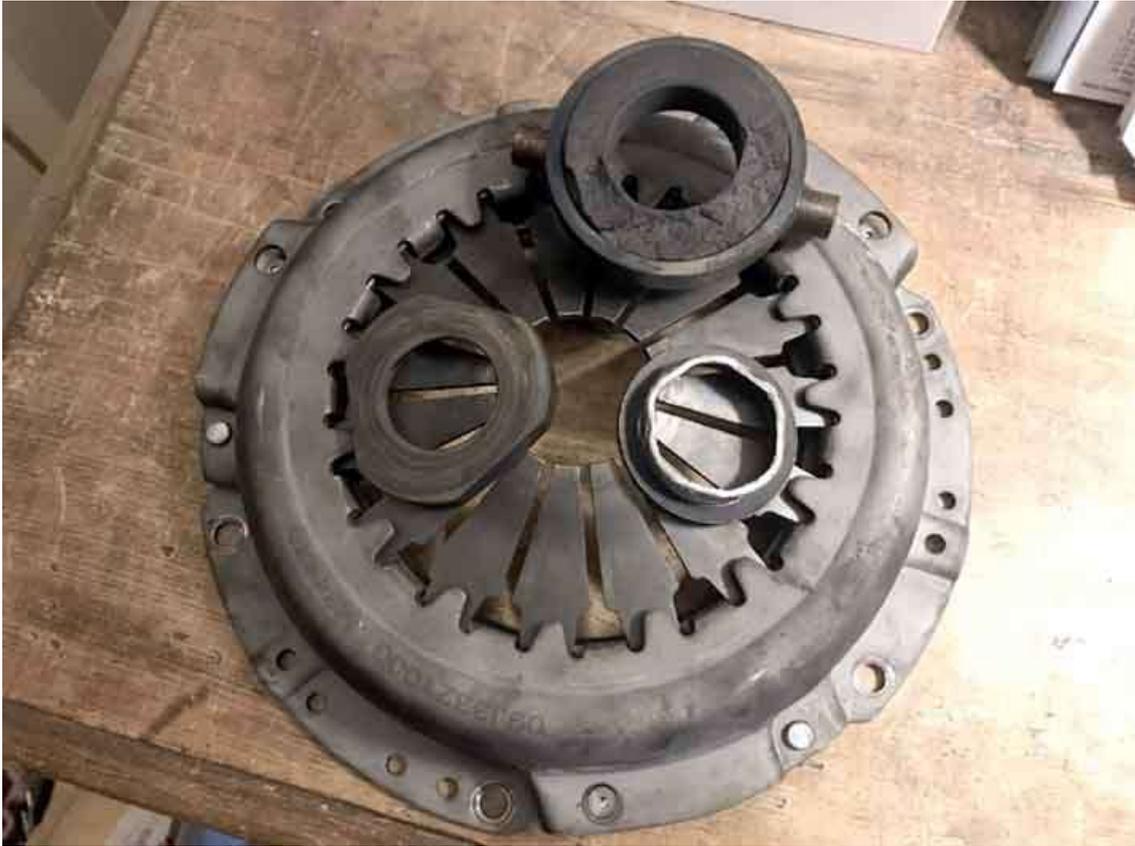
A claimed release bearing failure having caused the release ring to have been ripped off the diaphragm springs of the cover plate, rather than the release ring having come off and damaged the bearing: *(Name withheld to protect the naive ...)*

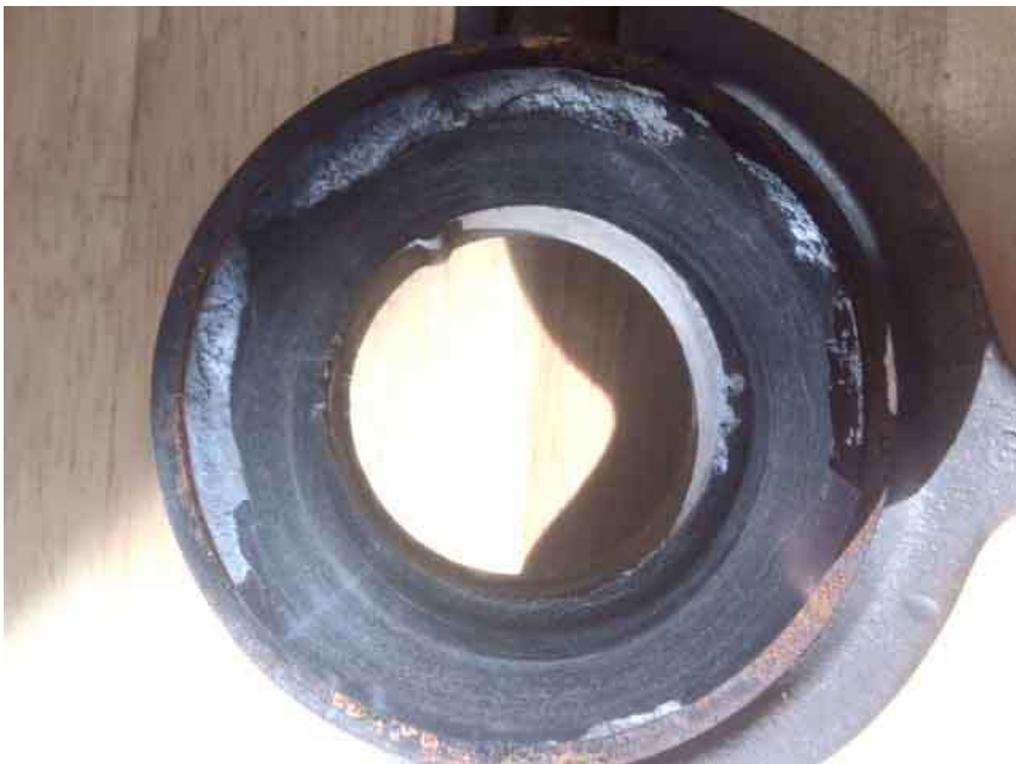
Peter King's showing the edges breaking away most of the way round, and further cracking elsewhere:

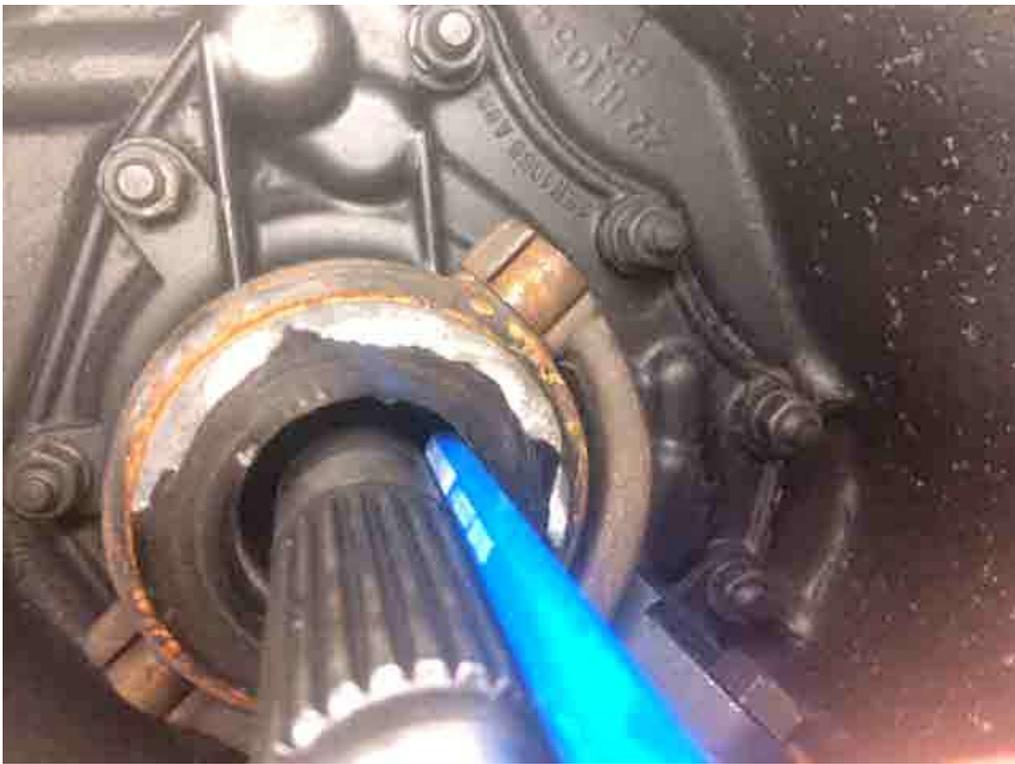
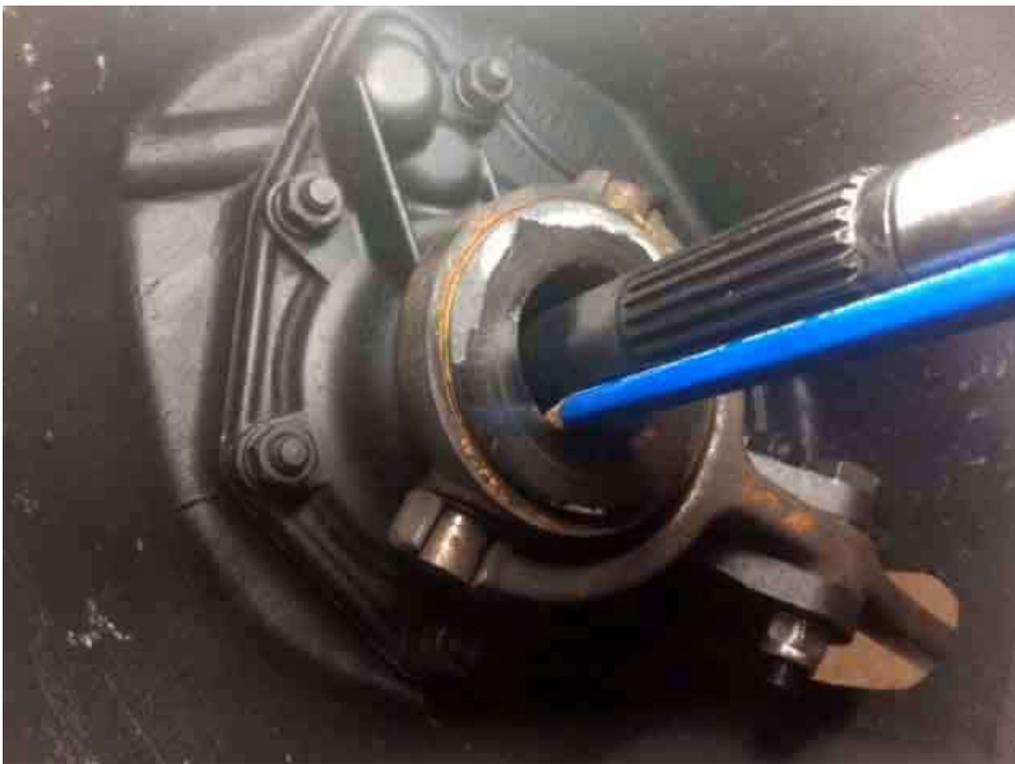
But the off-setting of the bearing to the first-motion shaft is very low:

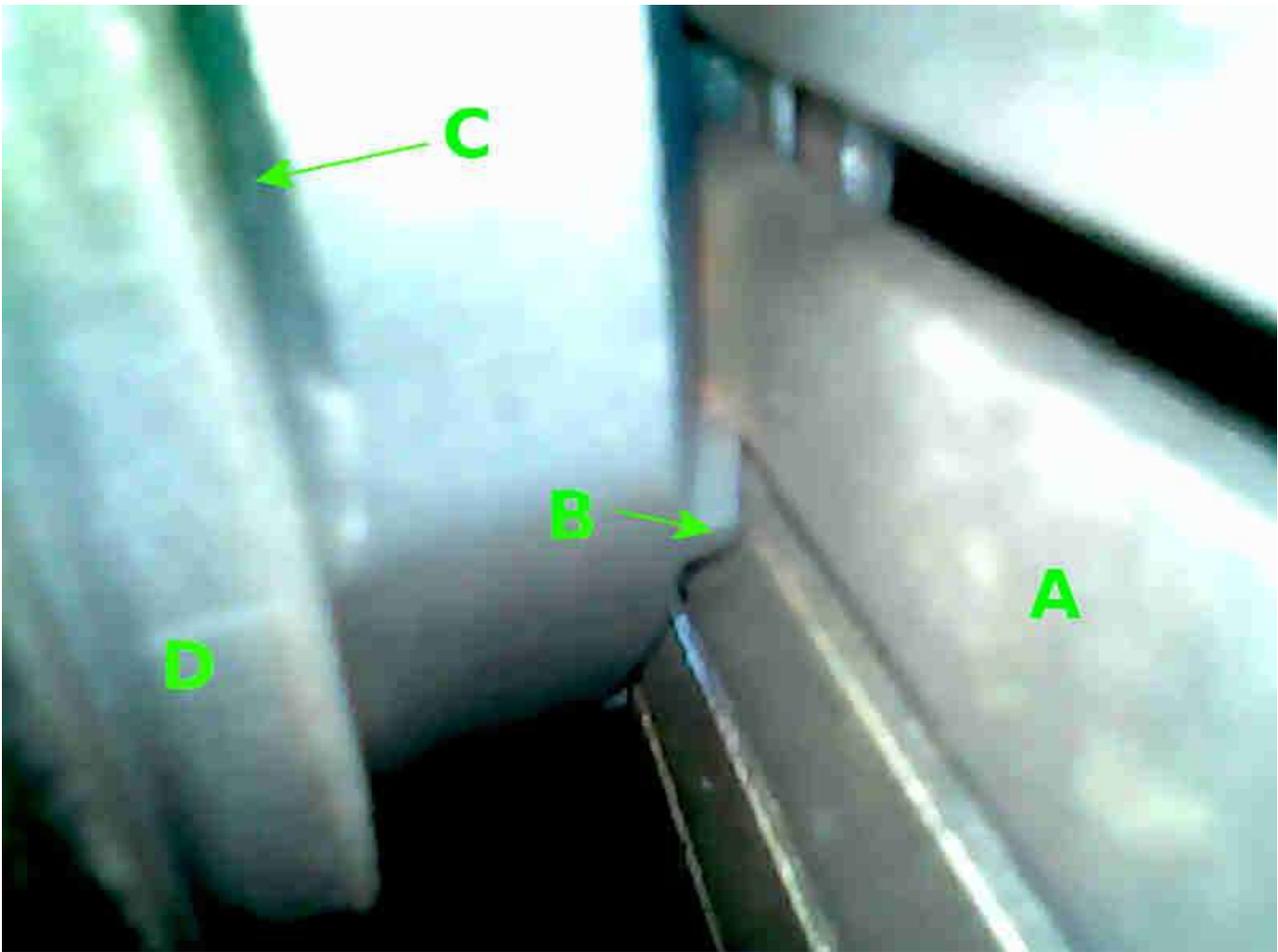
Looking up through the release arm hole, gaiter pulled back - 'A' are the diaphragm spring 'fingers' on the cover plate; 'B' is the release ring with 'teeth' (arrowed) that locate the ring in the slots between the spring fingers. The ring is retained to the cover plate with a flanged sleeve (see below); 'C' is probably the graphite ring on a new release bearing; 'D' is the release bearing casting. As the graphite wears down the casting will get closer to the release ring and the graphite vanish from view, but that will happen some time before the bearing needs replacement: (*Mike Dixon*)

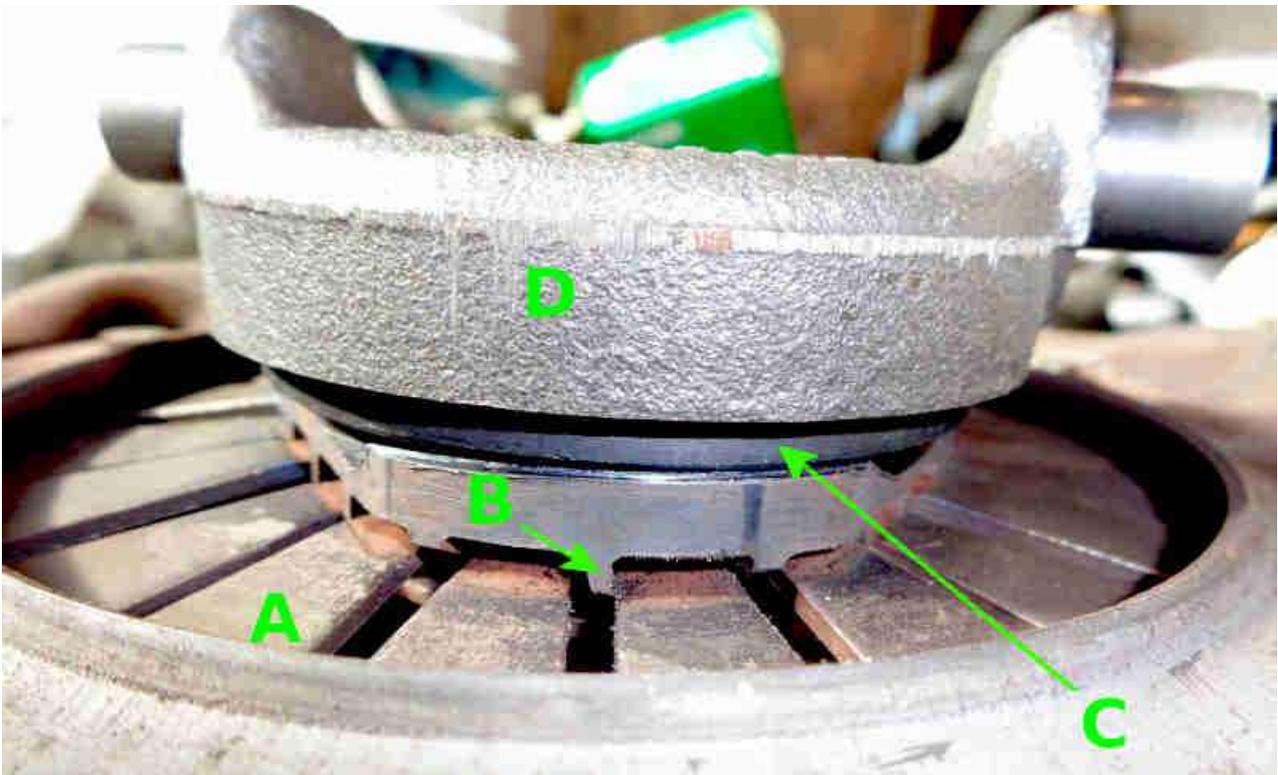
As above 'A' are the diaphragm spring fingers on the coverplate, 'B' is the release ring with its location teeth, 'C' is the graphite on a new bearing, and 'D' is the bearing casting:

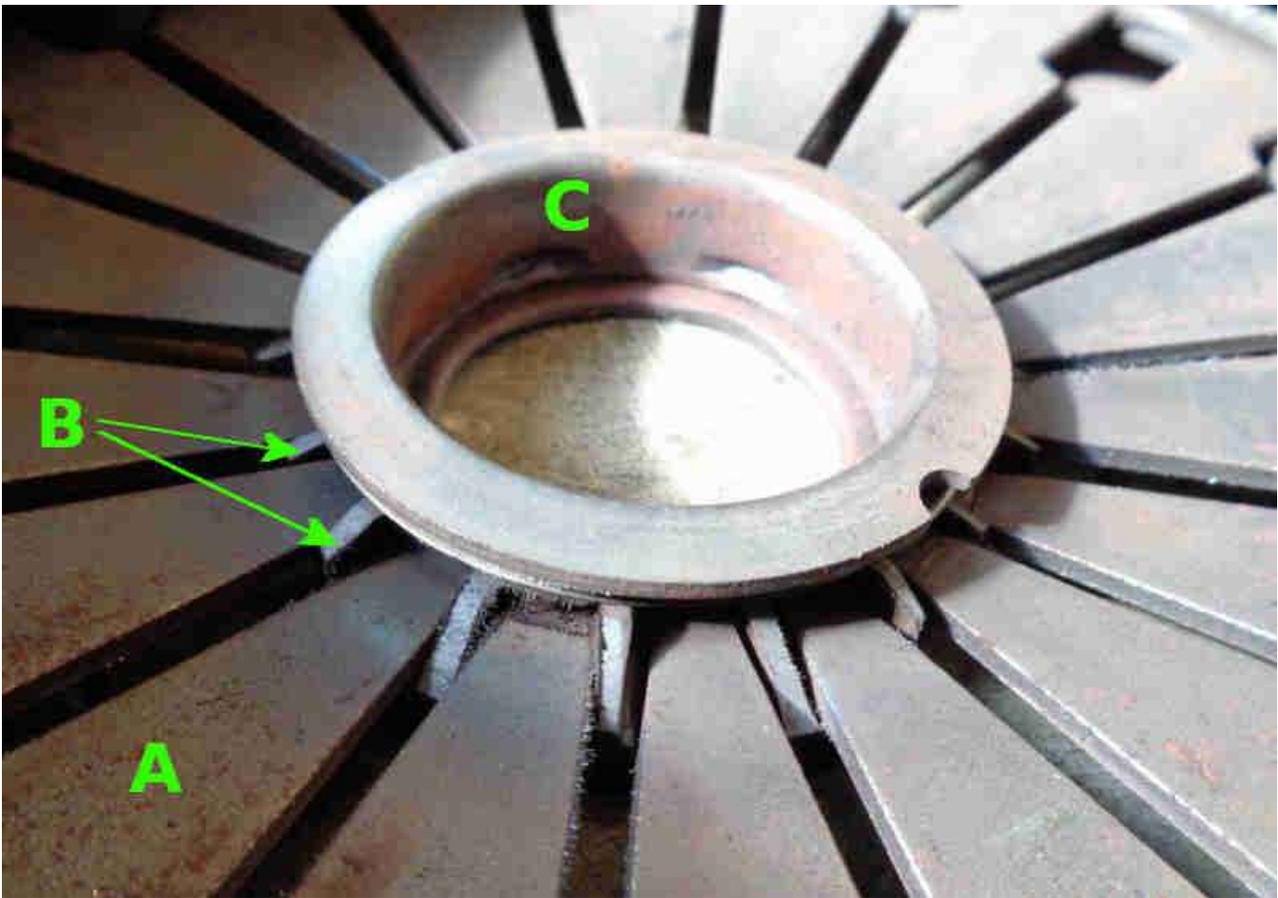
The 'back' of the cover plate with 'A' and 'B' as above, 'C' here is the flanged sleeve that retains the release ring on the spring fingers:
