Bee's Clutch Change 2016

Last updated 22-Dec-2023

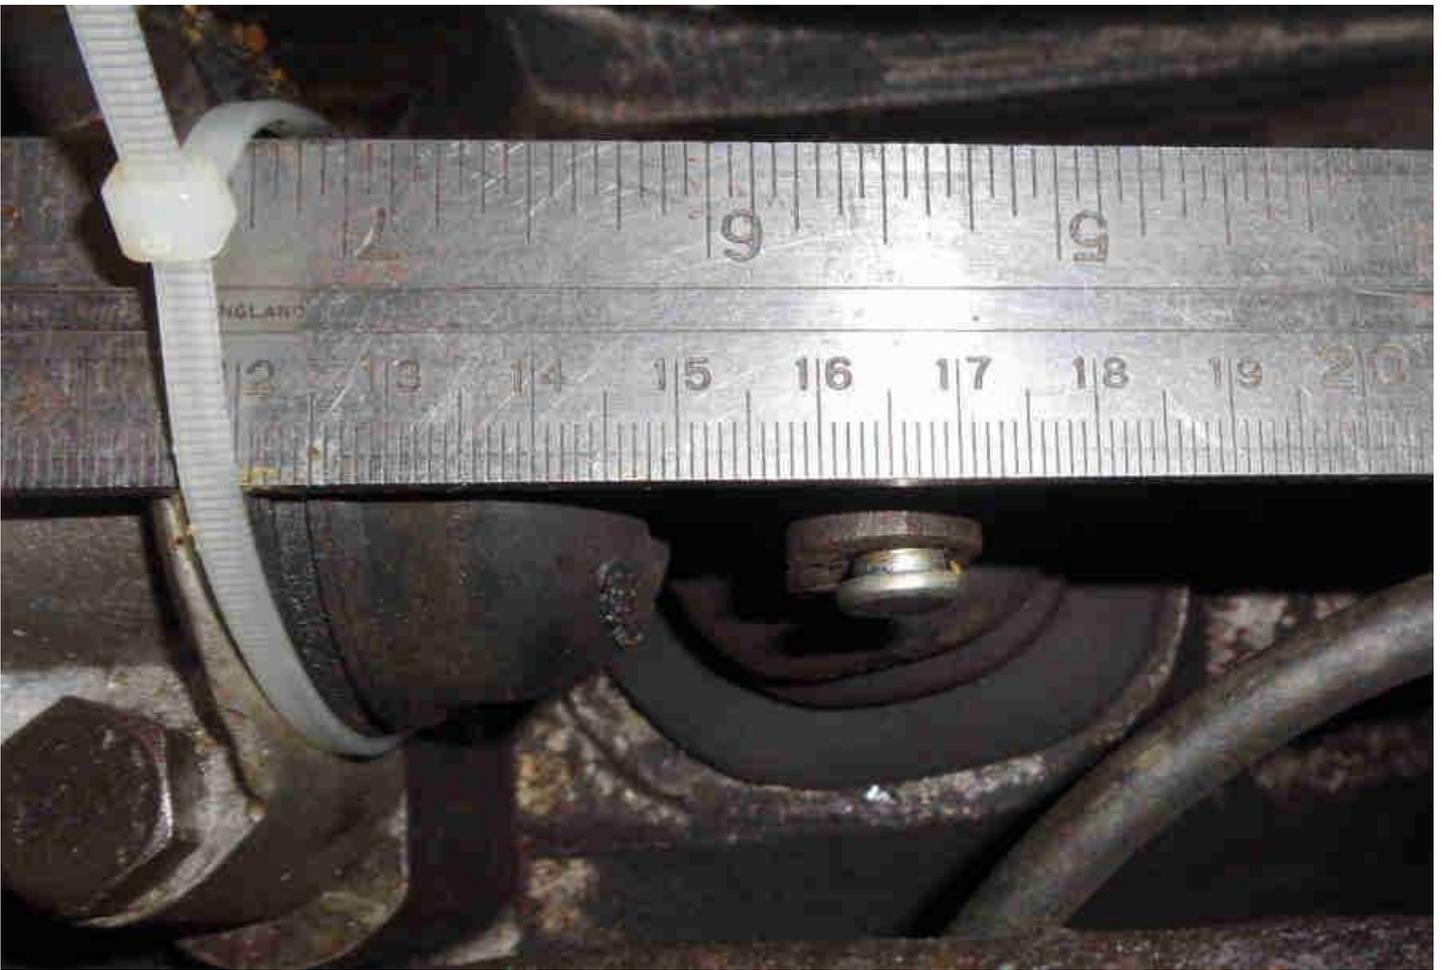
Pedal fully operated, mark now at 166mm. This means there has been 11.5mm of slave push-rod travel, or 0.453". That's between $7/16"$ and $15/32"$, so as near as dammit $1/2"$, and makes the biting point slightly higher than I would like so no shortage of travel there.

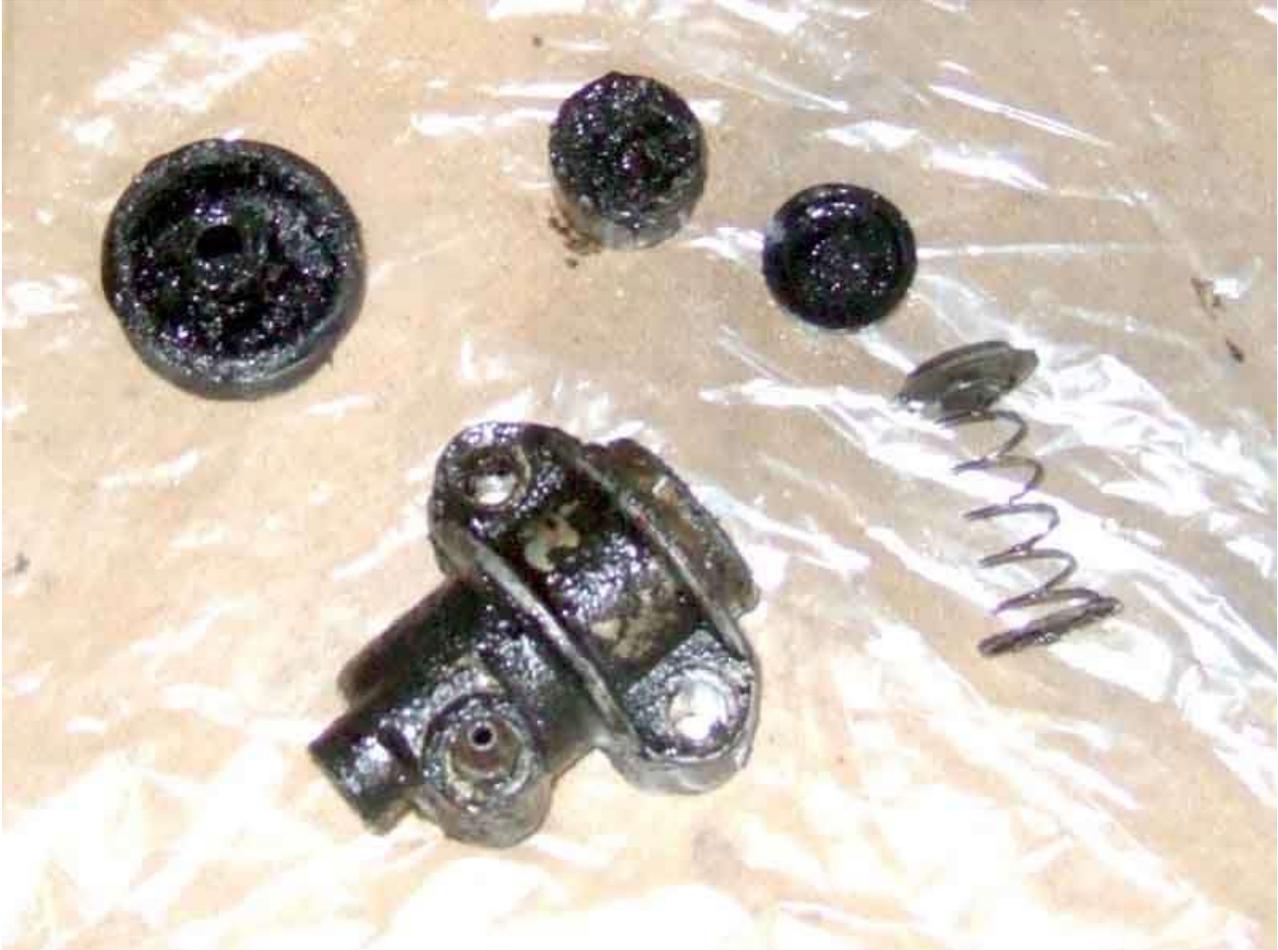
The muck and gunge both inside and outside

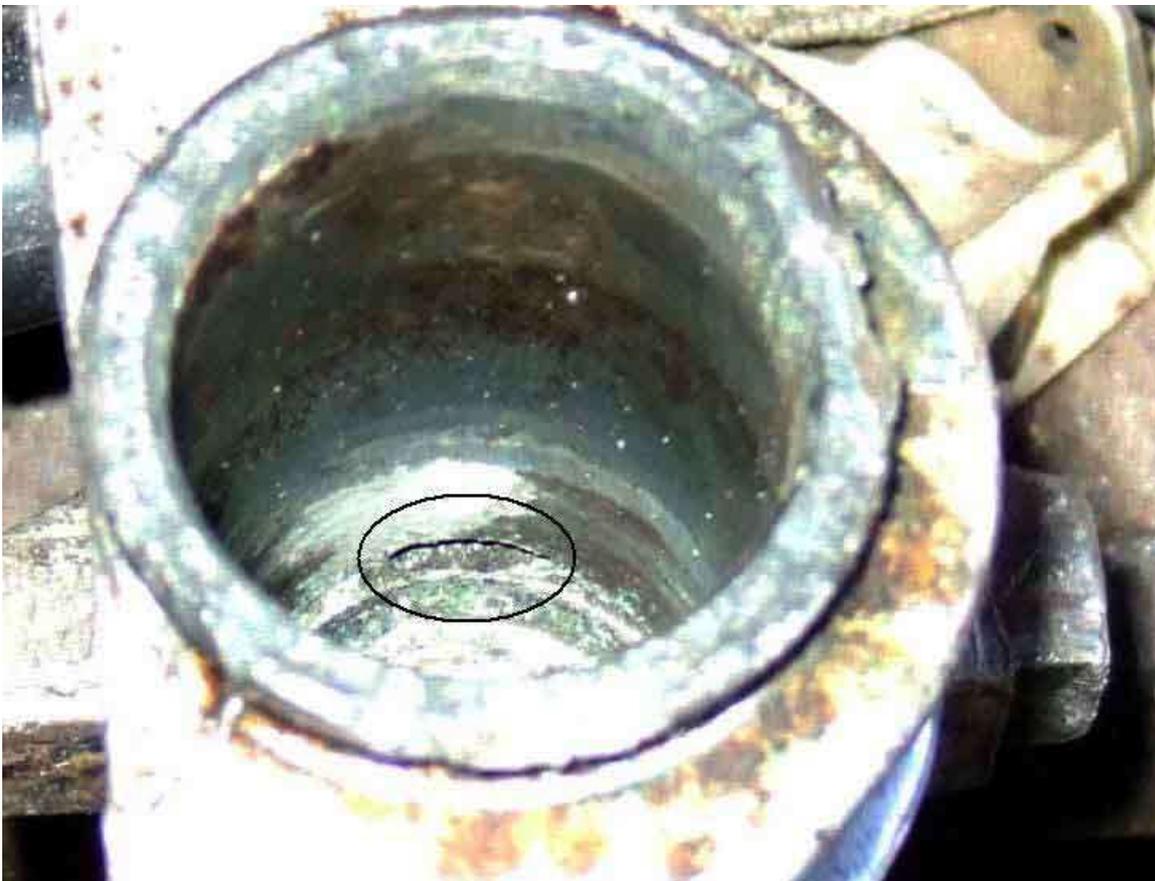
Showing the bleed hole (circled) drilled along the line of the join of the cylinder wall to the back wall, in an arc at the top of the cylinder, normally at the highest point of the cylinder when the car is on its wheels or has the front raised.

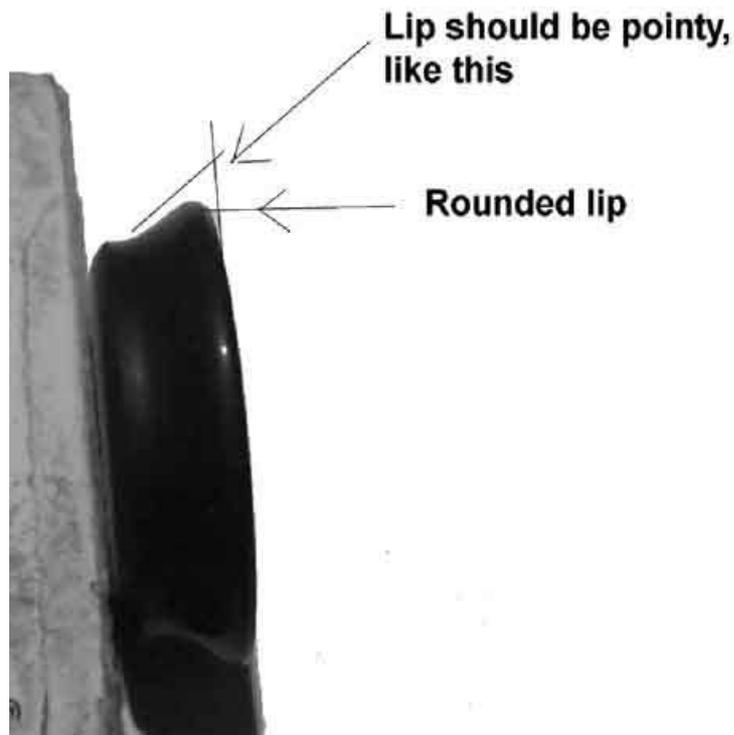
Herb Adler's clutch slave seal, was sucking air in:

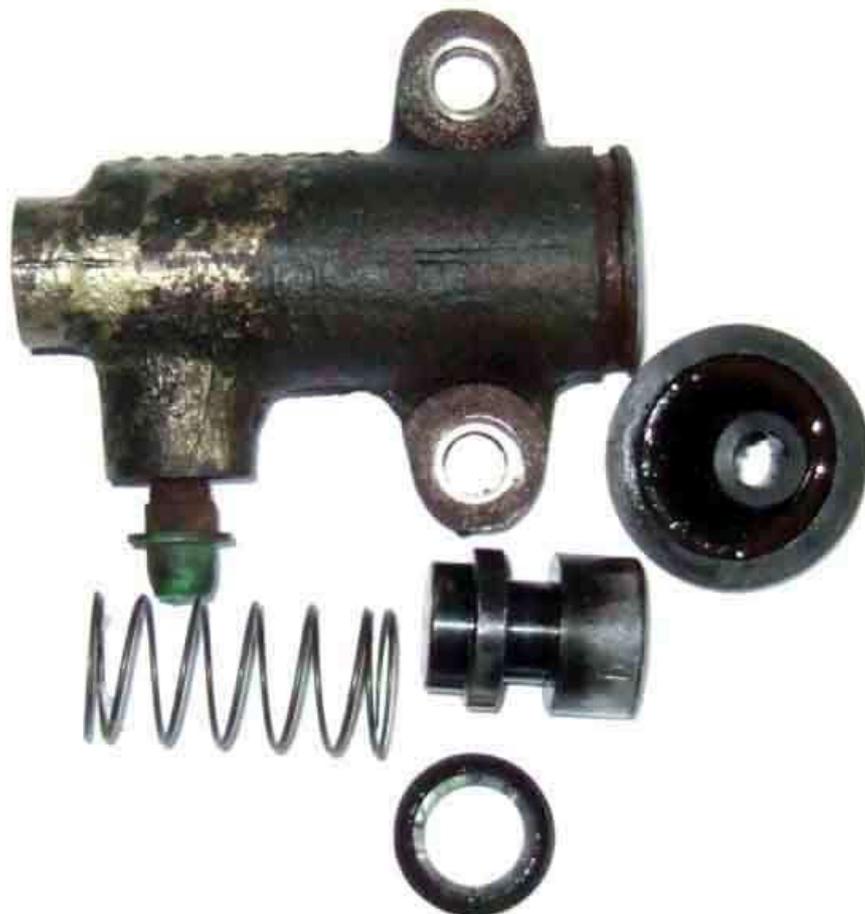
Vee's replaced because of a leak - significantly different. Instead of a 'loose' seal and piston as on the 4-cylinder the pressure seal here is a ring-seal that has to be stretched over the end of the piston and dropped into the groove, similar to brake slaves. Hence the longer piston, and longer slave overall. Also has the 'push out' spring confirming it's not solely used to spread the seal on the 4-cylinder type. Like Bee's brake slave I changed earlier this year the seal is only slightly wider than the piston, so doesn't bear very firmly onto the cylinder wall.

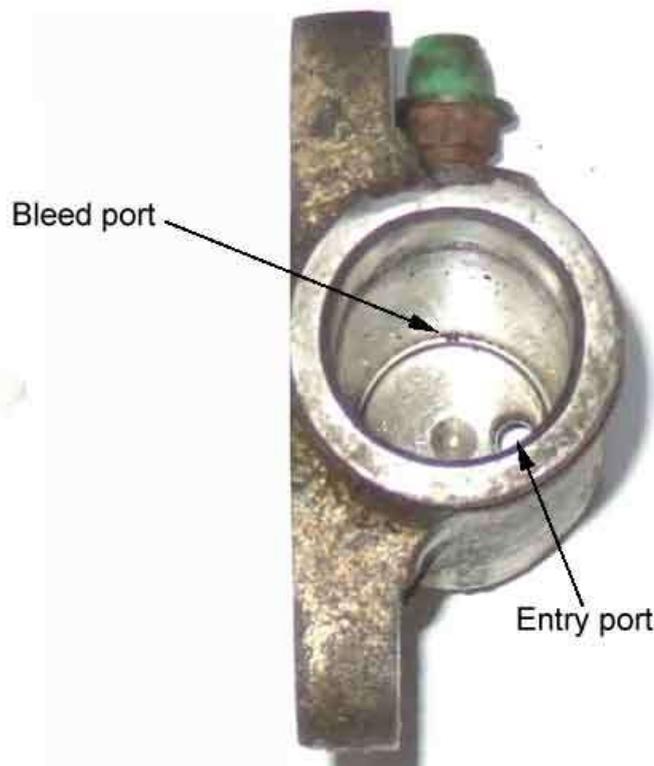
Internal of the cylinder showing the fluid entry and bleed ports. The walls are very clean apart from a ring of something at the extremity of movement of the seal, although this is the top half.

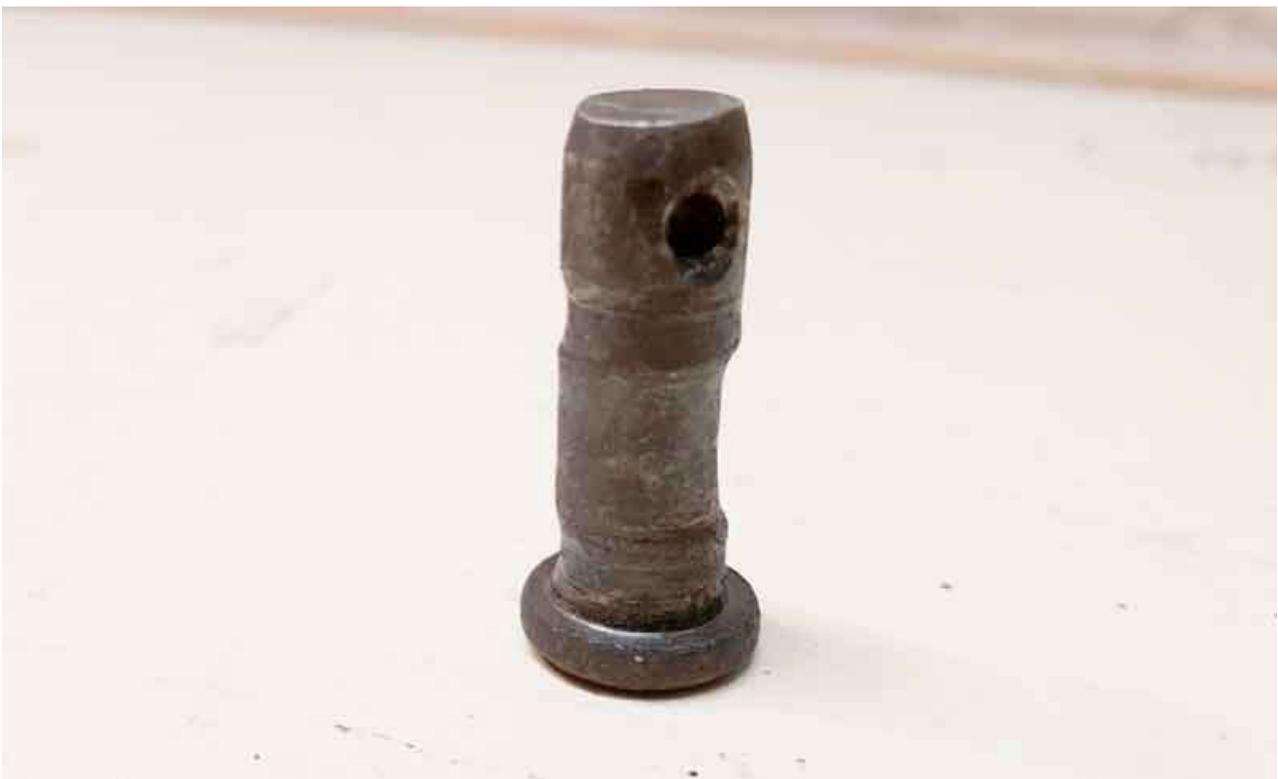
Steve's clevis pin as badly worn as Bee's was:

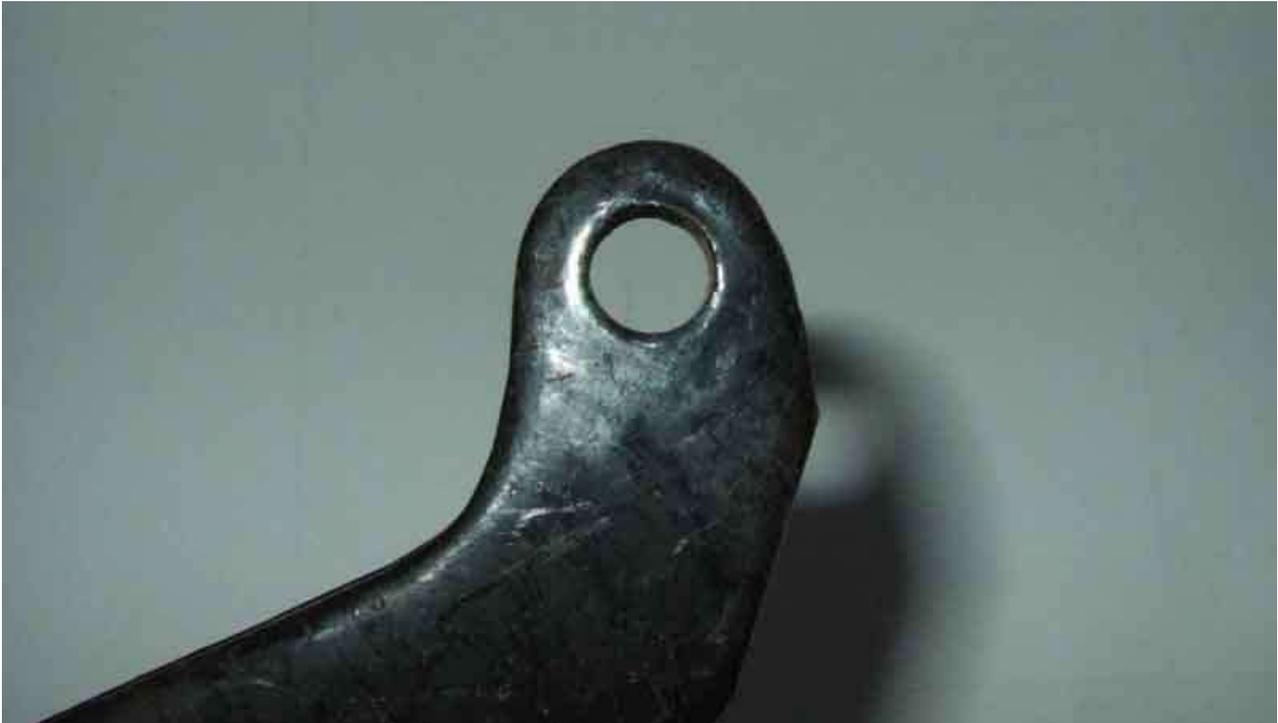
But looking at Steve's pedal I realised that all the wear is to the right, which means originally the hole would have been considerably off-centre, whereas I remember Bee's (with the wear removed) and two spare unworn pedals were central. This is one of the unworn spares showing that, but it also shows that the left-hand side of the hole is about the same distance from the left-hand edge of the pedal in both cases, so Steve's pedal must be much wider than mine at that point. Not only that, but this hole is nearer the top than Steve's is, which if the pedals have the same distance from the pivot to the top means that Steve's will have less leverage and hence less 'throw' than mine:

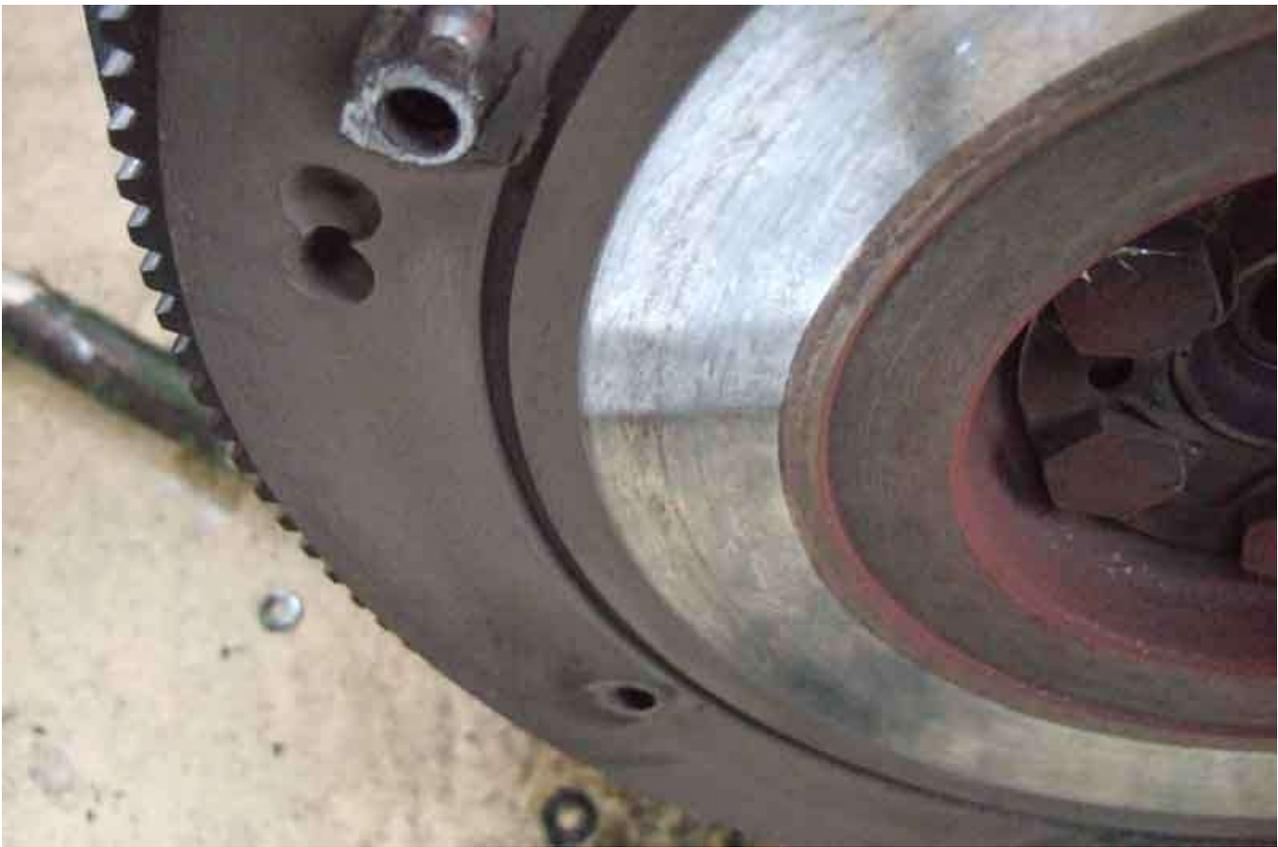
Witness marks as the rivets pass by, but no grooves on the flywheel, which could have happened with any previously worn-out clutch

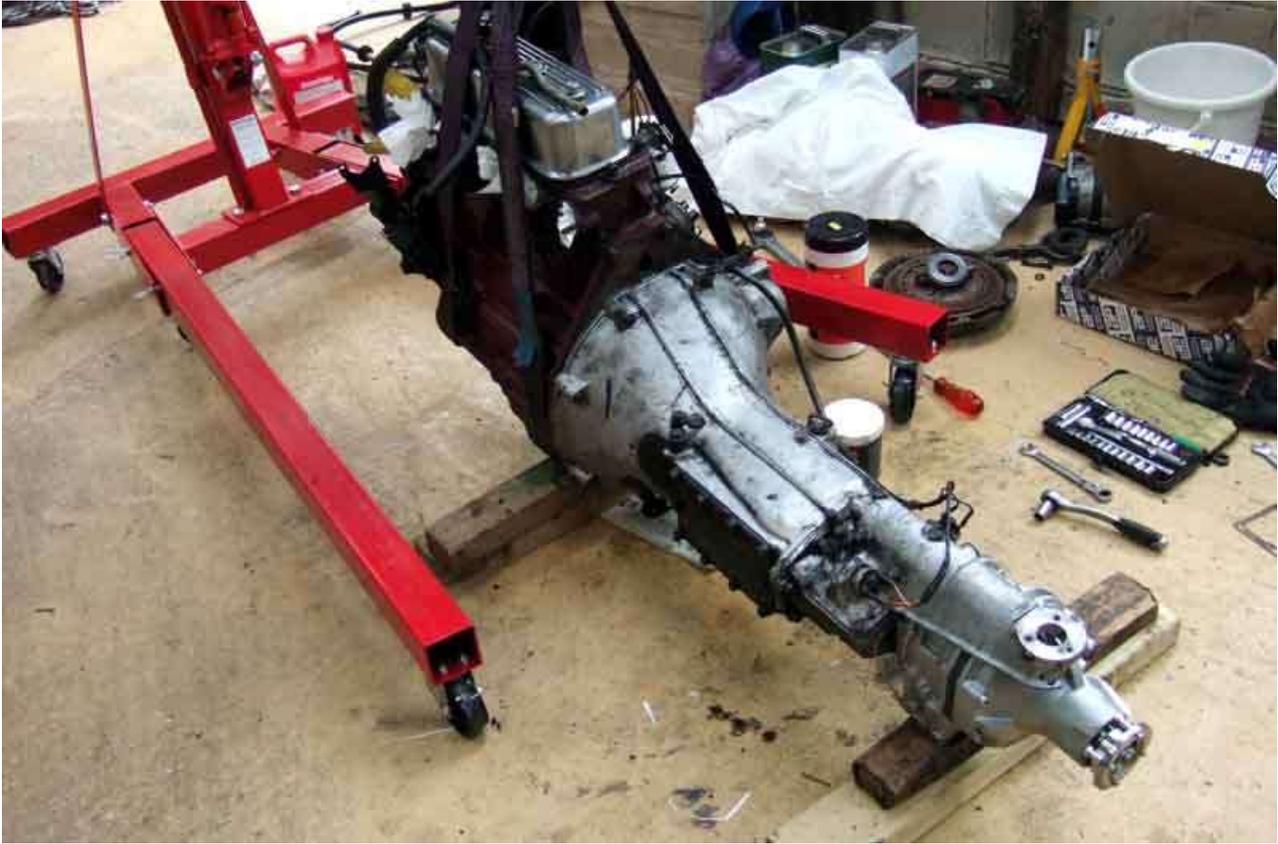
easier than trying to do it once installed! Note that the harness should go under the remote extension between the two switches, not over as here.

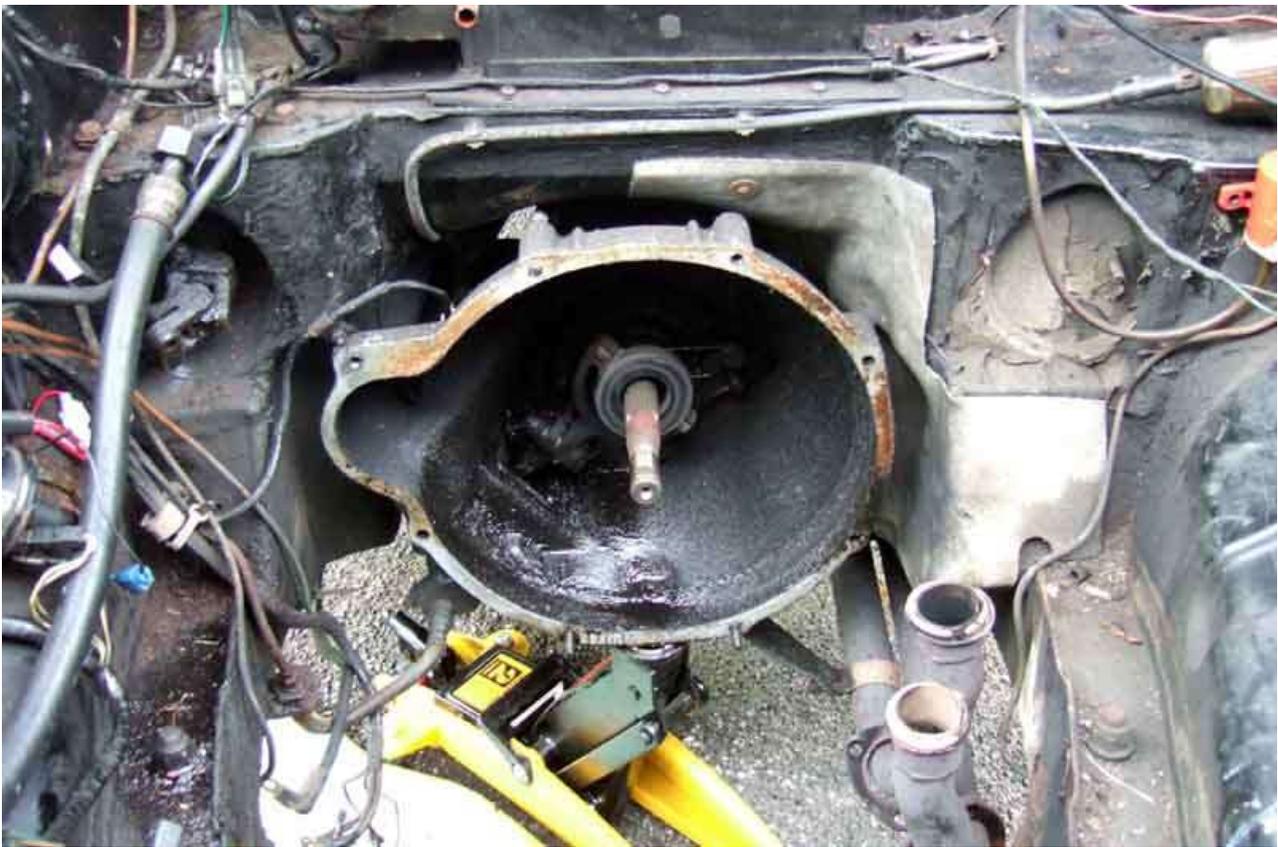
Gunky oil in the bell-housing, around the release arm rather than straight down from the first-motion shaft and cleaner oil if it had been the oil seal. I would very strongly advise freeing-up the connection between the clutch hydraulic pipe and the end of the hose, and the locknut securing the hose to the bracket on the chassis rail while the engine is out even if you don't think you will be removing it later. It's an absolute pig when the engine is in.

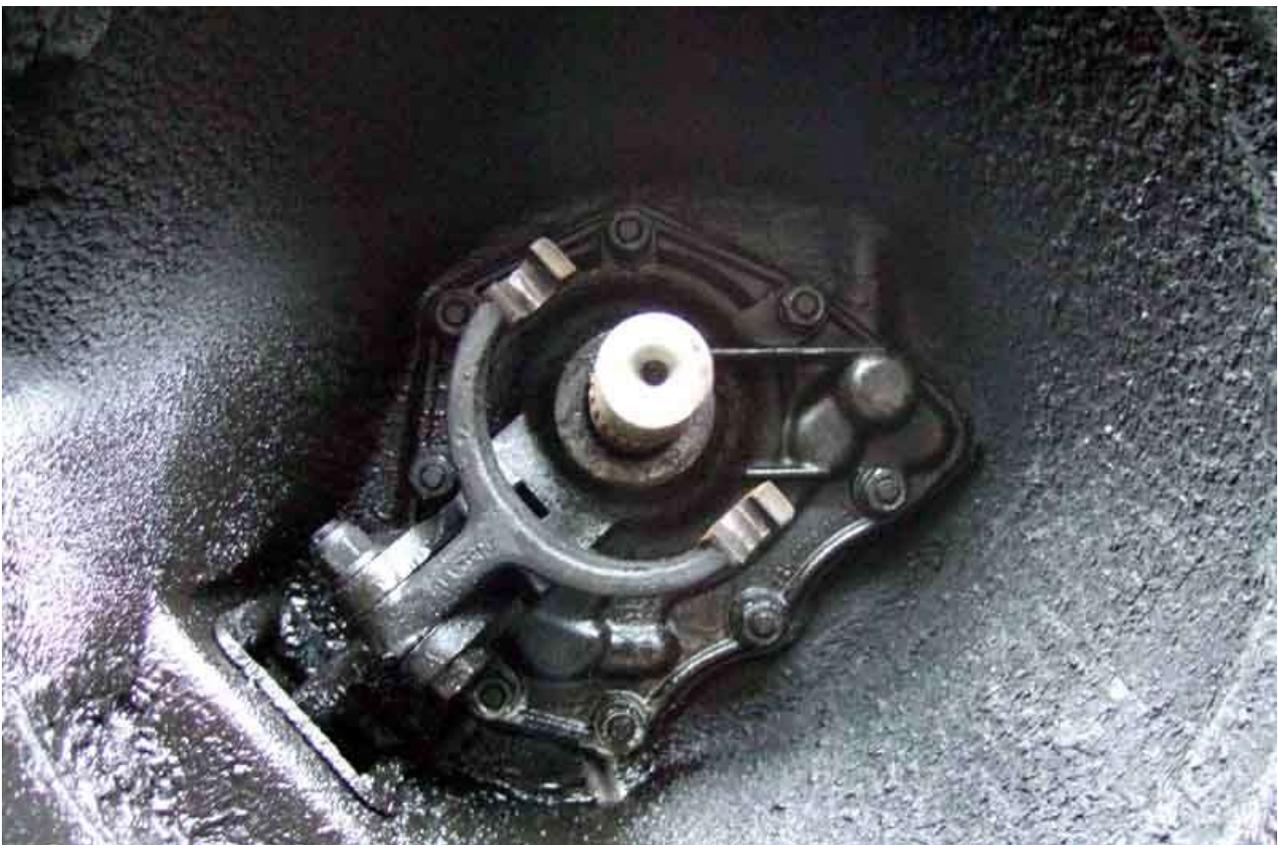
No visible seepage from the seal itself, so just checked the nuts on the seal plate for tightness. Check the release arm does not wobble on its pivot, but still moves freely. If the arm wobbles the release bearing can be off-set to the cover plate which causes premature failure. Also note that the release arm fork is pretty-well concentric with the first motion shaft, [which wasn't the case on Bee in July 2016](#).

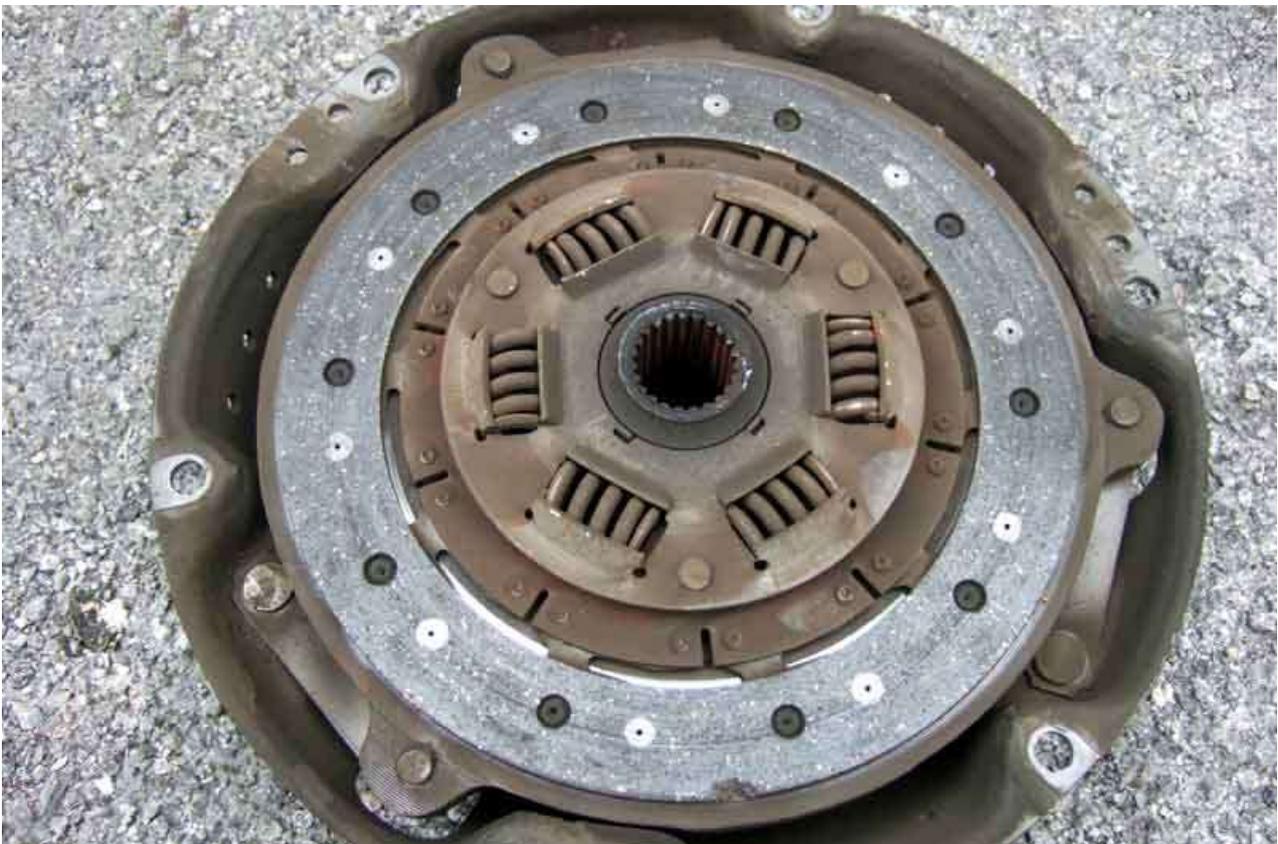
Friction-plate down to the rivets, fortunately only on the cover-plate side (facing upwards here).

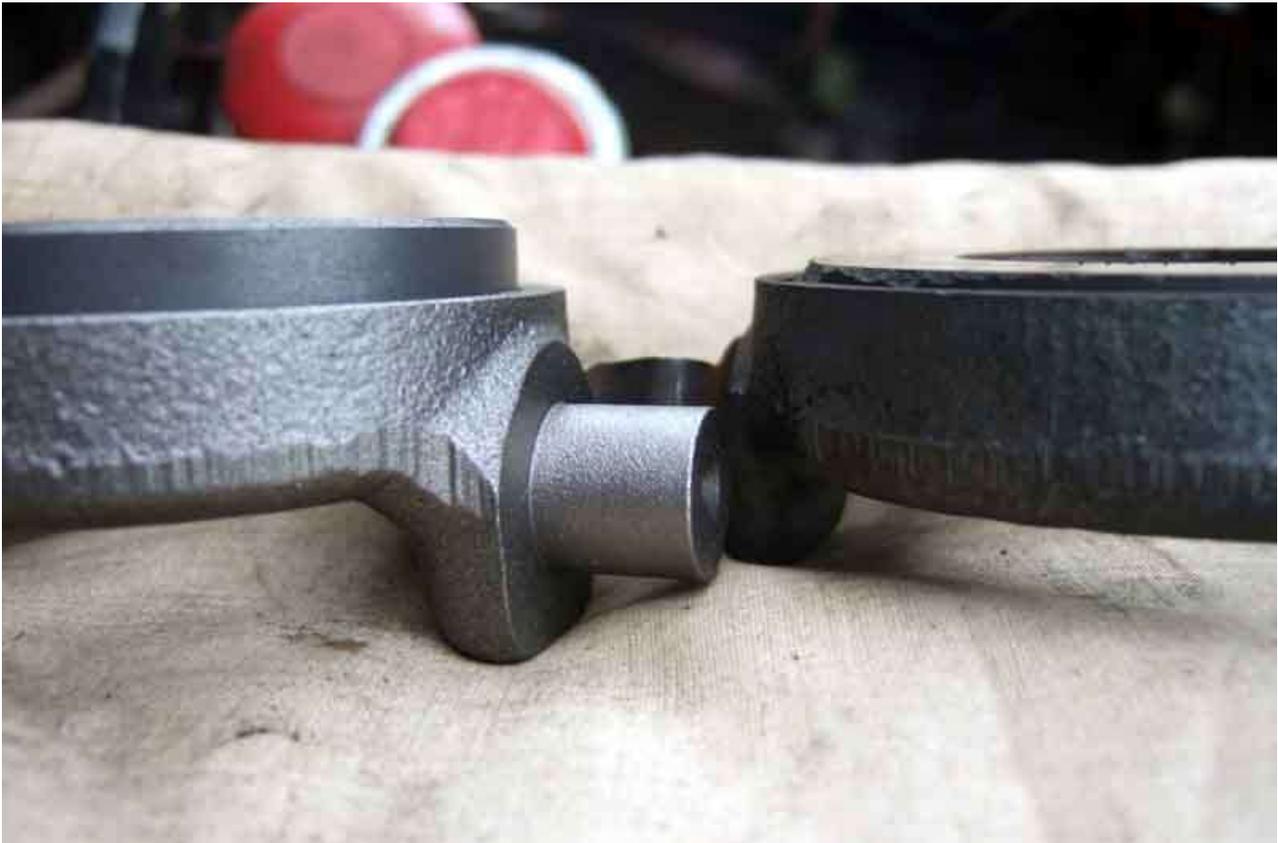
New (left) and old (right) release bearings - plenty of meat left on the old, perhaps only 1/3rd worn, as in theory the boss on the cover plate can go right down inside the release bearing casting. However the release bearing would need to be exactly

concentric with the cover-plate boss, and in practice it seems there can be significant misalignment between the two which would mean that as soon as the graphite has worn flush with the bearing casting, you get metal on metal and very rapid wear on both, to be followed by catastrophic failure of the bearing casting. Under those circumstances, this bearing is just about worn out.

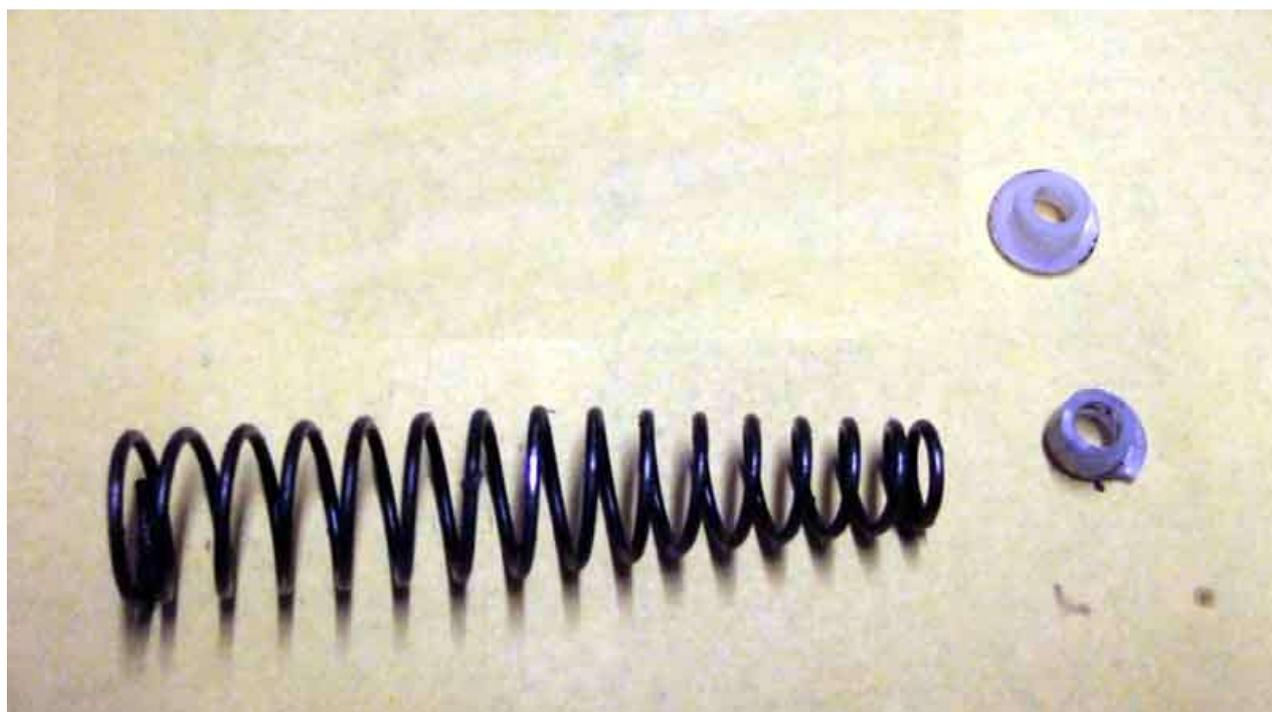
Despite being a 1973 model Bee's master does not have the later markings, and even though the clutch master hadn't been tampered with in my ownership of 26 years (and I suspect it was original to the car) I drained the system by opening the bleed nipple and pumping with the pedal and removed the piston and seals before ordering spares so I could check the bore. A long screwdriver is needed to get at the one cover fixing screw tucked down beside the inner wing, but a driver that takes hex bits with a couple of adapters and a 1/4" drive extension reached that OK, the others are easier. Cover twists out across the front of the masters towards the engine, with just the water bottle removed from its cradle to give a bit of slack on the tubing which normally sits over the flange of the cover. Split-pin and clevis pin removed, dust-cover pulled forwards, circlip pliers and a wiggle and pull removes the push-rod. The internal return spring pushes the end of the piston with the secondary seal out, pulled that the rest of the way out with my fingers, leaving the primary seal etc. still in the bore. Extra-long nosed pliers (from my BT days) tip the seal over so it can be gripped and pulled out. Peering into the bore I can see the plastic 'spreader' that sits between the end of the return spring and the fluid face of the seal has half a flange broken away so it had been at an angle on the spring and setting the seal at an angle. I can also see a broken piece of the spreader sitting in the bore. The seal itself is quite distorted, so must have been like that for a considerable time, amazing it kept going as long as it has. Fish the bit out and the spring with the remains of the spreader.

The broken seal spreader that came out (bottom) and a good one from an old cylinder (top):

Wrap some hand-wipe cloth round a chop-stick (!) and use that to wipe round the bore, which looks perfect. Because Bee's biting point has been rather low for as long I can remember, and I did modify the push-rod some years ago to give more 'throw' (which only improved things slightly), I decided to order both kits - the original at £4 and the conversion kit at £11. New spreaders not available, but having kept the guts of Bee's brake master and both masters off Vee changed some years ago, and out of those three two had the old-style seals with the same spreaders, so I had two spares!

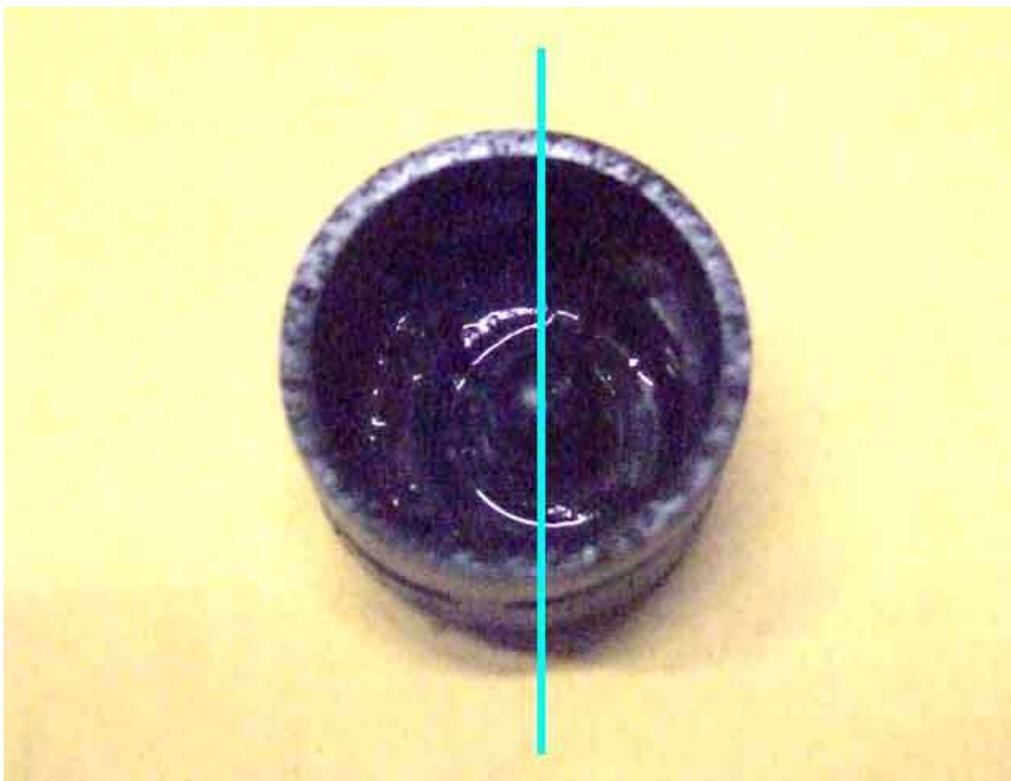
The distorted seal. The vertical line runs through the centre of the pip that is at the bottom of the cup and sits in the hole in the spreader. That should be central, but is clearly displaced to the right because of the broken spreader.

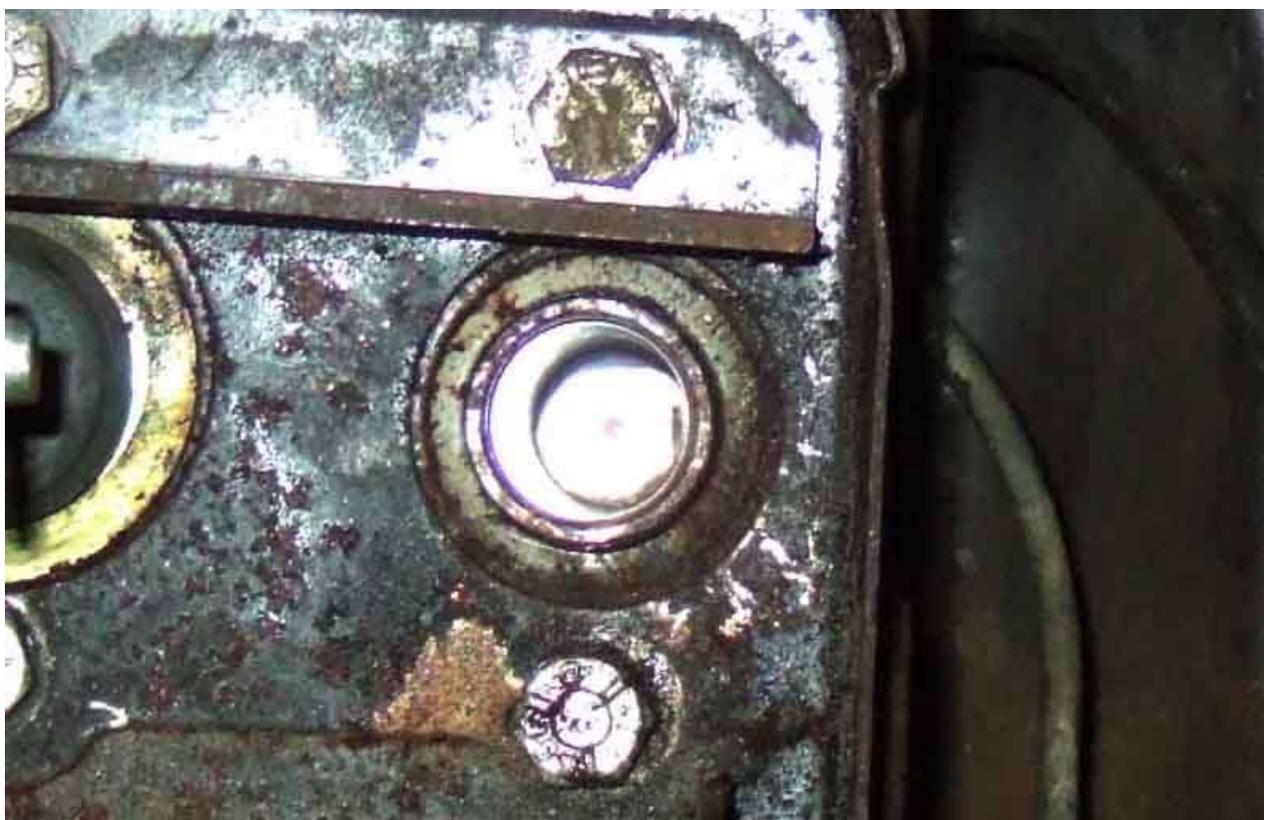
Shiny bore full length and all the way round:

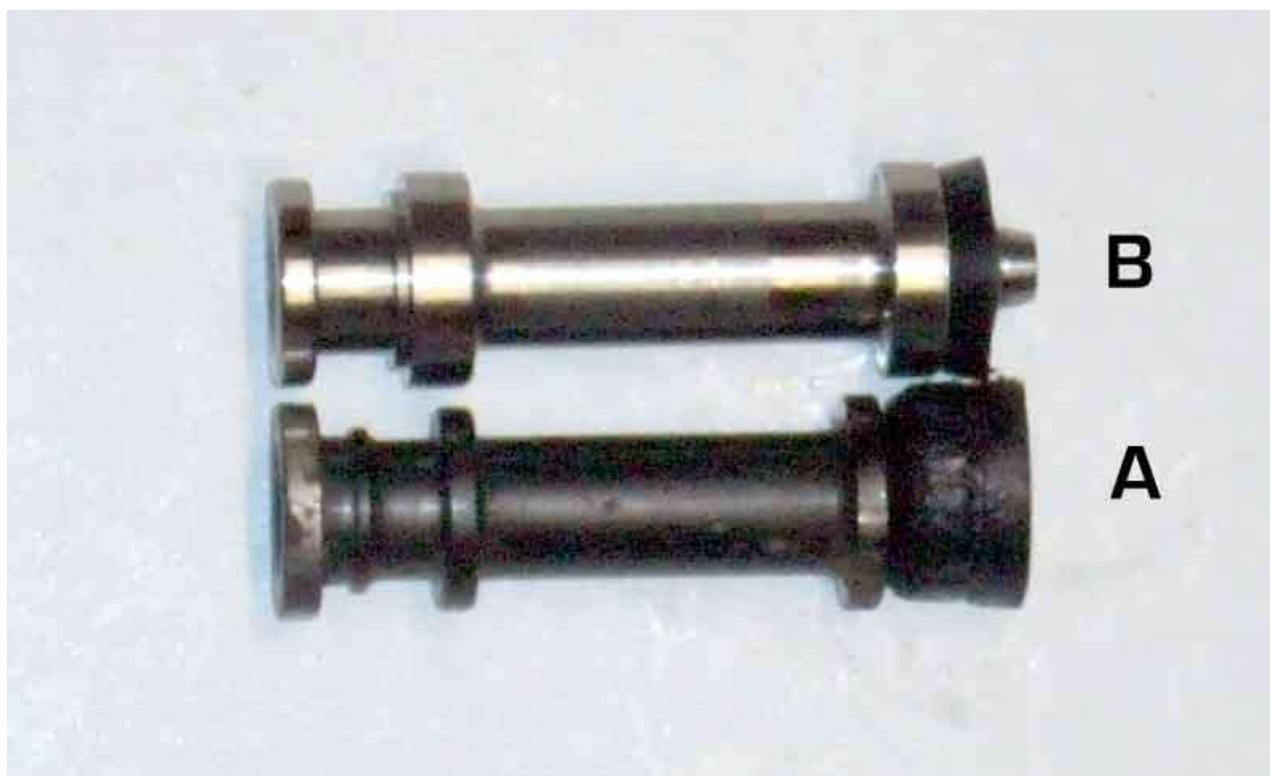
So that means I have to move the hole back down on the pedal to correct the angle of the push-rod, as well as move it away from the master a bit as there is no point in having the pedal pad so high that the master stops it way before it reaches the floor. But why is my biting point still so low? I take some comparative measurements with the V8, and whilst the V8 has more free play in the clevis pin linkage, it obviously starts to build pressure earlier than Bee. I then look again at the seal I removed from Bee, in conjunction with the older piston and seal, and realise that the seal I have just taken out is a good 1.8" deeper than an older cup seal. I didn't note the depth of the new seal that is now fitted, but if it is shorter than the one I have taken out then [the seal will have to move further before it closes off the bypass port from the reservoir, which it has to do before it starts building pressure.](#)

Piston and cup-type seal from Bee's clutch (A) significantly longer than the piston and ring-type seal of the conversion kit.

I could take the piston and seals out again, and perhaps fit the conversion kit, but that is also about 1/8" shorter than a piston with the original seal so isn't going to be any better. And after the problems with bleeding I'm not keen on having to go through it all over again. If I could put a spacer between the push-rod and the piston, then with the pedal fully released the piston would already be part operated, and if I could arrange for that position to be just short of closing the bypass port I would have maximum travel to pressurise the fluid.

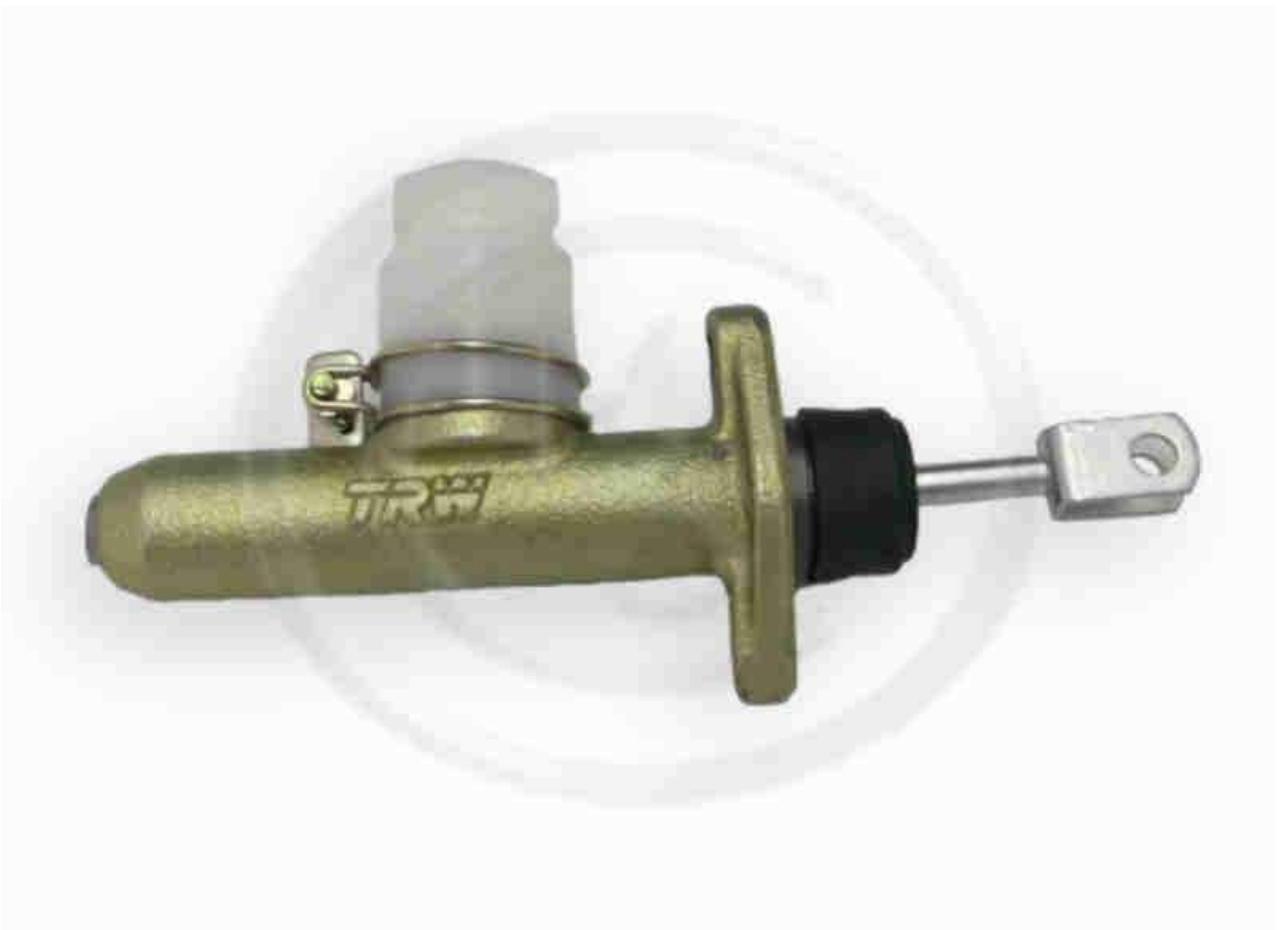
But this one from [MSC](#) seems to have the upper wire very close to the top and the lower wire may not even be on the plastic reservoir:

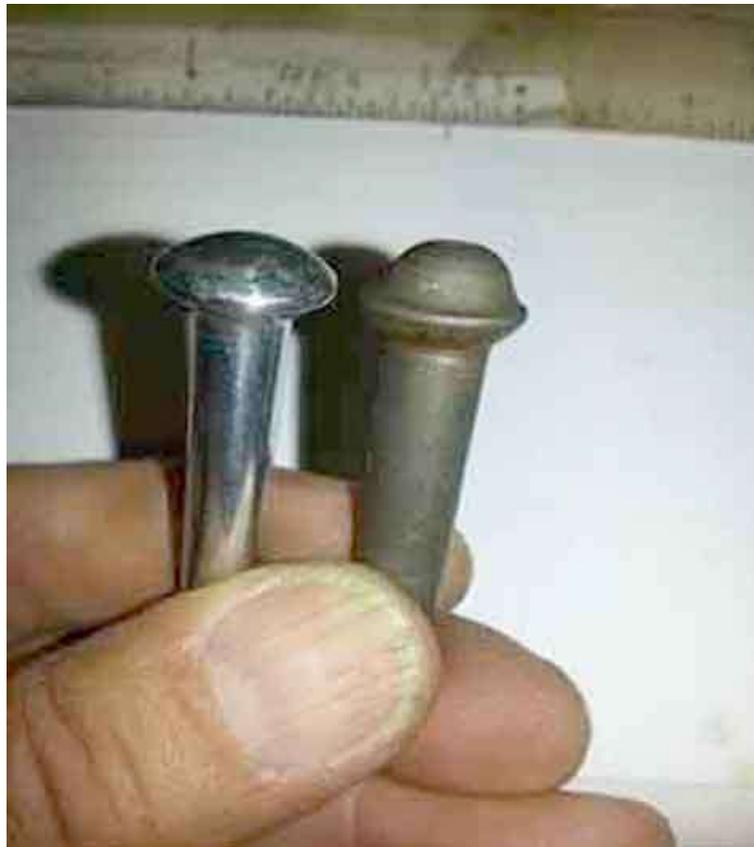
The reason (in my view) is twofold, the shape of the old push rod and the size of the hole in the retaining washer.

The Girling is on the left, Lockheed on the right. As the Lockheed is more pointed it would move around on the end of the cylinder's piston and because the retaining washer had a large hole the push rod would move to one side and catch the retaining washer on its return stroke. It's done this a number of times when driving, just flick the brake pedal and they would unlock.

So went back to the Girling push rod, made a new retaining washer (smaller hole) and adapted the old Clevis (drilled and tapped) to fit on the Girling push rod with locking nut. Having a locking nut (half nut) does not interfere with the overall travel of the push rod.

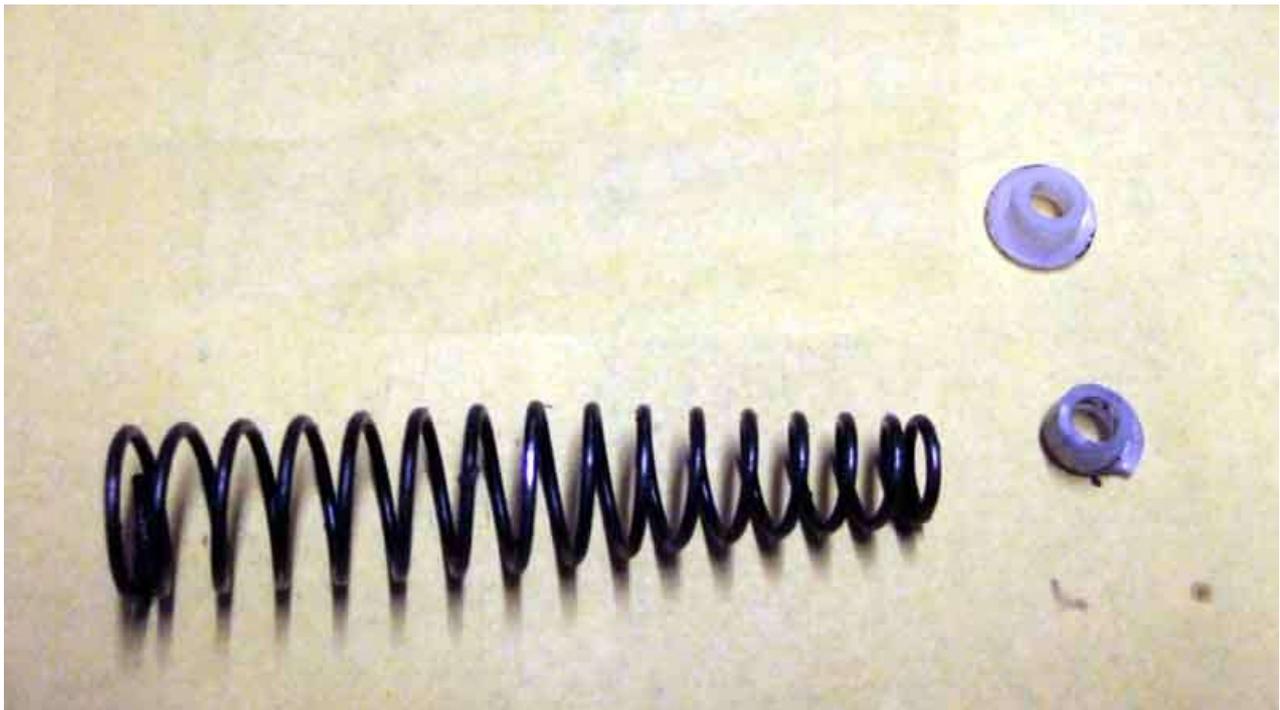
Bee's broken clutch seal spreader that came out (bottom) and a good one from an old cylinder (top):

The spreader does not appear to be available meaning if this is broken or lost the ring-seal conversion kit would have to be fitted.

of the piston and seal I could tell that the seal had been cocked to one side because the spreader had broken, but fortunately I had kept an old master and reused the spreader from that. Otherwise I'd would have to go for the conversion kit.
