Bee's Clutch Change 2016

Last updated 22-Dec-2023

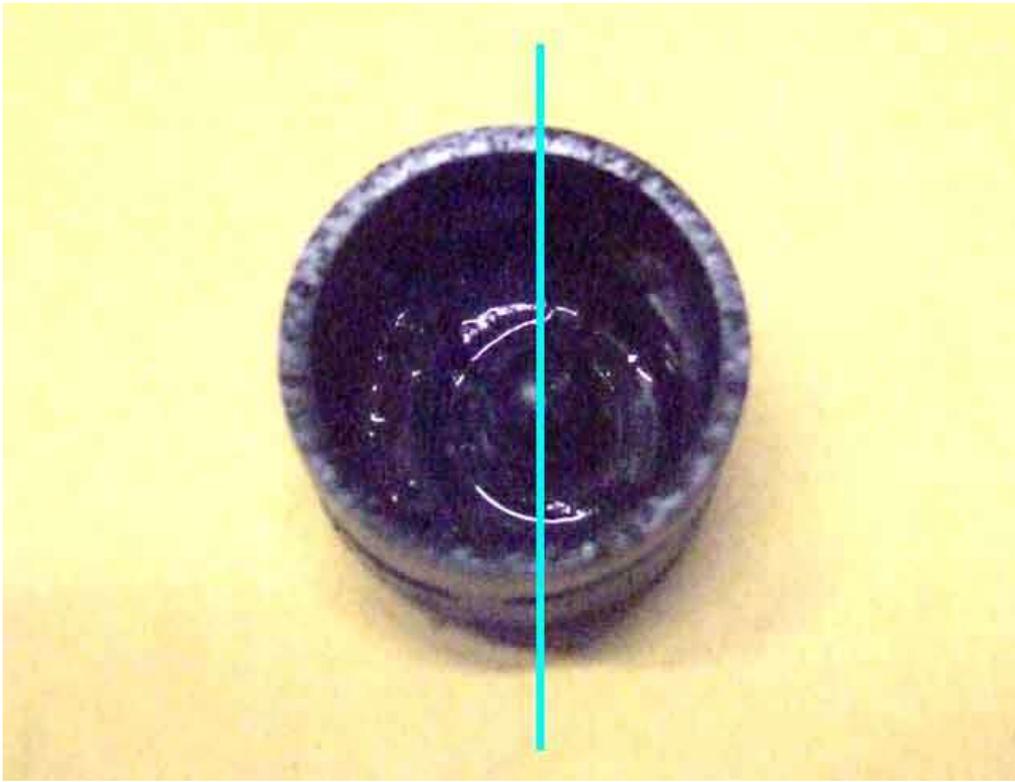
The distorted seal. The vertical line runs through the centre of the pip that is at the bottom of the cup and sits in the hole in the spreader. That should be central, but is clearly displaced to the right because of the broken spreader:

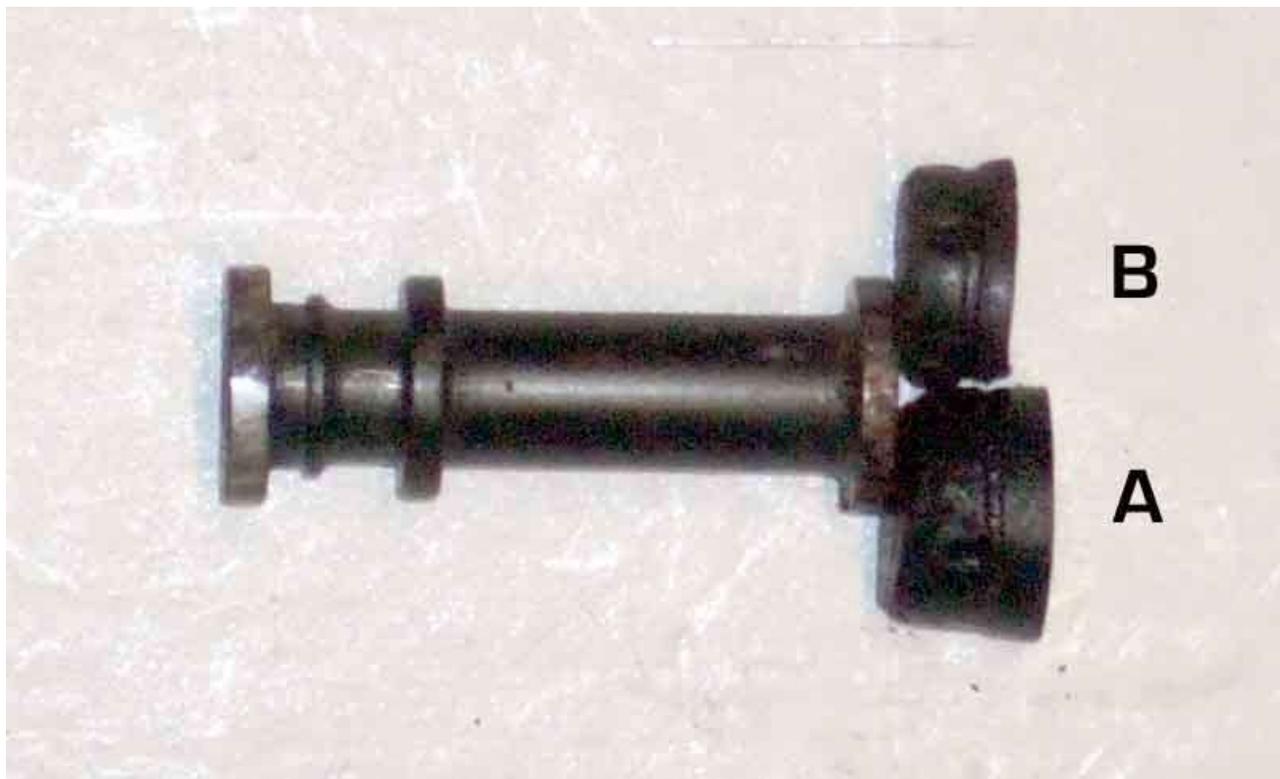
The cup-type seal removed from Bee's clutch (A) significantly longer than a similar seal from another cylinder (B). If the replacement seal is like B, that would explain why the biting point is now lower. (It wasn't, that turned out to be a problem with the release arm and bearing alignment with the cover plate):

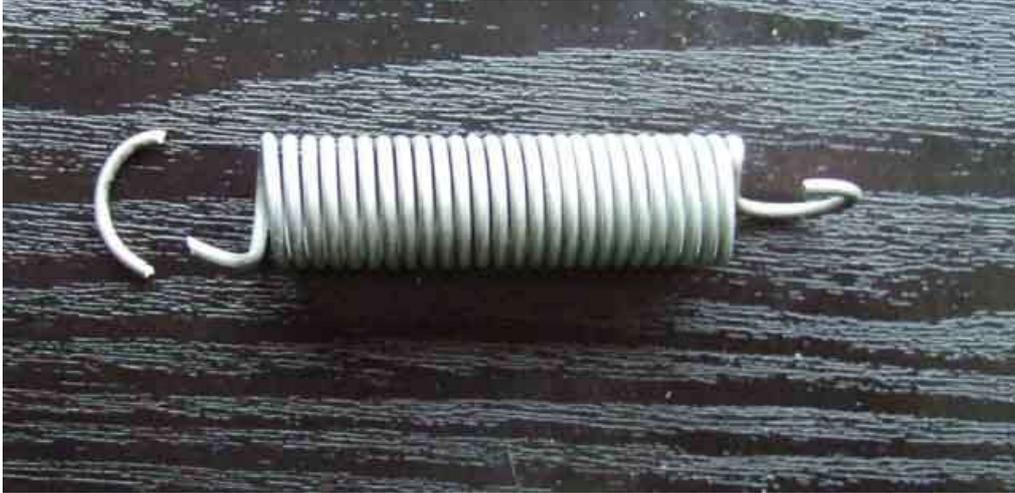
Clutch Pedal Return Spring

The fracture well away from the marks showing the pivot-point.

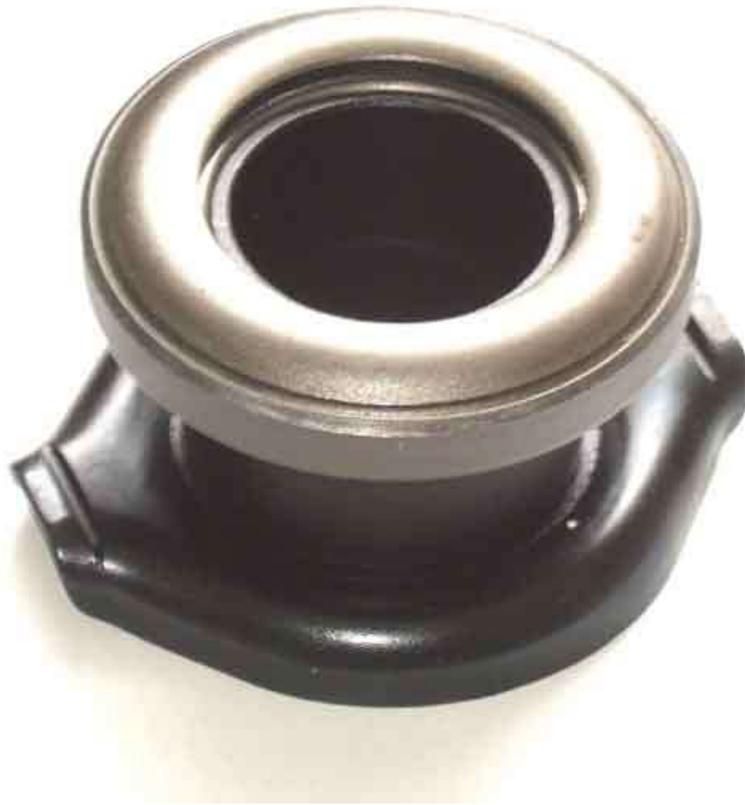
GRB224 from [Clive Wheatley](#), with an extra part at the bottom. When finally (2016) Vee's engine and gearbox was removed I found the bearing was like this one and nothing like the one from B&G below. However there seemed to be a set of plastic fingers at the roller bearing end of the tube on my bearing which looked like they might retain the [basic bearing](#). But as I could see no way to get the new bearing off its tube, and may break some of the fingers on my carrier, I had no option but to reuse the old bearing as-is. Annoyingly I've had access to the gearbox for some weeks now, so could have discovered it earlier and done something about it, but foolishly I thought it would be obvious and simple - which it wasn't.

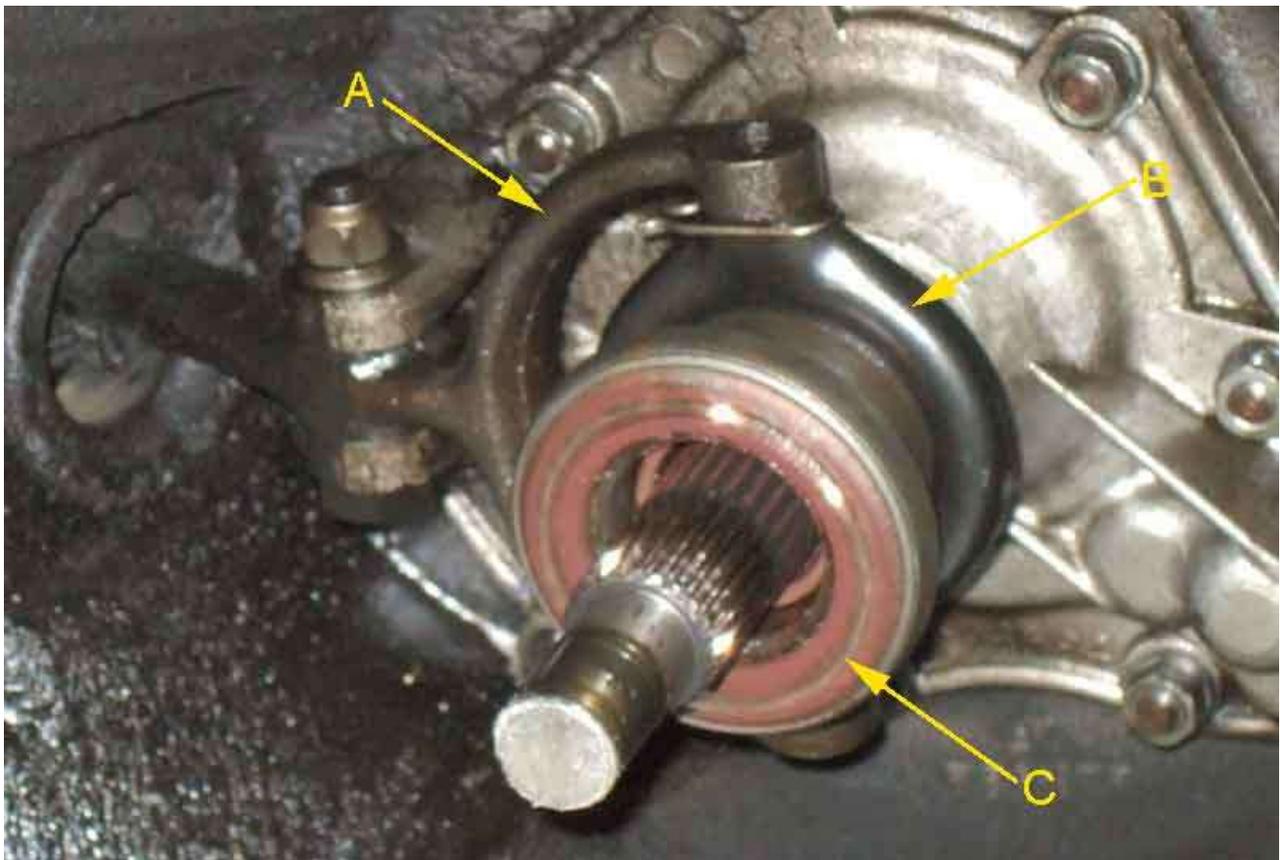
When Vee has her engine out for a rebuild I get the opportunity to see just what is there. 'A' is the release arm, 'B' the carrier, and 'C' the bearing. So the Rimmer image above shows the bearing plus the carrier. The red colour appears to be rust powder from the springs in the friction plate. Note the release arm pivot bolt is installed from underneath with the nut on top of the bracket, probably because the bolt can only be inserted from that end due to the design of the bell-housing:

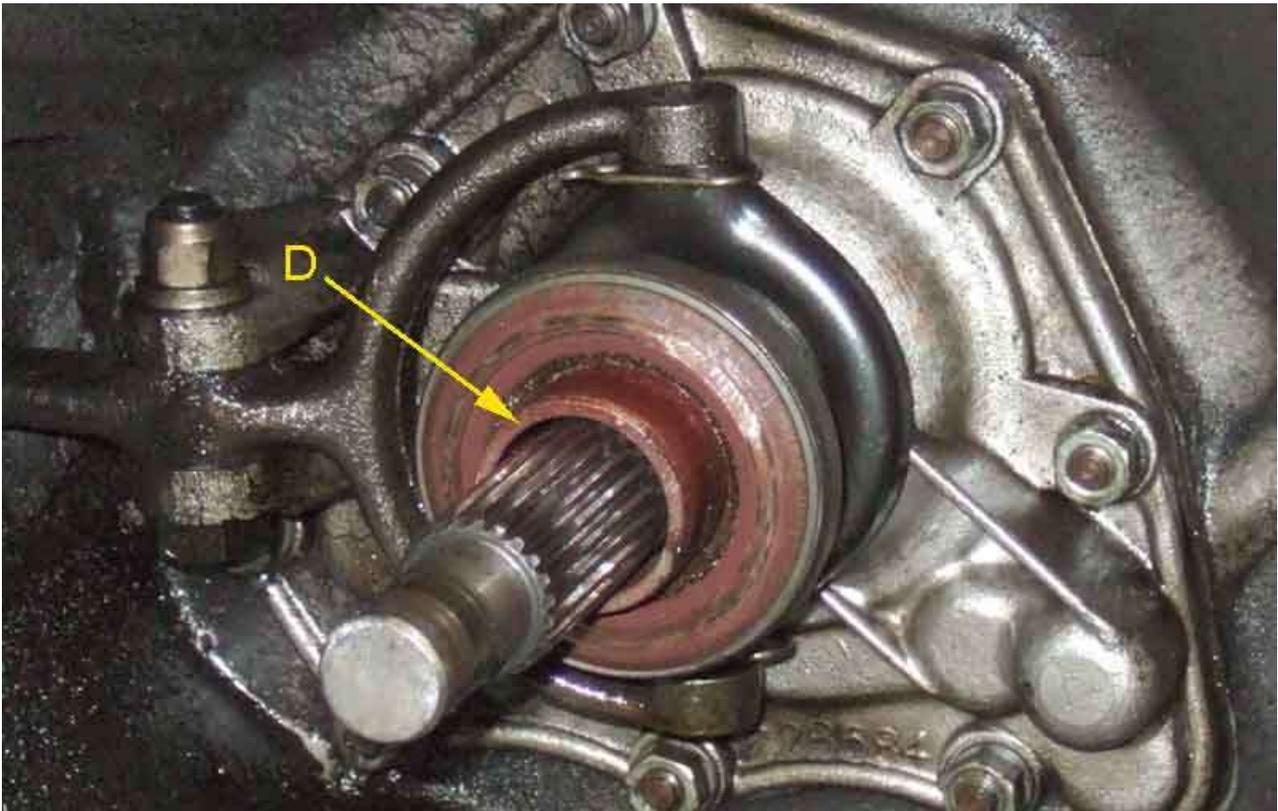
Showing the release arm and bearing fully retracted, and the guide tube 'D' that keeps the bearing concentric with the shaft. The tube is part of the front cover, and apparently the whole assembly can be fitted to the 4-cylinder 4-synch gearbox - if you can find a V8 box that is beyond repair! There seems to be a very sticky substance on the nose of the first-motion shaft that fits in the pilot bearing, which may have been causing the dragging when not used for a bit. I'm hoping when that is cleaned off and out, and lubricated, the dragging will be a thing of the past. (It is - bliss!)

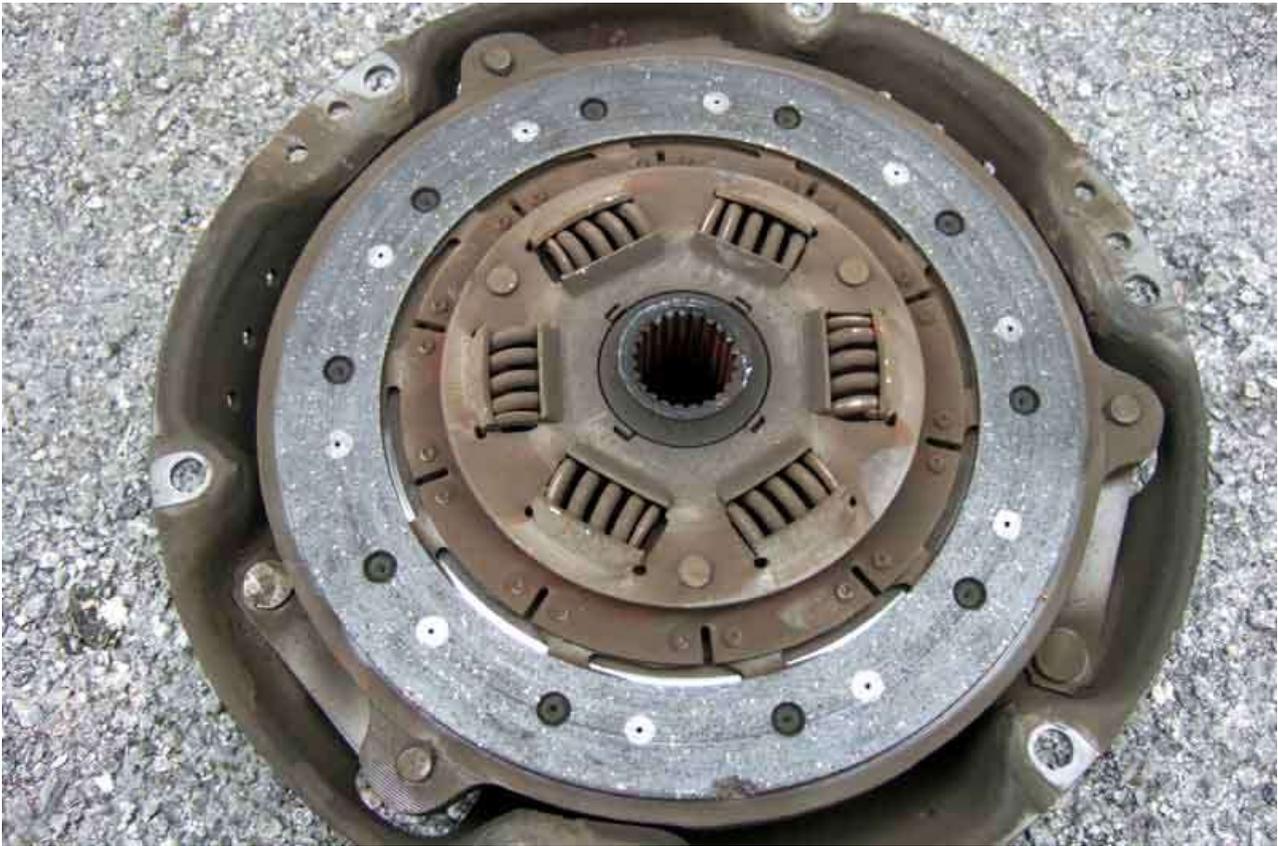
Friction-plate down to the rivets, fortunately only on the cover-plate side (facing upwards here)

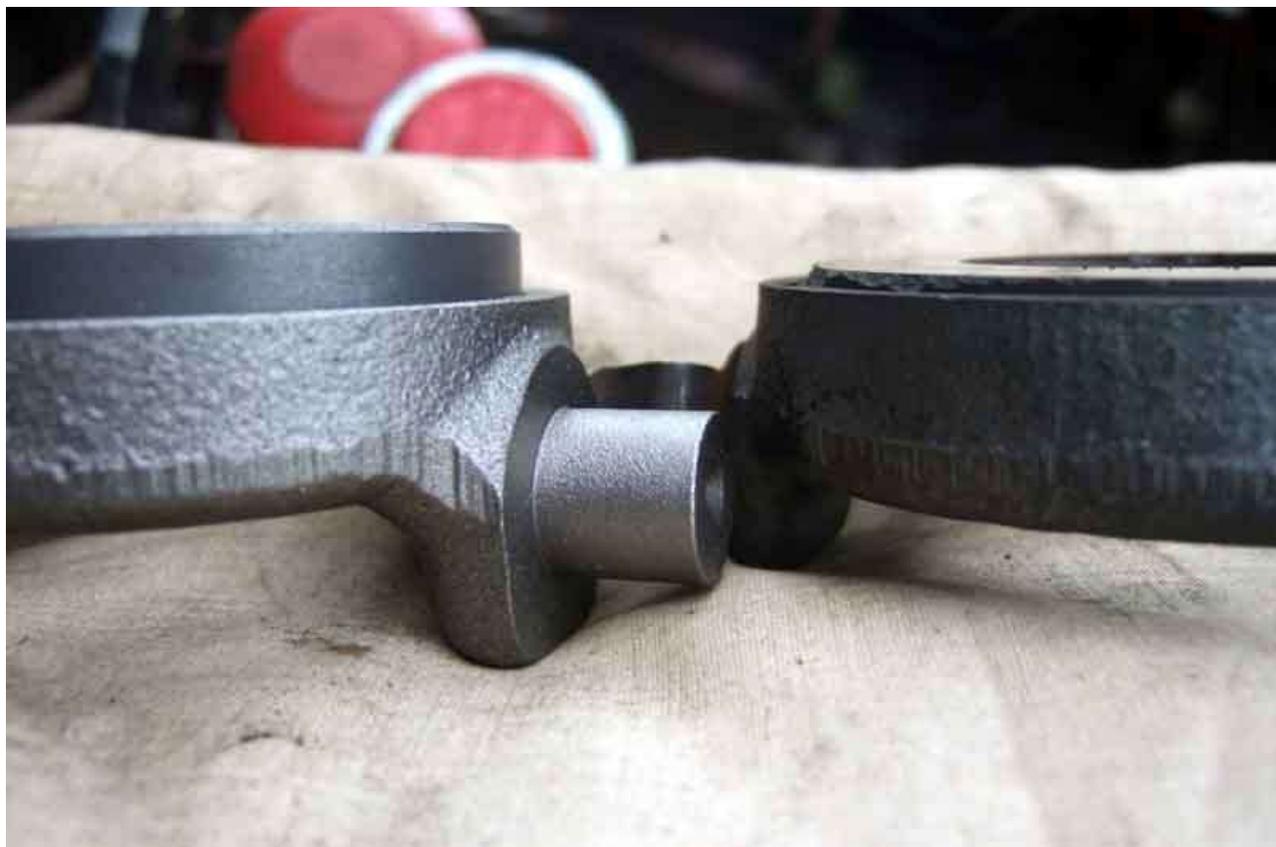
New and old release bearings - plenty of meat left on the old, perhaps only 1/3rd worn, as the boss on the cover plate can go right down inside the release bearing casting.

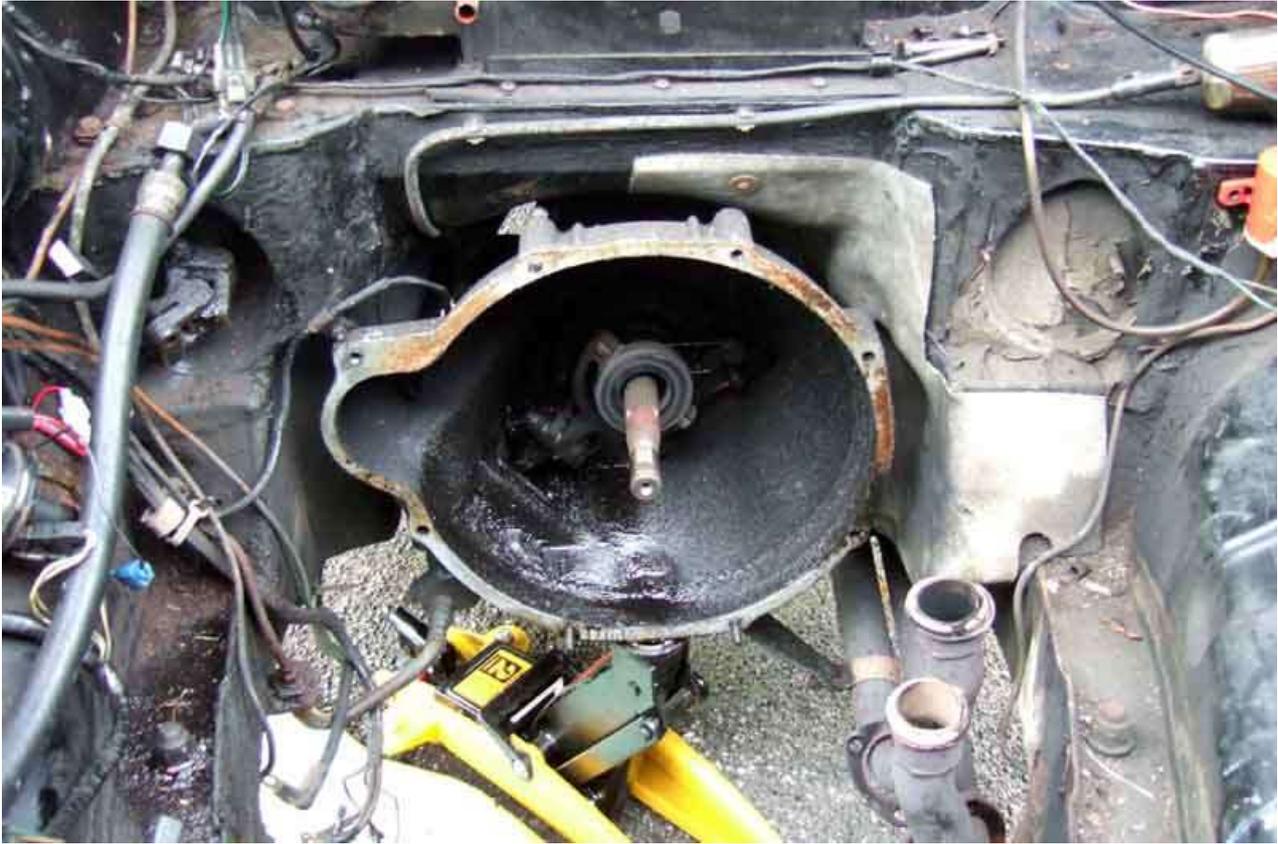
... and engine out (wish it were as easy as that). Gunky oil in the bell-housing, around the release arm rather than straight down from the first-motion shaft and cleaner oil if it had been the oil seal. I would very strongly advise freeing-up the connection between the clutch hydraulic pipe and the end of the hose, and the locknut securing the hose to the bracket on

the chassis rail while the engine is out even if you don't think you will be removing it later. It's an absolute pig when the engine is in.

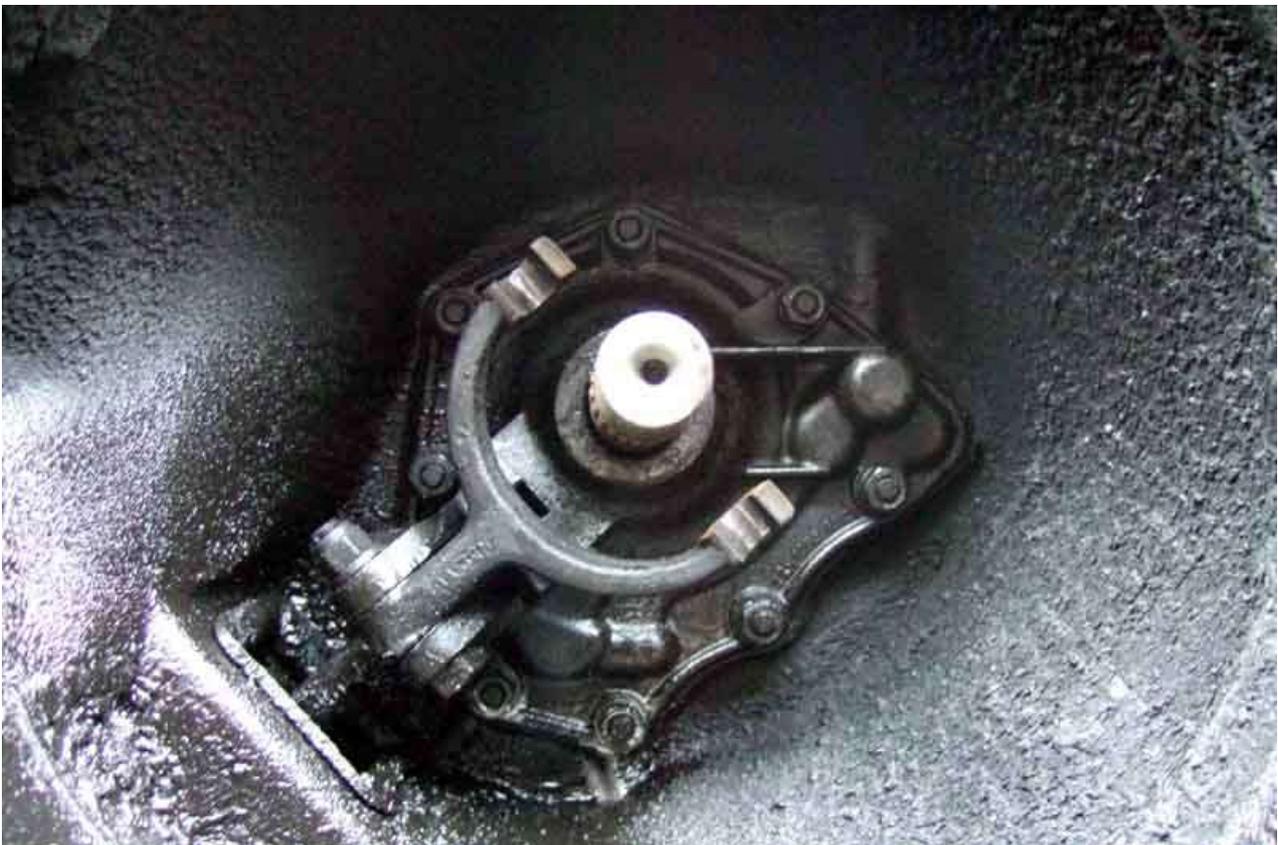
No visible seepage from the seal itself, so just checked the nuts on the seal plate for tightness. Check the release arm does not wobble on its pivot, but still moves freely. If the arm wobbles the release bearing can be off-set to the cover plate which causes premature failure.

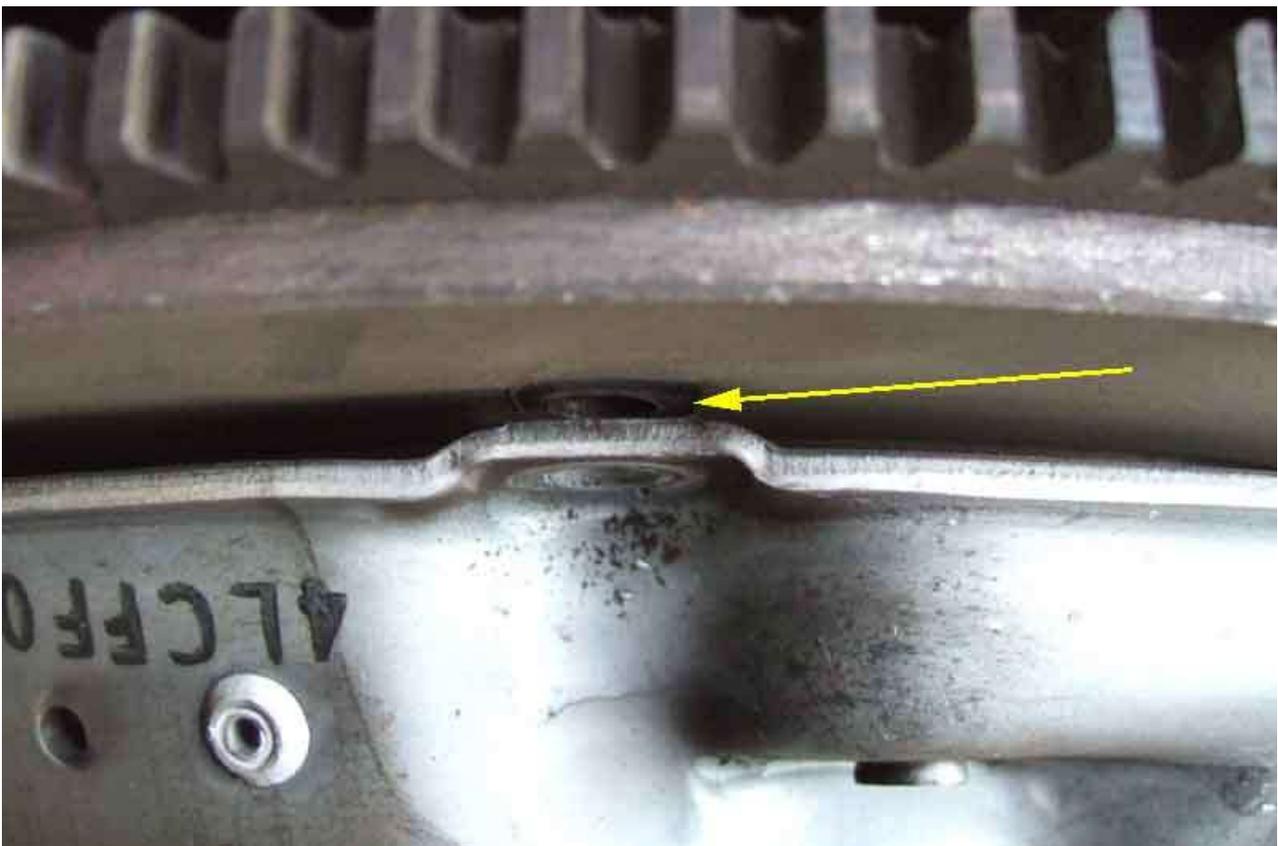
Cover plate pushed off by the diaphragm spring ...

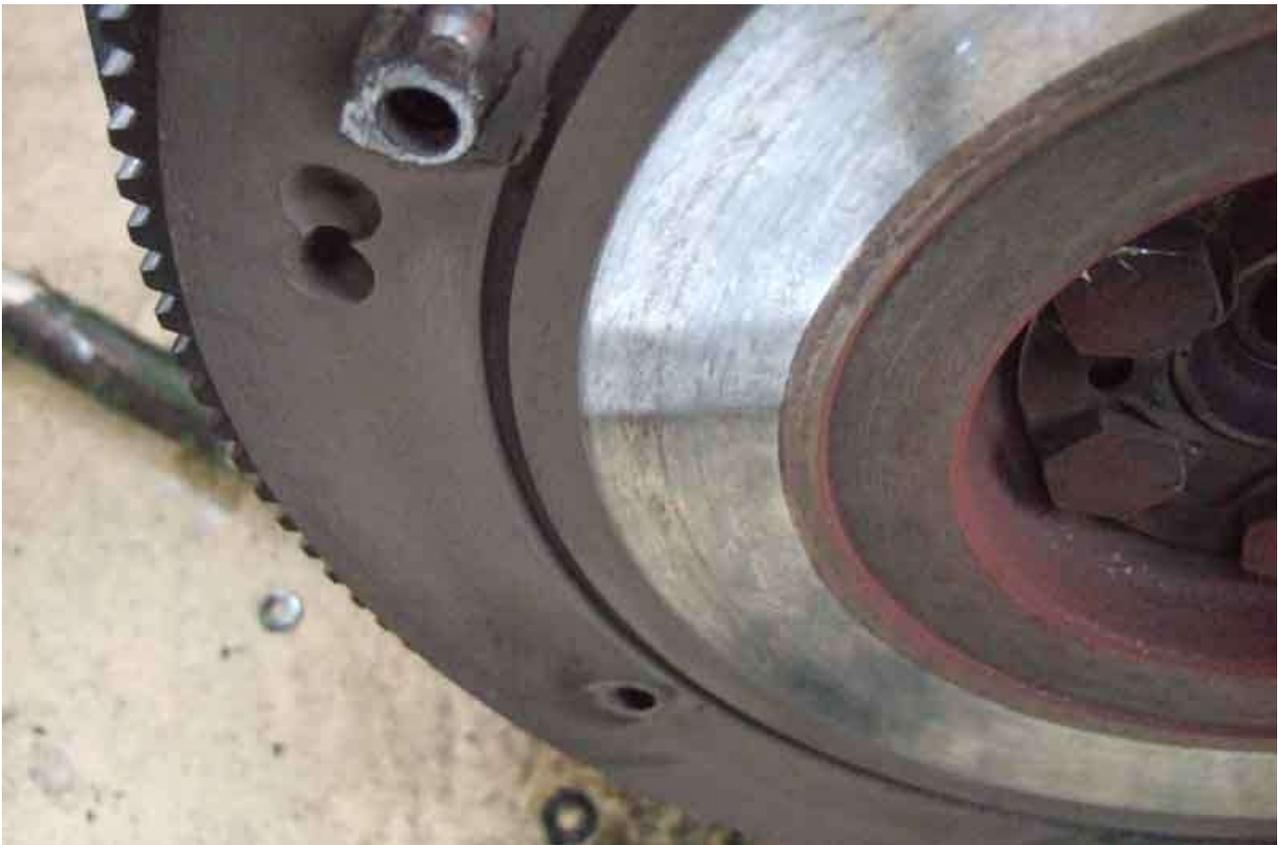
Witness marks as the rivets pass by, but no grooves on the flywheel, which could have happened with any previously worn-out clutch

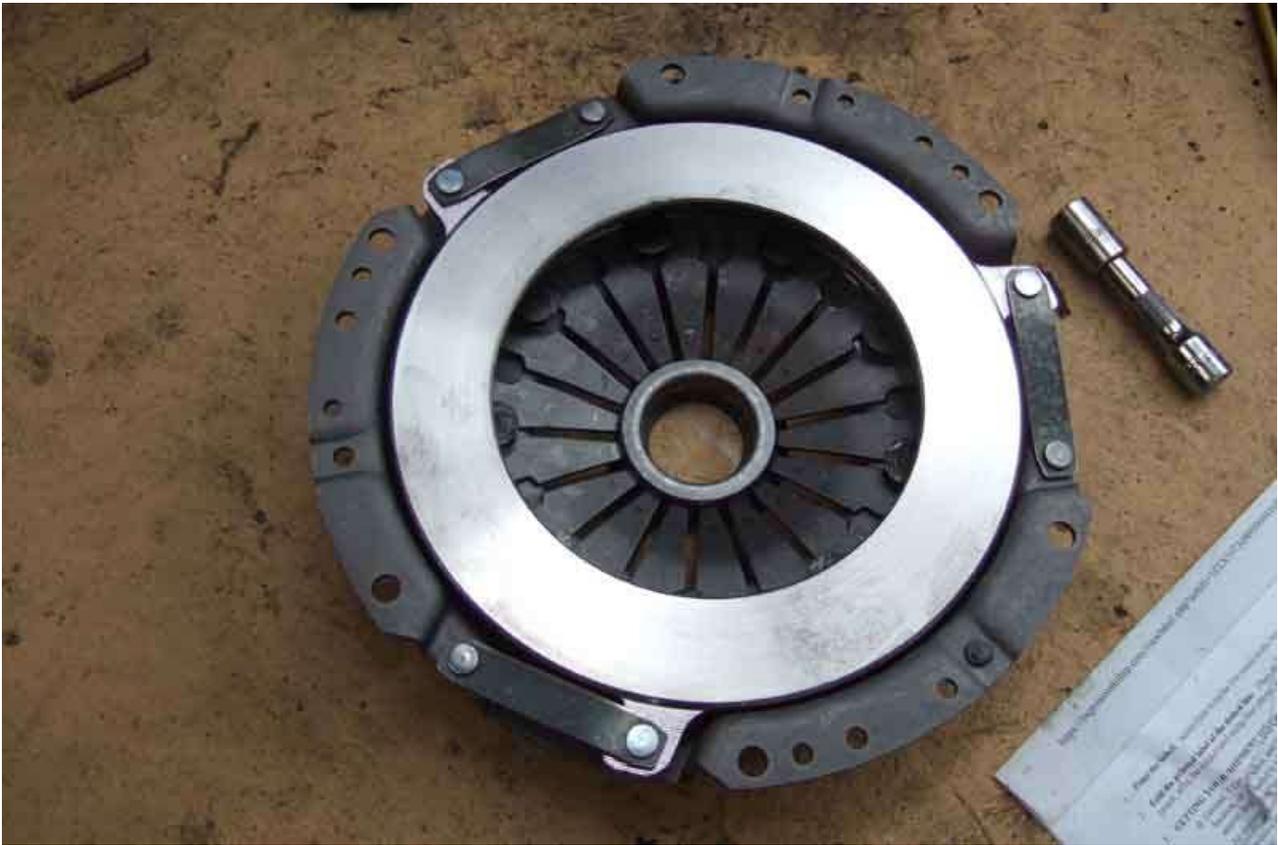
New cover plate

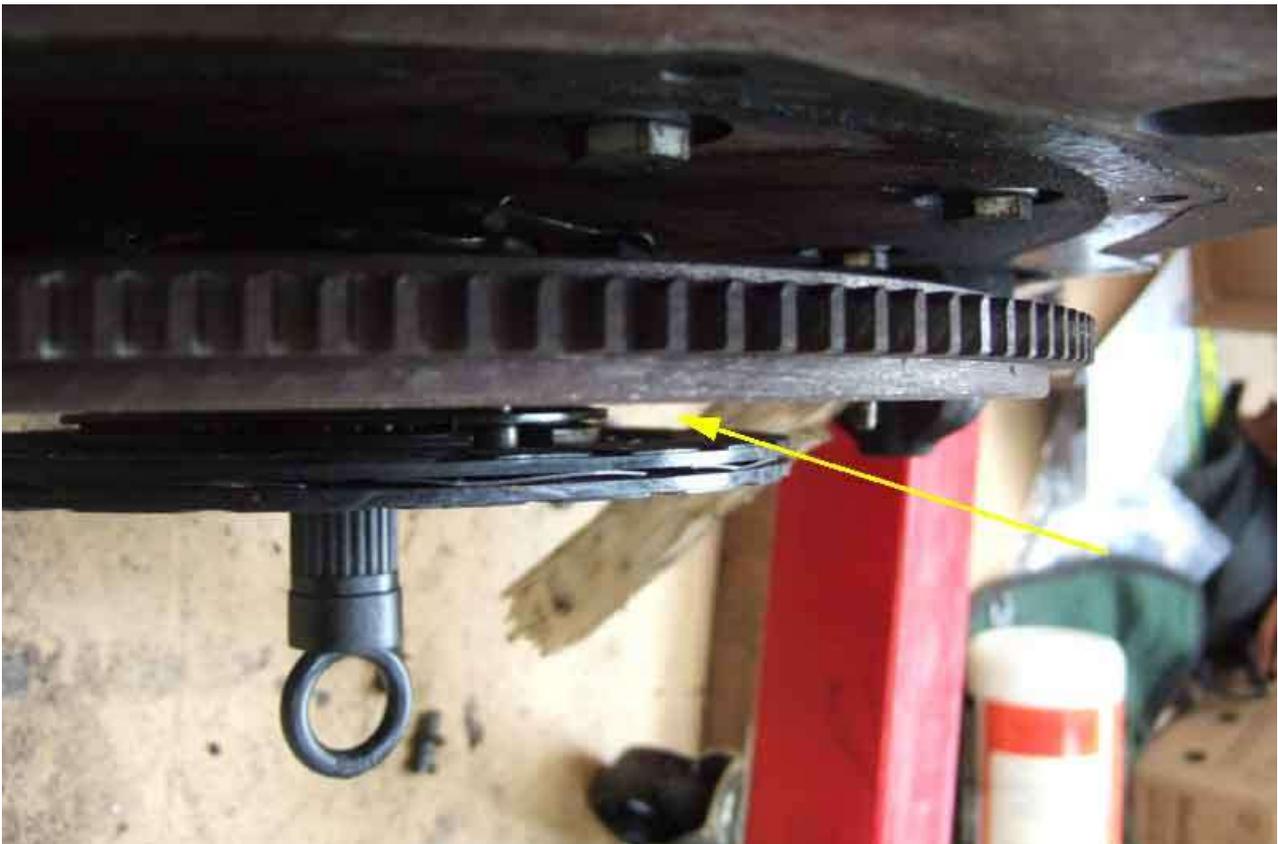
Friction plate fitted the wrong way round, miles away from the flywheel

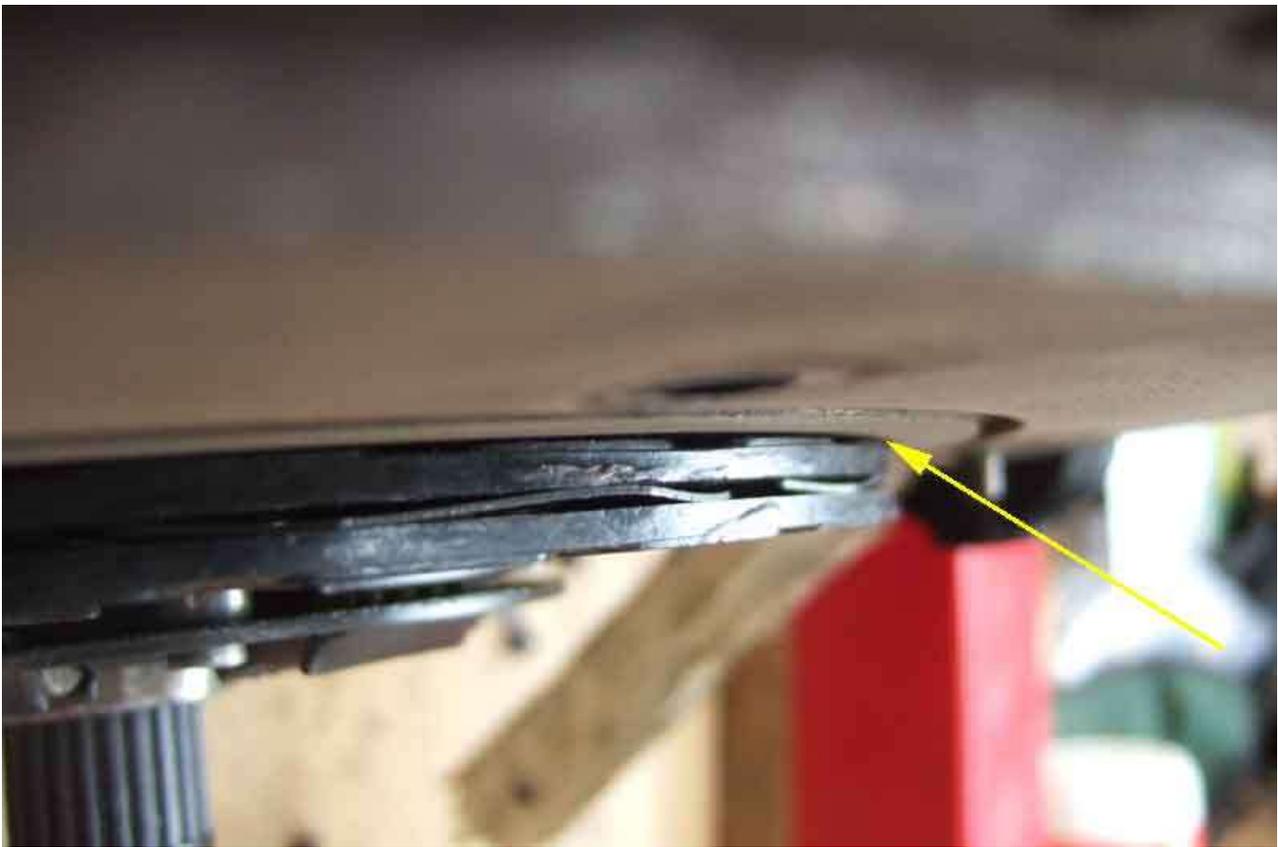
Fitted correctly, no gap

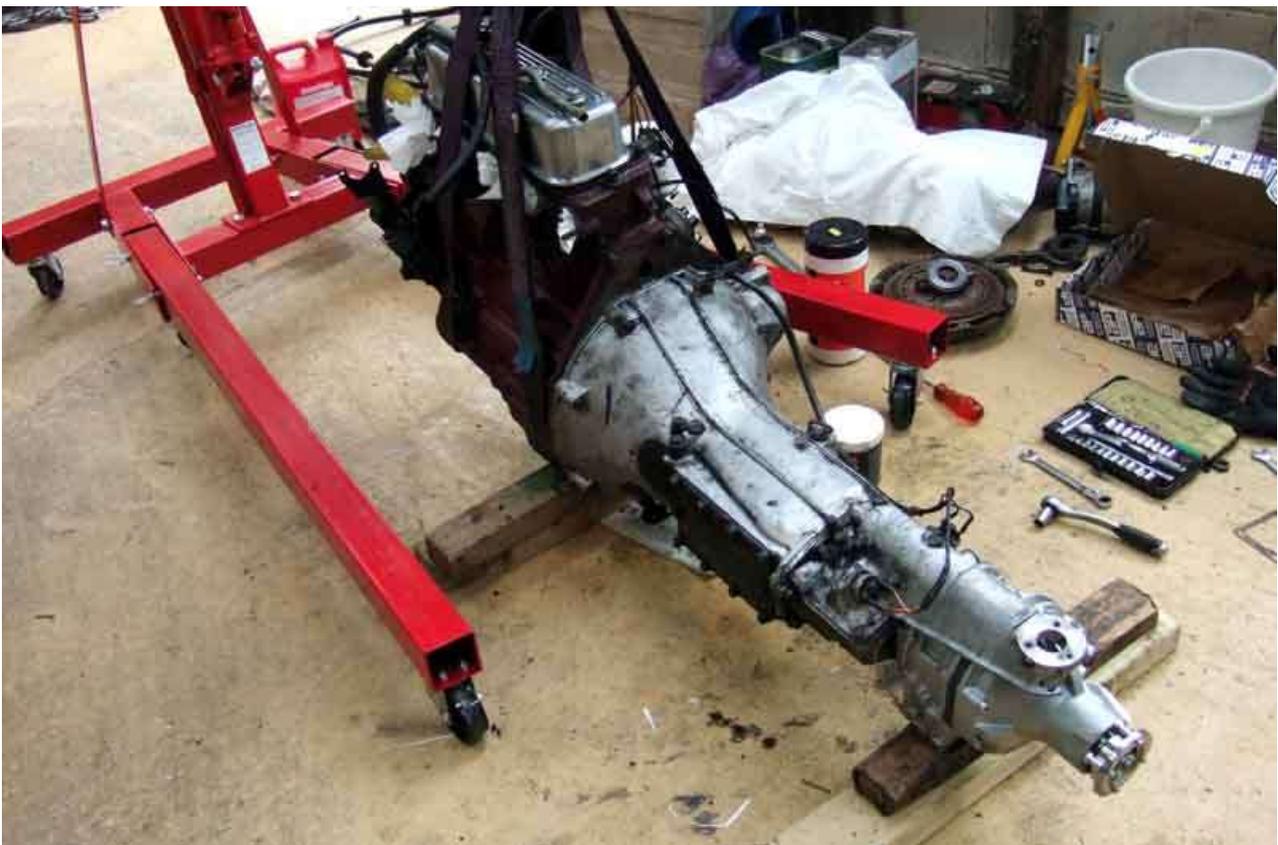
Back together, gearbox harness fitted, ready to go back in. However the harness should go **under** the remote change housing from the reverse switch to the OD switch, not over as here.
