Body and Fittings

Aerial in Front Wing

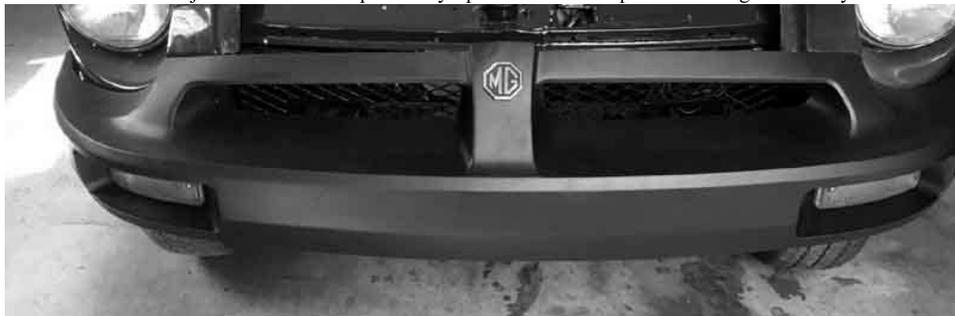
I've seen wet and dry mentioned several times over the years, not something I fancied doing myself. I'm not sure how acceptable an 'original' finish would be these days, just last week a pal in America sent me this of a NOS front cover he's just had fitted. I suspect today's polisher would expect something more shiny:

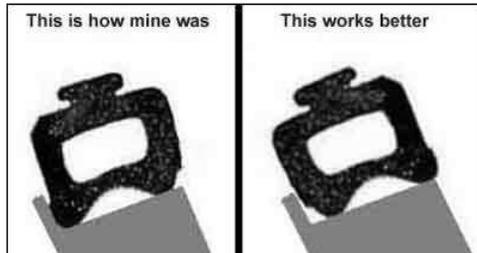
Header rail seal

When closing the hood I'd always had to run a finger along the seal in the gap between the header rail and the screen top rail from inside the cabin to prevent the rubber seal getting trapped by the flange on the screen top rail, which was a pain. When I received the new seal I immediately noticed that it was slightly asymmetric front to rear in that the two 'bumps' on the seal that press down onto the screen top-rail are slightly off-set. I checked the old seal and found that this off-set was rearwards (i.e. to the left in this profile image) which could account for

the seal getting trapped. Fitted the other way round the rear bump drops neatly onto the screen top rail without getting trapped. But the forward bump, instead of lying flat on top of the rail, now lies on the angle between the top and front faces. My first thought was that this can't be right, surely lying flat on the frame rail is correct, but then it occurred to me that being on an edge rather than a flat surface it probably conforms to the shape better giving a more effective seal. Since then it has never leaked even in torrential rain, whereas it had before. Someone subsequently stated that the bumps should be rearward as the original was, and they hadn't had problems of the seal getting trapped. The new seal may have been responsible by itself for the non-leaking now i.e. whichever way round it was fitted, but as it doesn't leak, and as I don't get the trapping problem either, it will stay as it is.

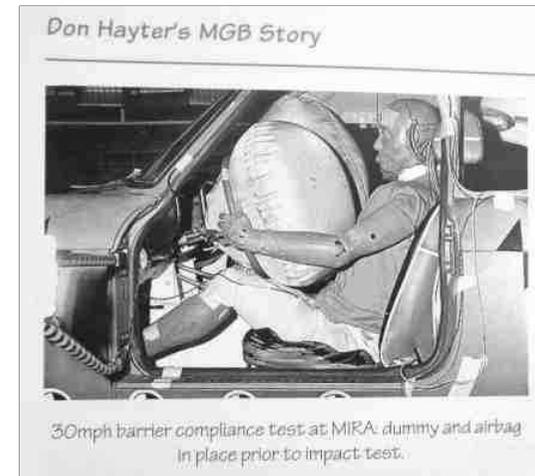
to prepare for a test at Mira. The airbags were inflated at 3500psi by a compressed nitrogen cylinder activated by a speed deceleration sensor (set above 14mph) on the bulkhead. Similar tests determining air bag size, inflation pressures and the effects of deceleration on the crash dummy eventually resulted in a successful system. A film of this development work was made by the BBC's Raymond Baxter and called *Safety in Numbers*".

He also has this picture of a MIRA test, this time of a GT with no door so different to the video above. Earlier in the above chapter on Safety Legislation he writes that because of possible rollover problems they had decided to take a GT to the American Transpo72 along with many other European manufacturers to demonstrate various safety systems, in the shape of the MGB GT SSV1. He mentions Consequently it seems odd to have take a 'tourer' to have air-bags fitted, perhaps faulty memory.

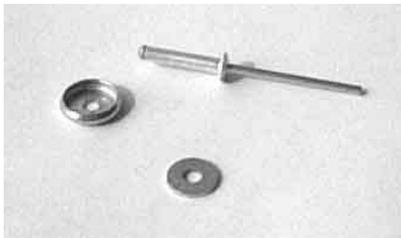
Fitting kits are available containing the full complement of pop-rivets with cup-shaped washers attached and six studs and nuts, sometimes washers too sometimes not, as shown in this picture.

However I have found that if a panel has been replaced from the trim down there can be a double-thickness of metal plus filler, and the pop-rivets as supplied are not long enough to go right through. Consequently they expand inside the hole and can work loose, sometimes when trying to refit the trim. Also if a panel has been skimmed, painted and drilled a couple of times or more the holes can become large and uneven, so again the pop-rivets don't expand behind the holes but inside. I bought some long-reach rivets and transferred the cup-shaped washers over, then used an appropriately-

sized washer behind the panel, so not only did the pop-rivet go through a skim of filler two panels and a washer, but it also secured firmly behind the washer no matter how large and irregular the hole was. The cup-washer removed from the original pop-rivet, a long-reach rivet, and a suitable washer can be seen in the picture.
