[Contents](#) [Index](#) [So you think you want an MGB or V8?](#)

Engine

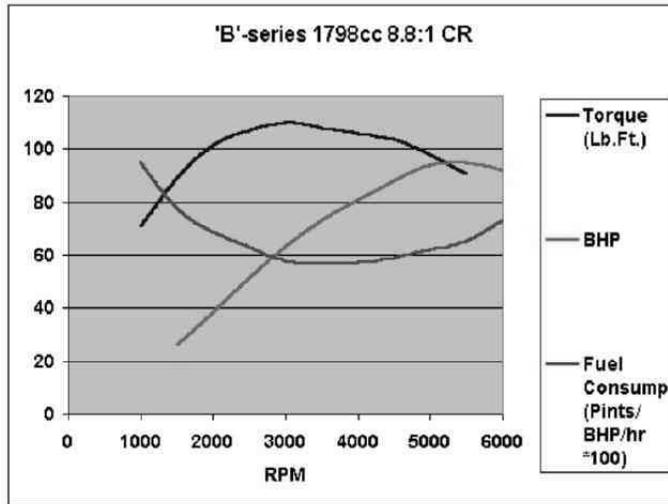
Data for the following BHP, Torque and fuel consumption curves cropped up on the MG mailing list recently, makes interesting reading. Originally published in 'The Motor' September 26th 1962, subsequently reprinted in a 'Brooklands' book - "MG Cars 1959-1962" - and posted to the mailing list by Blake (aka [Bullwinkle](#)). Note these figures were taken at full throttle with an engine brake to obtain the required rpm. The fuel consumption figures have been multiplied by 100 to fit the vertical axis.

RPM	Torque (Lb.Ft.)	BHP	Fuel Consumption	
			Pints/ BHP/hr	Pints/ hr min.
1000	71		0.95	
1500	89	26	0.78	0.338
2000	101	38	0.69	0.437
2500	107	51	0.63	0.536
3000	110	63	0.58	0.609
3500	108	73	0.57	0.694
4000	106	81	0.575	0.776
4500	104	88	0.59	0.865
5000	98	94	0.62	0.971
5500	91	95	0.65	1.029
6000		92	0.73	1.119

See also [this table](#) of North American MGB and Midget performance figures from Skye P Nott's 'MGB Experience'. Note that the reduction in MGB power and torque from 1973 onwards only applied to North American spec cars, UK cars retained full performance to the end.
