Crankcase Breathing

Cylinder Block

Engine Numbers

Dating the Block

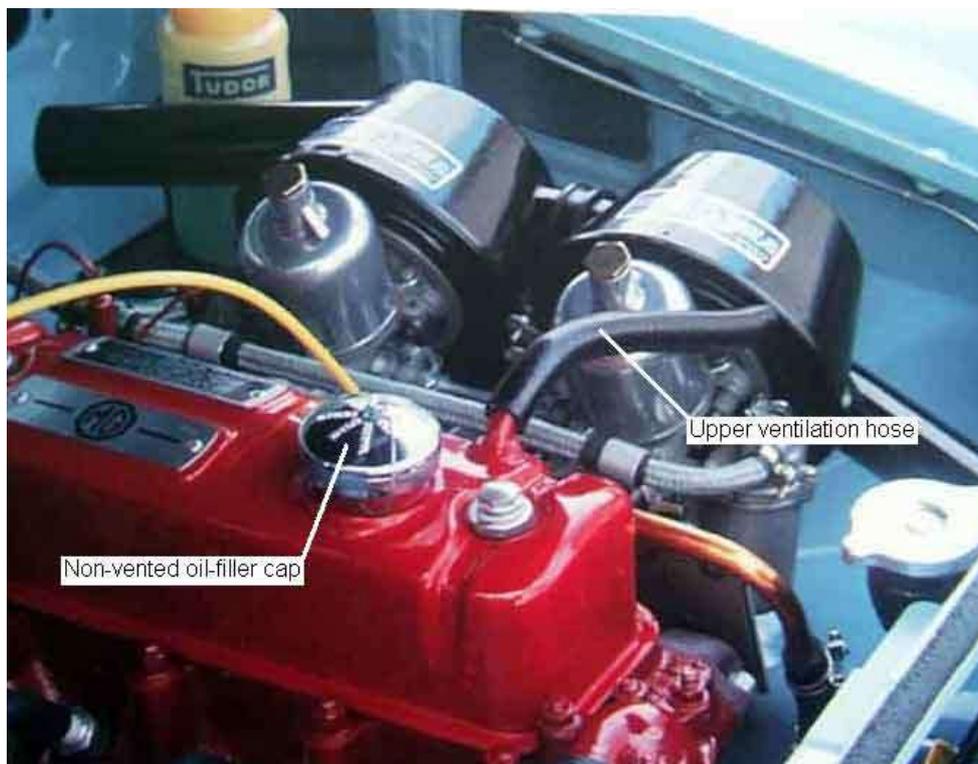
Non-positive system used until February 1964. This uses a hose from the rocker cover to the front air-cleaner (outside the filter) and a non-ventilated oil filler cap: (*Clausager Original MGB*)

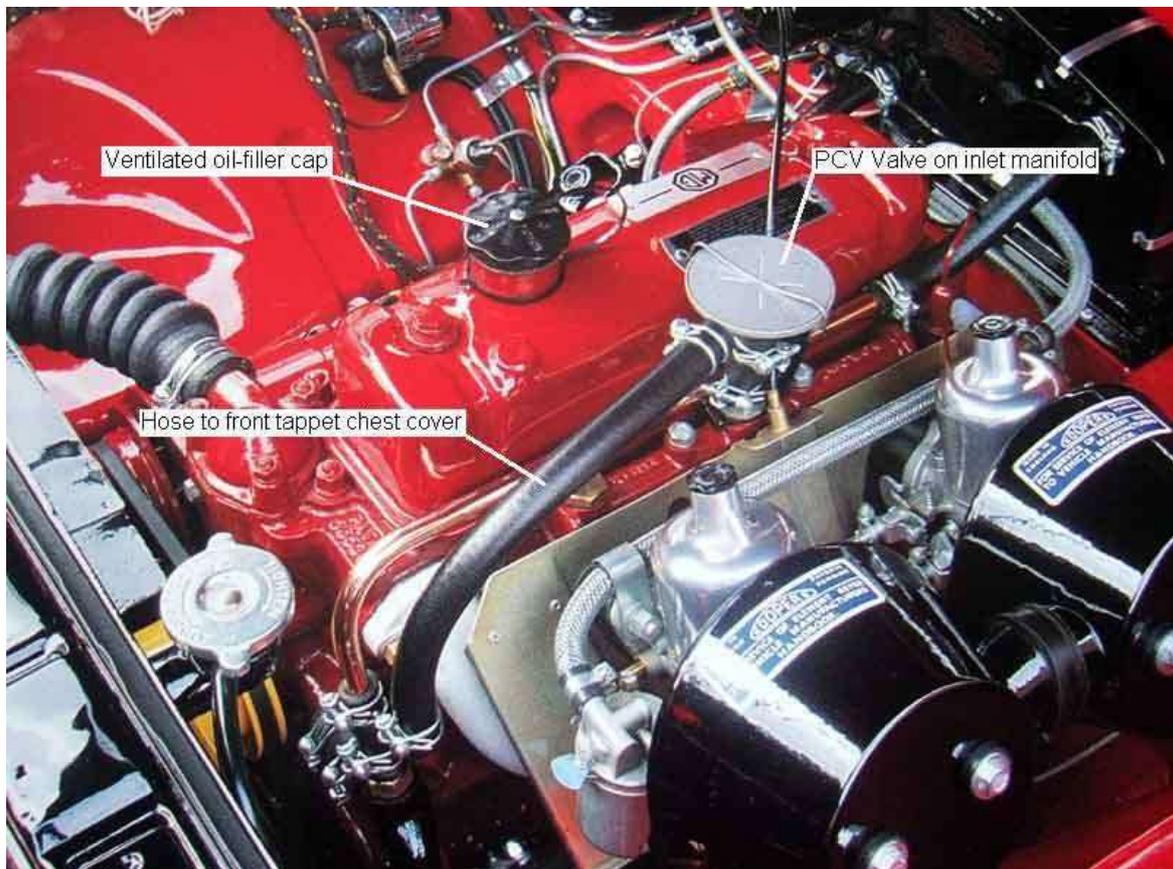
In February 1964 a positive ventilation system was implemented. Until October 1968 it consisted of a PCV valve (13H5191) mounted on the inlet manifold, plumbed to a port on the front tappet chest cover. The oil filler cap is now ventilated with a restriction and a filter: (*Clausager Original MGB*)

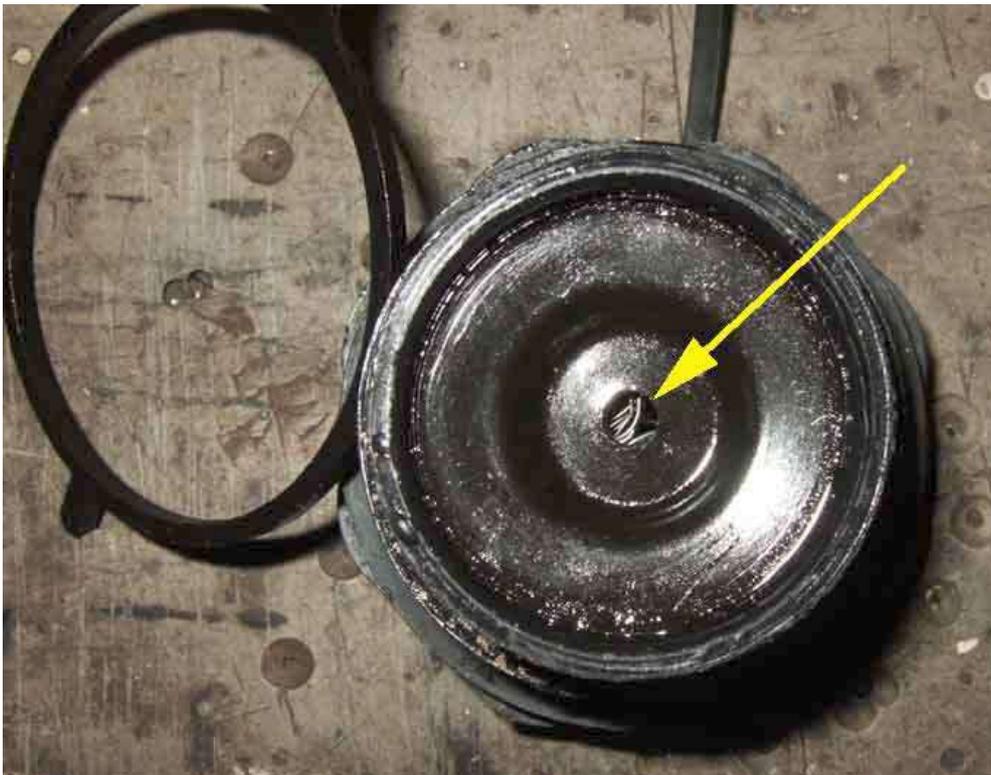
Ventilated oil filler cap, with filter gauze visible through the hole at the bottom. Non-ventilated caps are hollow inside and should not be used on engines with positive crankcase ventilation:

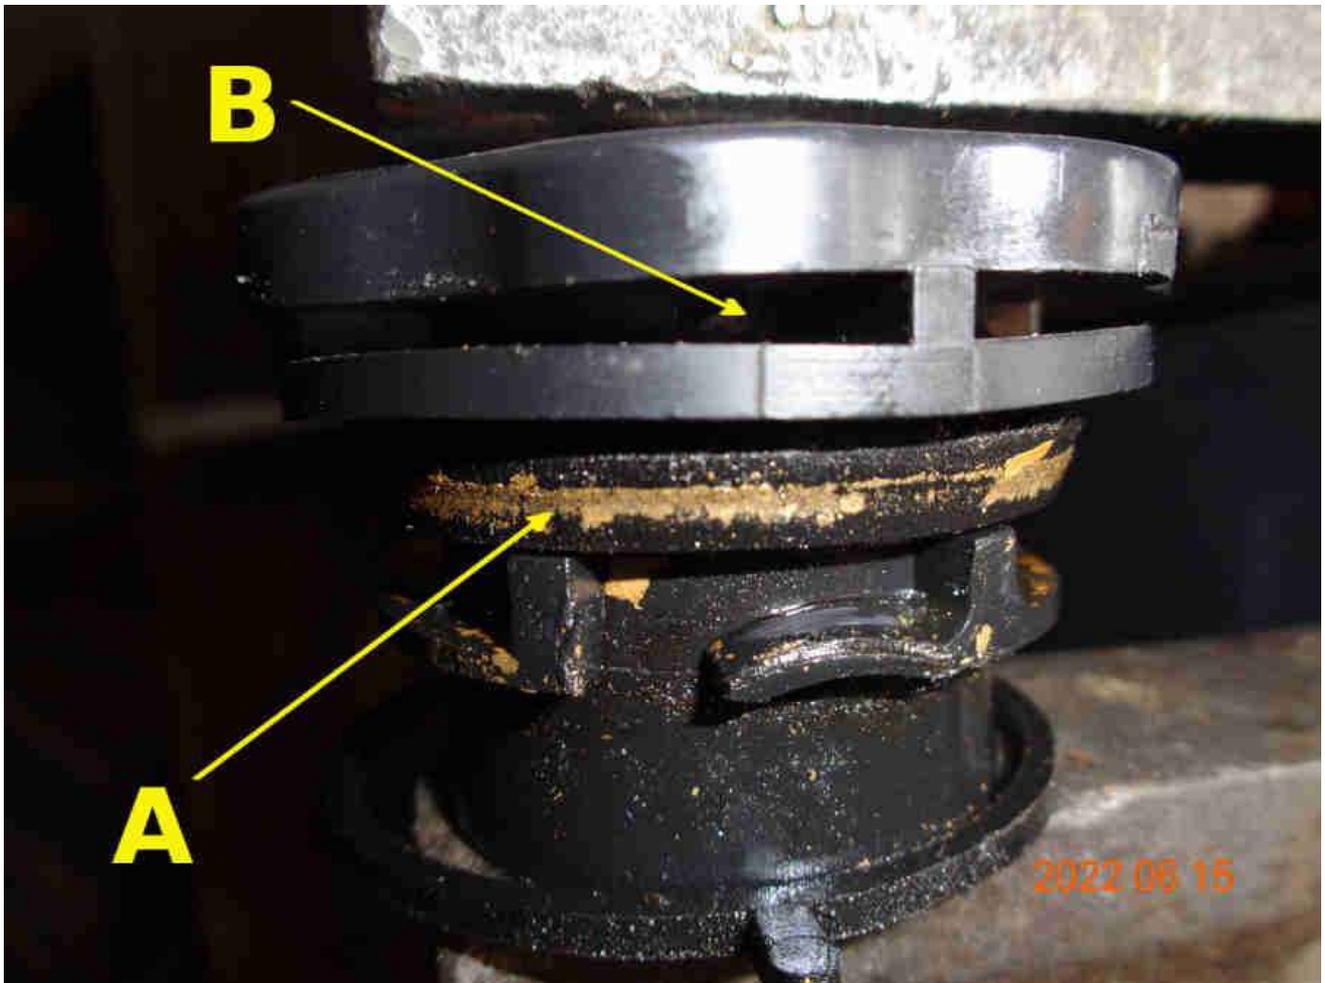
'A' is the rubber seal to the filler neck, 'B' is one of two air inlet holes:

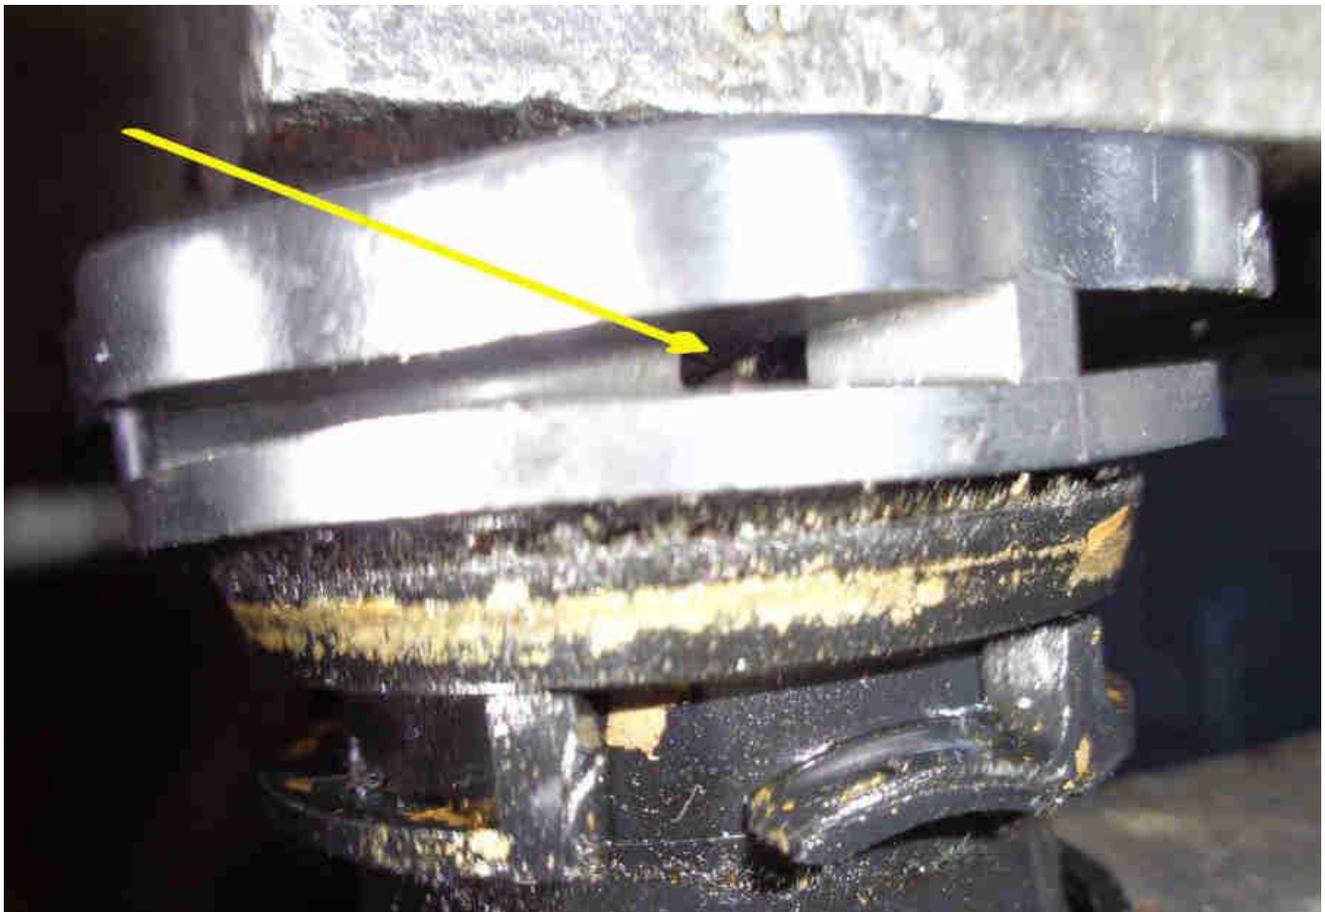
One of the two air inlet holes, just above where the cap locks onto the pins in the filler neck. With a light shining straight down onto the hole you can see the filter mesh:

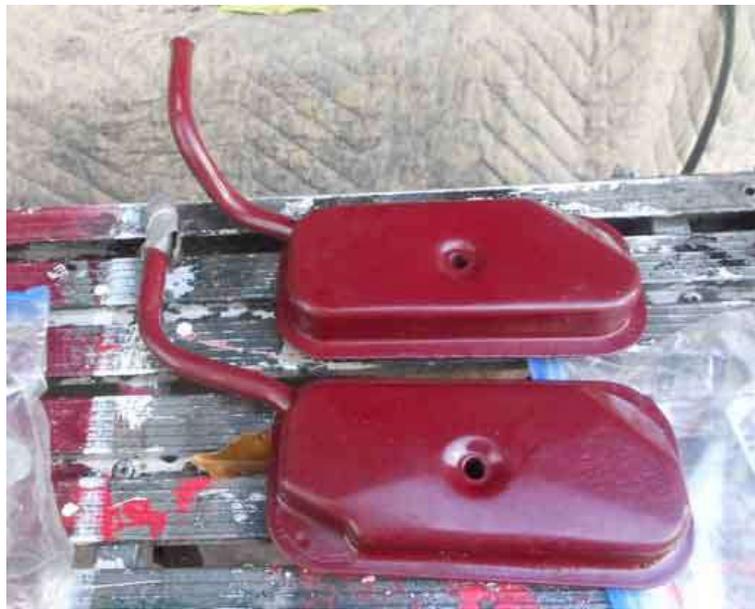
Cover 12H1399 (above) with internal filtering and oil separation, used with the PCV valve: *(Chris Howells)*

... with internal oil separator/flame trap steel 'pan scourer'. However [at least one person](#) has found this resulted in excessive oil burning via the cover and replaced it with the earlier PCV version 12H1399. With one corner flattened and the opposite corner changed in shape as per [the lower one here](#).

Oil burning via the breather: Adam's original (12H4395) and replacement (12H1399) covers. The strip of metal near the top left corner of the replacement cover is positioned over another set of holes. I suspect these are nominally the inlet, with the strip of metal acting as a shield preventing oil running down the walls from trickling in. The holes at the bottom draining any oil mist converted to liquid drops by the wire wool.

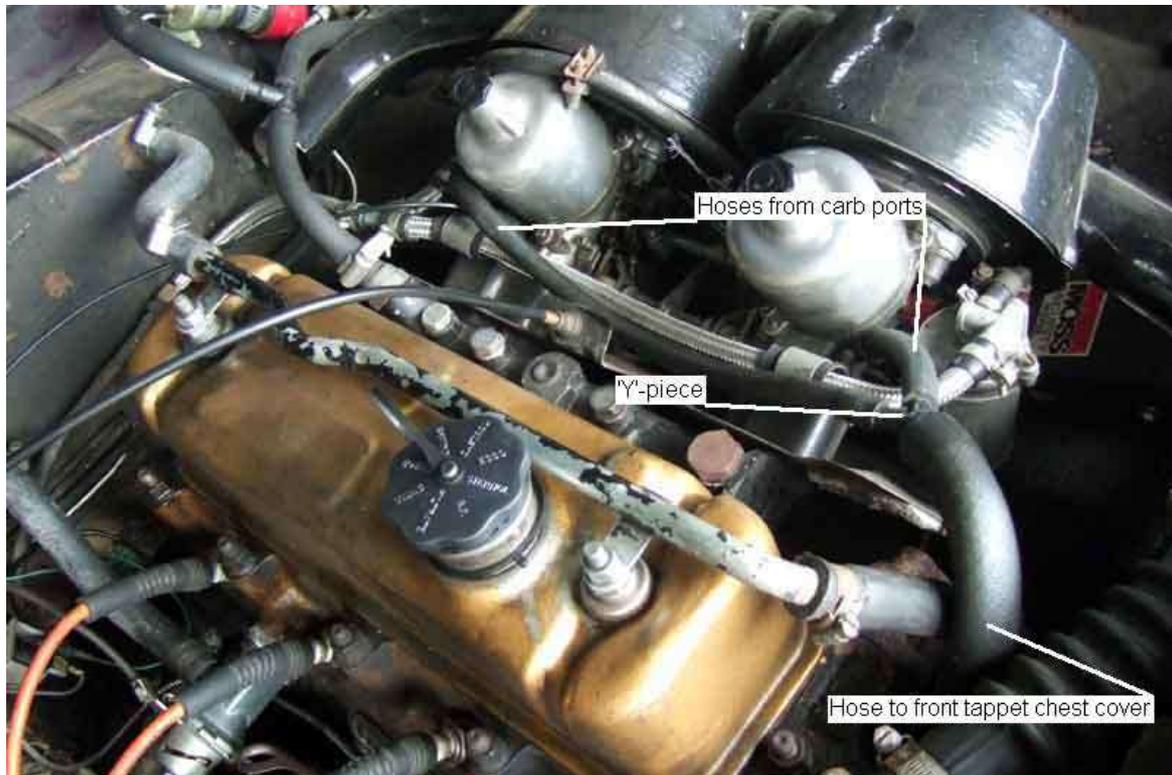
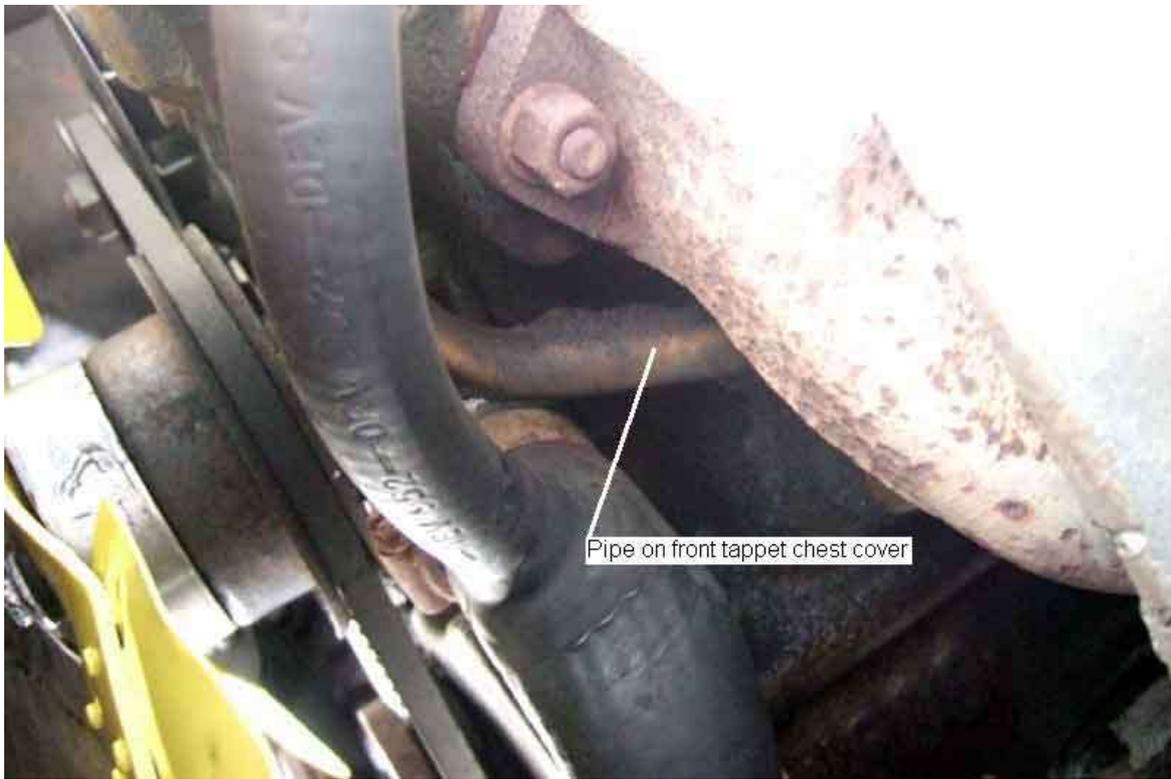
In October 1968 the PCV valve was replaced by carb ventilation, with ports on both carbs connected together and taken down to the front tappet chest cover. The oil filler cap is ventilated as before. This system was used on UK cars until the end of production:

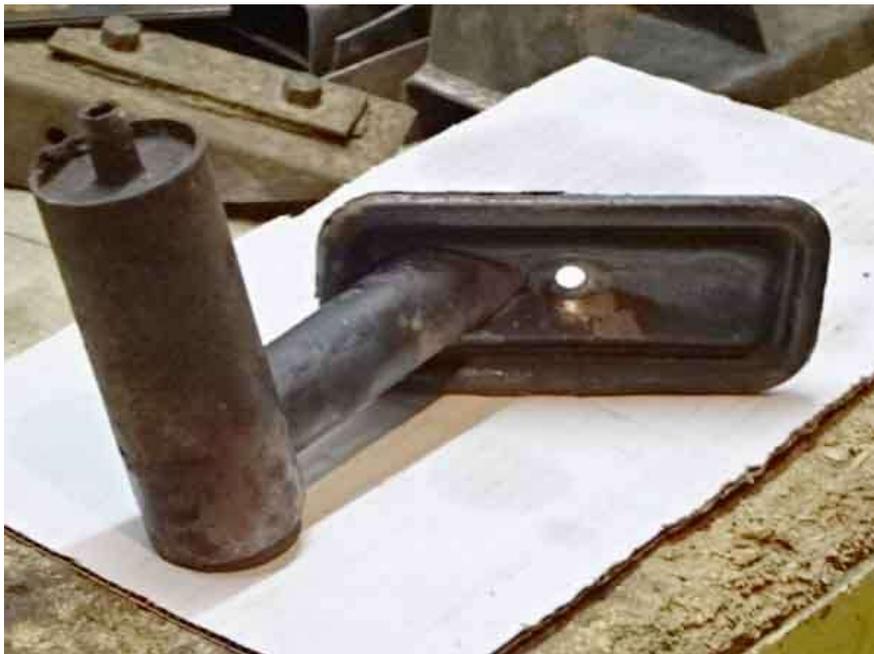
Cover with external filter and separator 12H3684 used with carburettor ventilation until the 18V779/780 engines during the 74 model year. However the Parts Catalogue states that rebuilt engines used the cover below, as is the case on Bee's Gold Seal engine: (*William Revit in Tasmania via the MG Enthusiasts forum.*)

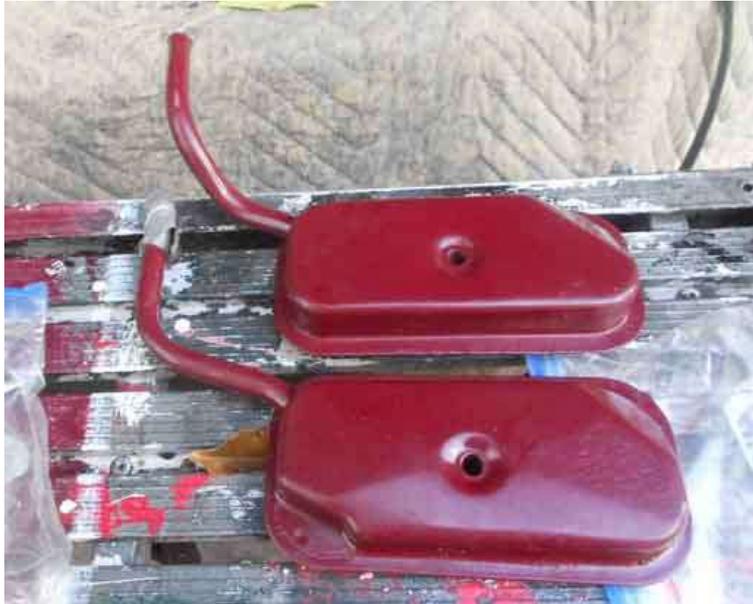
Cover 12H4395 (below) again with internal filtering and oil separation, used with original 18V797 and later engines, and for all

rebuilt 18GG and later engines: *(Chris Howells)*

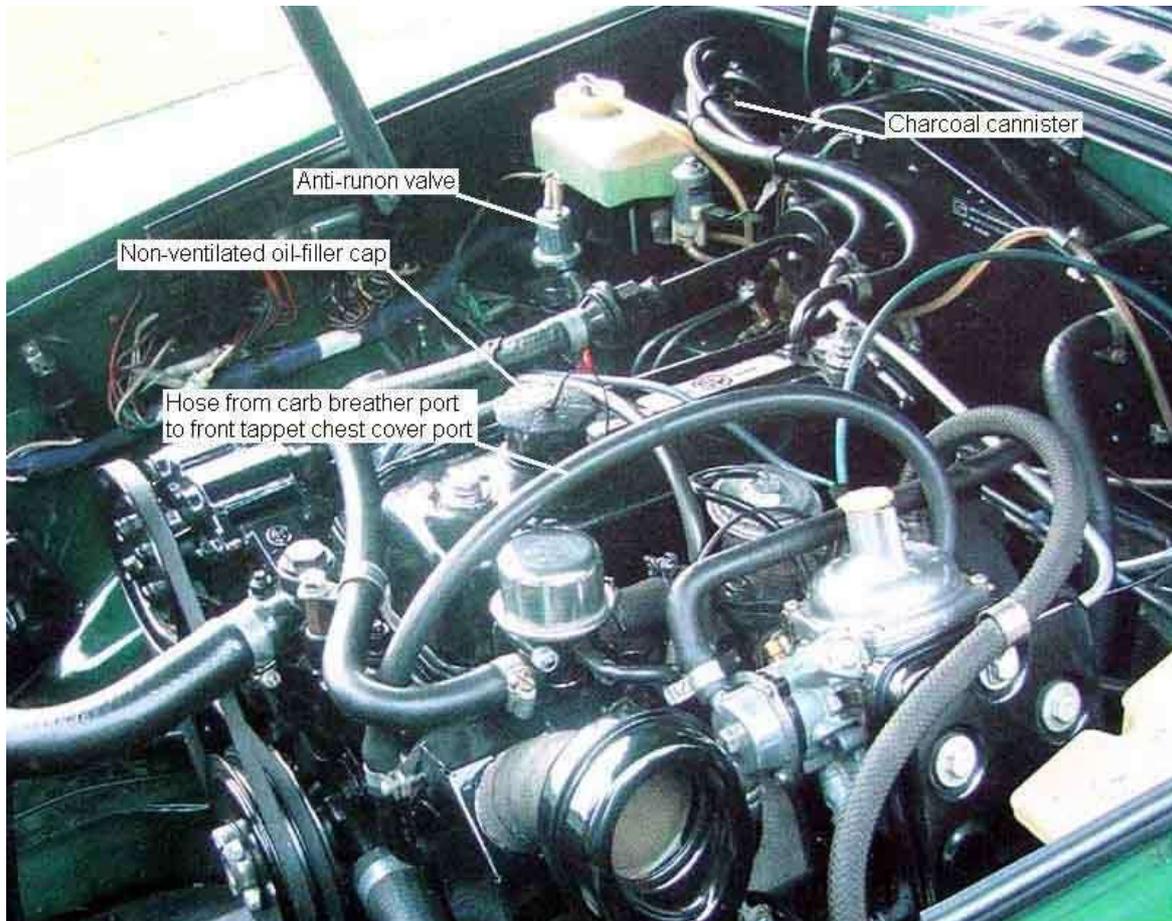
North American spec from October 1969 with the charcoal canister. Originally with twin SUs connected to the front tappet chest cover as before, but with a non-vented oil-filler cap. This version shows the later single Zenith/Stromberg carb and anti-runon valve: *(Clausager Original MGB)*

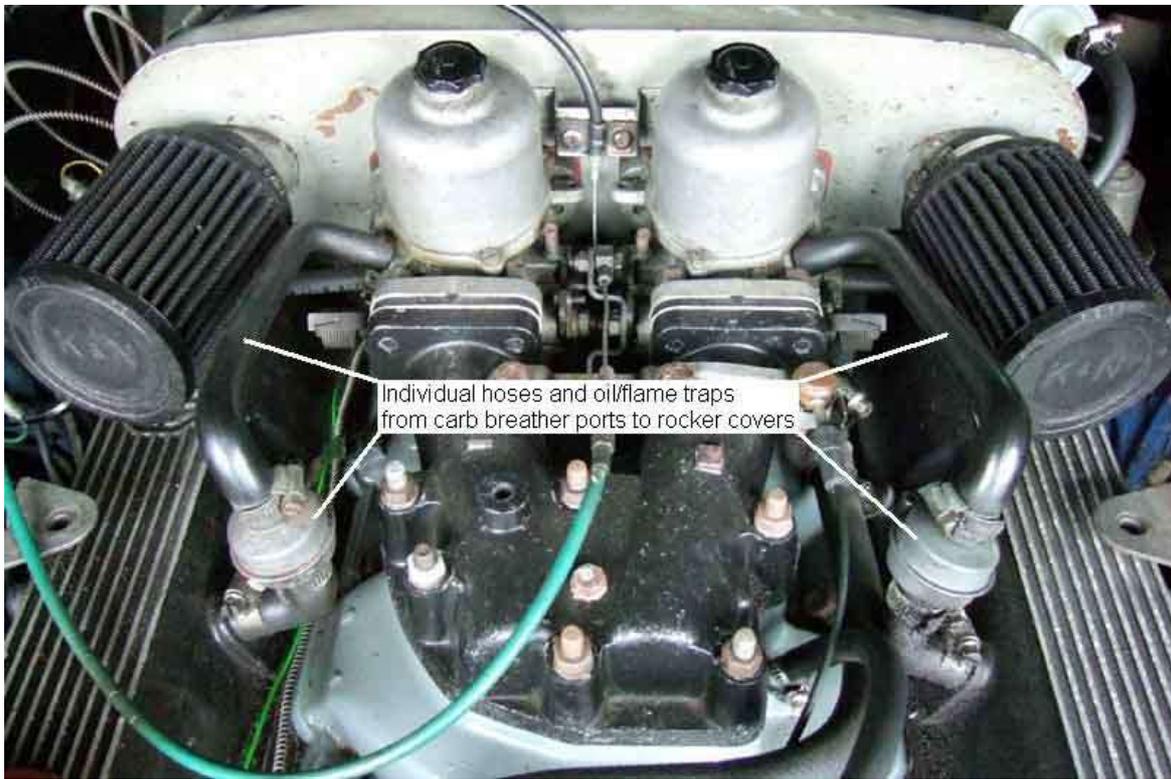
V8 with individual hoses and oil/flame traps from carbs to rocker covers:

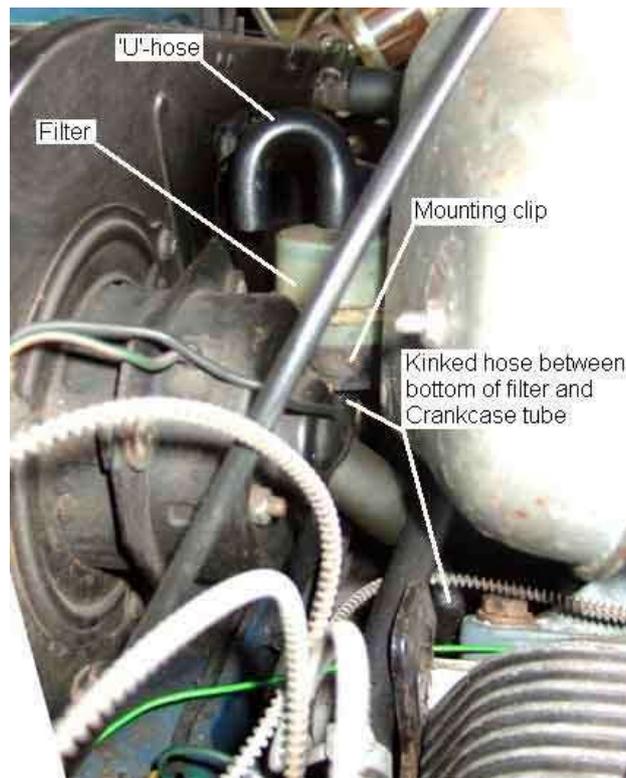
Rear of the V8 air-cleaner box showing the breather intake filter with mounting clip and hoses, the oil filler cap in unventilated:

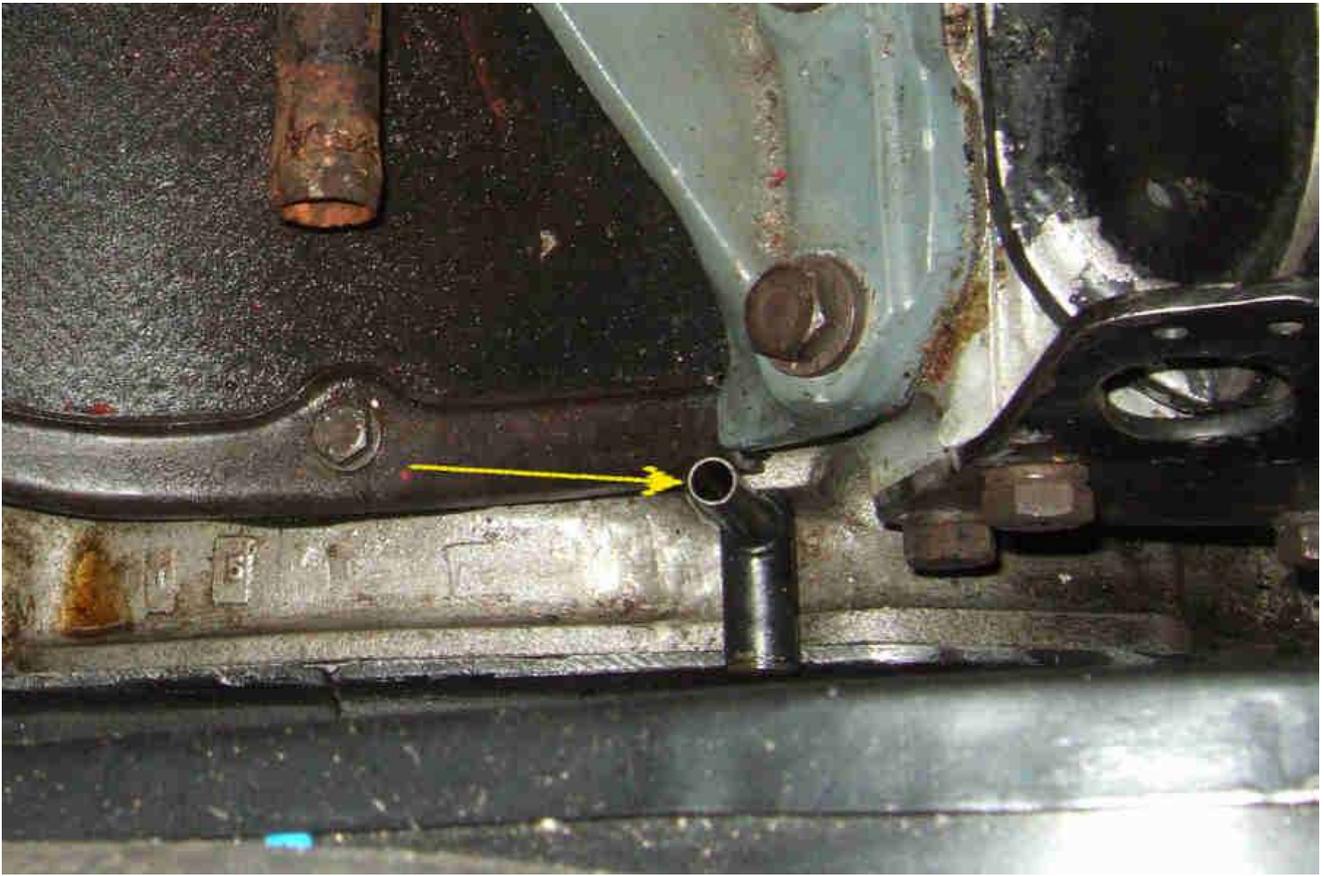
Clutter out of the way, the vent is a horizontal tube with a closed outer end pushed into the back of the block with a vertical tube pointing up to take the short hose to the filter:

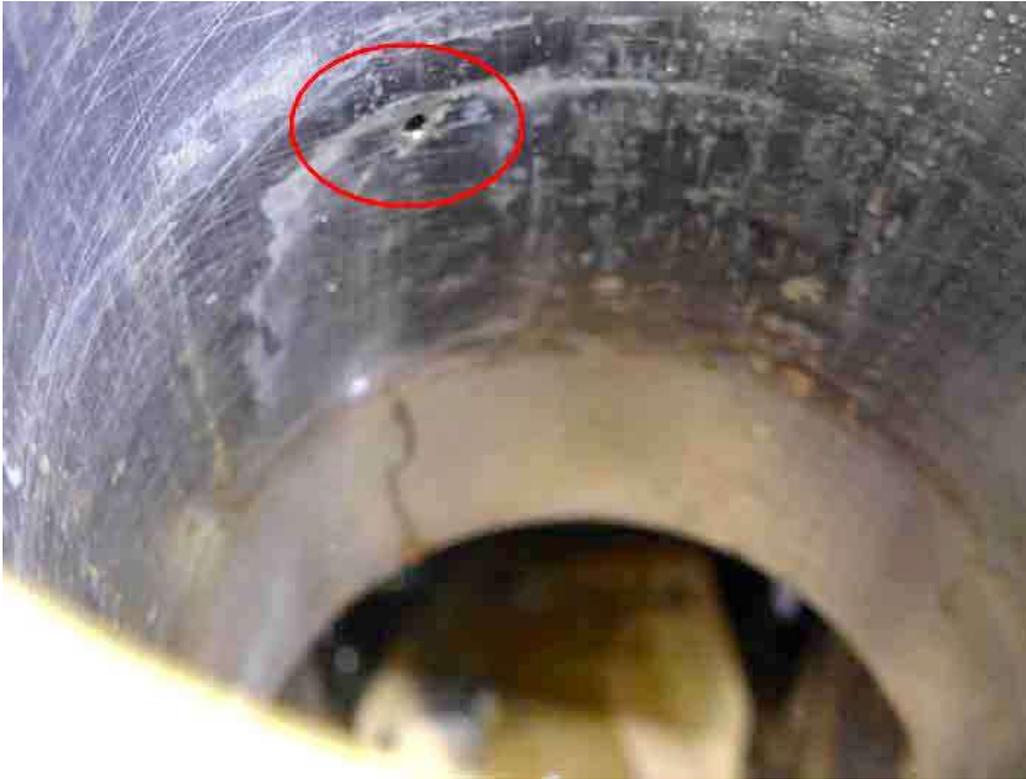
Hole in the wall (No.1 cylinder) ...

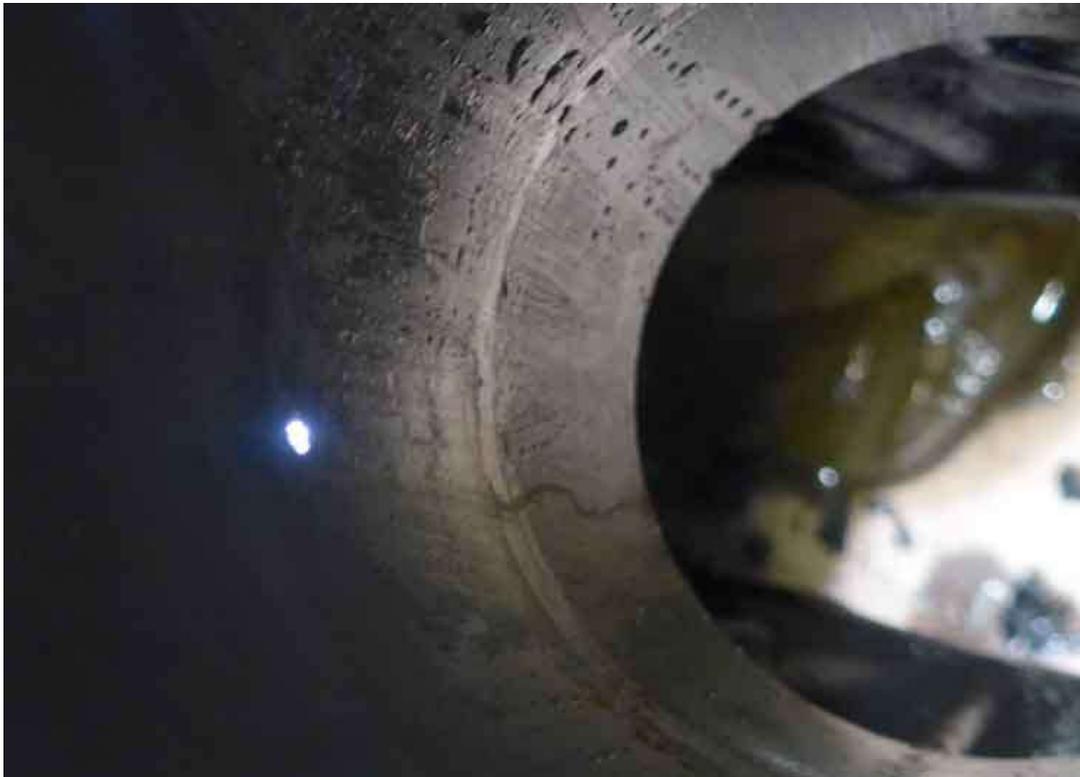
... clearly visible with a light shone down the water jacket:

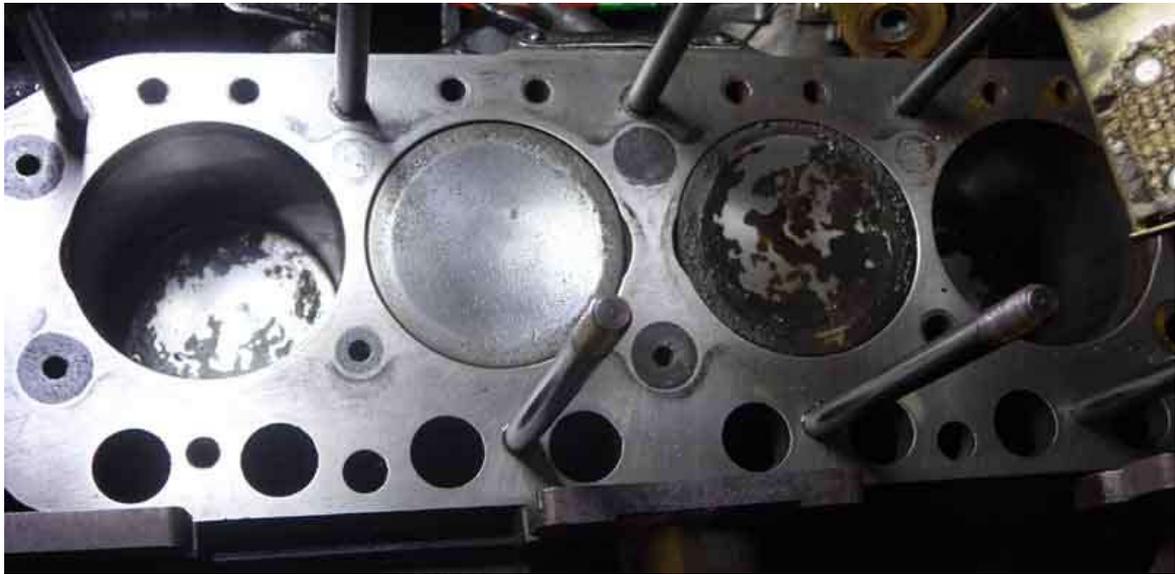
No.2 piston completely clean ...

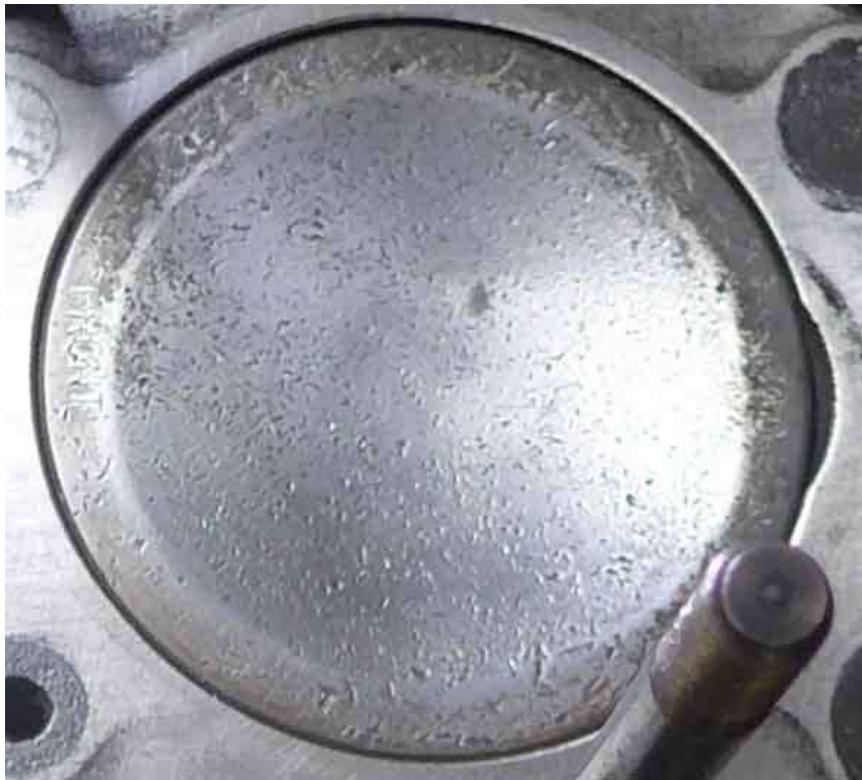
... and covered in nicks, probably from the piece broken off the exhaust valve 10k ago:

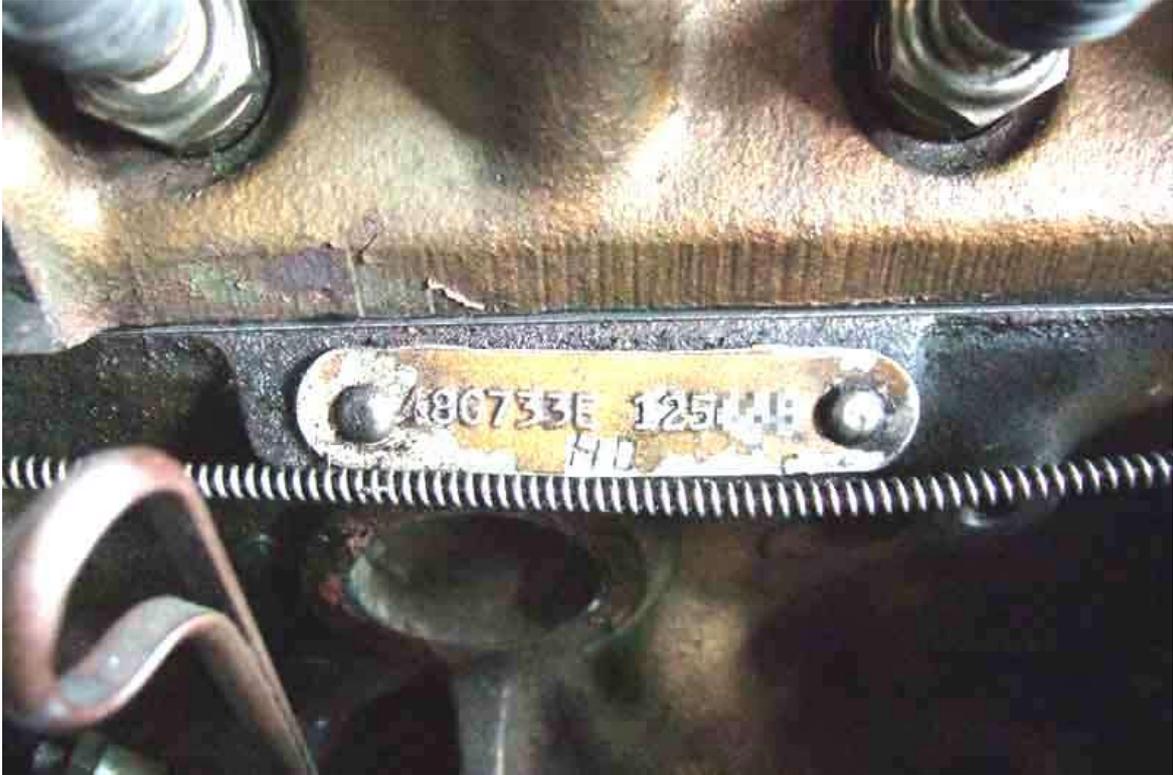
Gold Seal: Bee's 48G733 with 'E' suffix:

However looking at the one above there does seem to be space to put flat type over the top of cup type! With mine (top picture) the outer edges of the cup-type are virtually flush with the face of the block, so no room there.

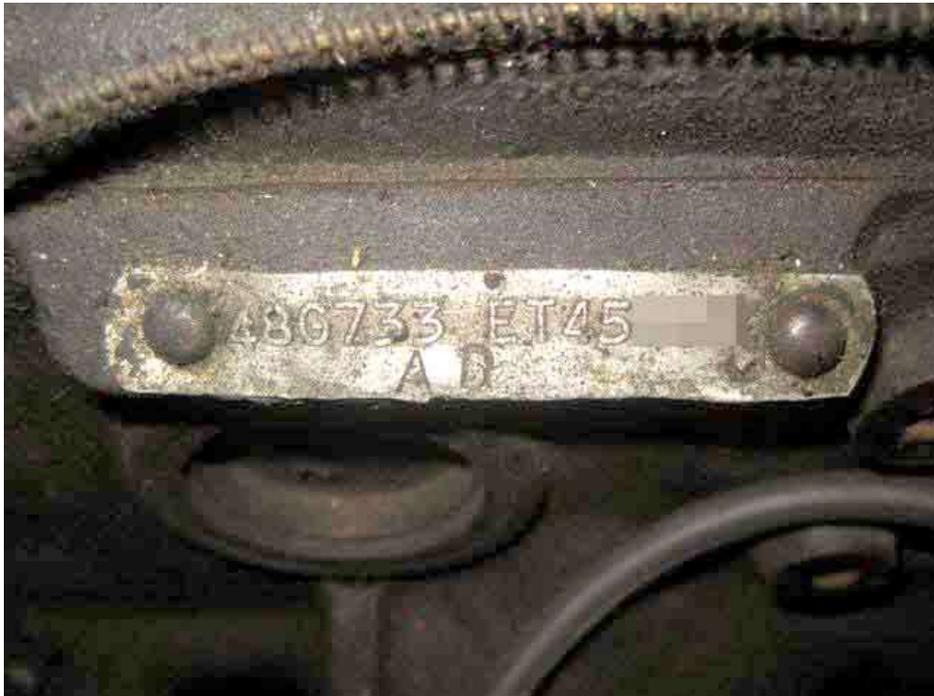
Another 48G733 this time with 'ET' suffix, and adjacent to the serial number instead of the engine type, the indented letters are said to be the engine builder's initials:

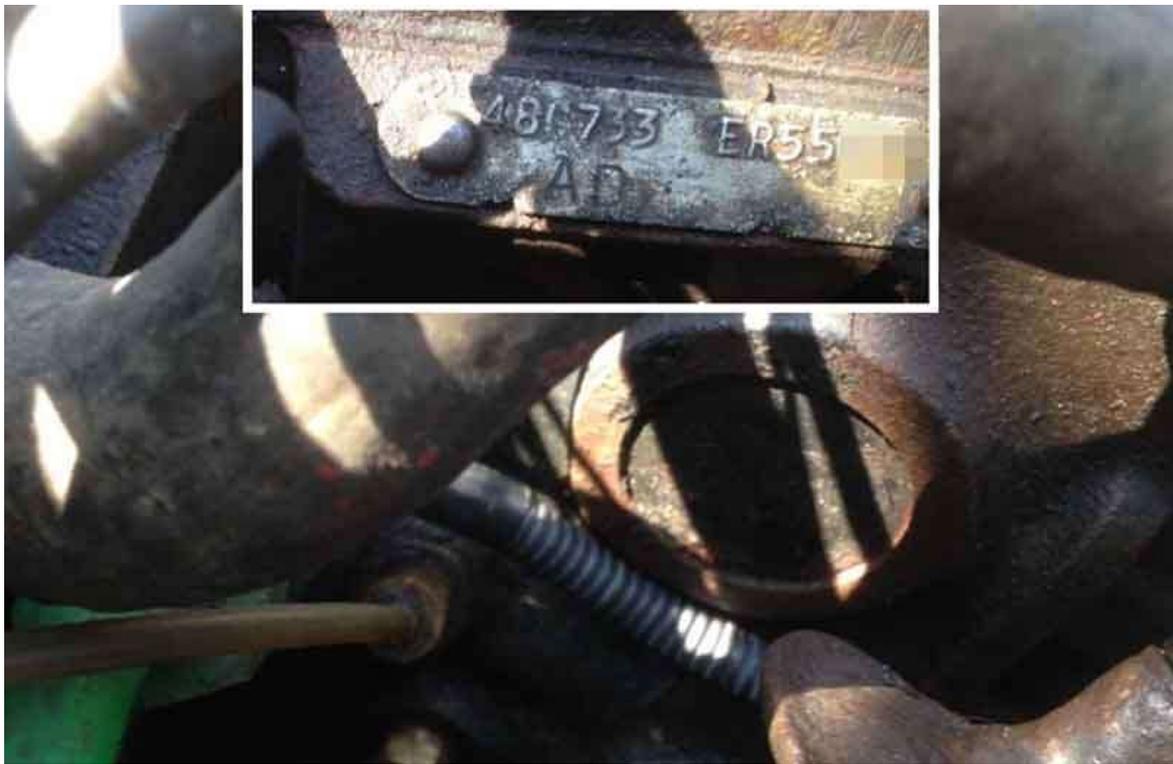
Nigel Brown's, very similar type and age but with an 'ER' suffix, same engine builders initials, but definitely flat core plugs. Something else of note is the very similar surface coating on this and the one above (more evident on the originals I cropped down to these), unlike the gold paint on mine:

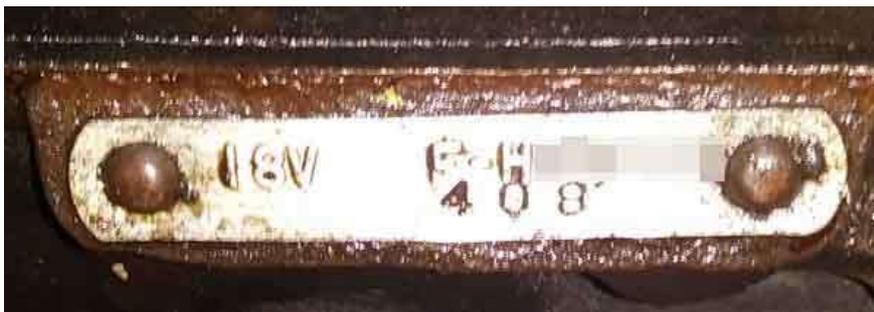
Marina Engines: Mark Holgate's 68 GT with an 18V engine:

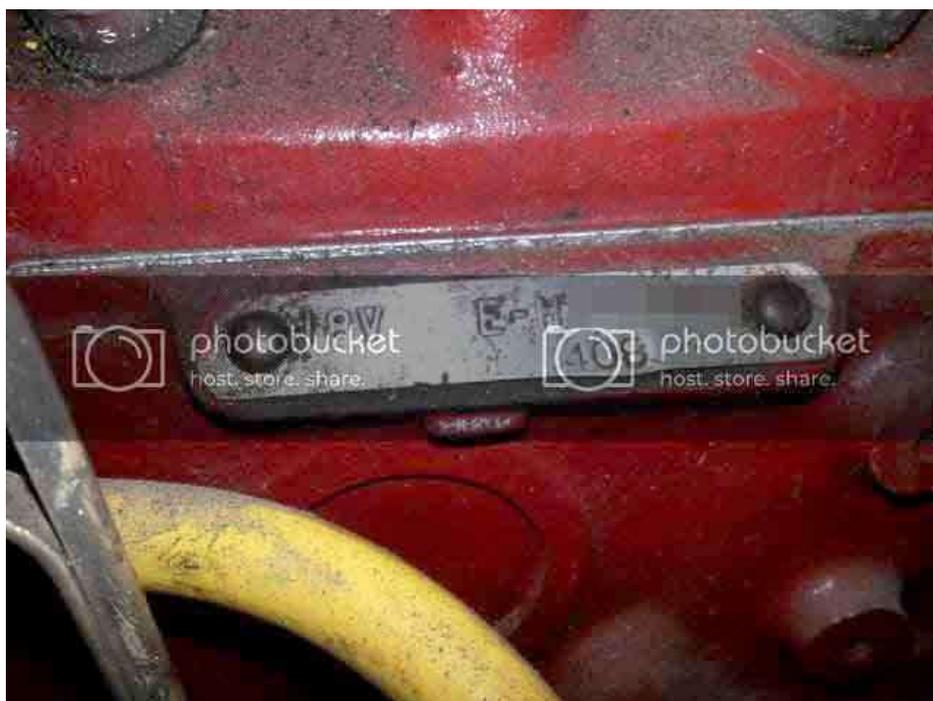
On a Marina TC engine: ([Fast Marina Magazine forum](#))

In the above forum thread other 3-digit numbers stamped in the same way are 247 (a couple found in New Zealand), 464, 486 and 641 and 642 which were Police spec.

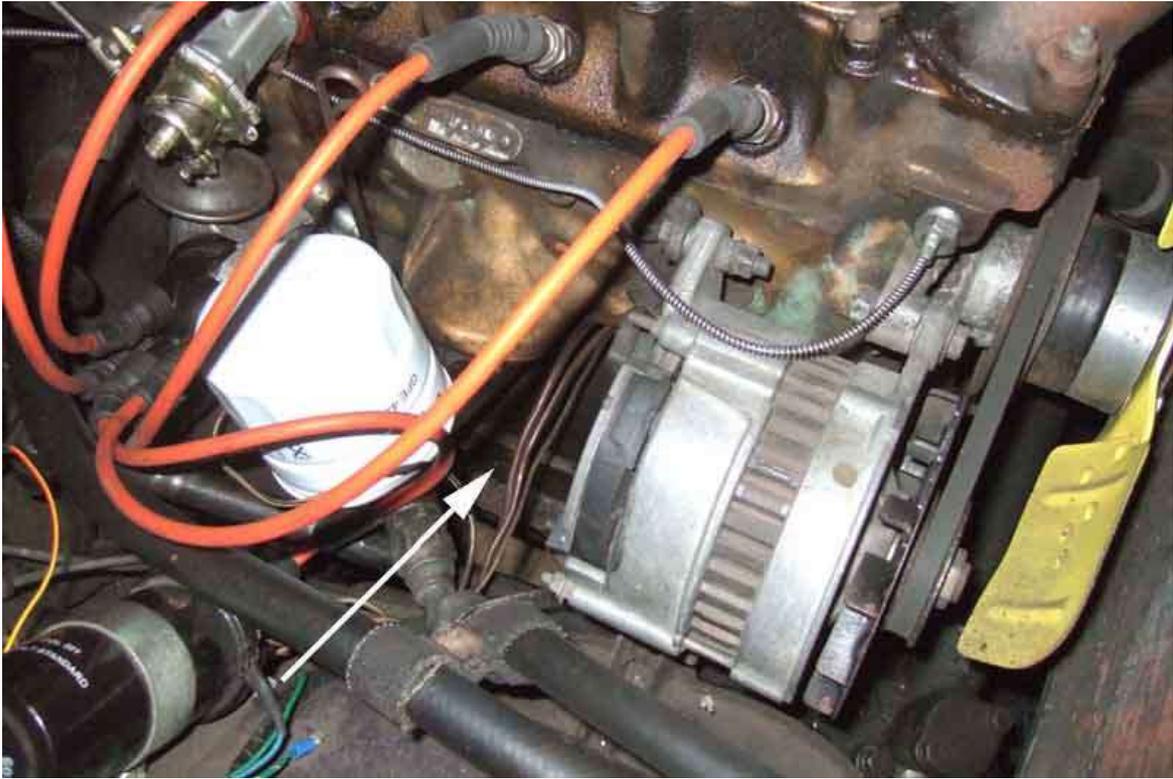
Locating the date mark, relatively easy with no emissions kit and the inverted oil filter:

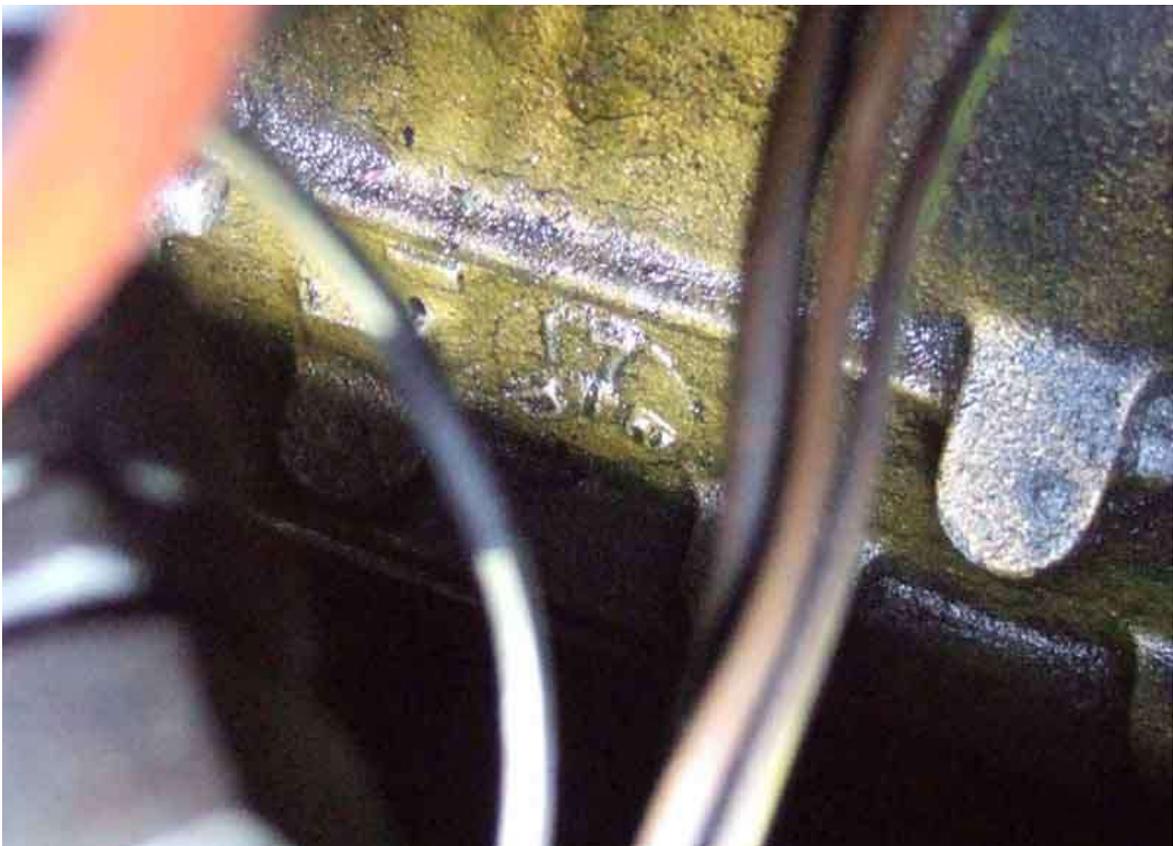
Although a Gold Seal engine the engine number prefix of 48G is correct for the 1972 year of manufacture of the car, and appears to be 17, D, 1972:

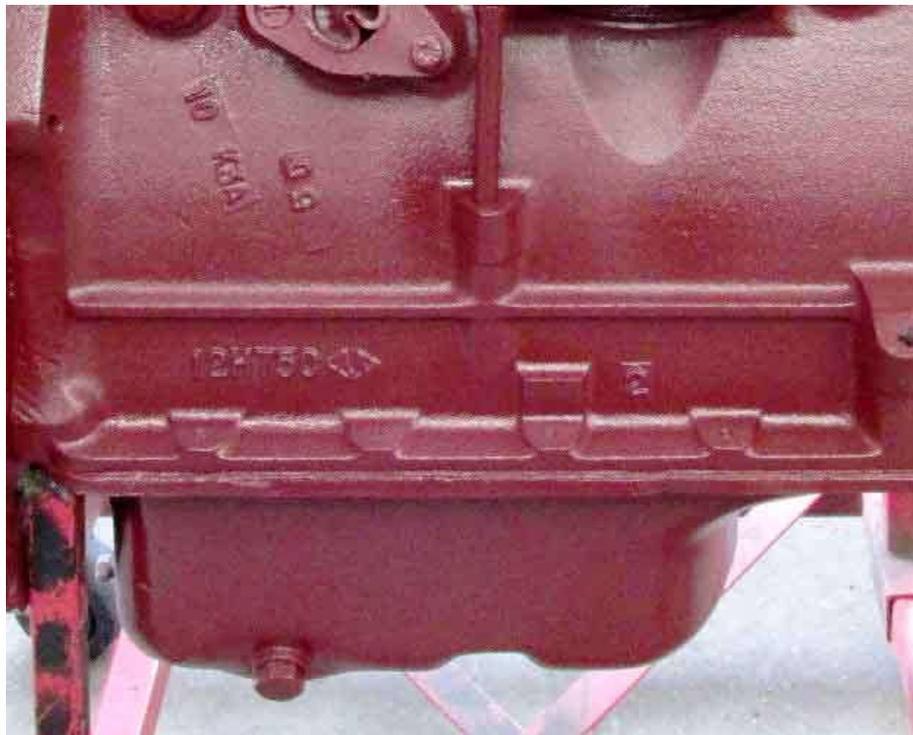
However this 18G 3-bearing engine has just a '2' where the date code would be i.e. directly under the oil filter housing position. '12H750', some odd numbers higher up. The flange under the dip-stick hole is full length:
