Crankcase Breathing

Cylinder Block

Engine Numbers

Dating the Block

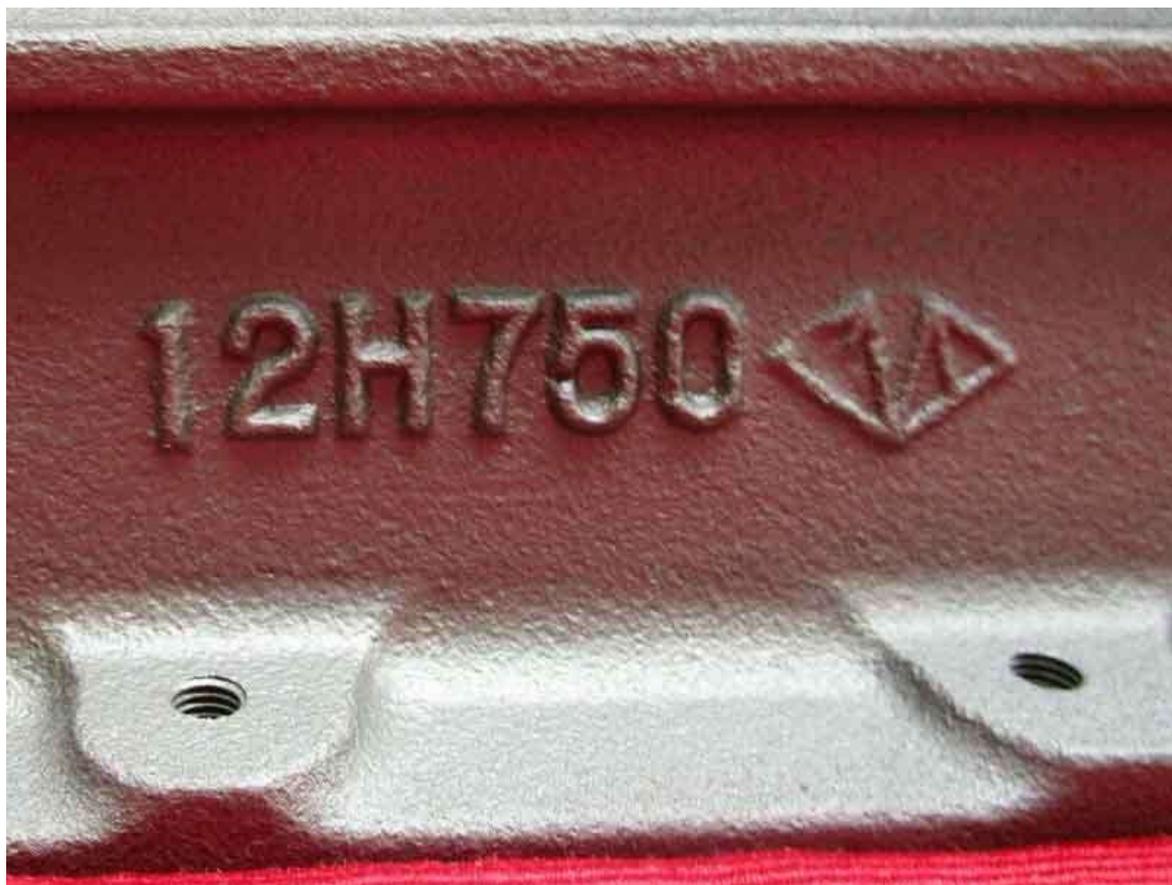
The above block has a logo beside the casting number, representing the Wellingborough Iron Foundry, even though it looks more like an enclosed 'M':

If we're talking about the small letter W surrounded by a lozenge, that's indeed a foundry mark indicating the block was cast by the Wellingborough foundry. See: www.gracesguide.co.uk/Thomas_Butlin_and_Co.

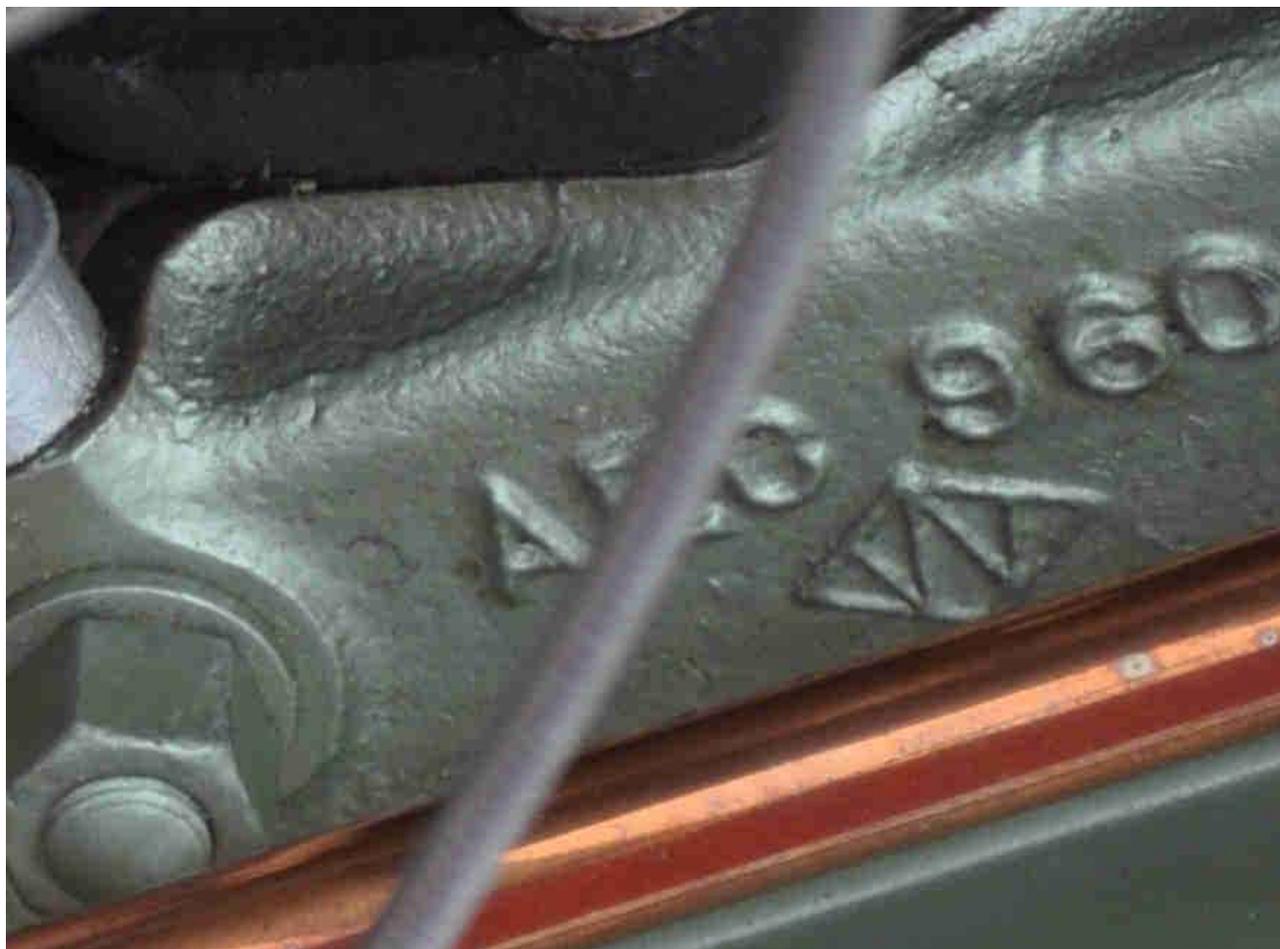
Healey 3000 manifold, with the logo the right way up relative to the casting number: *(Fred Horner)*

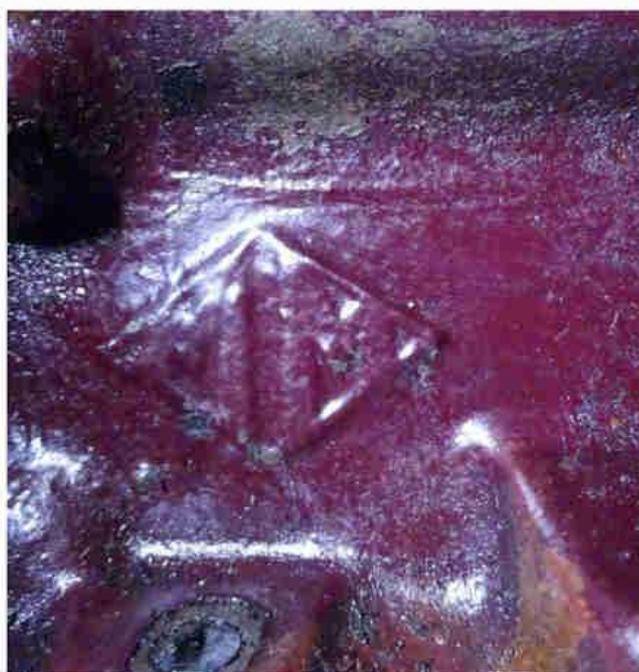
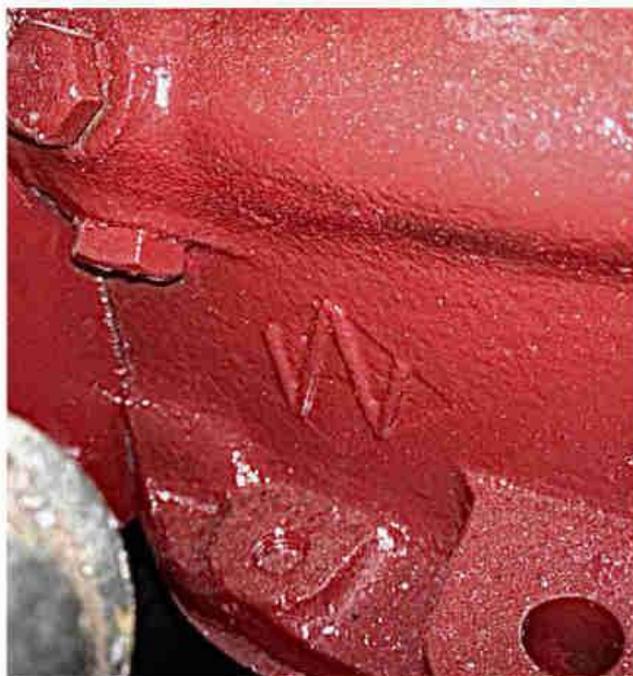
Examples of 'MM' (Morris Motors) and the 'W' in the lozenge on T-Type blocks, again the right way up: ([MG Car Club T Register](#))

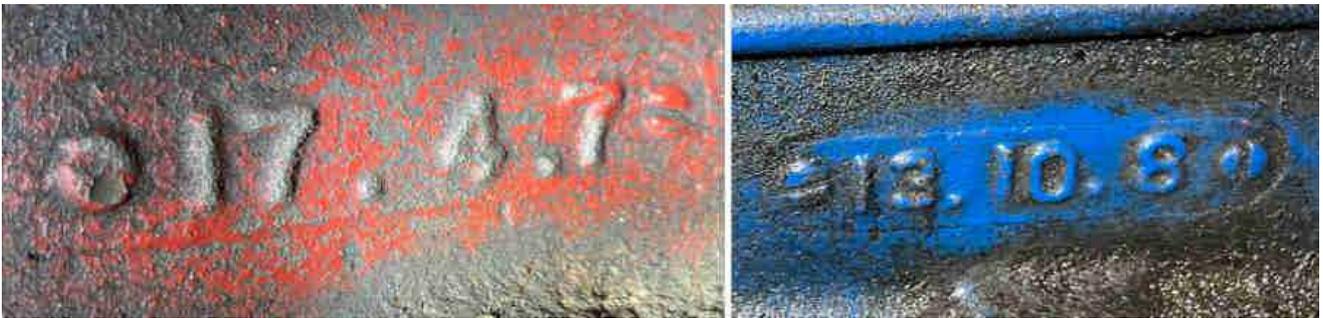
Examples of date strips from a 57/58 ZA/ZB, and an MGA with a 'BP15GB' engine: (*Fred Horner*)

All these strips conform to the requirements even though they don't conform to the BL document.

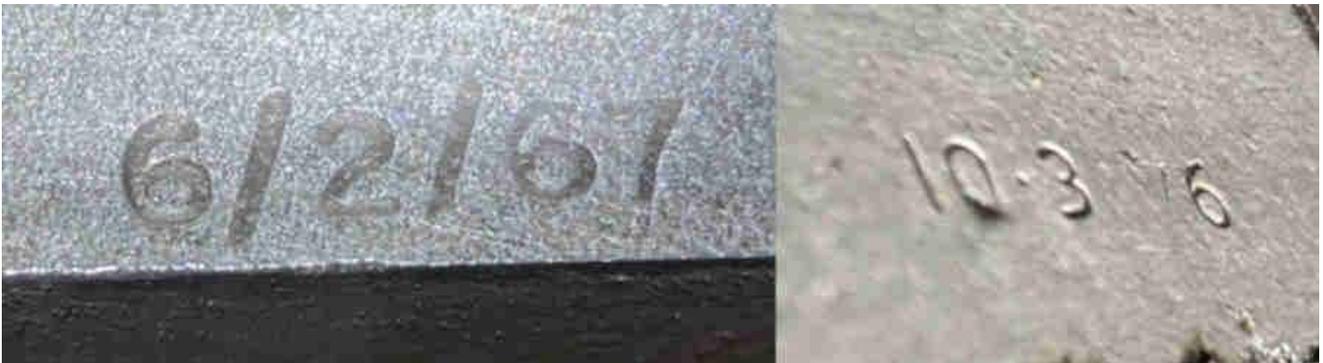
MGB 3-synch gearbox date stamp left, 1976 4-synch right: (*Fred Horner*)

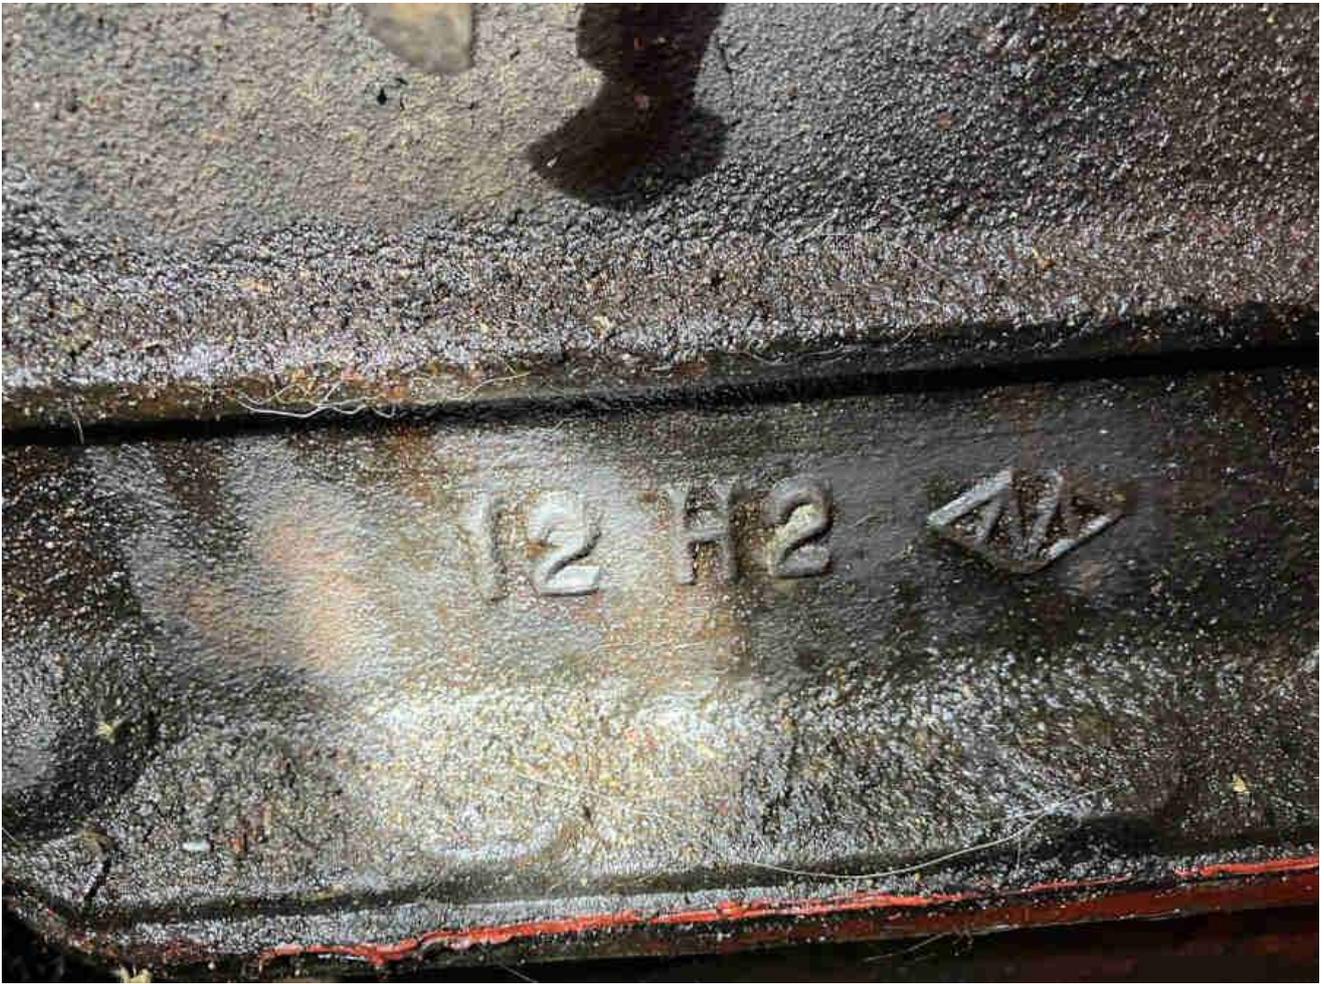
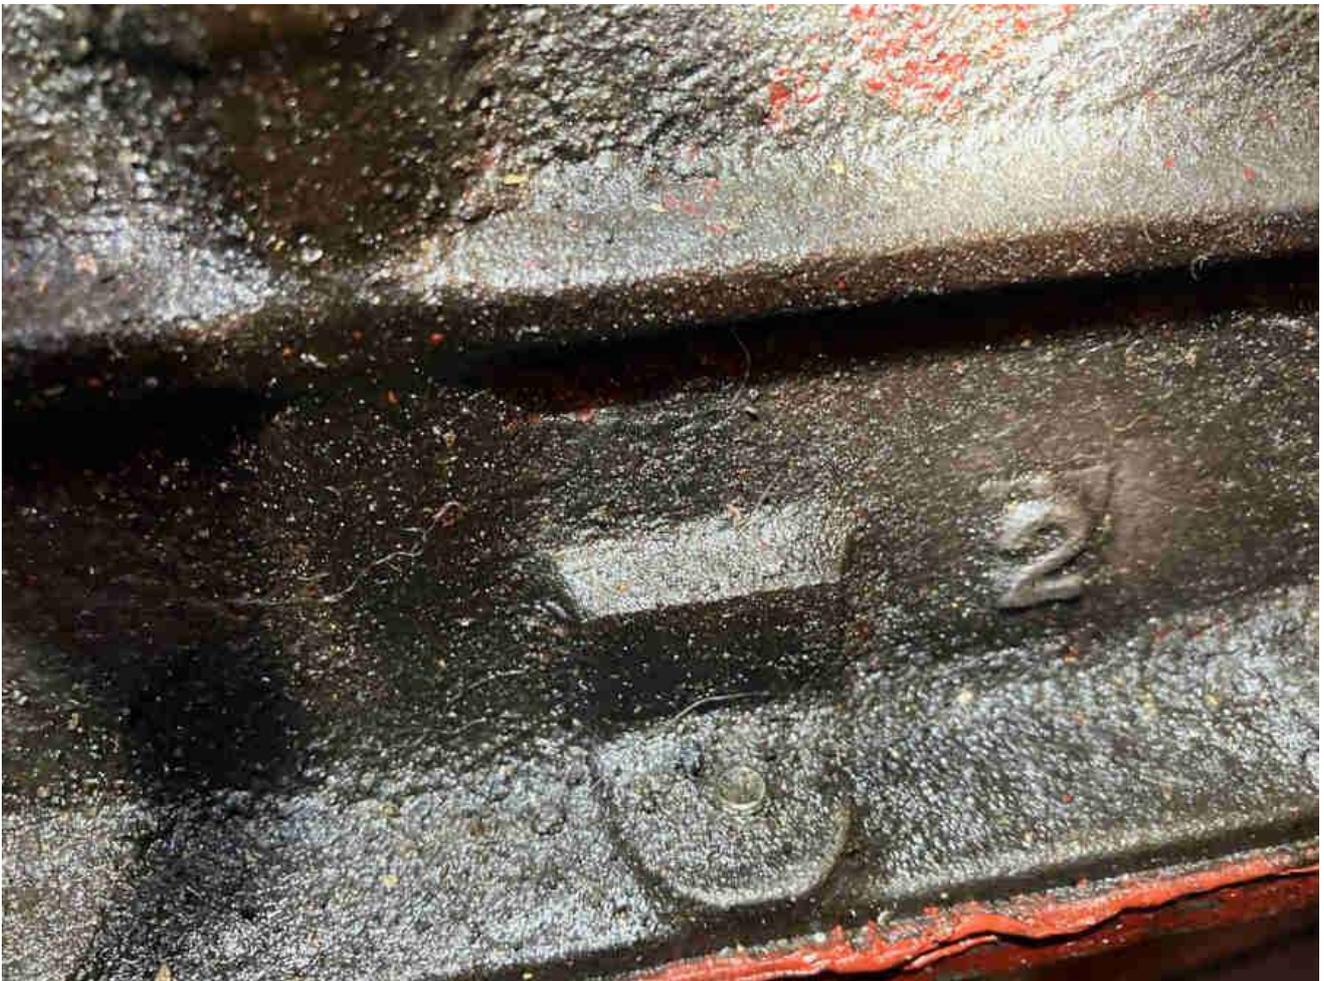
Similar examples on an MGA 16GA engine: (*Fred Horner*)

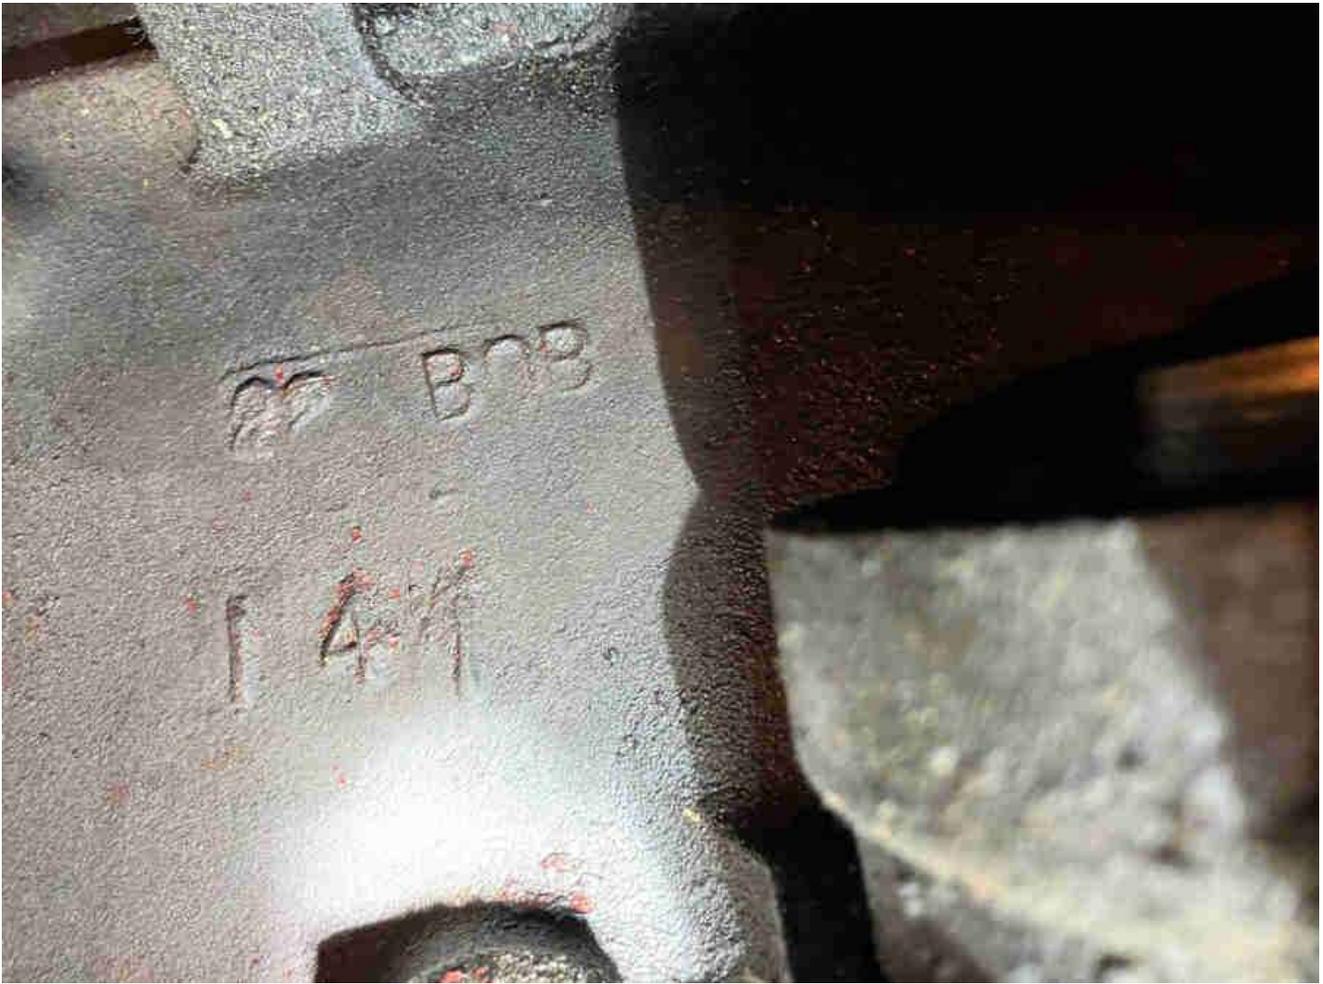
This also has some characters upside down forward of the filter mount (image inverted for clarity). Cast by 'Bob'?

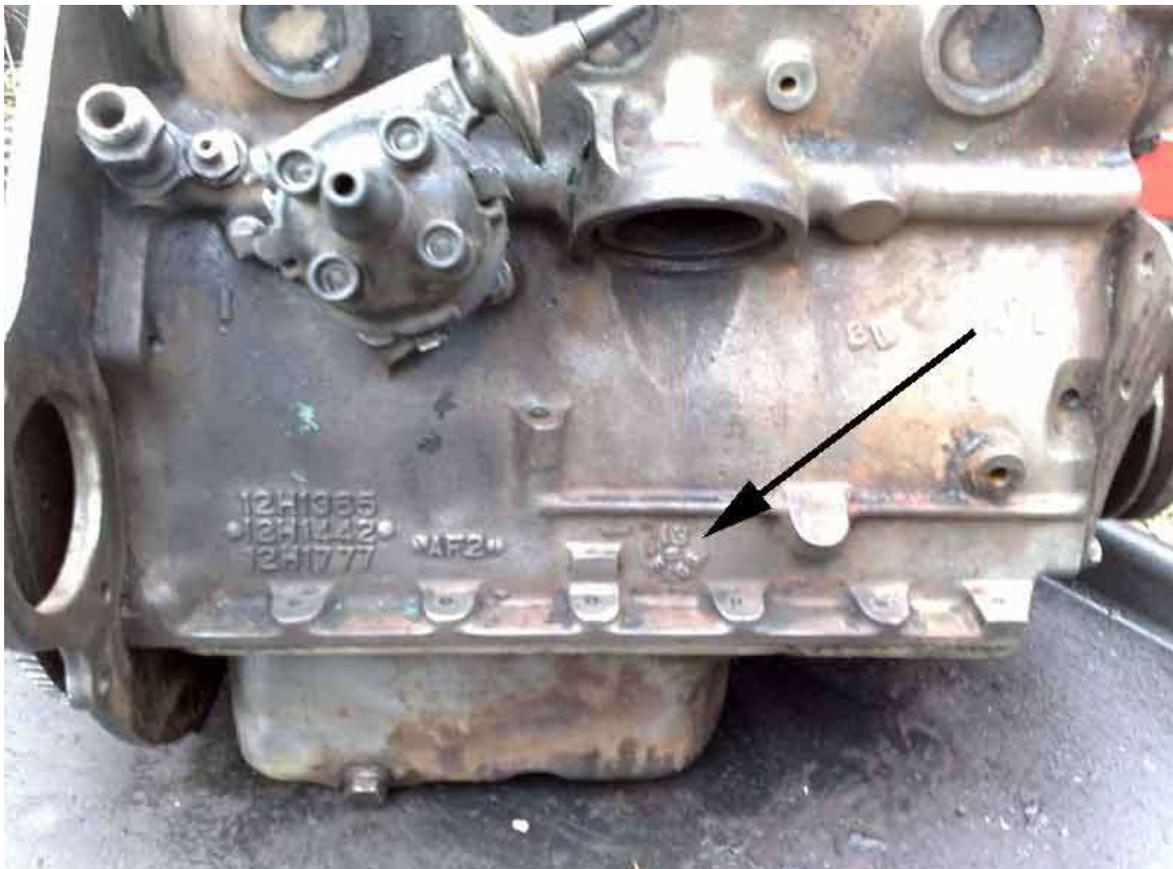
Back to MGB engines, probably 13, E or F, 1966, with an engine number of 18GB i.e. 3-bearing. Three '12Hnnn' numbers, and 'AF2'. Flange under the dip-stick hole only going forwards:

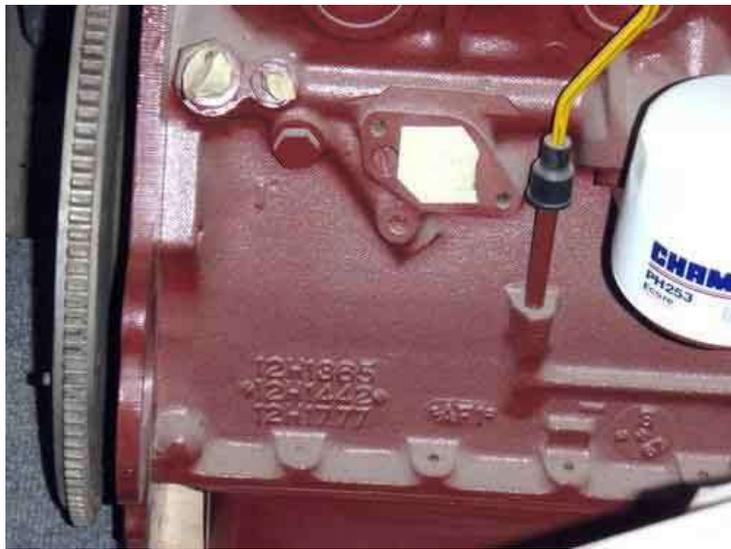
Another 18G/Gx block with the same three '12Hnnn' numbers as above, but this time 'AF1'. Date code indicating 1967, so an 18GB or GD (*Ryan Foster, USA*):

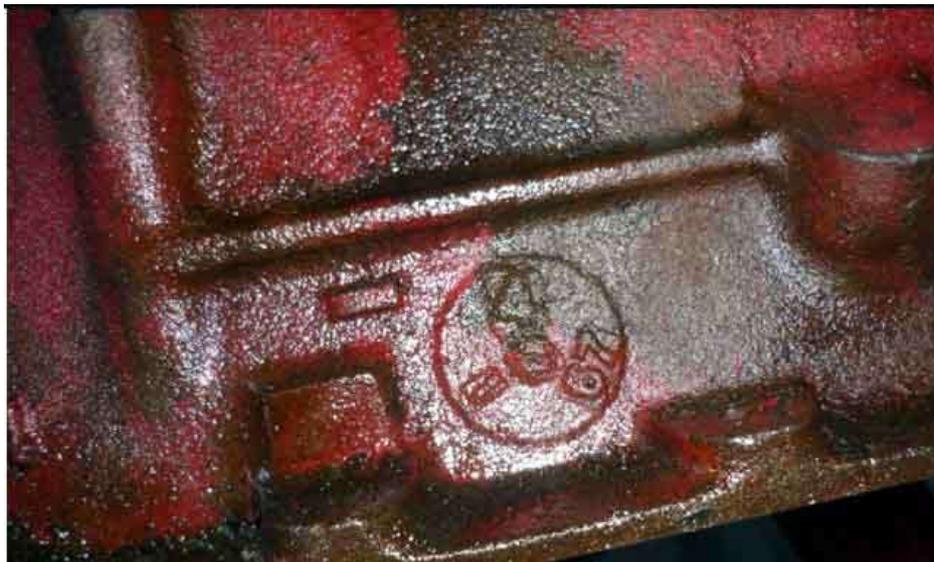
A 1967 18GB - is that a digit '1' or a letter 'I' in the month position? Both would be counter to the BL document above: (*Kevin*)

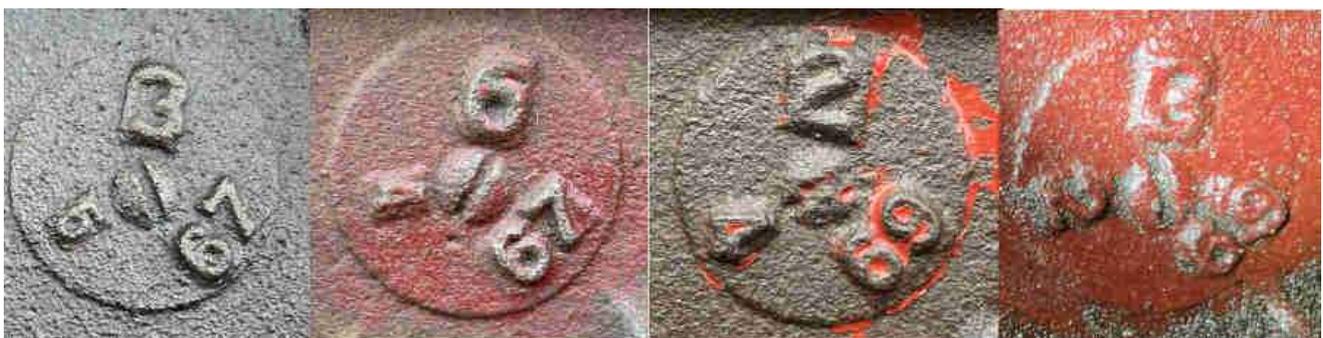
Four more examples of digits where the month letter is supposed to be, the first two are from the head and block of the same engine, the other two are blocks: (*Fred Horner et al.*)

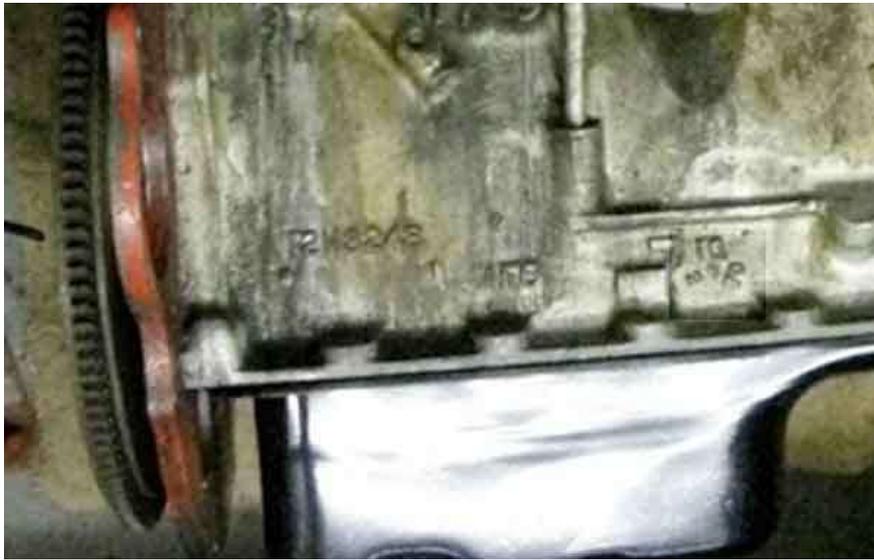
This engine has 1970 on the dating code, so an 18GG to GK, but a single 12H3248 casting number and 'AF5' (*Mustang Shire*):

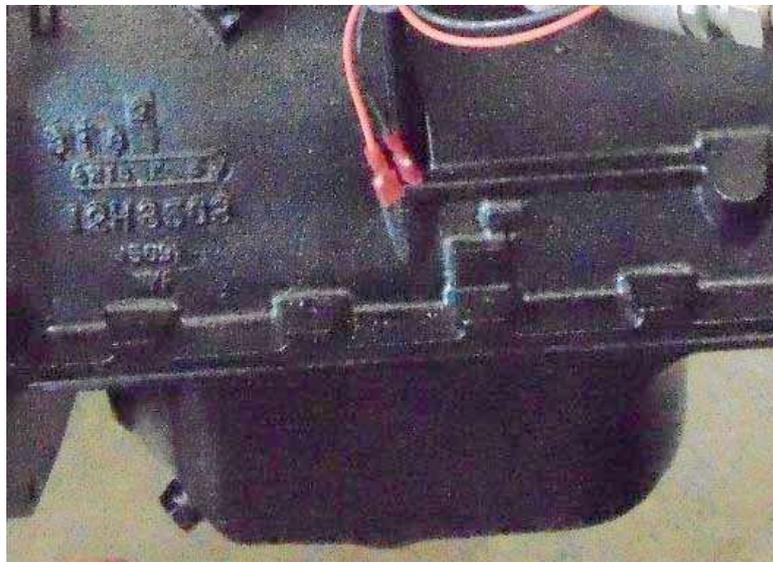
A five-bearing 18GH (from the engine number tag, so Oct 68 to Aug 70), again no date code or anything else under the filter. Very different numbers at the left including '12H3503' and the [West Yorkshire Foundry](#) mark, no 'AFn' number, and rectangular bosses for the sump screws instead of rounded:

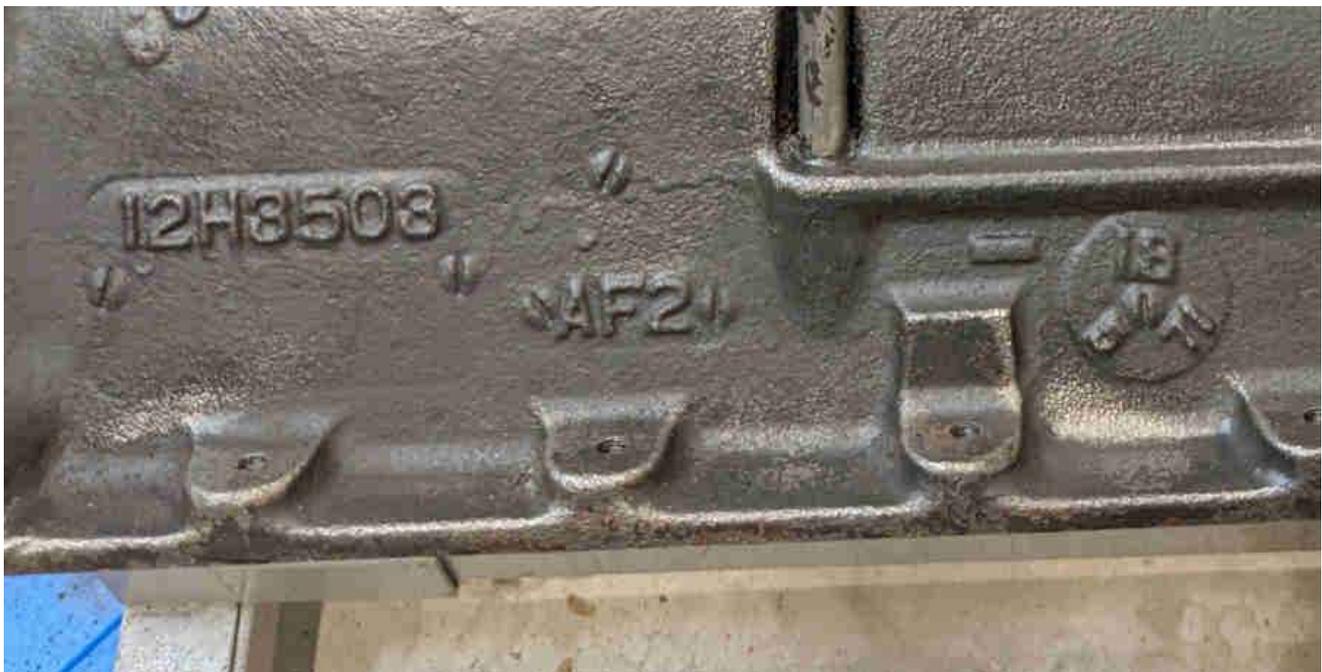
An unknown block from Stephen Howden. Clearly dated 1971 (which goes against the BL document above), and 12H3503 AF2, so could be 18GG/GK or 18V. But on the other side ...

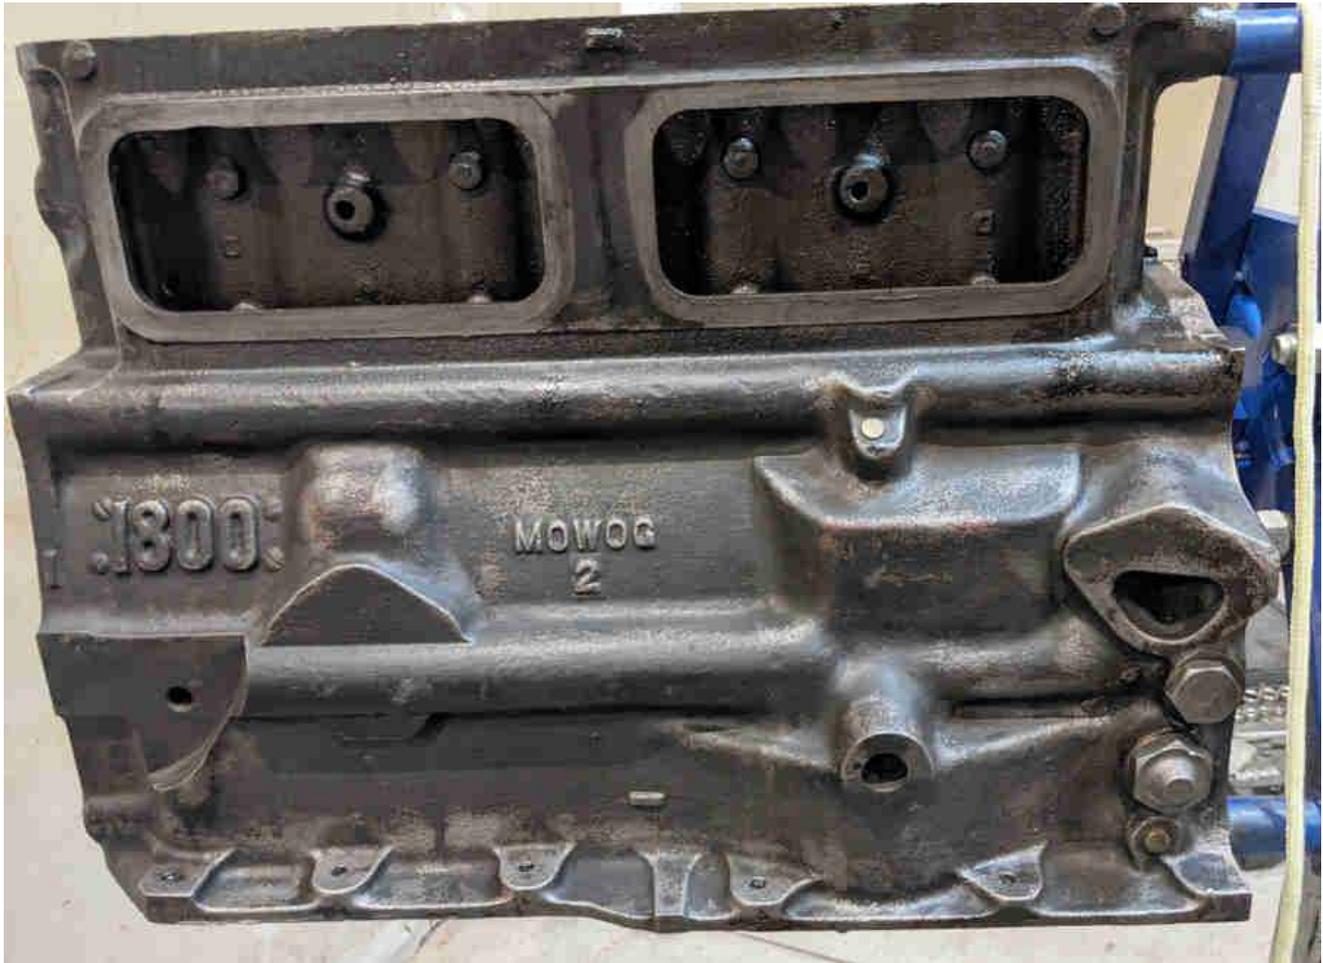
... an unpierced moulding for the mechanical fuel pump. Clausager says one of the differences on the 18v is that this was pierced, so the implication is that 18Gx weren't, making this an 18GG/GK. Another indicator is 'MOWOG', which seem to be on 18Gx but not 18V:

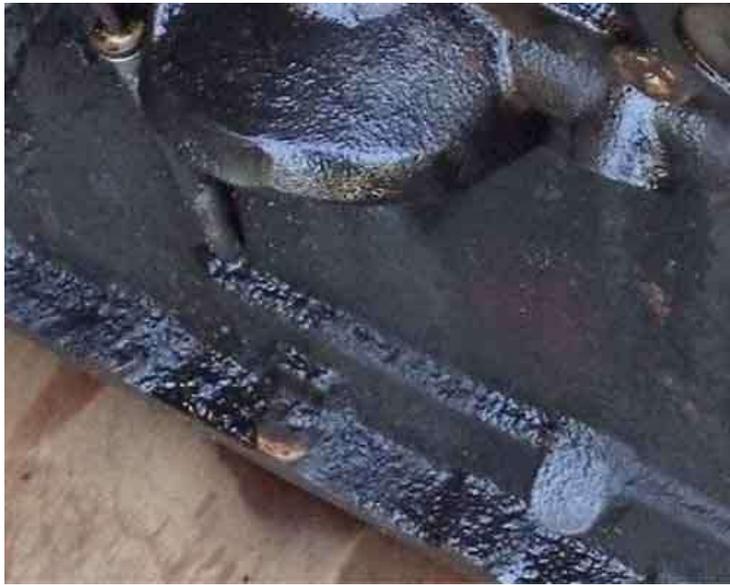
And yet this 18V673Z (going by the engine number tag) i.e. August 72 to September 74 has no date code:

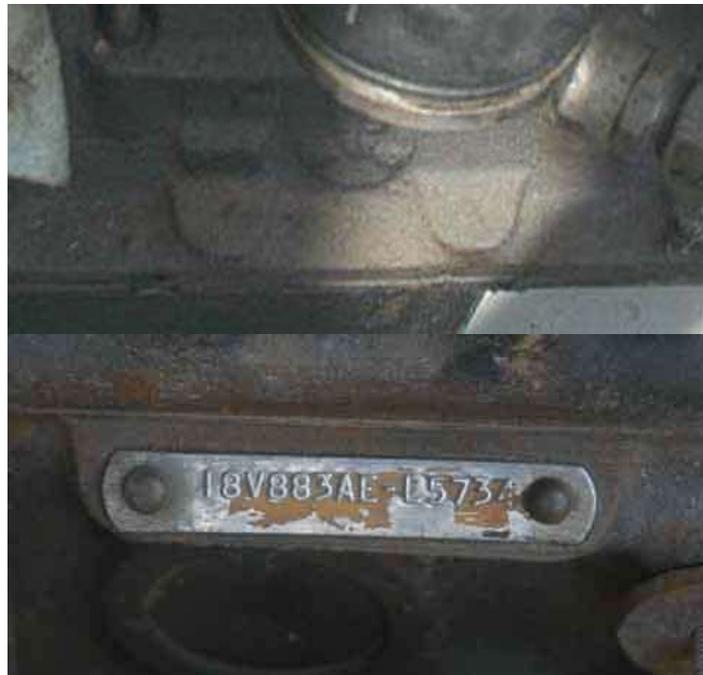
Barely legible - but the year digit looks more like a 5 than a 6, the engine number dates to about October 76 so the casting could be from late 75 or early 76:

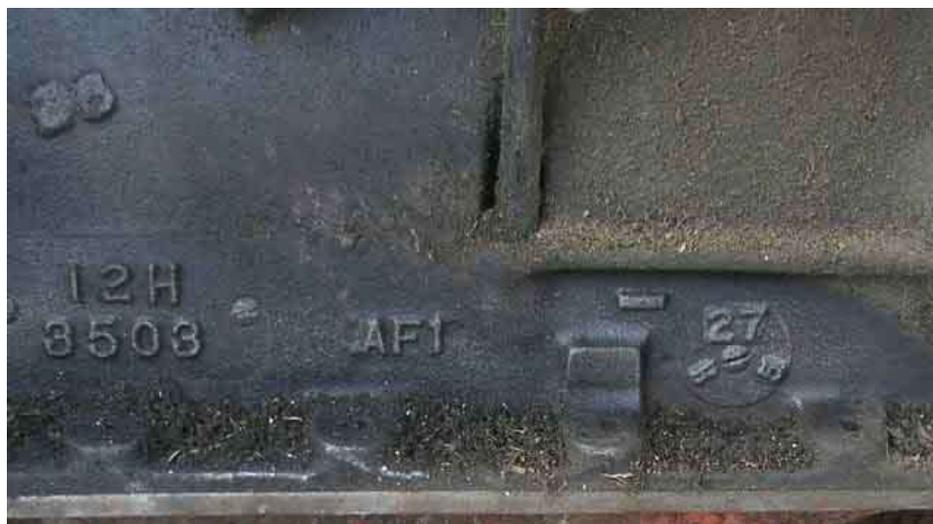
An 18V block with '12H3503' on two rows and 'AF1', and a date code indicating 1975, i.e. an 18V 846/847, 18V 797/798, or 18V 801/802. None of the other markings as on the previous engine. Back to rounded sump screw bosses: (*Jim Bronson, Canada*):

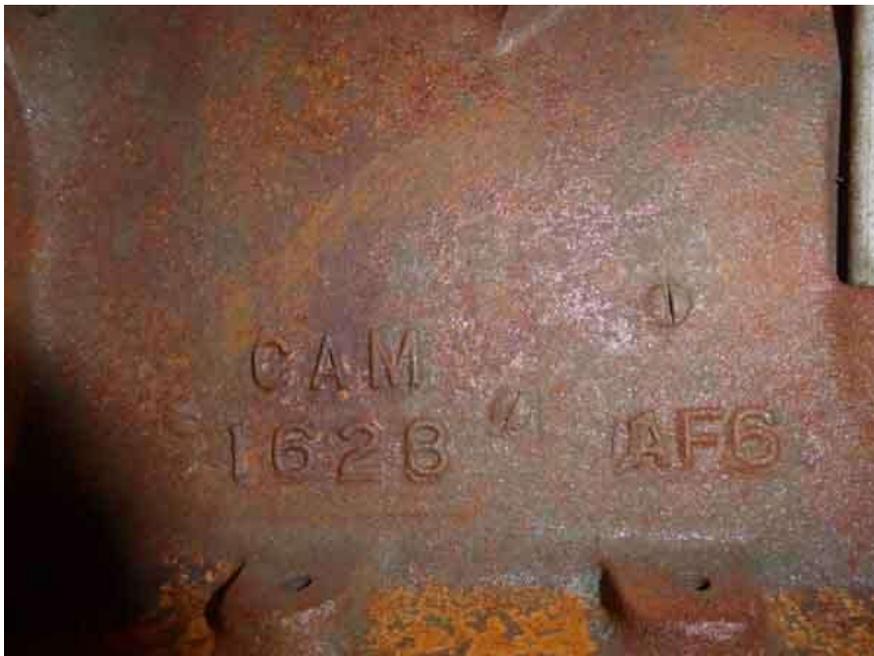
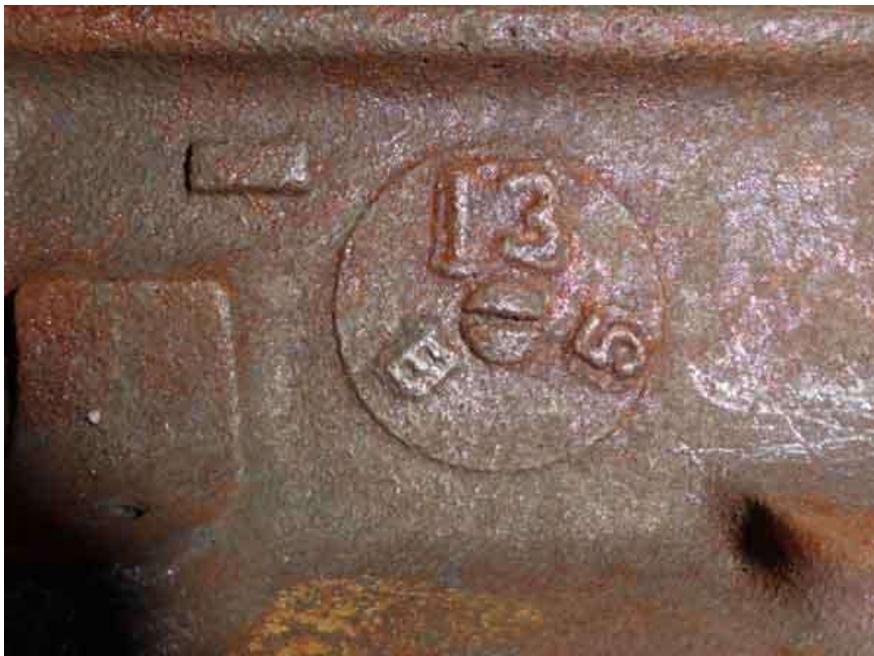
I've seen two examples where CAM1628 replaces the 12H numbers, with date wheels showing 1975 as in the next picture, and 1976: (*John Fraioli*):

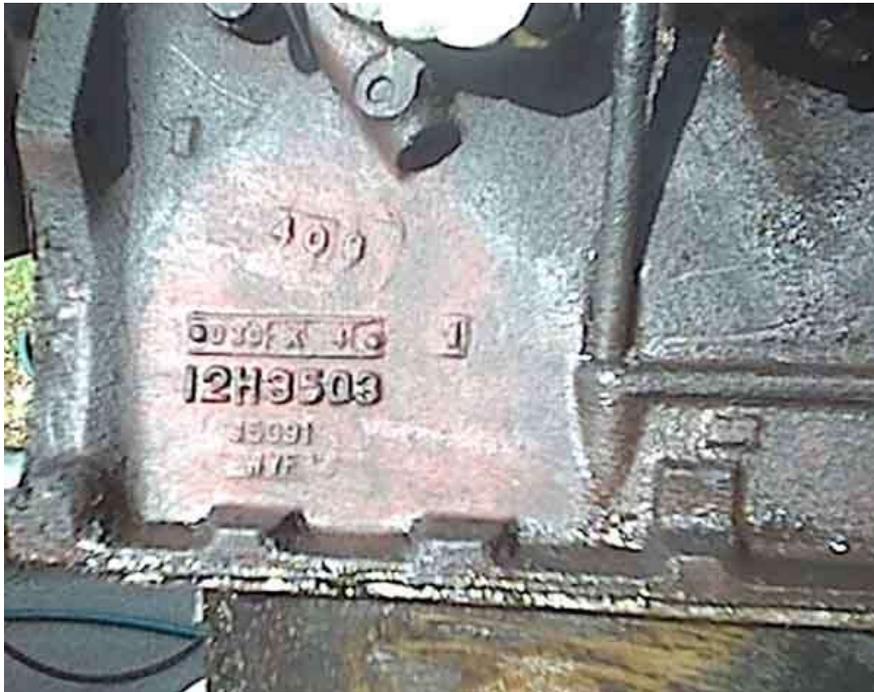
Another '12H3503' with the other numbers being different and no date code, with an 18V658 engine number i.e. from a Marina. The 'WYF' at the bottom indicates West Yorkshire Foundries, part of the BL empire until 1986: *(Mark Jones in Canada)*

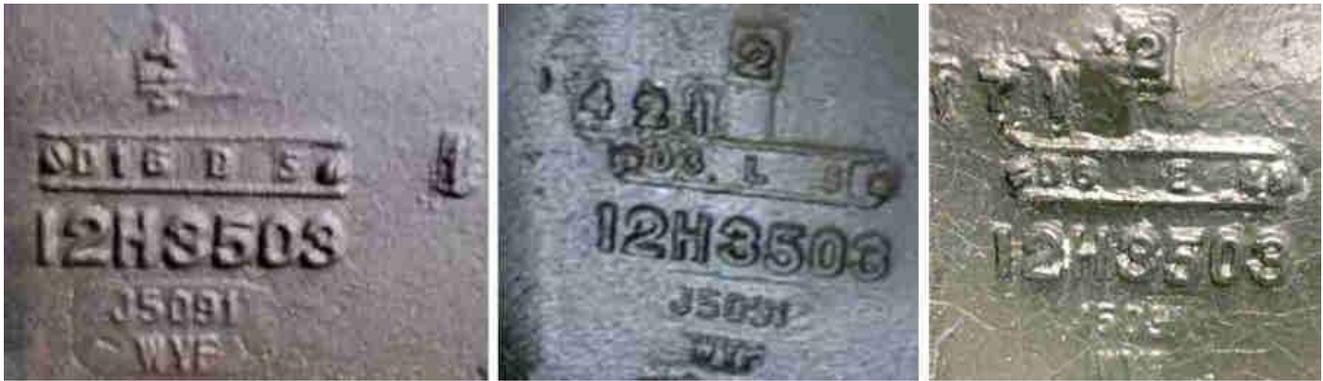
Three West Yorkshire Foundries 18V801, used from June 75 to June 76 for America. No circular date codes but a possible dating strip above the casting numbers:

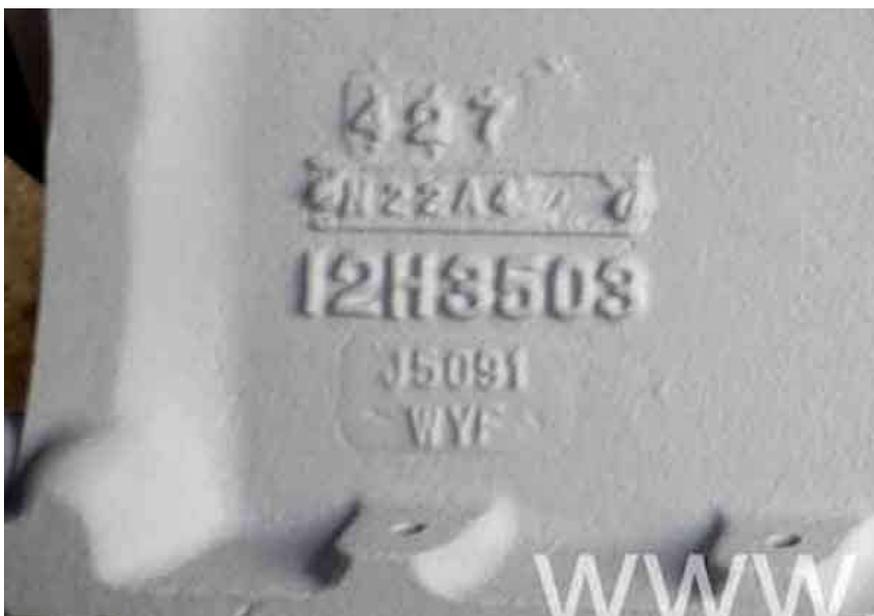
The strip of characters near the top has a '5' on the right in both cases, is this the WYF dating info? Another WYF block (engine number unknown), but no digit at the end of the strip. Different digits above and to the right of the strip in all of the WYF blocks:

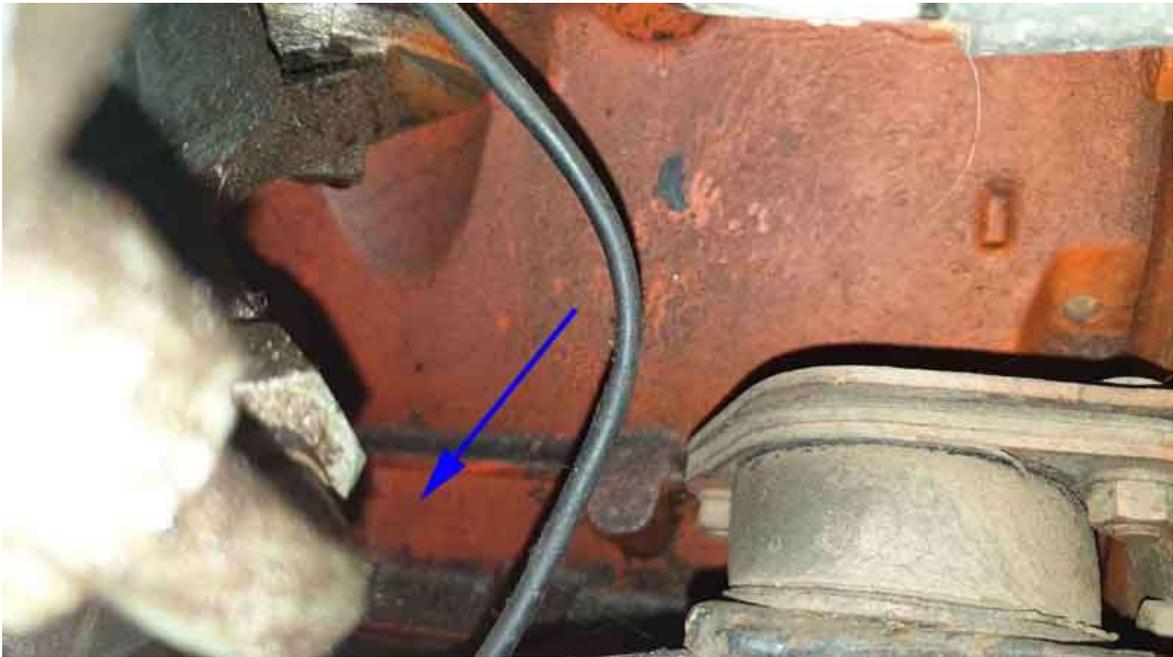
One of two 18V/801-802AEL engines from December 75-built North American cars without date codes: (Bill Etter)

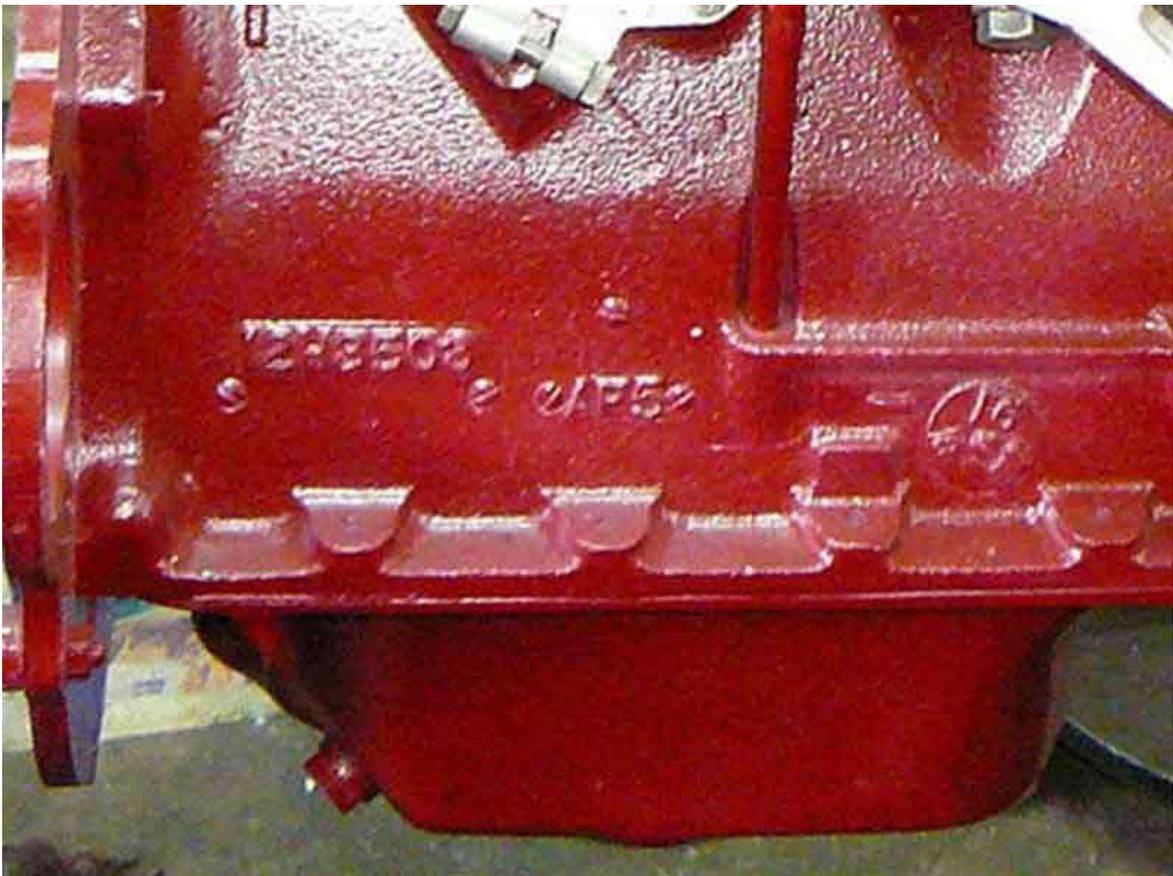
An 18v883 of Jun 76 to Oct 80, date code with a single '7' indicating 77. The same '12H3503' (but looks like 3508, on a single row) as above, and 'AF5':

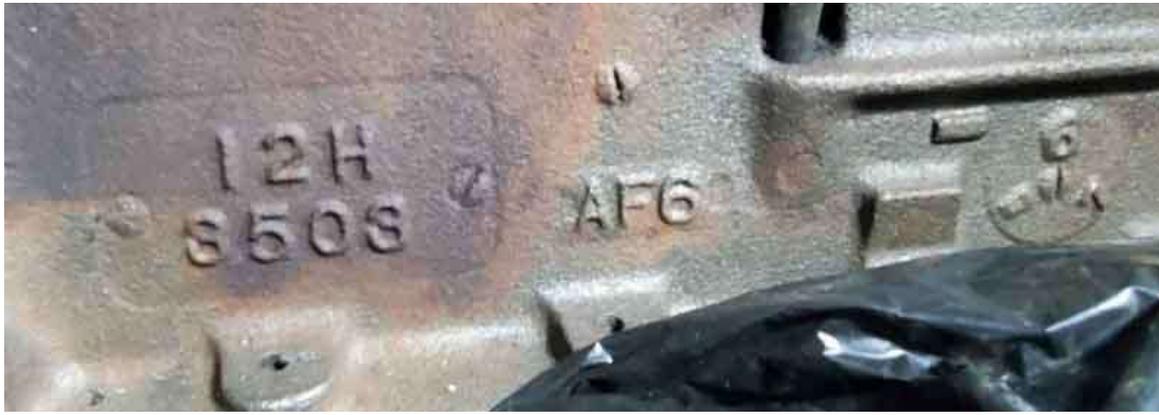
18V884 with 6, ?, 1977:

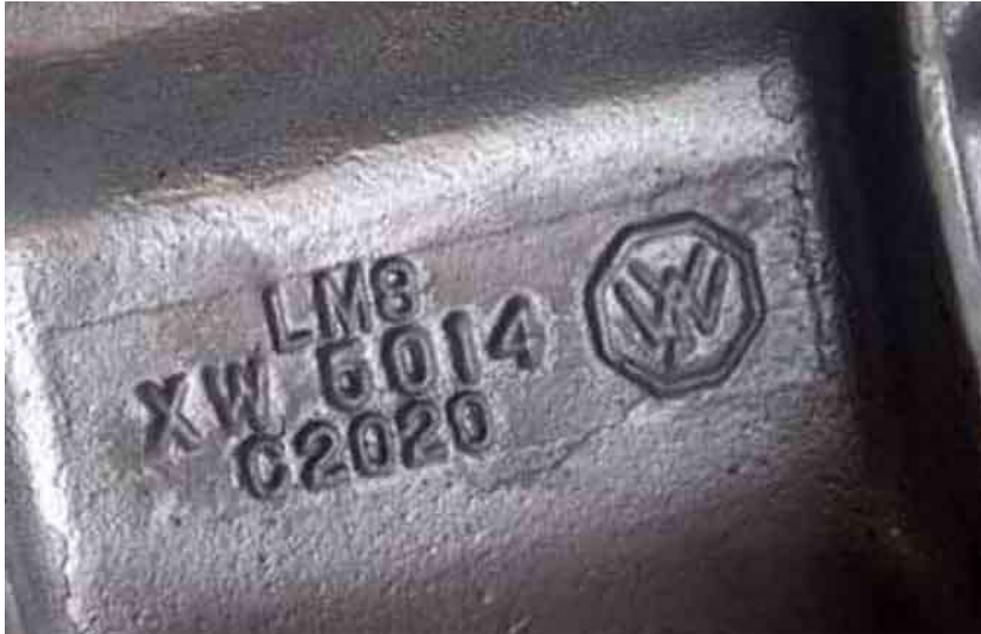
There is information about WYF on several Jaguar sites, and one of them has this picture (I bet Jaguar owners aren't impressed with the octagon!):

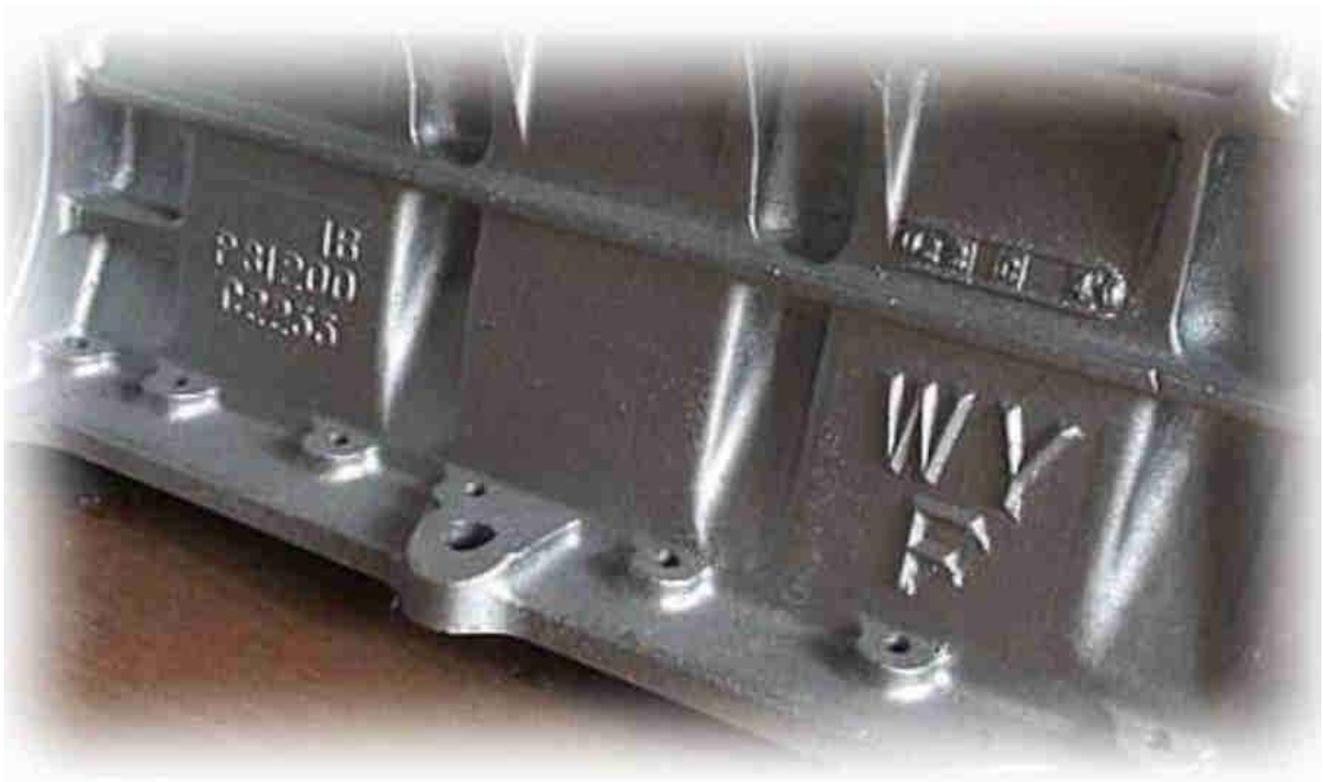
Another Jaguar example, a 1980s alloy V12, simple 'WYF' logo and same dating (?) strip:
