Crankcase Breathing

Cylinder Block

Engine Numbers

Dating the Block

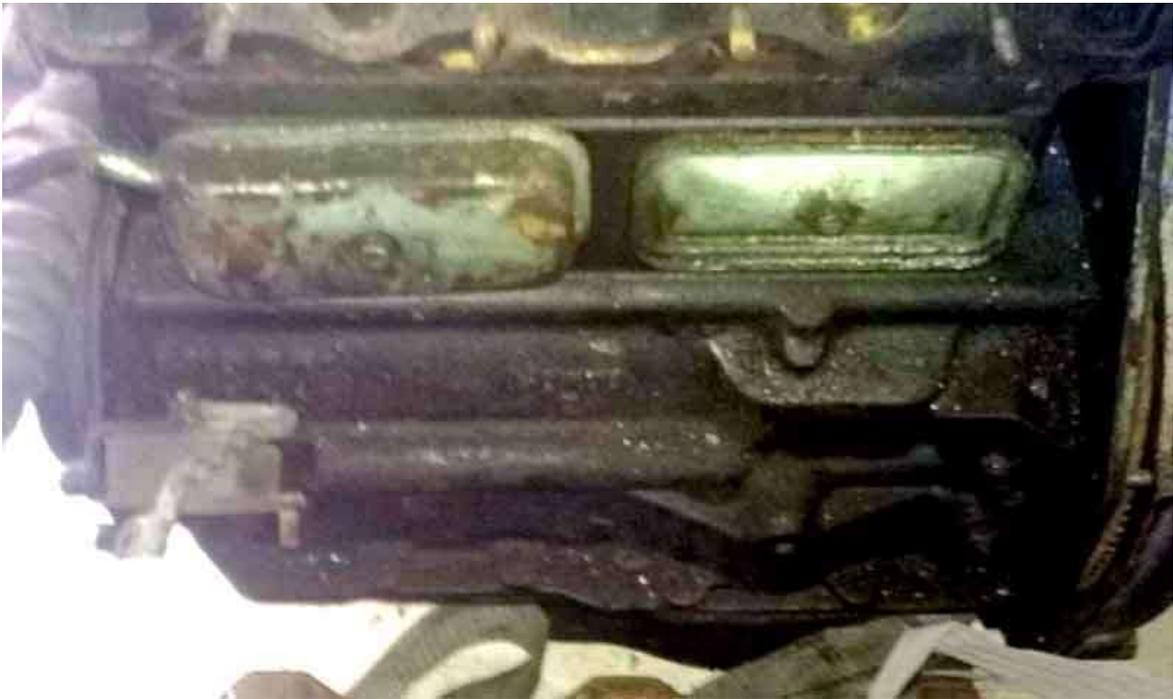
The 18GB, 66 dated block (as in the [top picture on this page](#) but before degreasing) with no position for the mechanical fuel pump:

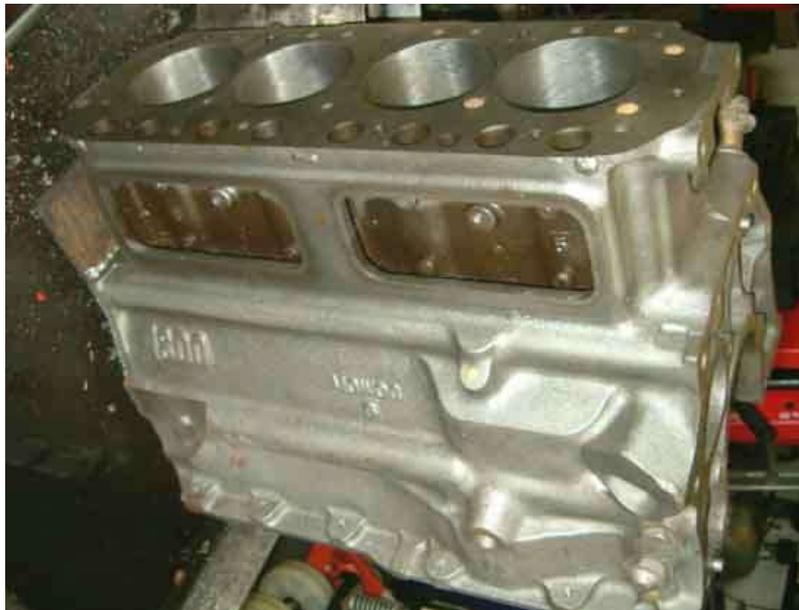
The 18GG to GK 70 dated block with no position for the mechanical fuel pump and with the 'MOWOG': ([Mustang Shire](#))

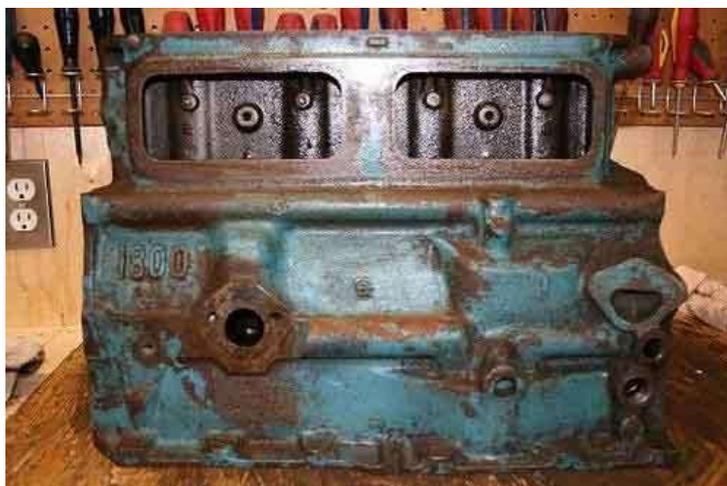
The fuel pump aperture - Clausager indicates this was new for the 18Vs - and no 'MOWOG' on an 18V engine with year code '73' and 12H3503: ([Duane Timbers, Canada](#)):

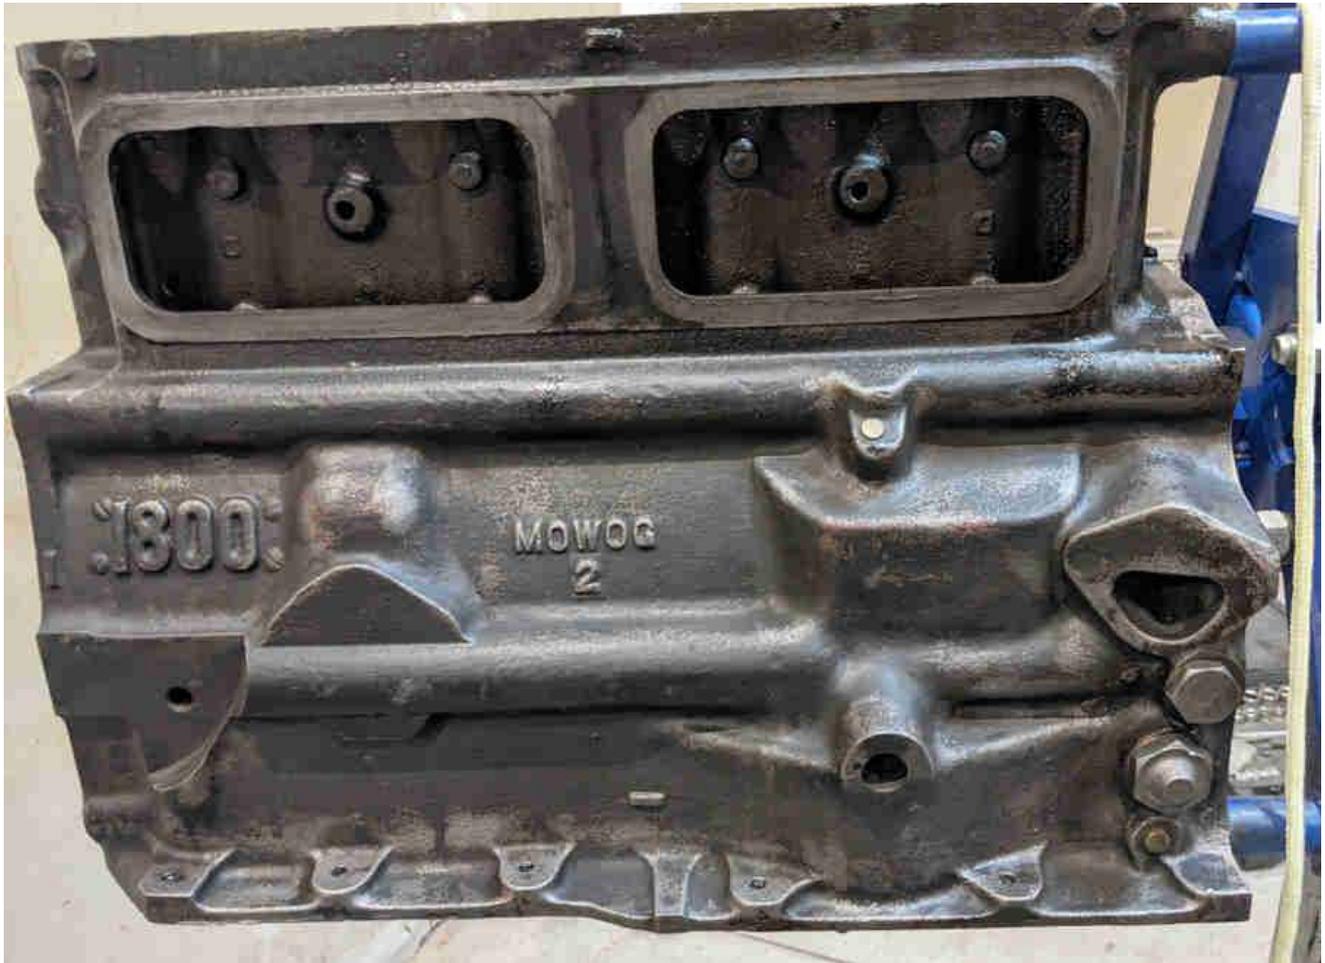
An unknown engine with year code '71' and casting 12H3503 AF2 on the other side, 'MOWOG' and an unpierced moulding for the fuel pump this side. The implication of all that is that it is an 18GG/GK, and in fact an 18GK as the head (also dated 71) has air-

injection holes: (Stephen Howden)

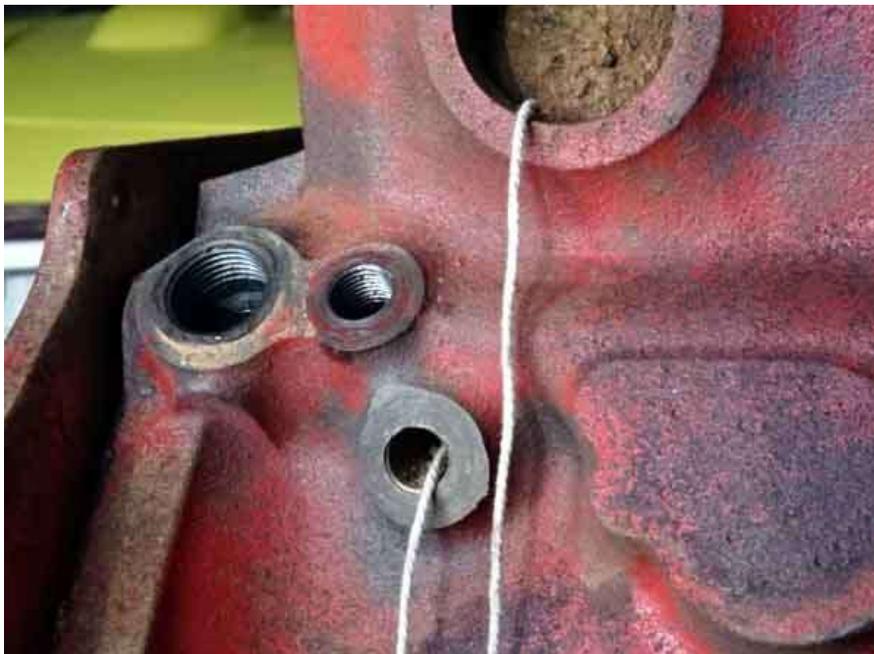
Even odder is this one, with no provision for a distributor, and a question posed by William Revit in Tasmania. It's a B-series, not a diesel, so what is it? (Ignore the string, that was just to demonstrate the hole below the two oil ports is the block drain port).

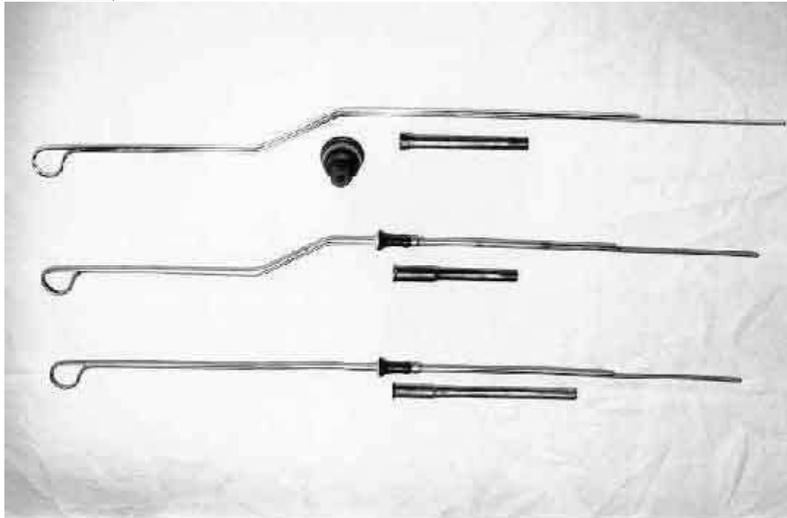
The three dipsticks and tubes:

- Top: 18G to GF, sliding dust seal, no stop. These rest on the sump bottom to give the correct oil quantity.
- Middle: 18GG to GK and early 18V581/582/583, 584/585 and 672/673. These have a stop on the stick and need the correct tube to ensure the correct oil quantity. the tube screws into the crankcase. The stop effectively wedges into the tube to give a decent seal on engines with positive crankcase ventilation, where the crankcase is under vacuum all the time the engine is running.
- Bottom: Later 18V. These also have a stop and need the correct tube to ensure the correct oil quantity. The tube is pressed in to the crankcase.

The middle and bottom sticks are said to be interchangeable, but the tubes are significantly different lengths which will give significantly different oil quantity, more with what is indicated to be the later tube in this picture. This goes against the **smaller** quantity of oil that other sources indicate was used in the later engines, unless the longer pressed-in tube goes in much further than the shorter screwed tube, which seems unlikely. I have the straight stick in my 18V673, which would be correct, and comparing the exposed length of my tube and stick, with the sticks and tubes here, with an allowance for how much might be in the block, my tube is much closer to the long tube. Which still leaves the question about oil quantity on engines with the shorter tube. (*image from [British Automotive](#)*)

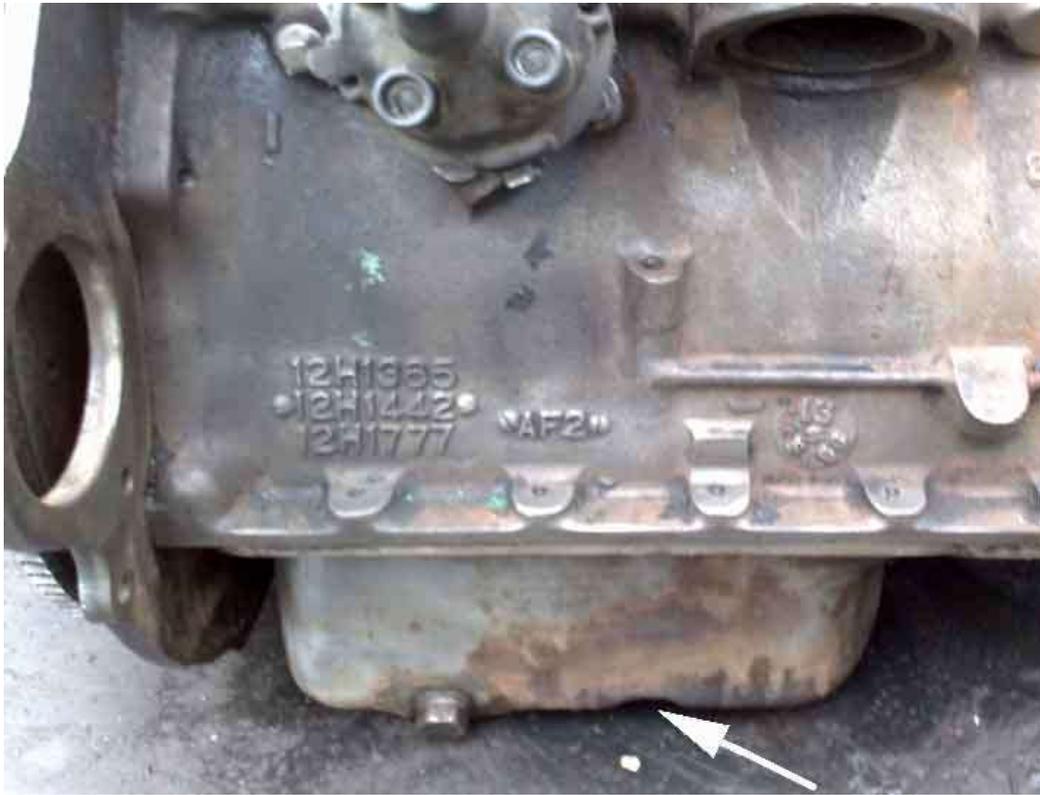
18G, GA to GF, and early 18GG and GK engines had the sump plug forwards of the right rear corner, sumps 12H395 (18G and GA) and 12H1426. When used with the early dipstick without the stop the stick rests on a raised portion of the sump (arrowed).

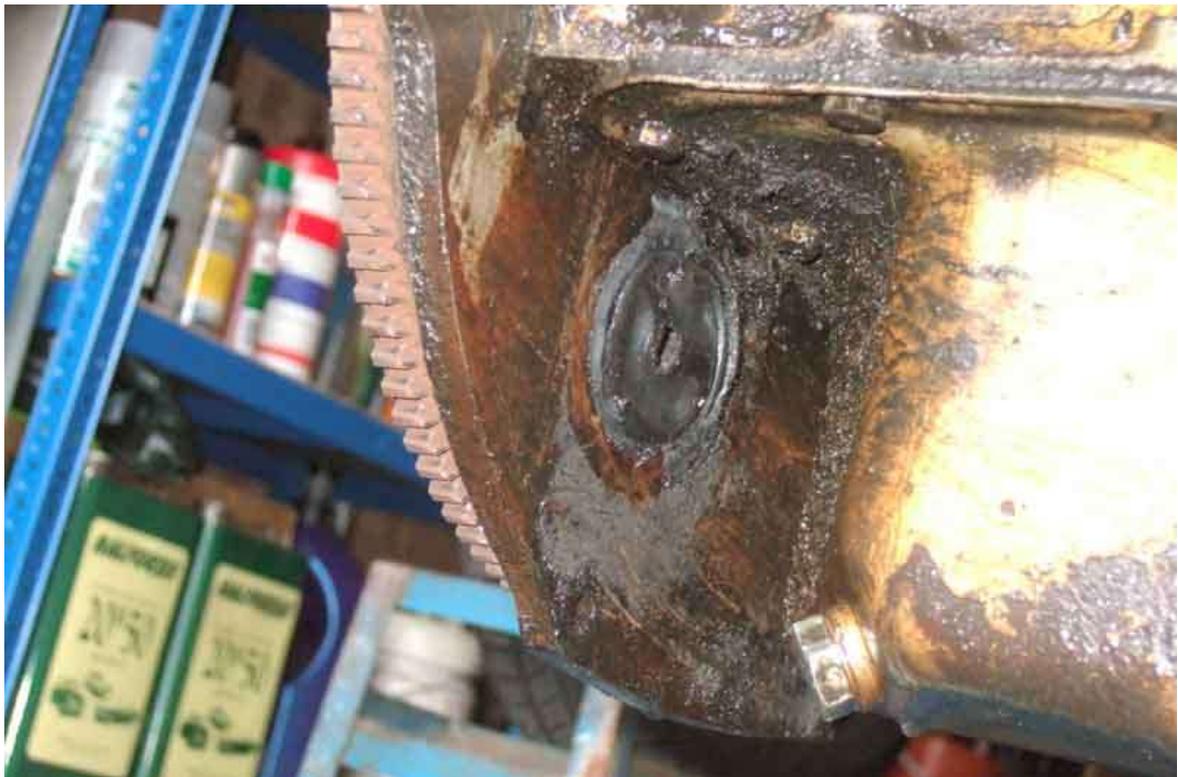
After that the sump plug was on the corner on sump 12H3541 ...

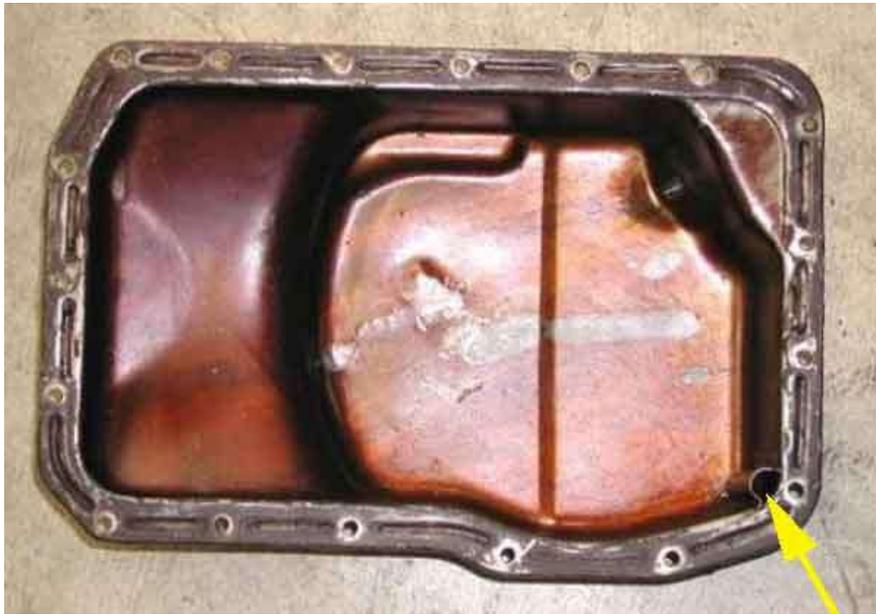
... as that part of the sump was 'cut away' to access the torque converter bolts for the automatic gearbox via the hole in the engine back-plate. (Chris at Octarine Services)

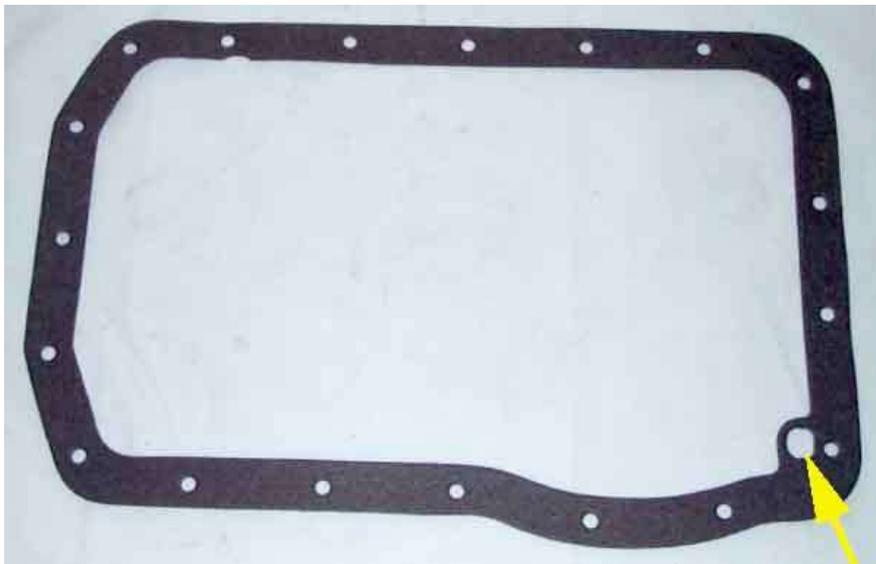
The bolt pattern on the 3-bearing sump is different to that of the two (interchangeable) 5-bearing sumps - the 3-bearing has an extra bolt along the left-hand side which moves the front left-hand one (lower left in these images) round the corner a little way. (Chris at Octarine Services)

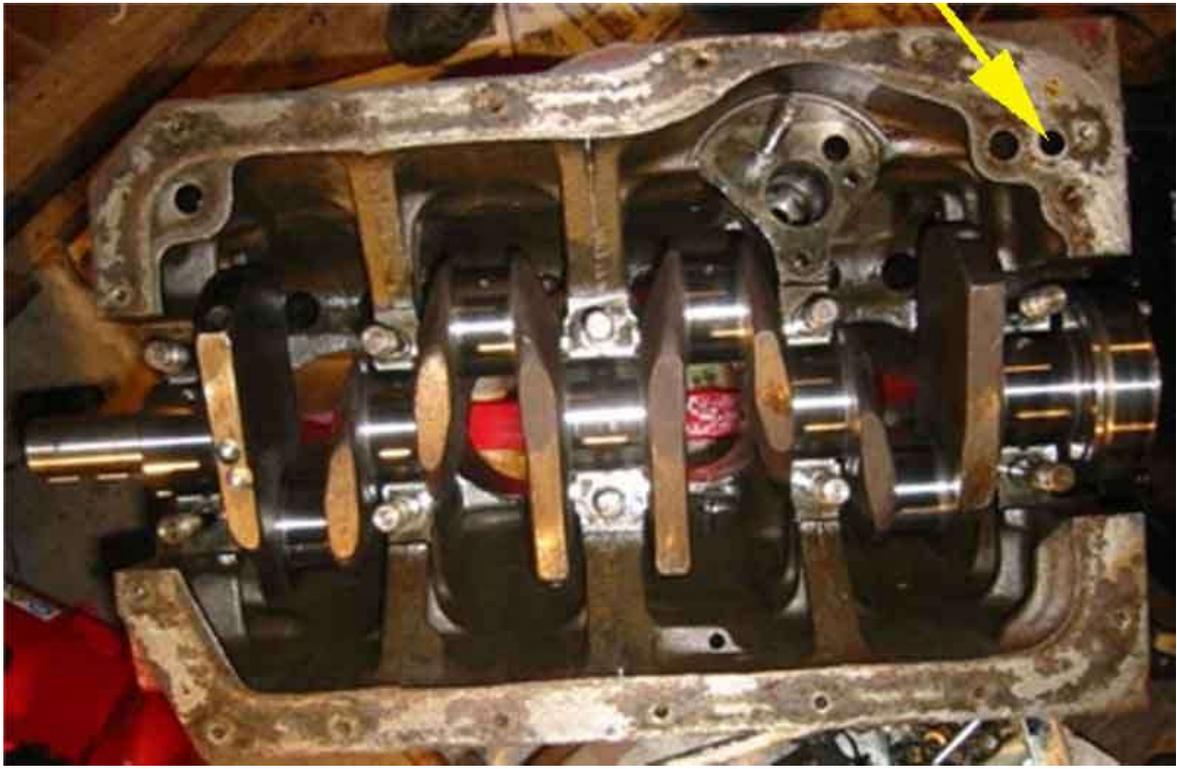
And what is the purpose of the vertical 'tube' in the lower right-hand corner of the 5-bearing sump, with matching hole in the 3-bearing gasket? There is a matching hole in the block right by one of the sump screws, overflow from the relief valve?

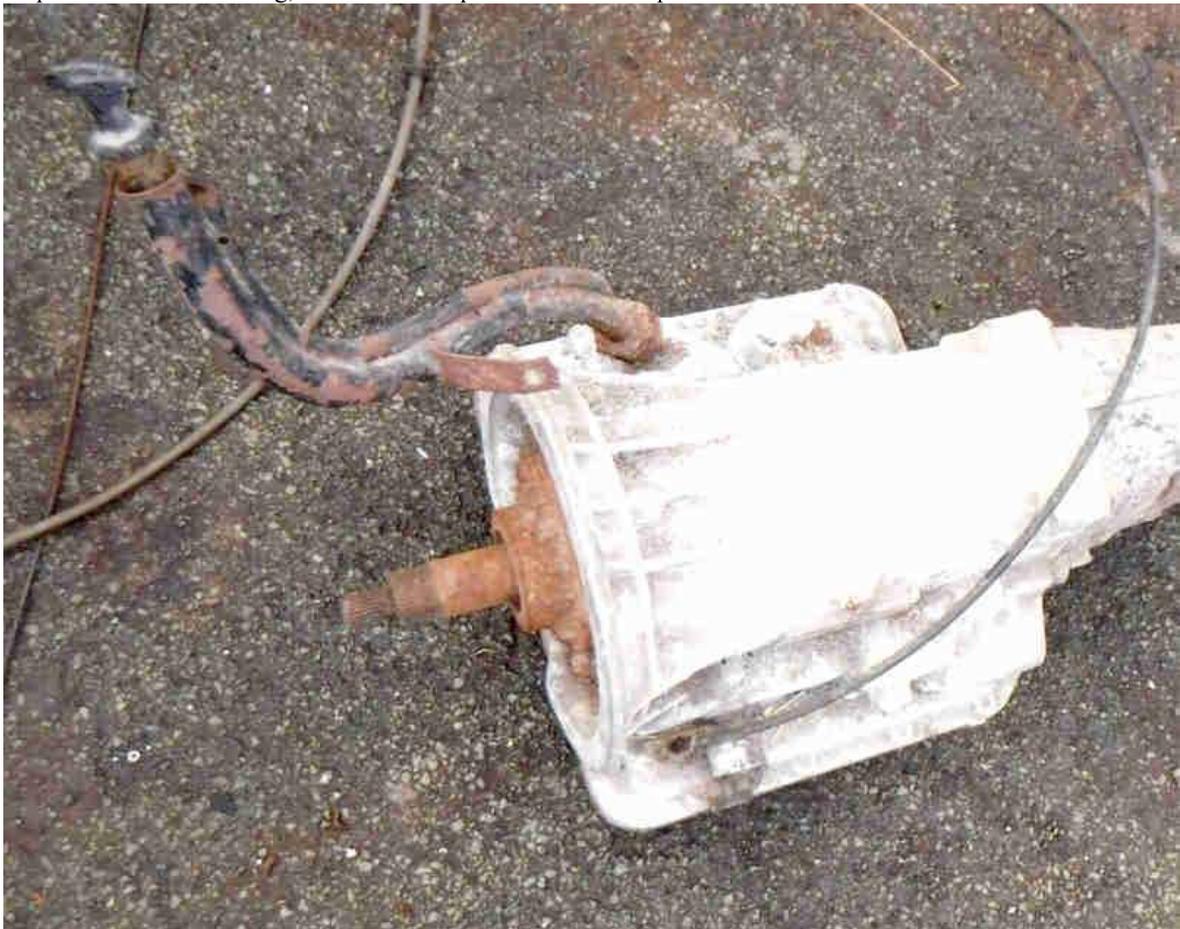
The Auto dipstick and tube are long, the latter has a pronounced 'S' shape:

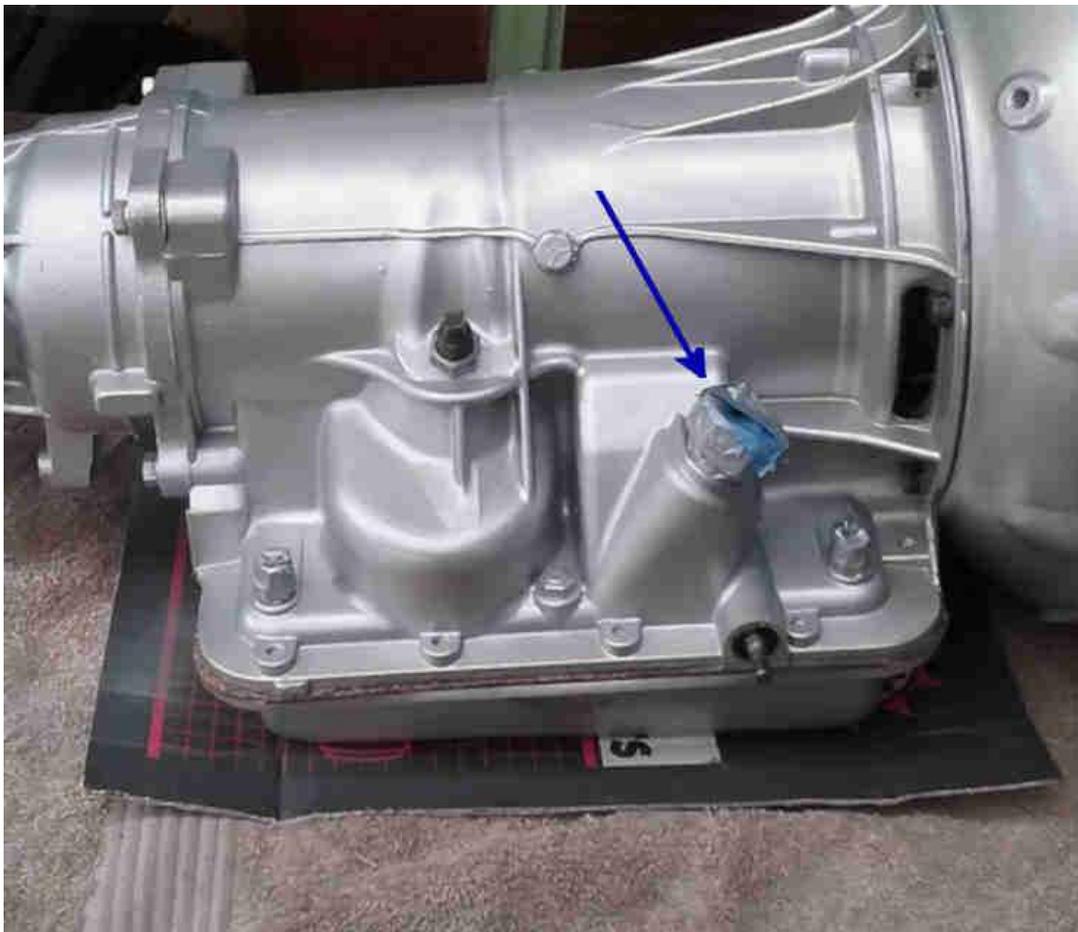
It appears to have a retaining nut that screws onto an adapter in the gearbox, similar to the oil-cooler hoses:

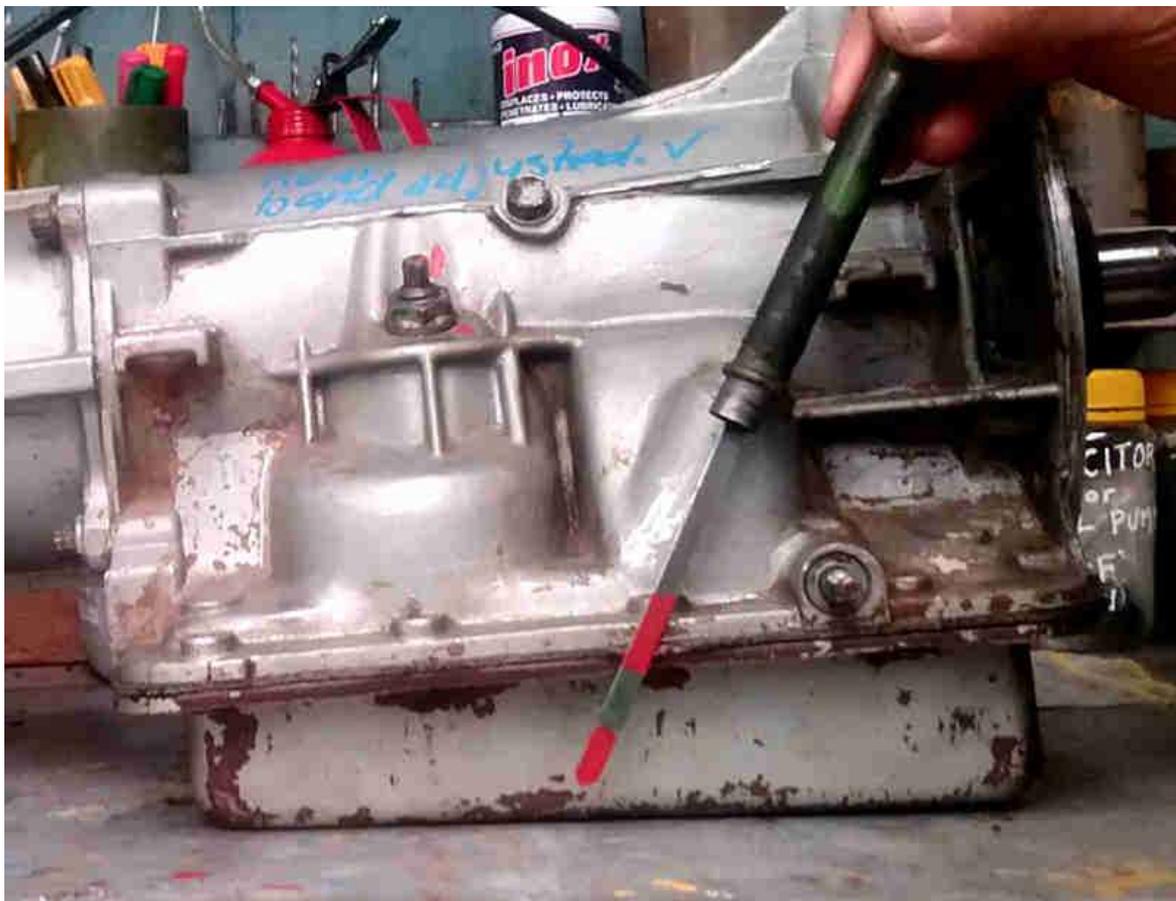
Showing the position of the dipstick in the sump: ([Rover P5 Club](#))

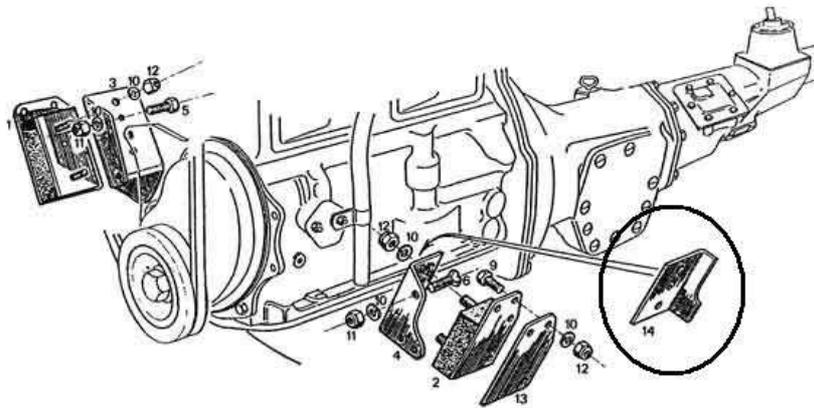
The chrome bumper control bracket (circled). The flange on the back of the bracket will contact the chassis bracket after a small amount of forward movement of the engine, preventing any further movement of the fan towards the radiator. Incidentally the two bolts that attach the mounting bracket to the engine front plate on the left-hand (carb) side, numbered 6 here, are countersunk, and there are corresponding recesses in the bracket itself. Logically this would be to prevent the heads of standard bolts rubbing against the rubber, but the two bolts on the right-hand (alternator) side are hex-head bolts. All four nuts are stiff-nuts, used with spring washers, whereas all the other nuts on the engine mounts are plain. Also note the optional spacer plate (13) which - when fitted - is always on the carb side. *Image from Moss Europe*

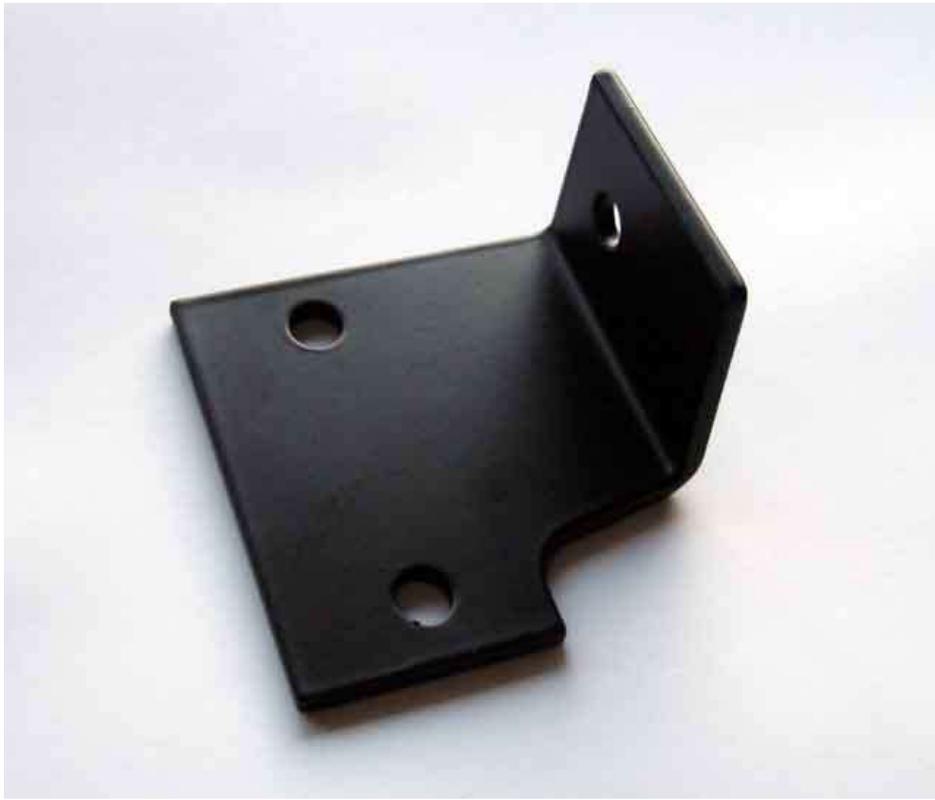
Chrome bumper restraint bracket AHH7890, one of three types listed in the Parts Catalogue this is the only one available and is suitable for all chrome bumper cars. Spot the subtle difference to the drawing above! The two holes on the left go behind the bracket attached to the engine front plate, on the mount studs. The hole in the flange is a bit of a mystery, it can be used to mount the carb vent/overflow pipes P-clip with a nut and bolt (although the correct place for it with HS carbs is to a bracket (NLA) mounted on a stud or under a bolt screwed into the block where the mechanical fuel pump goes on non-MG applications). Interestingly the image above shows the early non-positive vent pipe being clipped to the rear-most of two bolts through the blanking plate for the mechanical pump. I'd wondered why the bracket for the vent/overflow pipes was such a complicated shape, instead of the clip being held by one of the bolts directly as on rubber bumper cars. The bracket was obviously designed to fit round this early breather, which was only used until 1964, after that the clip could have attached directly to that rear bolt!

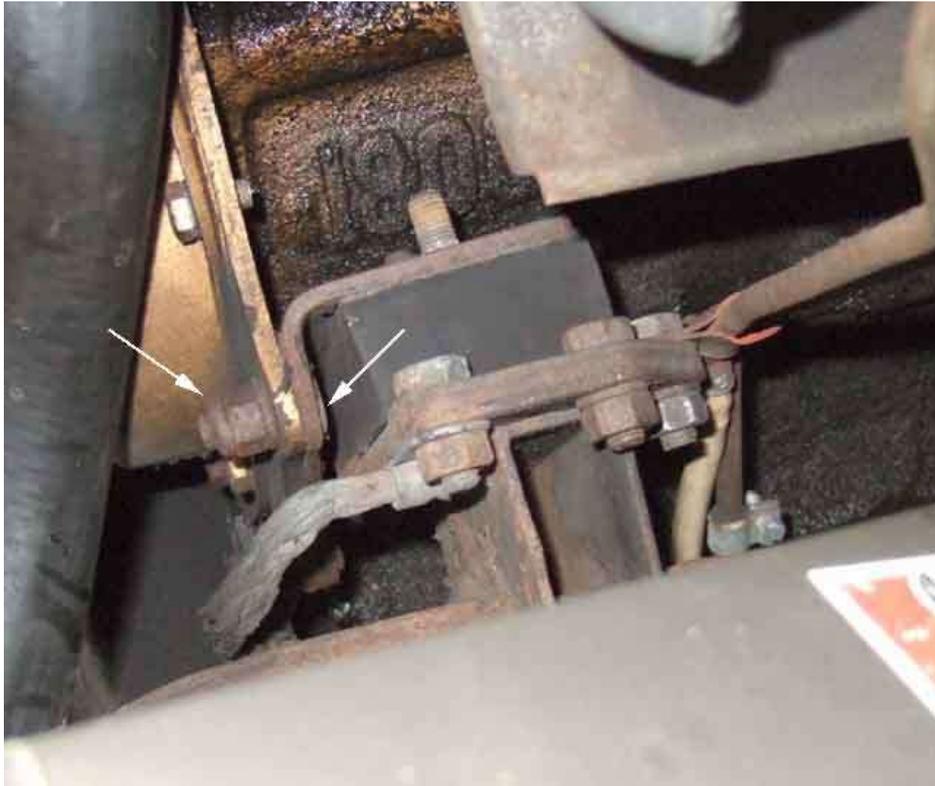
Vent/overflow pipes attached to the chassis side of the mount as I'd seen on a concourse winner (also shows the countersunk bolts and stiff-nuts, arrowed) ...

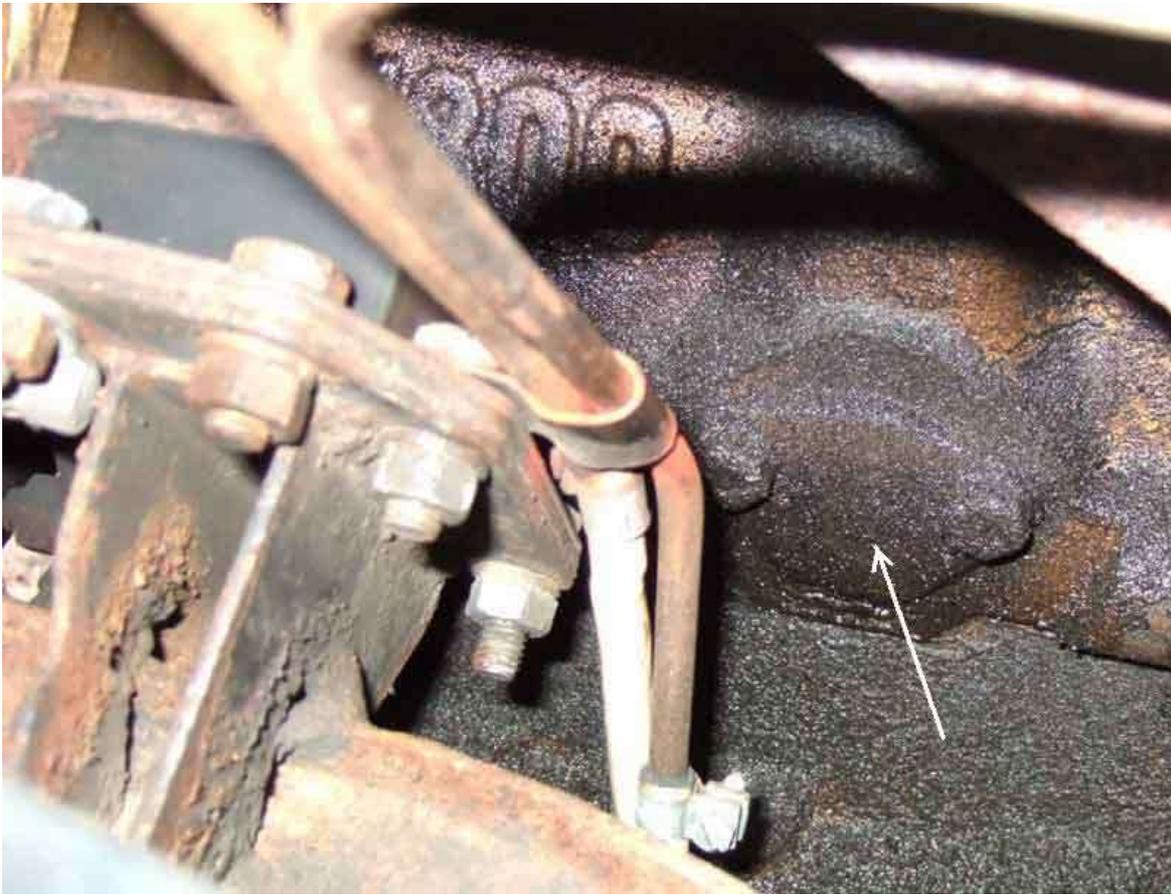
... so moving the pipes on their hoses as the engine rocked. Also shows the mechanical fuel pump blanking plate (arrowed), used for mounting the original crankcase pipe and carb pipe bracket. It's possible that the P-clip for the overflow pipes should go under the head of one of the blanking plate bolts.

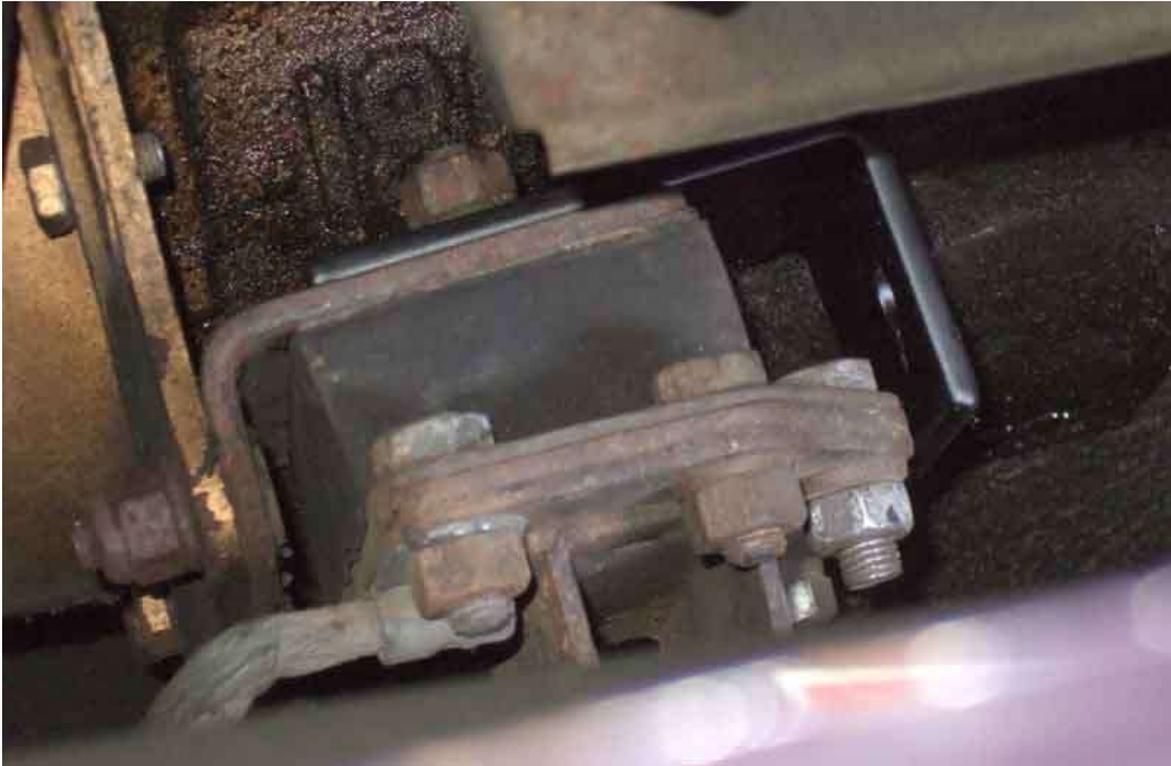
Restraint bracket mounted ...

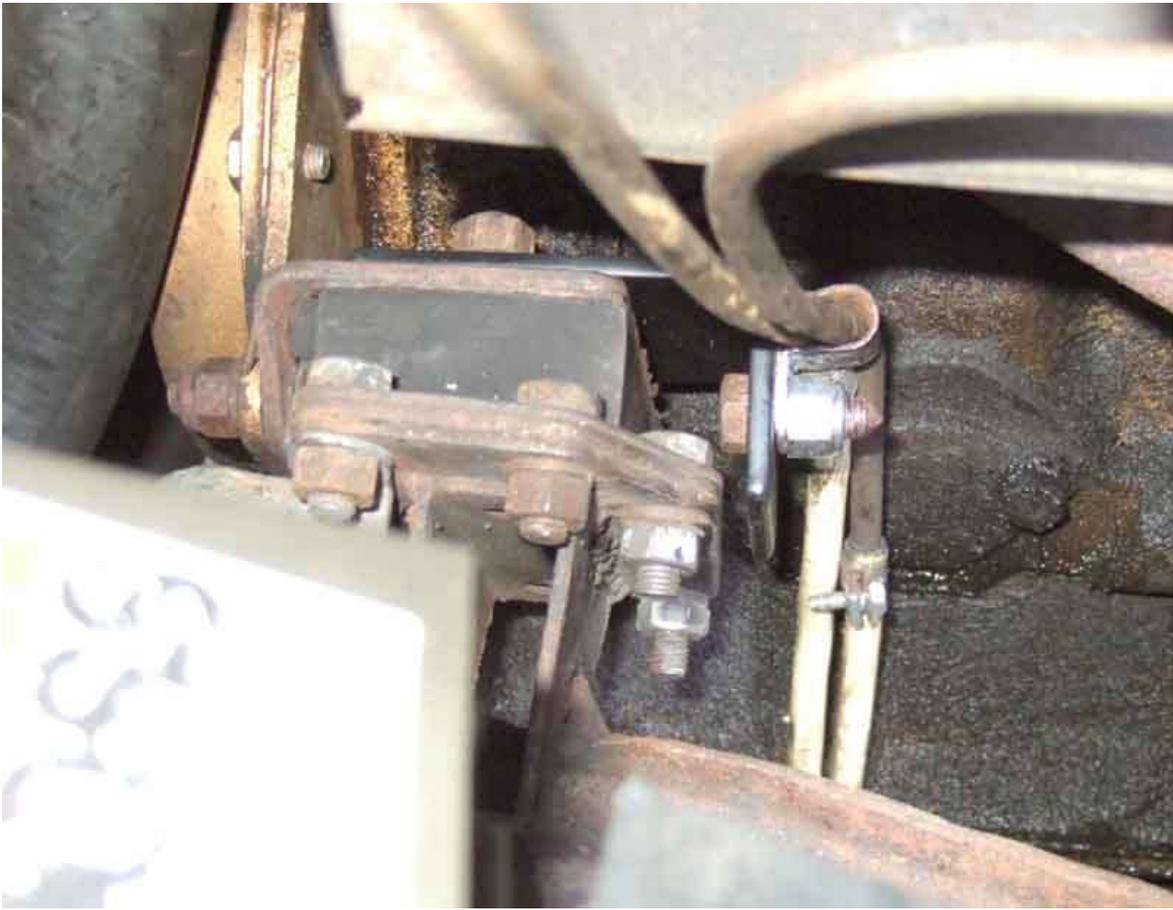
... limiting the forward movement of the engine to about 1/4", with the carb pipes attached to it using the convenient hole so they move with the engine. I opted for this point rather than a pump blanking plate bolt, as they proved pretty tight working from above and I didn't want to risk starting an oil leak (OK it looks oily already but it doesn't drip).

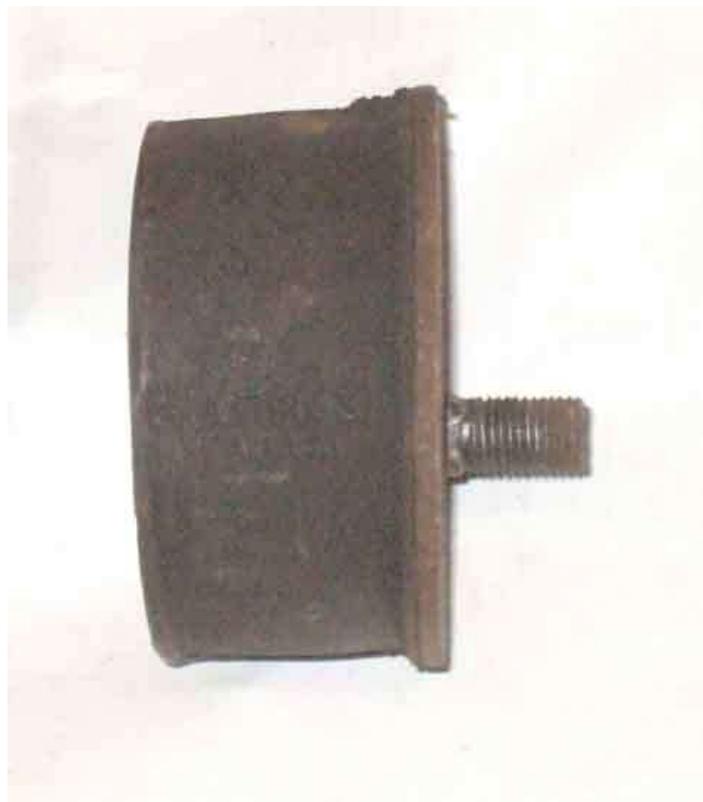
Showing the stud in the lower of the two possible positions when attached to the crankcase bracket. Note this is an old mount where the 'eared' or oval back-plate of the mount has been ripped off.

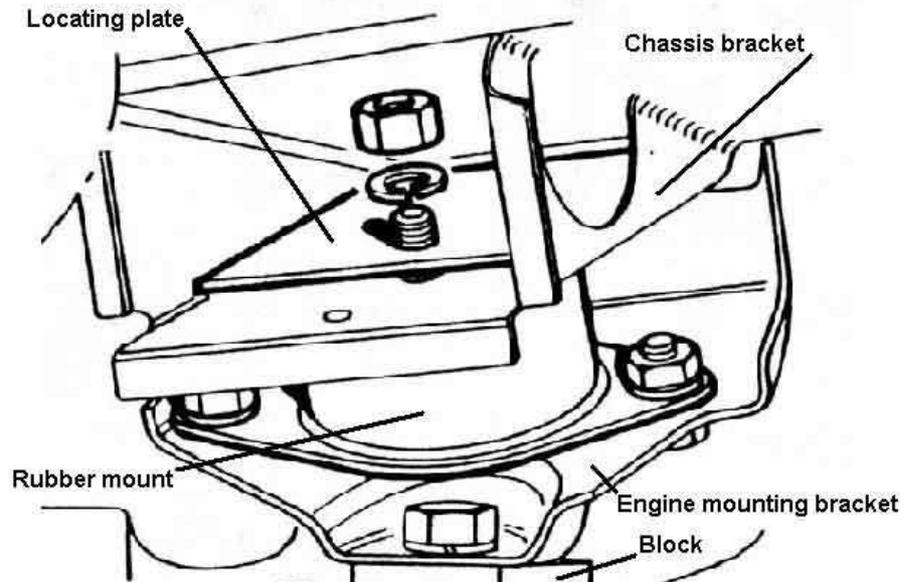
Looking up into the chassis bracket from below. The locating plate is fitted so that the hole is in the lower of the two possible positions, to ensure the mount stud is near the bottom of the chassis bracket slot. (Drawings of a V8 but the same principle must be applied to 4-cylinder cars).

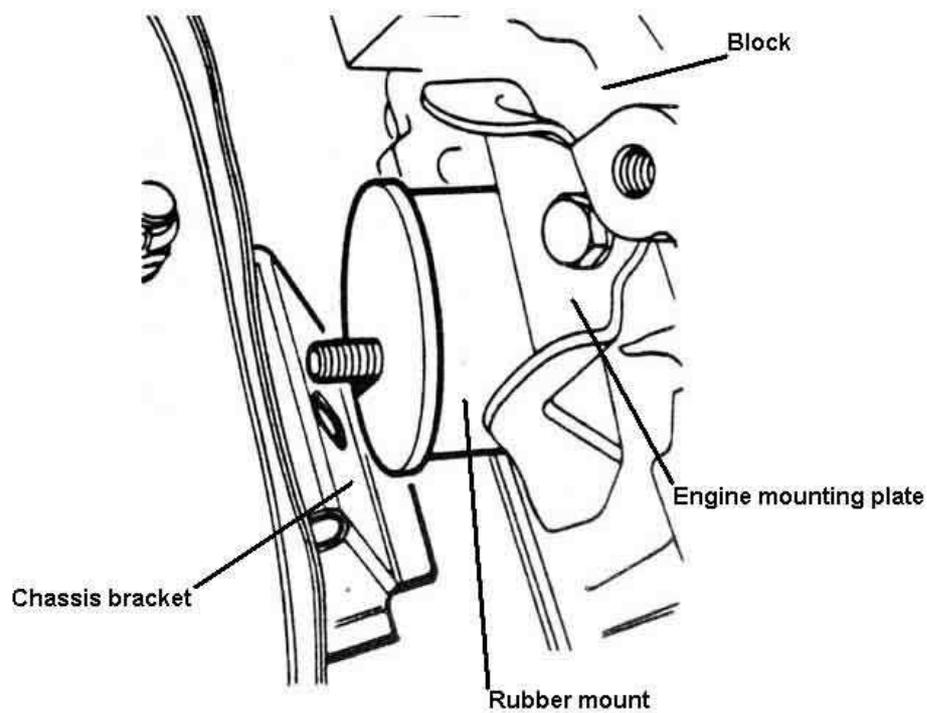
The chassis bracket from above. There must be sufficient spacers to prevent the stud lying in the bottom of the slot, but not so many that the locating plate cannot be fitted the correct way round. It's not indicated in the drawing, but this must be the near-side of a V8. The visible cross-member nut is slightly forwards of the chassis bracket, and the mounting plate is installed with its flat side towards the rear, and its angled side towards the front.

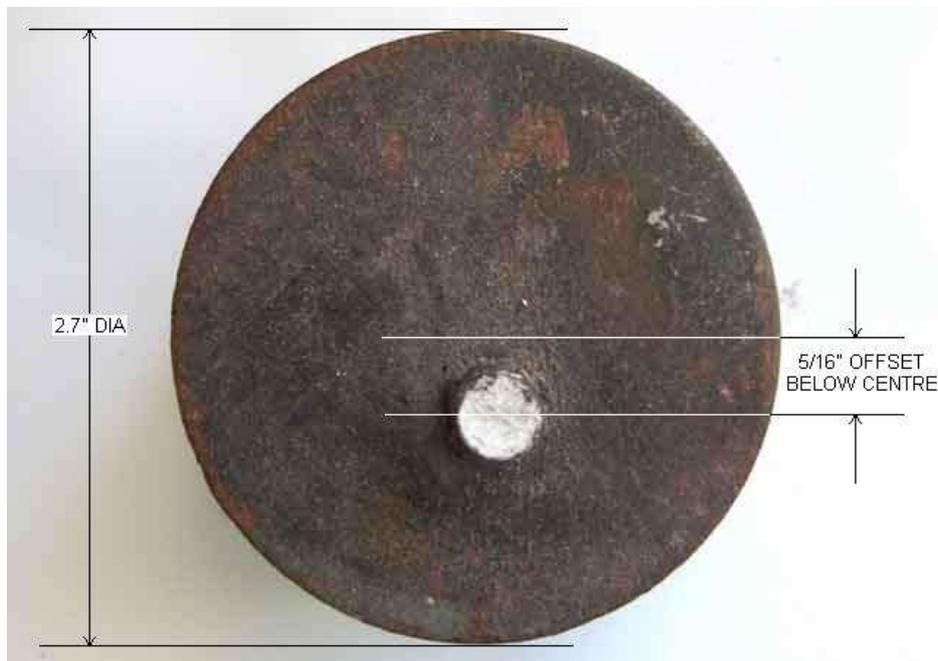
Dimensions for fabricating a spacer (applicable to V8 right-hand side)

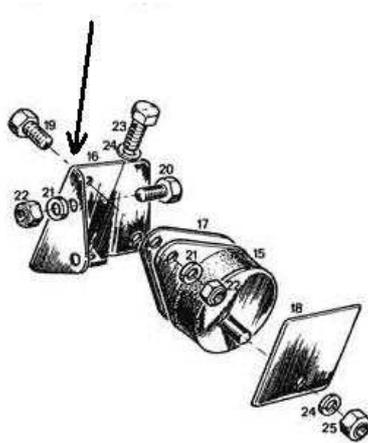
Showing the common point of fracture on left-hand 4-cylinder rubber bumper brackets (arrowed), also the correct orientation of the rubber mount 15 and locating plate 18: ([Moss Europe](#))

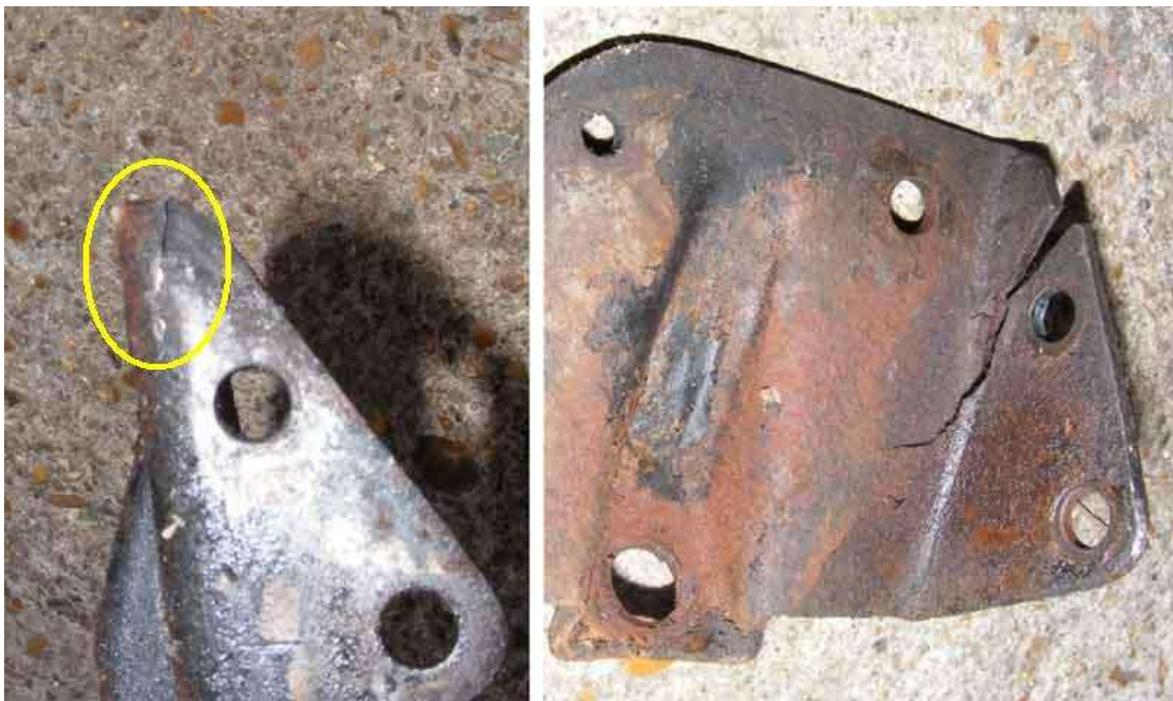
However Crispin Allen found both of his cracked, with the driver's side (on the right here) much worse than the passengers:

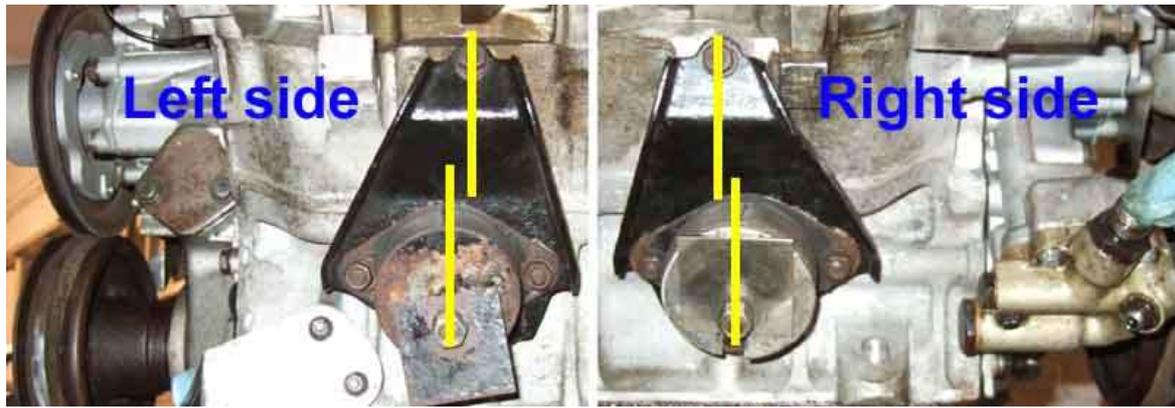
V8 mount bracket orientation: The upper bolt securing the bracket to the block must be behind the stud on the mount that goes into the chassis bracket, putting the engine in the rear-most of the two possible positions:

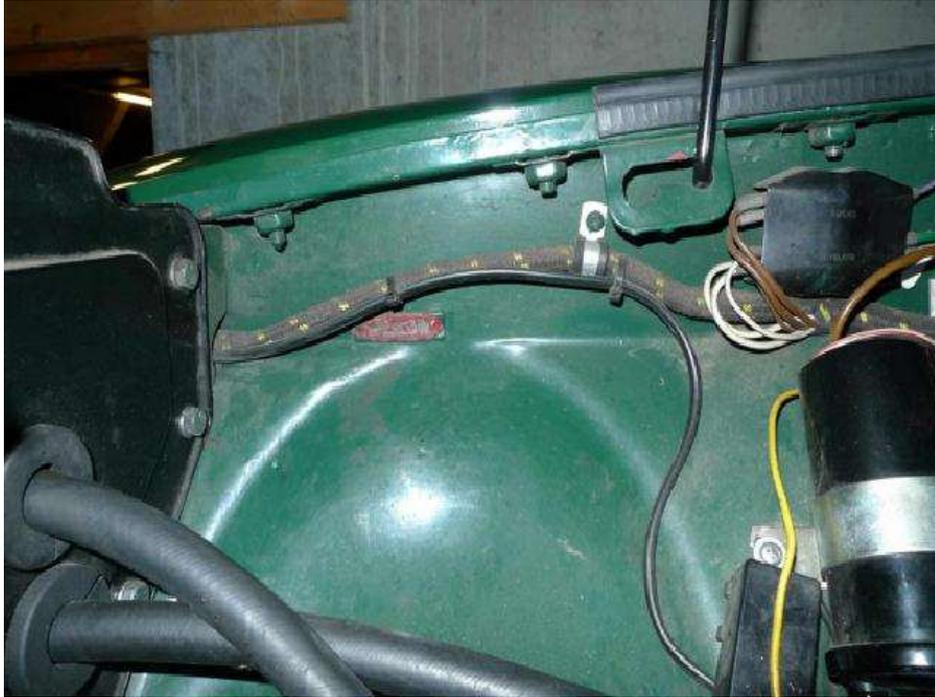
Feb 1963 - unprefix number by the dynamo (Tore)

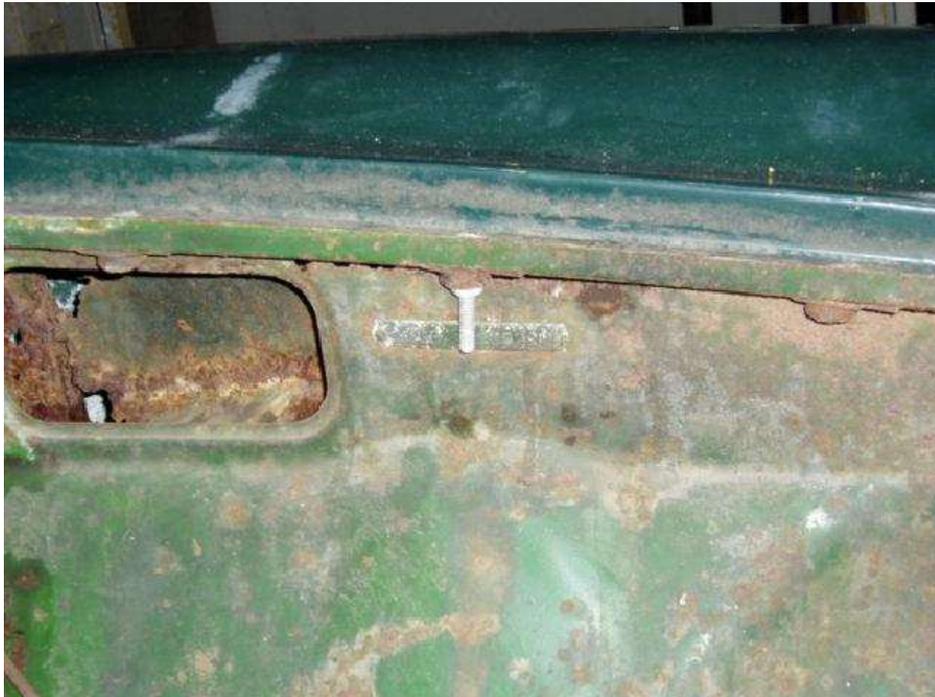
1963 - MGB number by the carbs (Ste Brown)
