Crankcase Breathing

Cylinder Block

Engine Numbers

Dating the Block

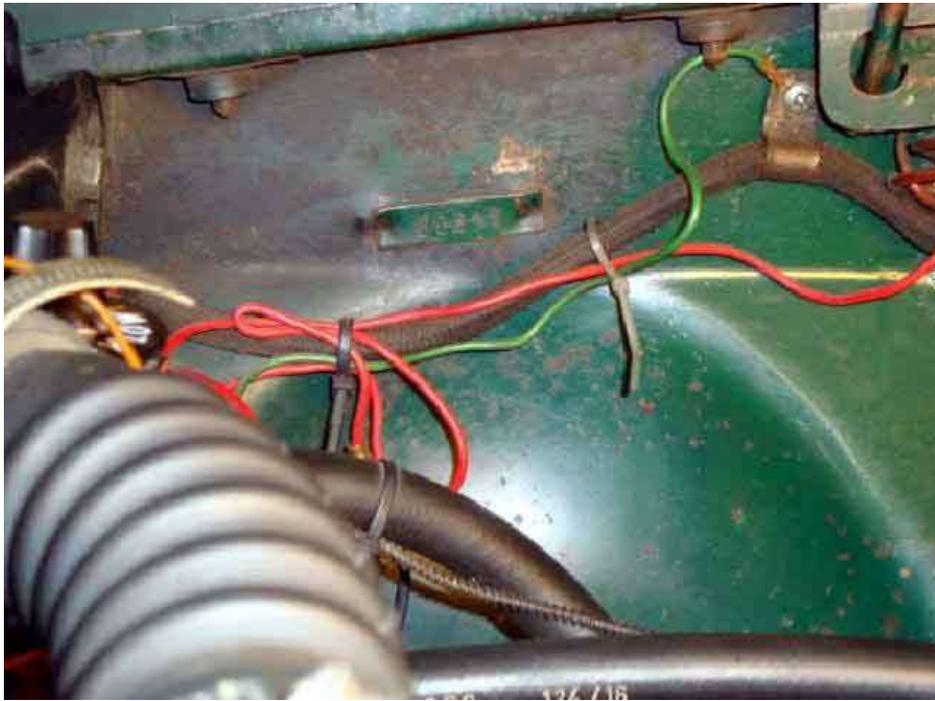
May 1965 - unprefix number by the dynamo ...

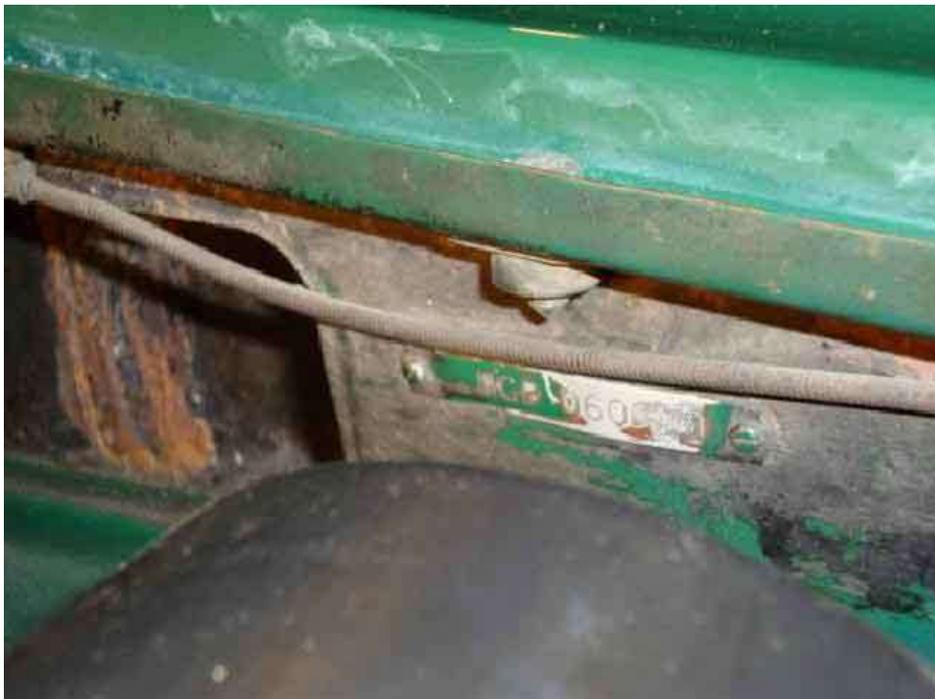
... and prefixed by the carbs (George Wilder)

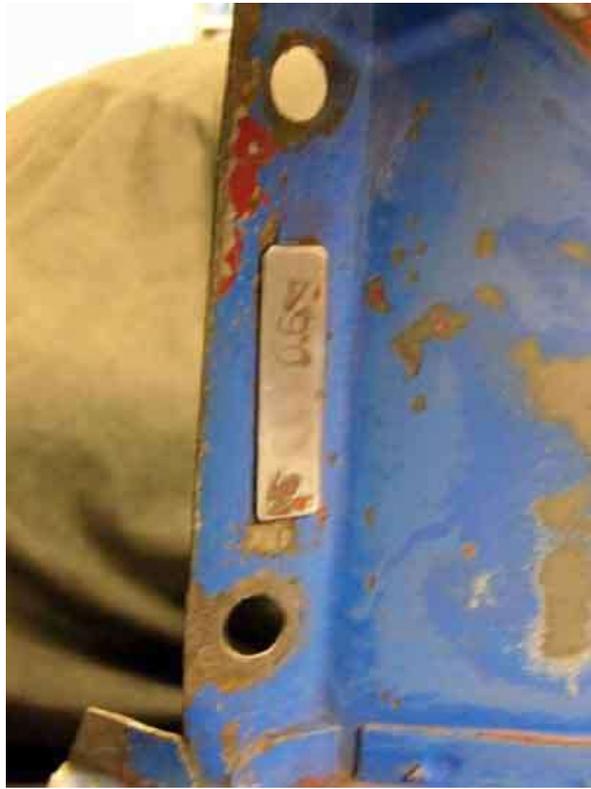
About October 1966 - unprefix number, very front edge of the inner wing on the dynamo side (Colin Parkinson) ...

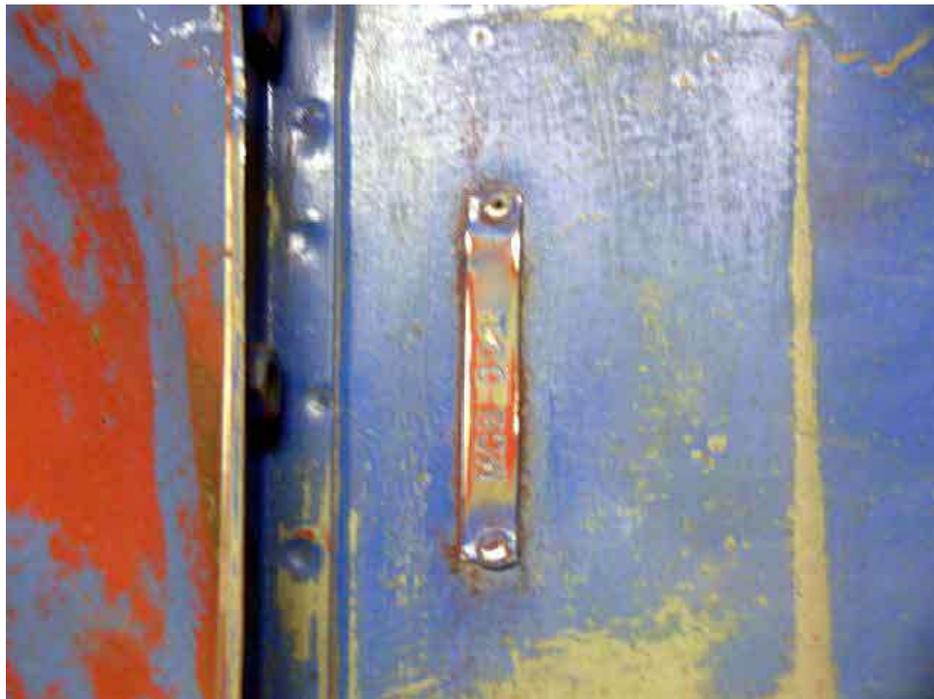
... and the MGB number, just in front of the radiator, carb side

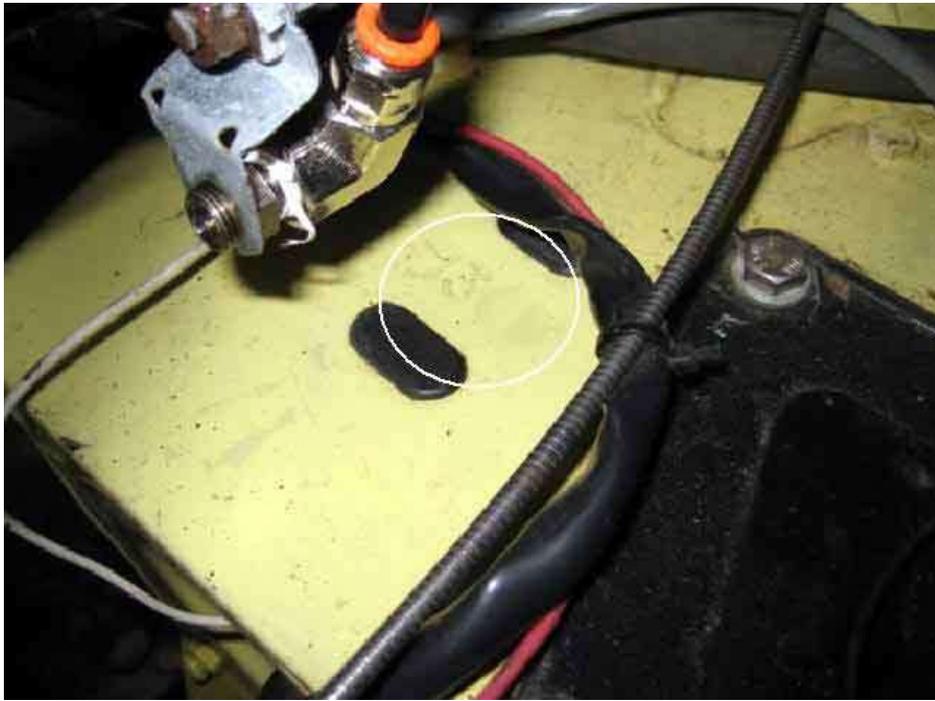
March 1967 - unprefix number, very front edge of the inner wing on the dynamo side (Dave O'Neill)

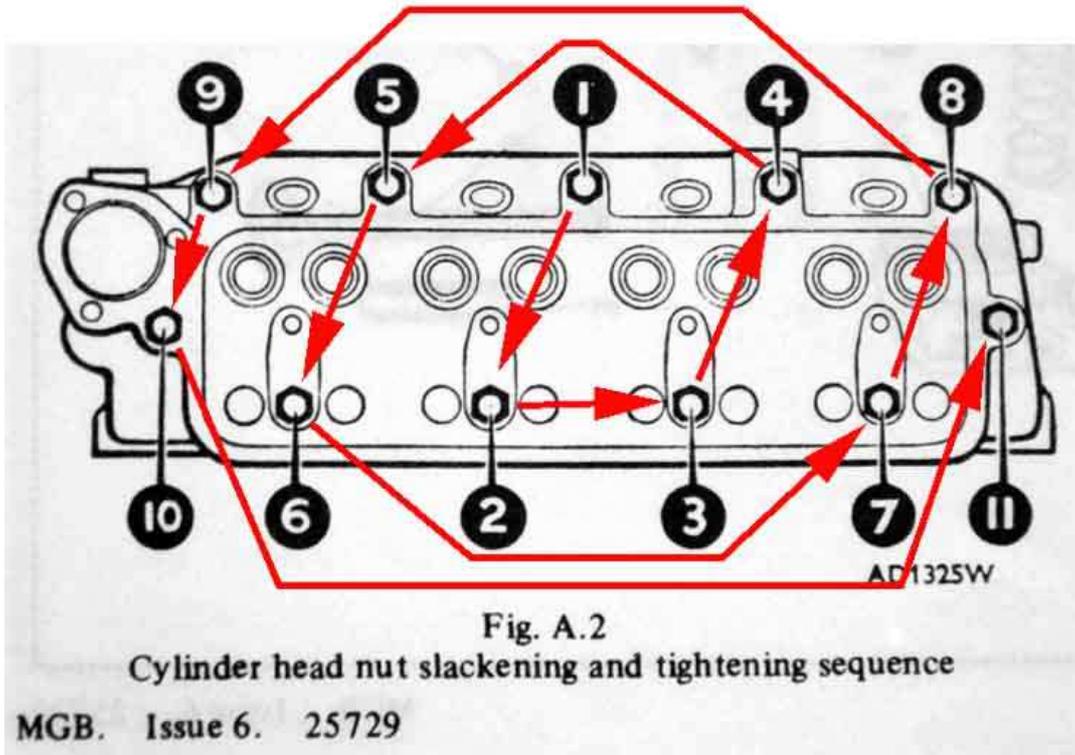
The 'anti-clockwise spiral' sequence of progressively loosening and tightening the nuts:

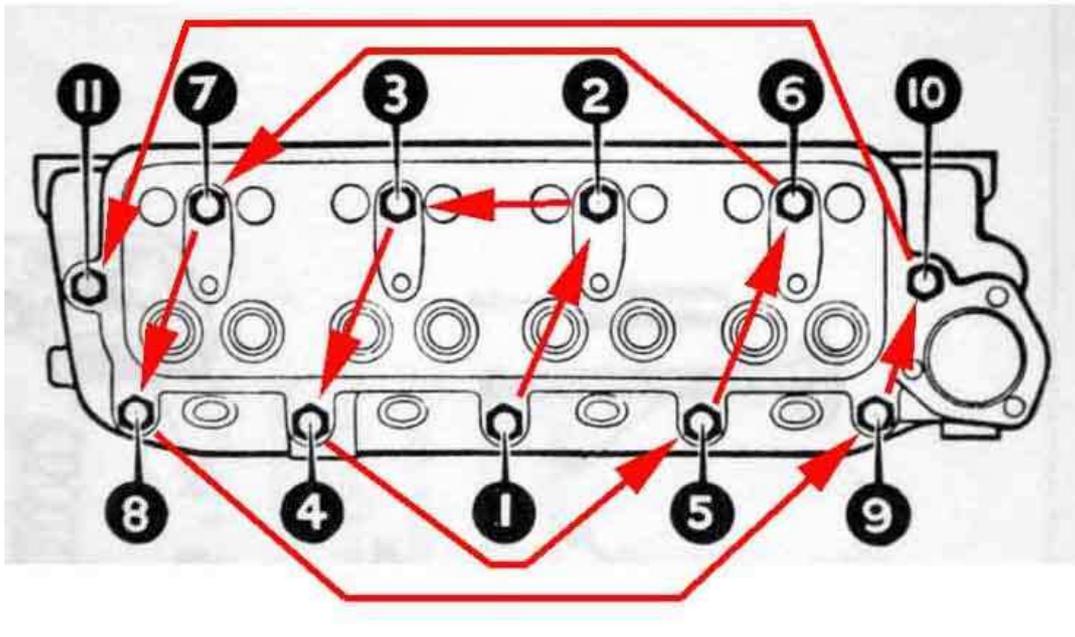
Note that in the drawing above the operator is standing at the carb-side of the engine, whereas in my case I have more space on the alternator side so choose to do top-work from there, in which case this may help:

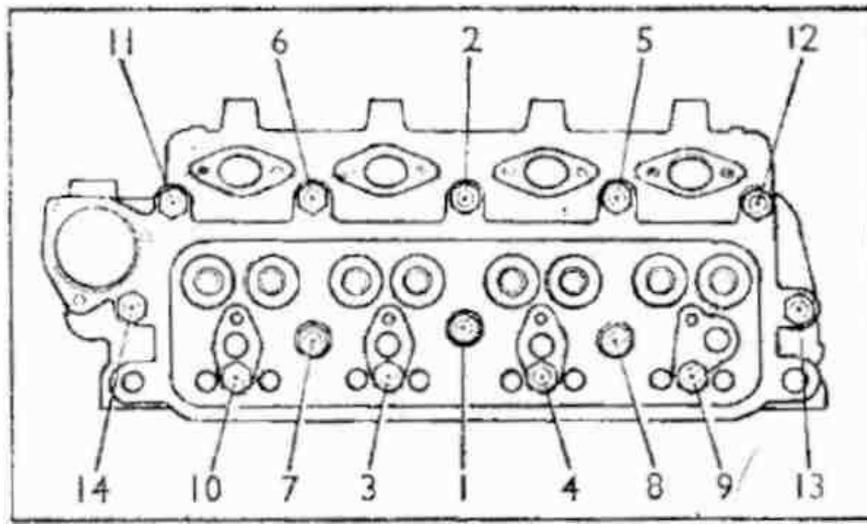
Three extra nuts 1, 7 and 8 (and modified sequence) under the the rocker shaft on a 1500cc B-series Diesel: (Dave O'Neil)

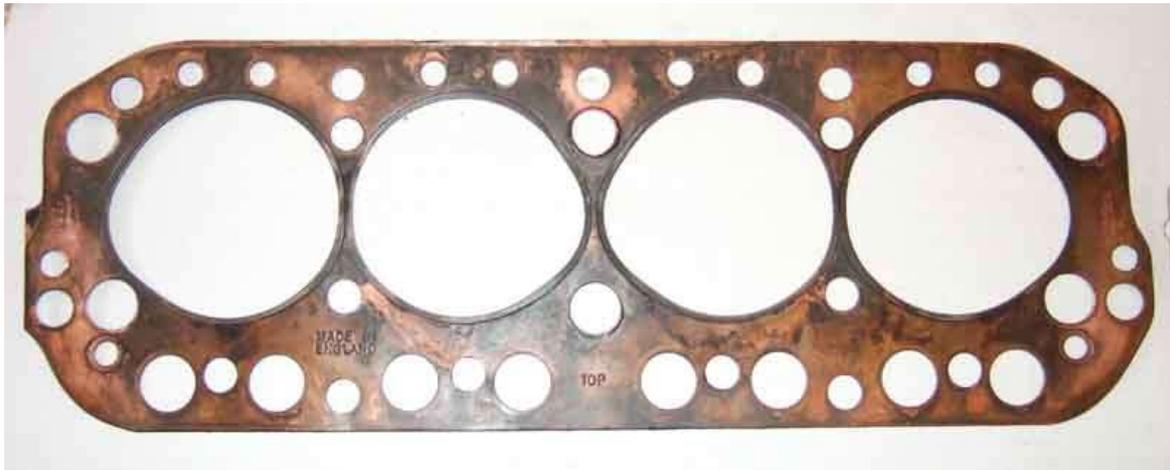
An original copper gasket copper side ...

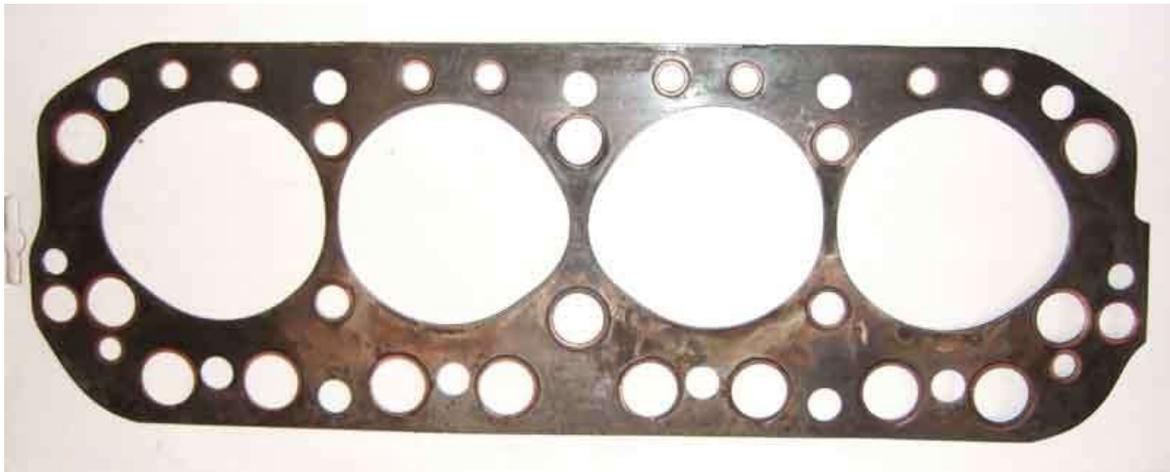
... and 'steel' side:

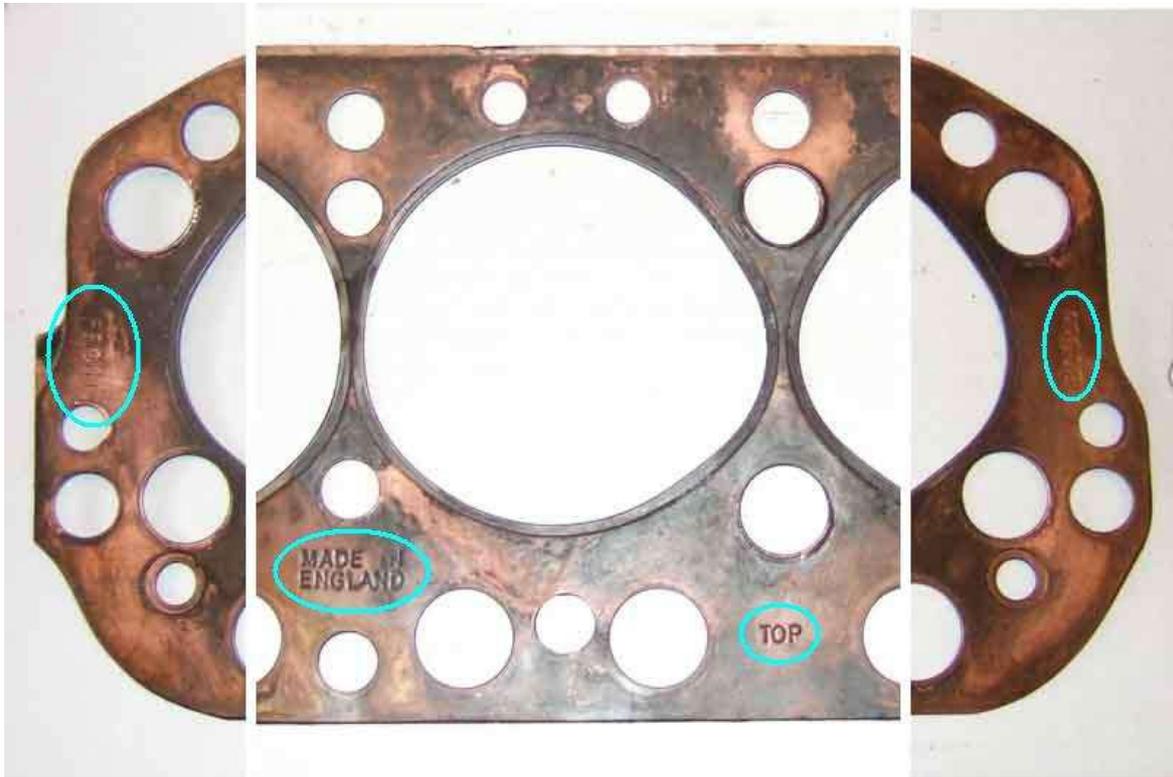
'Front' (left), 'MADE IN ENGLAND' and 'TOP' (centre) and '1800cc' (right) stampings very clear:

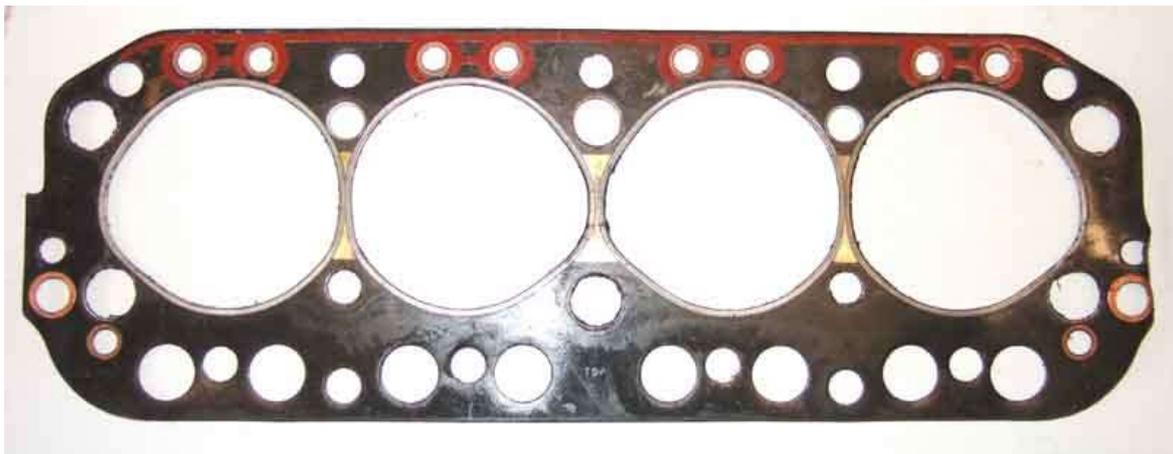
Payen top ...

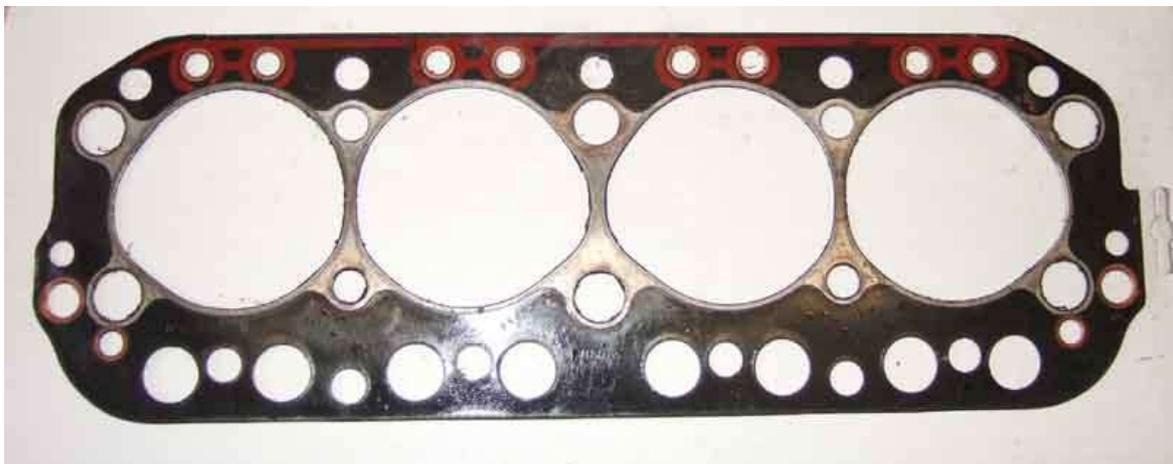
... and bottom - almost identical except for 'gold' wedges between each pair of cylinders on the top and larger 'silver areas underneath:

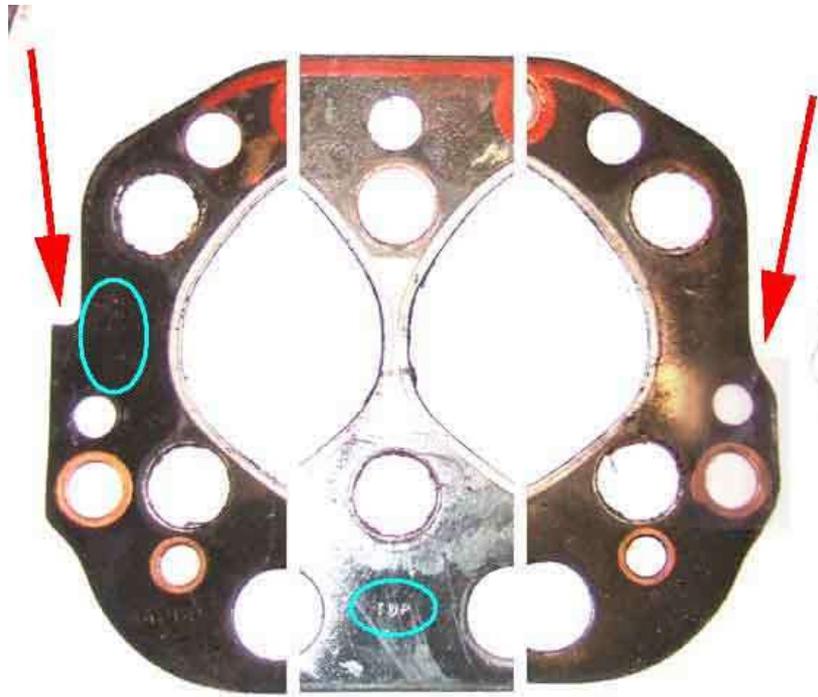
'FRONT' and 'TOP' markings smaller and less distinct and you have to look closely and carefully. However it has the same 'stepped' front edge and curved rear edge (arrowed) as the copper:

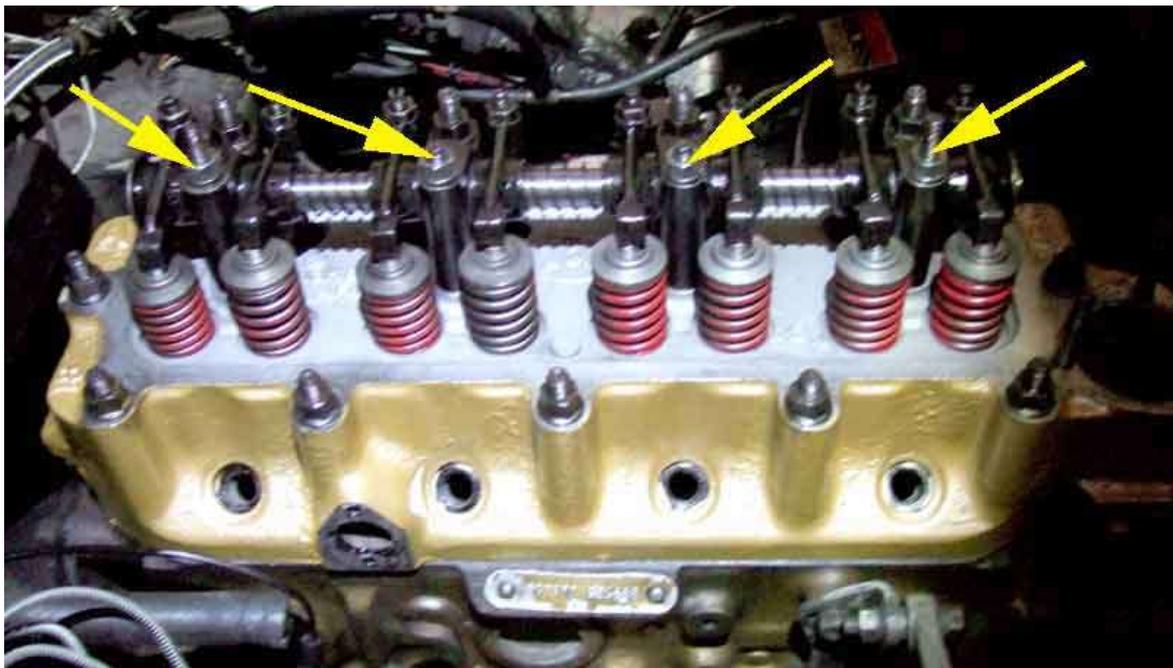
The indicated rocker pedestal nuts can be removed if required without affecting the cylinder head or gasket:

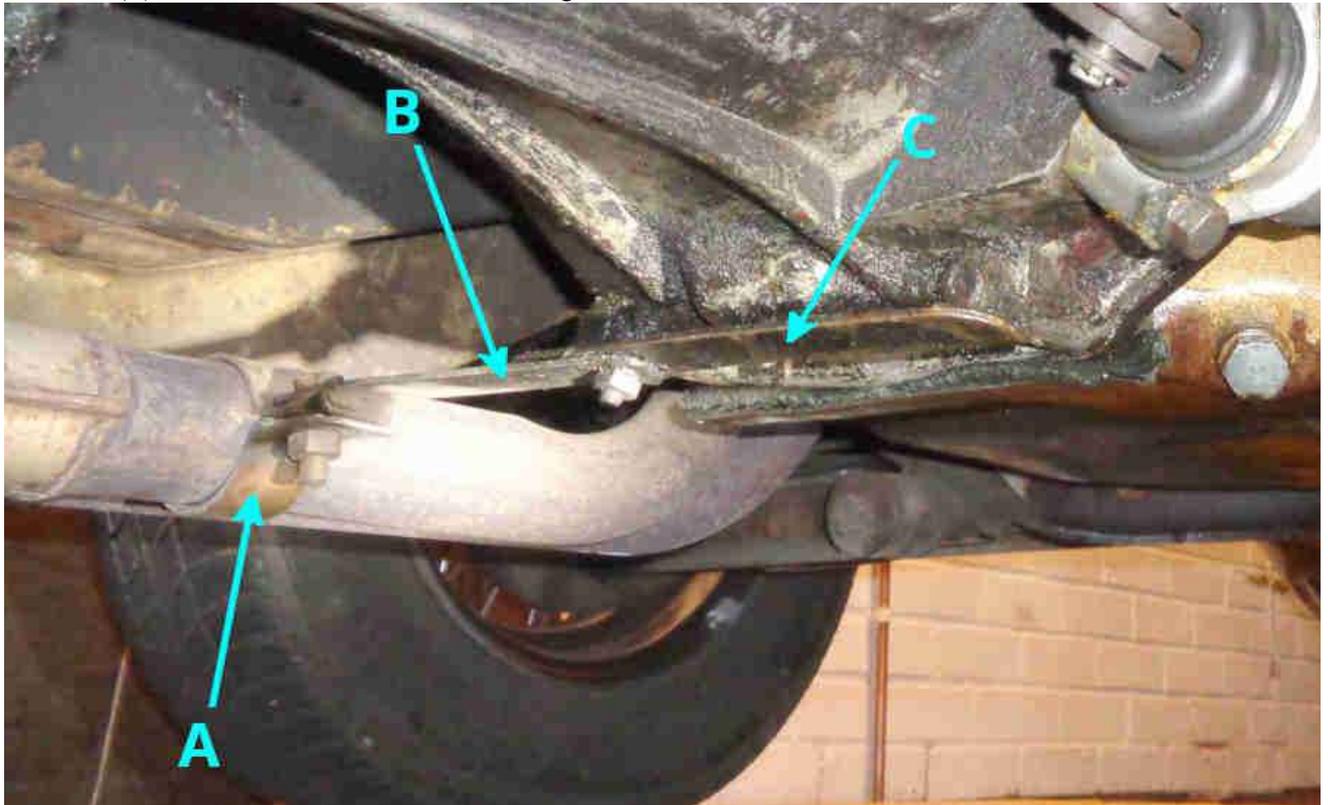
4-cylinder cars only - pipe clip GEX7074 (A) on the in-board down pipe attached to strap GEX7194 (B) bolted to bracket GEX7189 (C) mounted on the two lower bell-housing bolts:

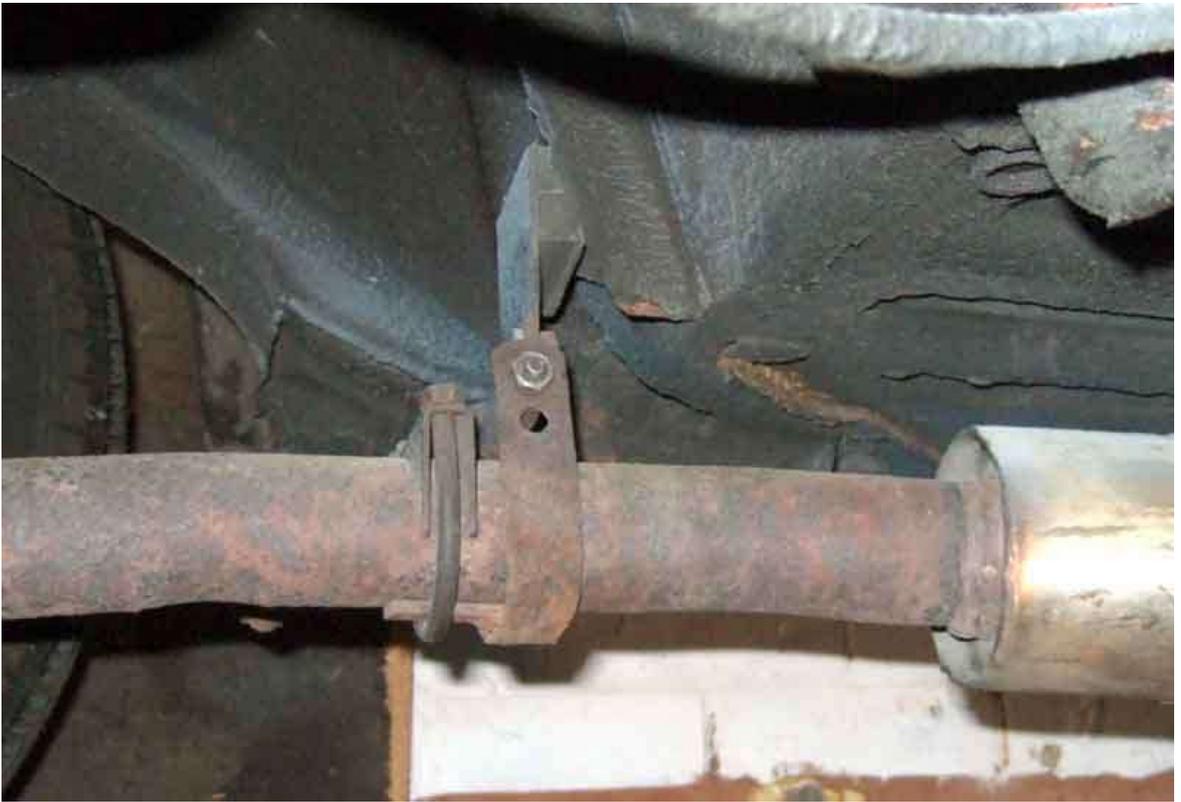
Multi-part assembly comprising the parts listed below. I've also welded a tab to the U-strap on both cars so I can clamp it and the pipe together, without that they fidgeted and squeaked. Some systems have the U-strap welded to the pipe which is annoying if just that part fails:

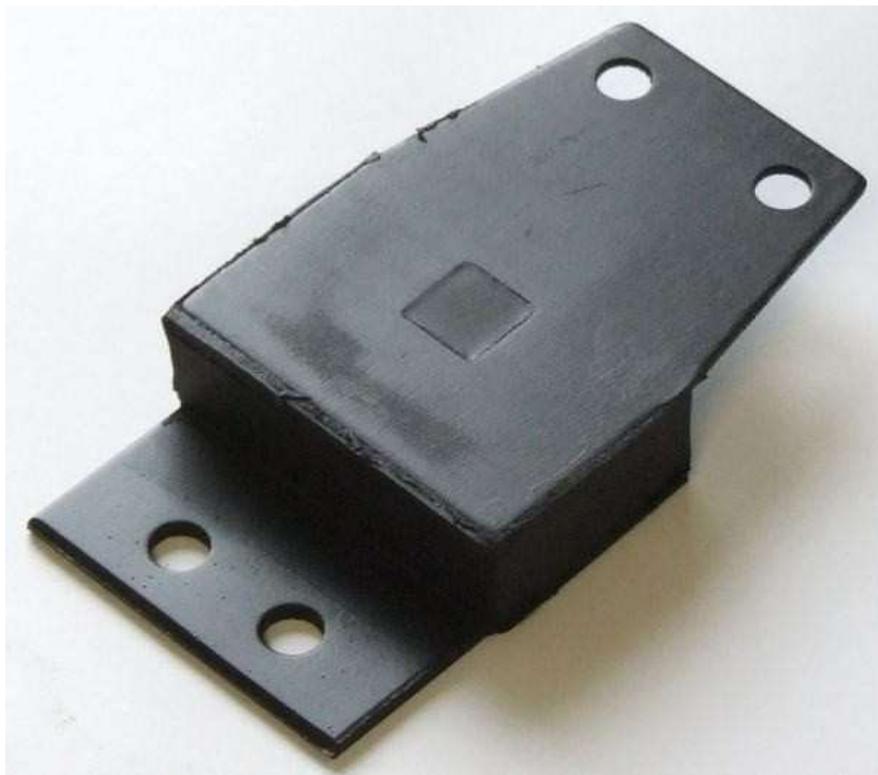
Main hanger GEX7204: (*Motaclan/Leacy*)

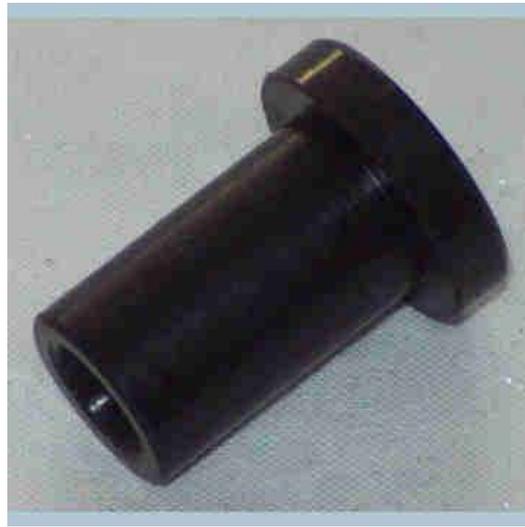
Heat-proof fibre bushes GEX7182 (two needed): (*Motaclan/Leacy*)

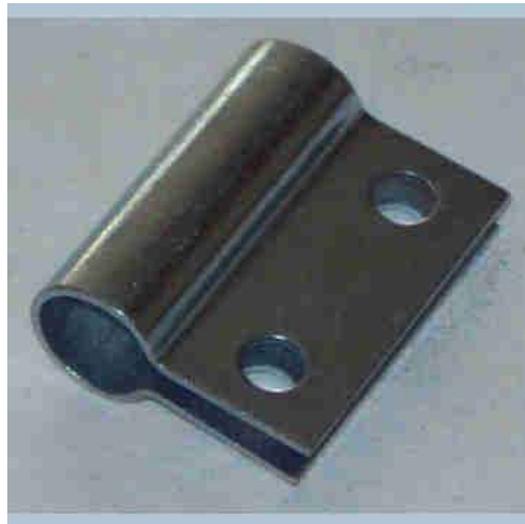
Housing for bushes GEX7183: (*Motaclan/Leacy*)

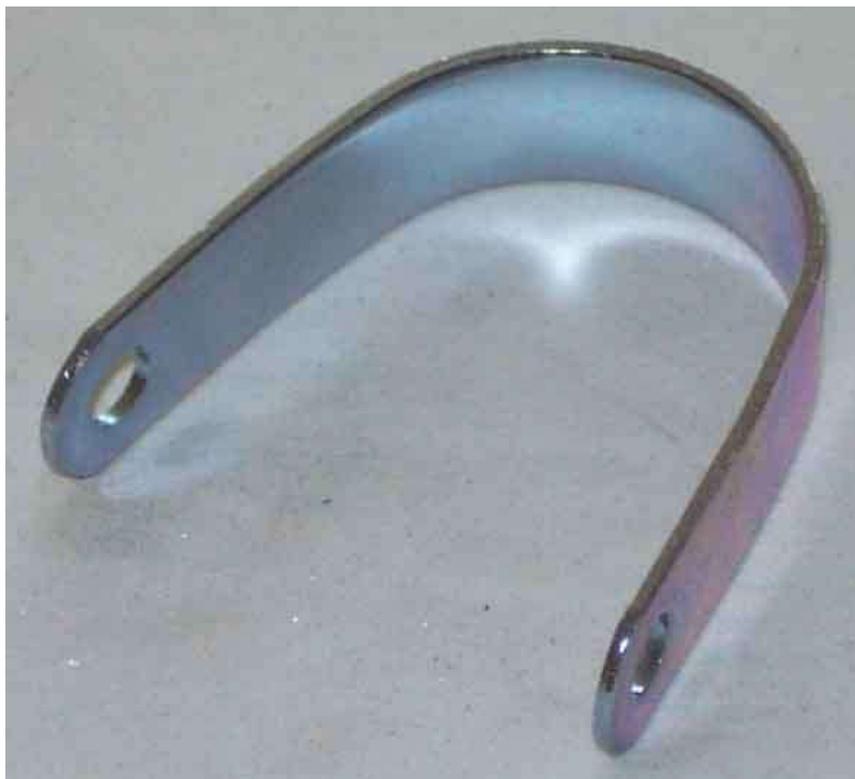
U-strap GEX7191, note this does not have the tab in the photo above to allow the pipe to be clamped to it and prevent rattles ... (*Motaclan/Leacy*)

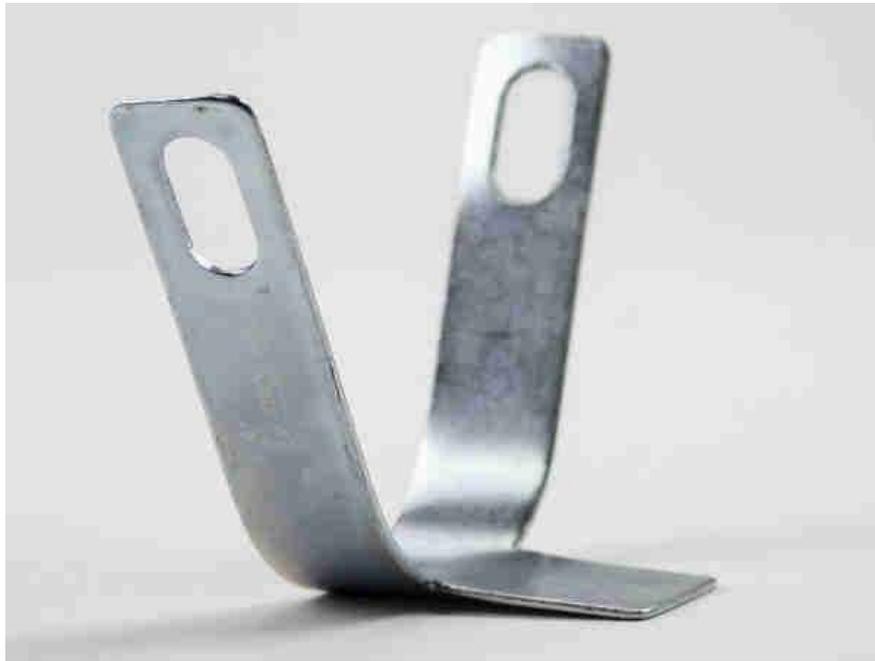
... unlike this one from [the MGOC](#) which does, although the metal looks to be quite a bit thinner:

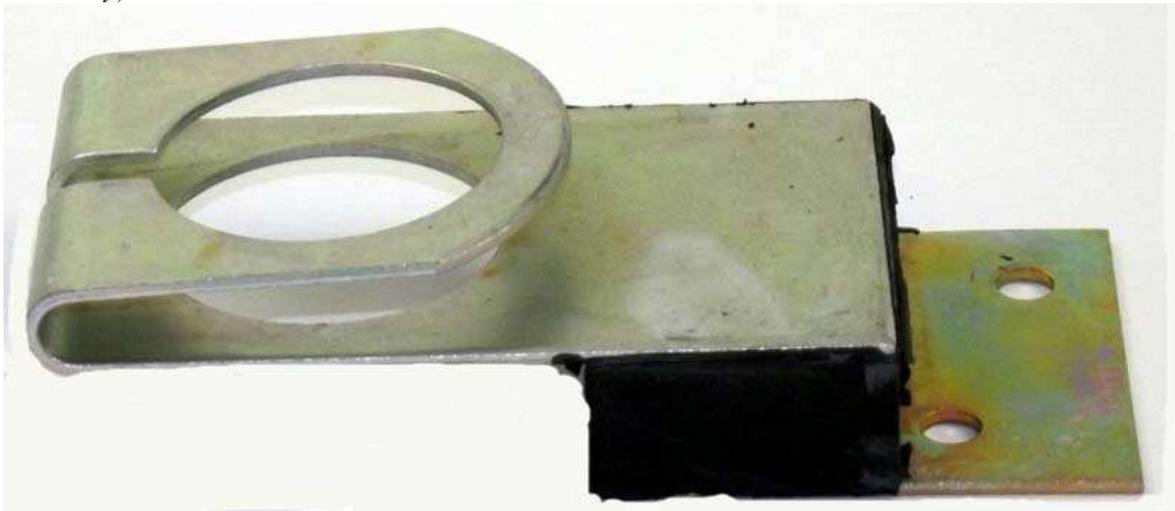
The early one-piece clamp (GEX 7275) used up to chassis number 167815 in Feb 69 (suppliers dates vary). This uses a metal-rubber-metal bonded sandwich very similar to the middle mount. However if the bonding on either rear or middle mount should fail a lot more stress is placed on the other bonded hanger. If that fails as well the exhaust will almost certainly drag on the ground. I've read that the rear hanger has two set-screws going through the sandwich, but not in any photos I have seen, although some do have rectangular holes in the metal parts filled with rubber or bonding: (*Motaclan/Leacy*).

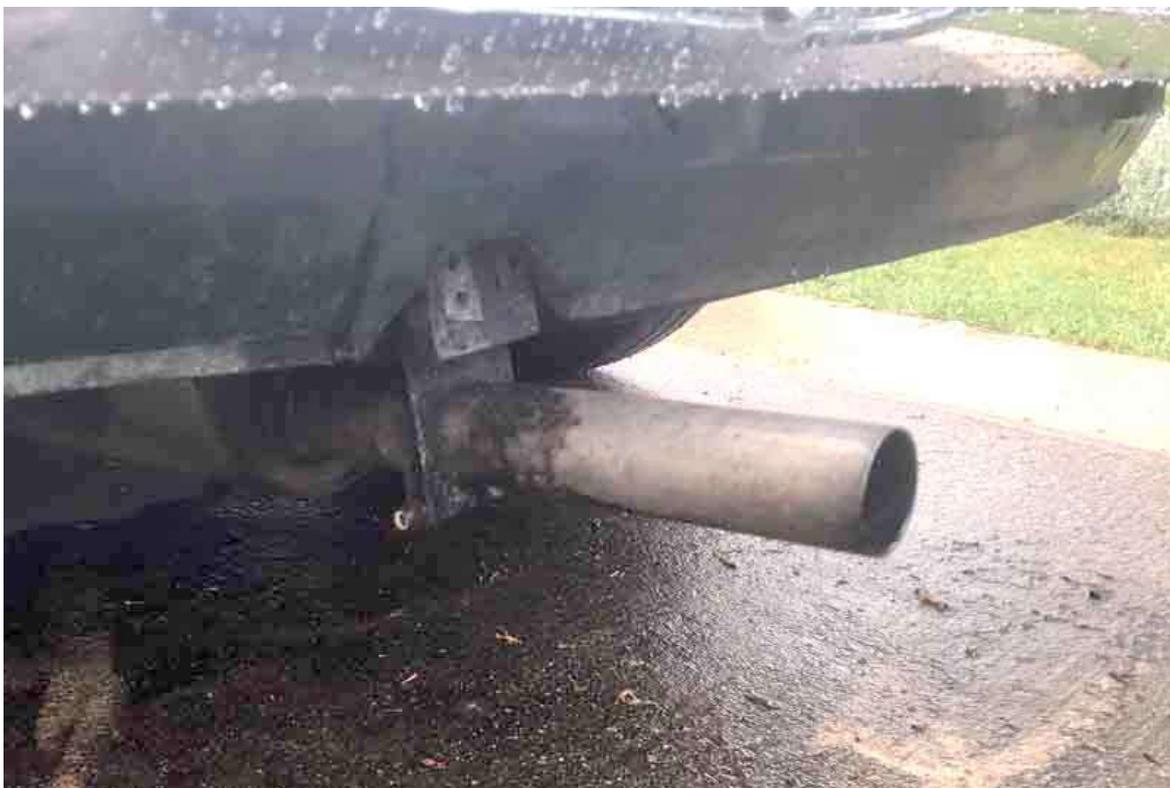
The earlier type from Ben Colomb:

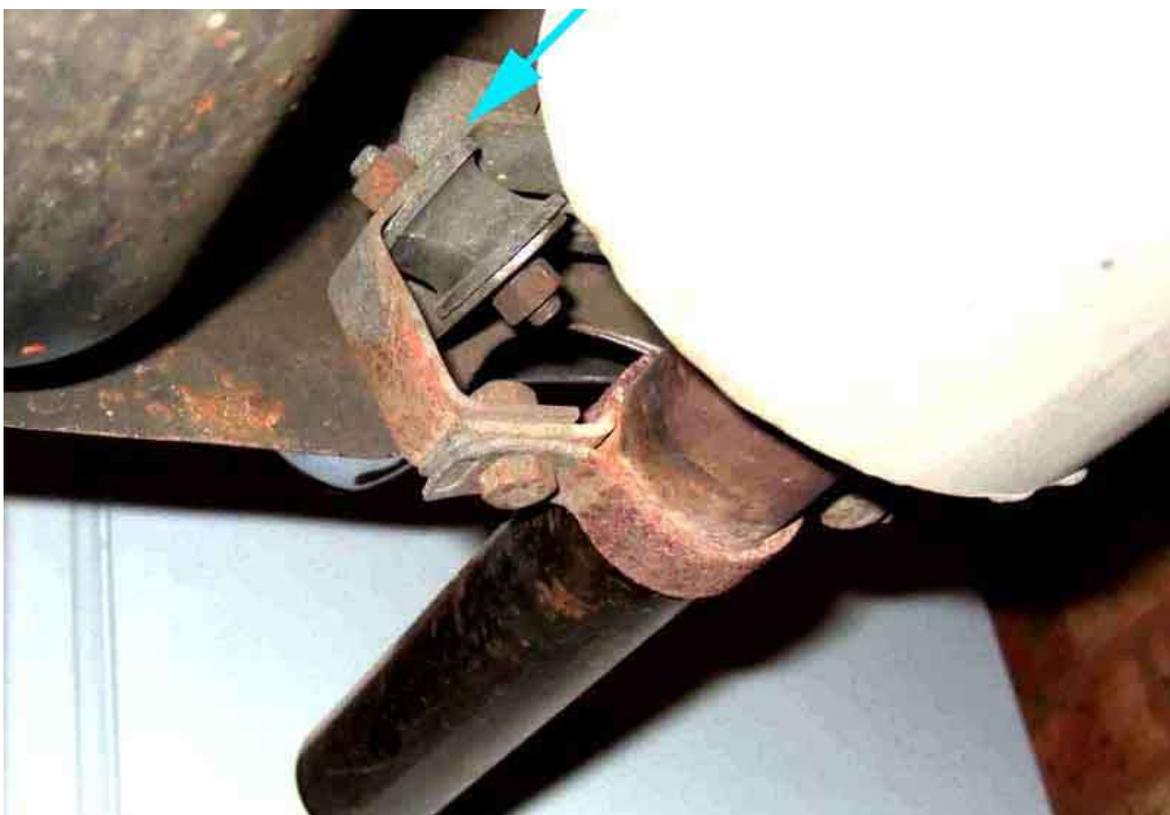
Later six-piece 'saddle-clamp' system (GEX 7201 CB/GEX 7442 RB, 7202, 2-off 7252, 2-off 7251). This is 'fail-safe' in that if both the bonded 'cotton reel' mounts should fail the exhaust is still supported in the same position, although it is likely to move around a little more in use. I've had both fail on the V8 and didn't know anything about it until I was working in that area and noticed it. The Parts Catalogue shows GEX7201 with no chassis number information just "use prior to GEX7442" which normally means the part was changed rather than there being different versions for CB and RB. However both types are available and suppliers do differentiate between CB and RB, RB being longer:

Several suppliers show heat insulation washers AHC442 for the saddle-clamp type, although not in all the kits. When they are listed by themselves the quantity is shown as 4, but logically only two are needed - between the rubber mount and saddle-bracket bolted to the clips around the tail-pipe itself (arrowed above): ([Rimmers ... other colours are available ...](#))

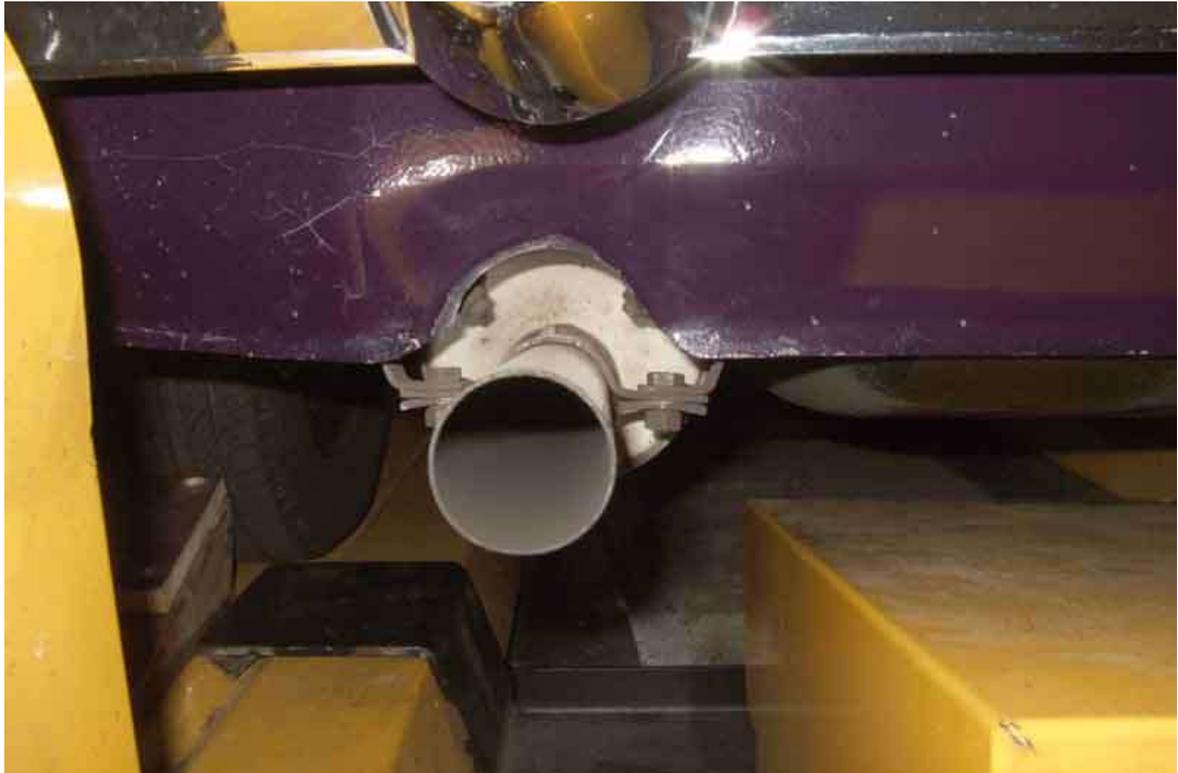
To me the later CB clamp is much neater than the early version with the clamp bolt underneath the tailpipe:

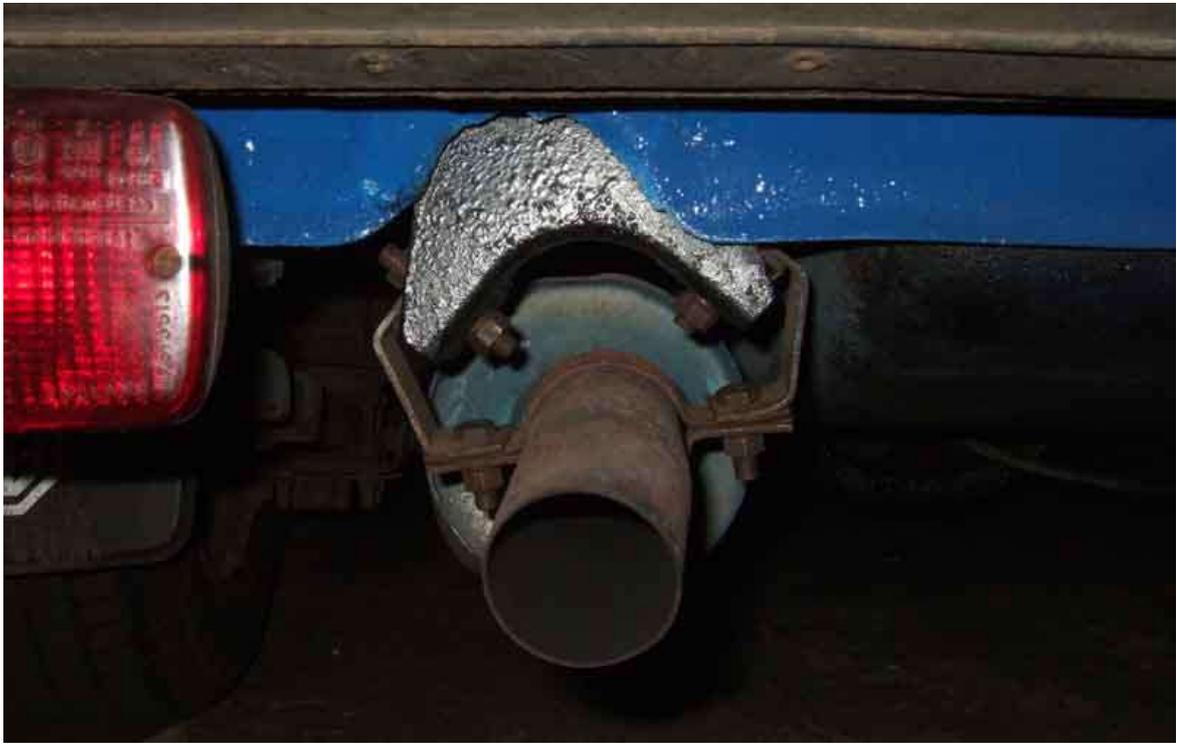
The RB version exposes more of the bracketry, but given how much the bumper protrudes it just isn't noticeable. So much so that I hadn't realised how skewed Vee's was until looking at this picture - caused by one of the hanger screws shearing in the body bracket when first fitting this system 24 years ago, and redrilling and tapping wandered off. I'll have to remove it and redrill the hanger to get it to line up:

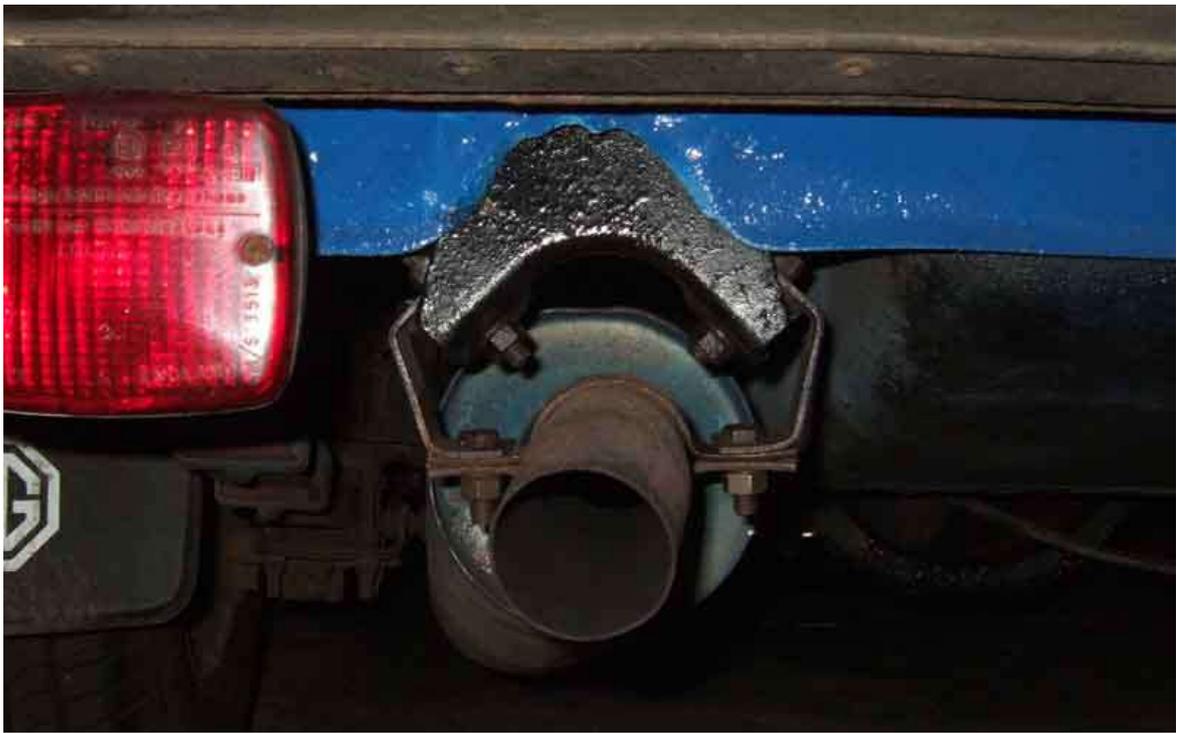
Corrected ... but then I realised that showed the tail pipe was twisted to the left:

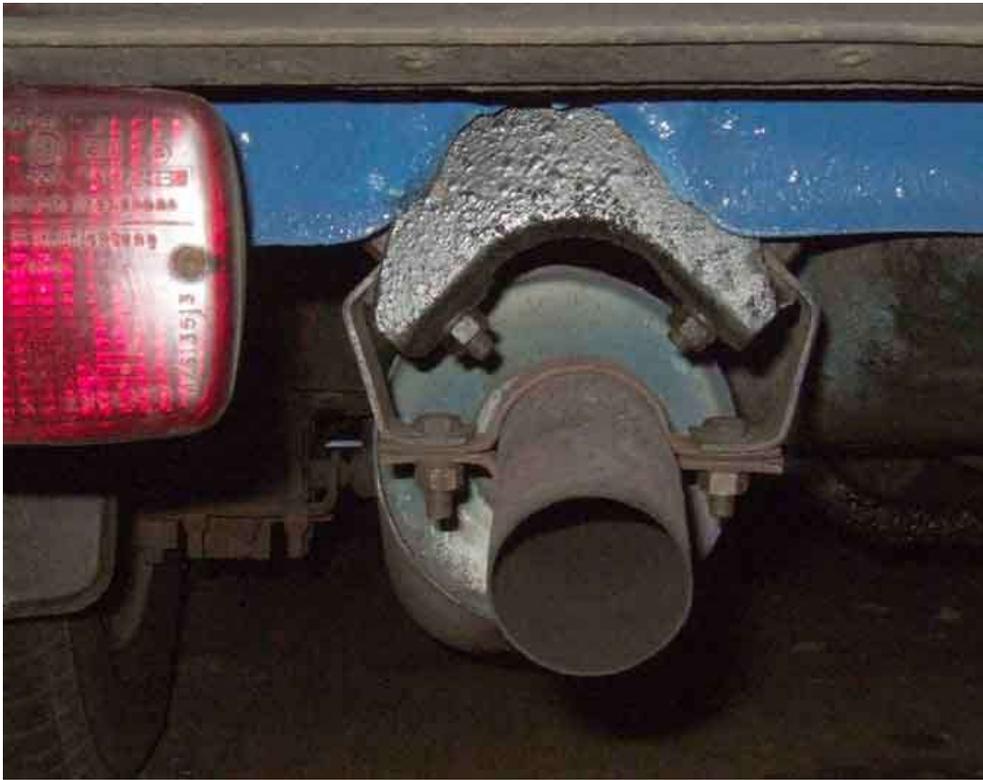
So subsequently corrected that as well:

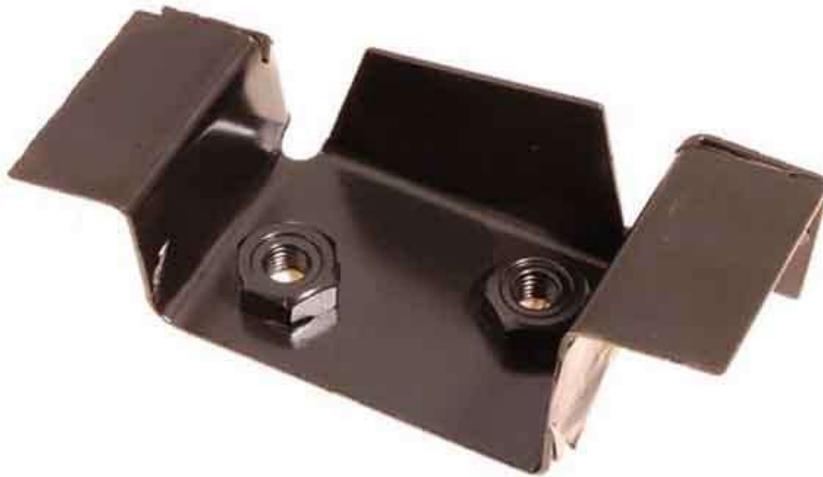
Valance bracket HZA479: ([Rimmer Bros](#))

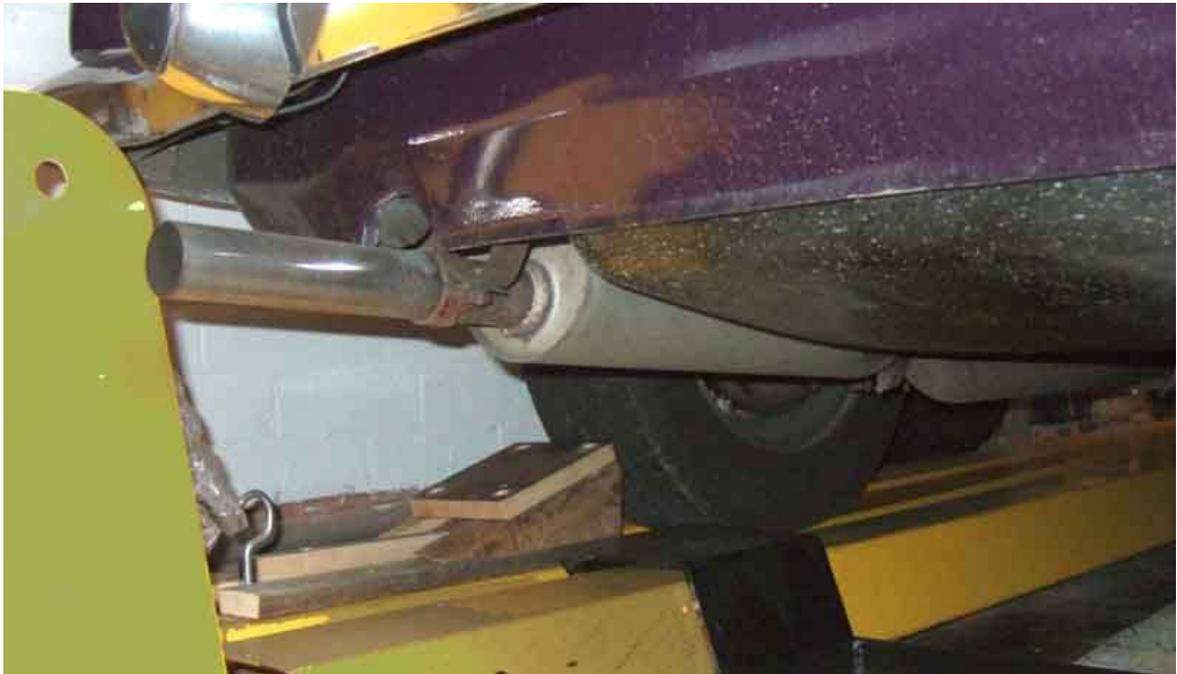
CB box tucked up beside the tank, it and its tail-pipe pointing straight back:

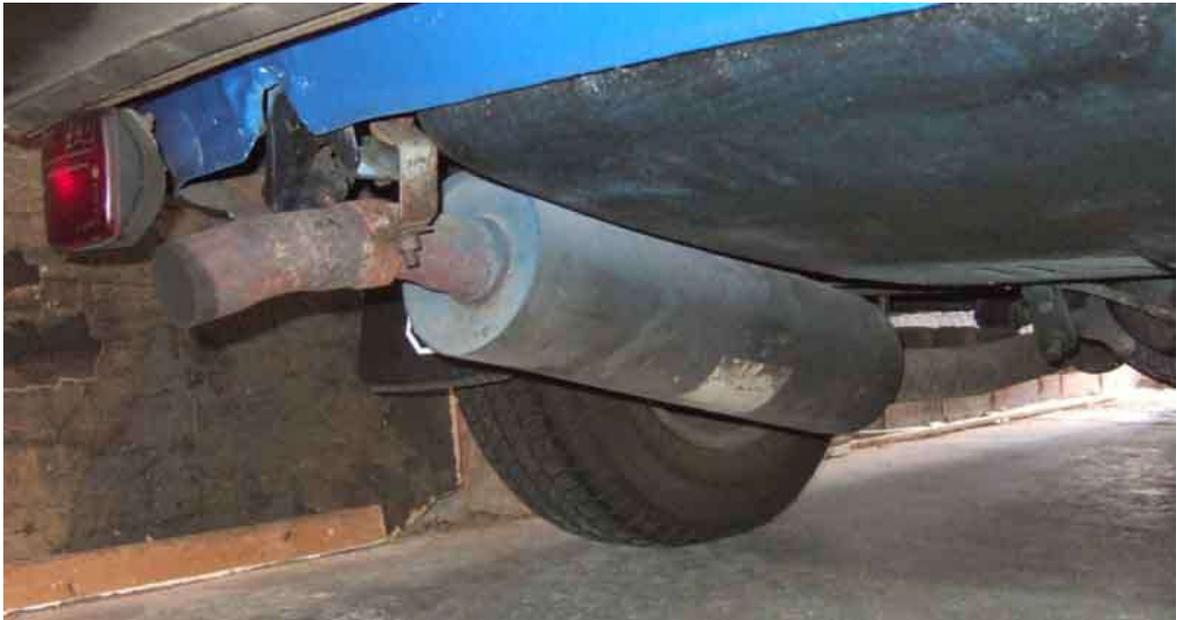
RB box lower than the tank to clear the axle, so has to be angled upwards to reach the mounting point, which also means the tail-pipe has to be angled downwards relative to the box (and ends-up angled slightly downwards relative to the ground. The [rear hanger is also deeper](#):
