Crankcase Breathing

Cylinder Block

Engine Numbers

Dating the Block

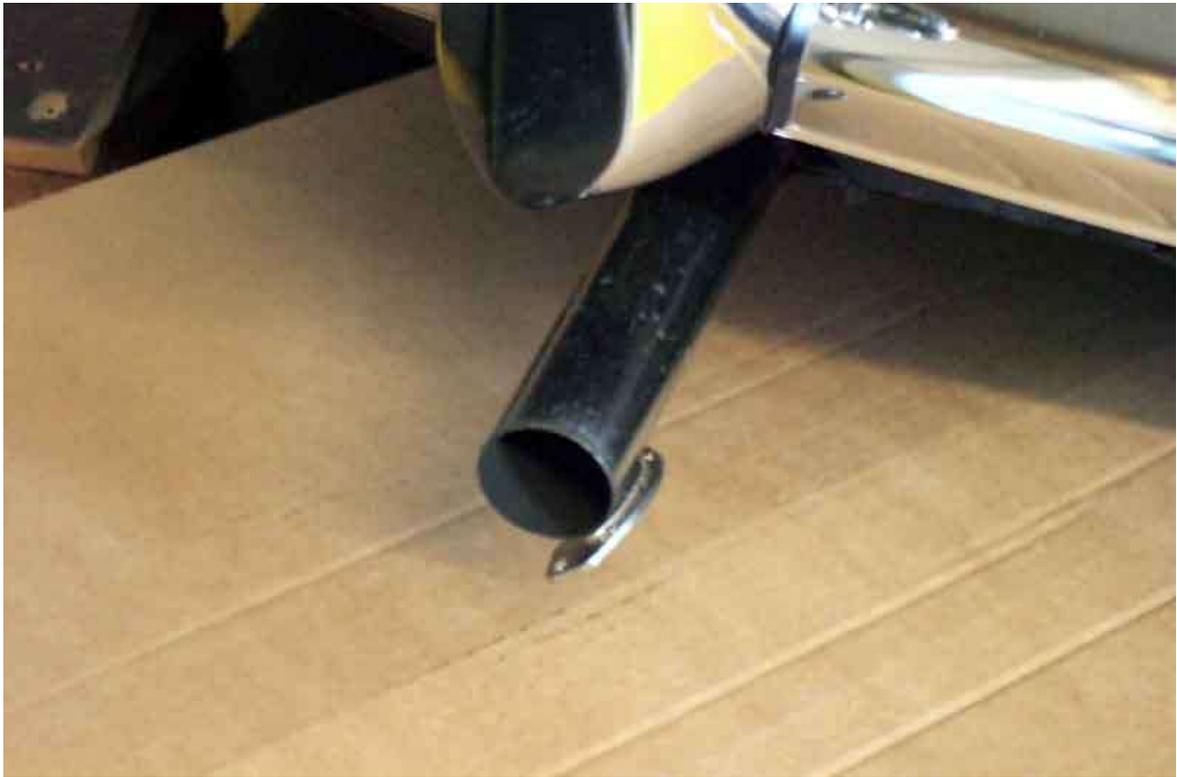
Stainless-steel exhausts can be magnetic:

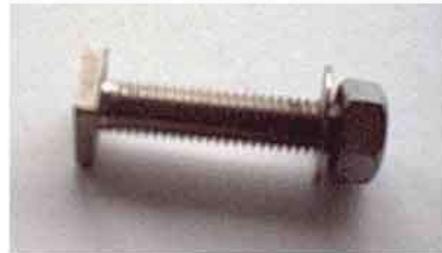
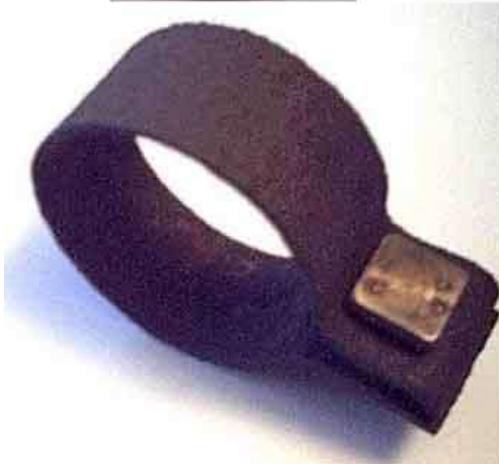
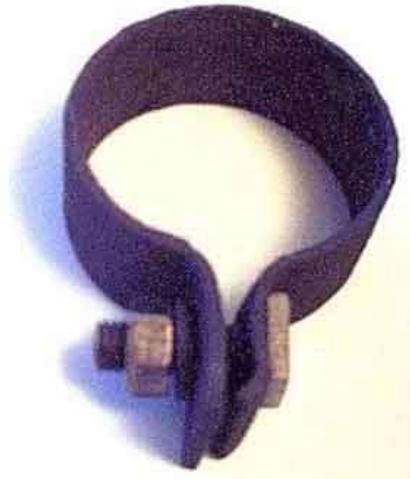
Local authority 'sign affix' stainless bolts are a good fit for the original-style clips, almost certainly these from [Trade Signz Manufacturing](#).

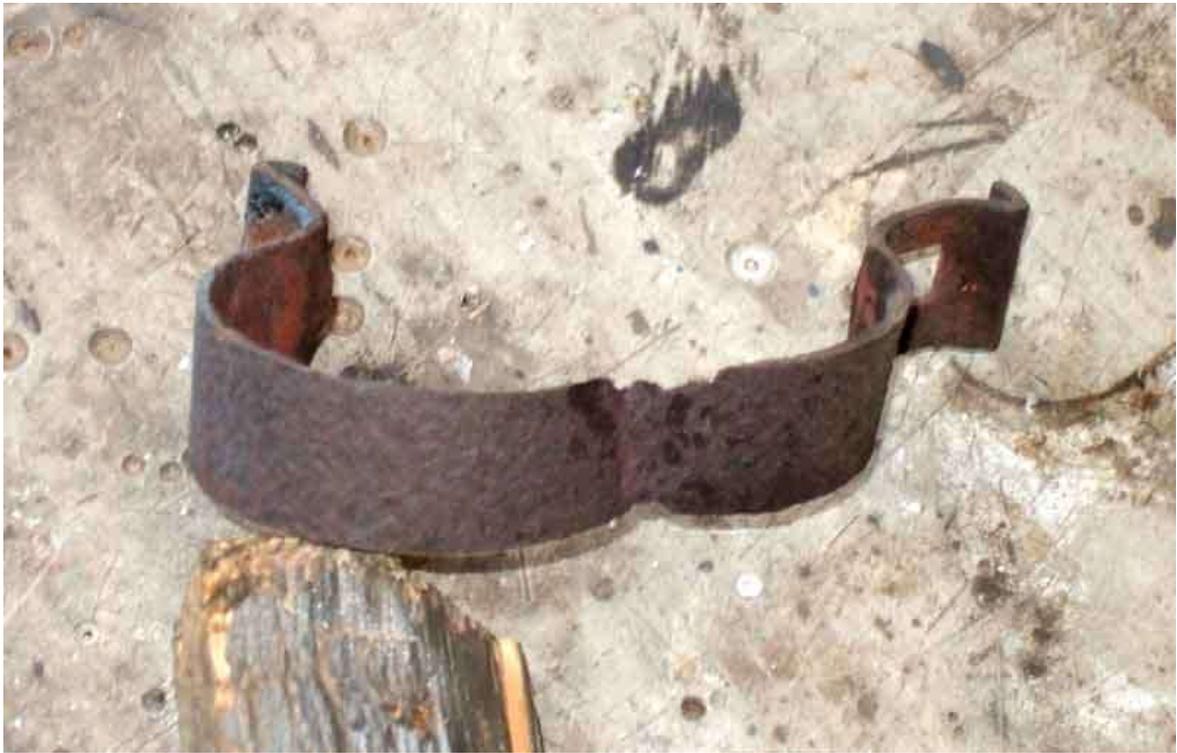
The stainless nut and bolt came undone easily, and peeling the clip off the pipe showed significant corrosion, so probably stretched and come loose. Temporarily replaced with a 1 7/8" conventional U-clip (which unlike the originals can be fitted without parting the pipes) pending a proper job later on. It might be tempting to use these permanently, but the two arms of the 'Y' are so close together the two clips would have to be staggered, meaning one would be partly off the end of the 'Y' and the other too close to the end of the split, so neither would clamp properly.

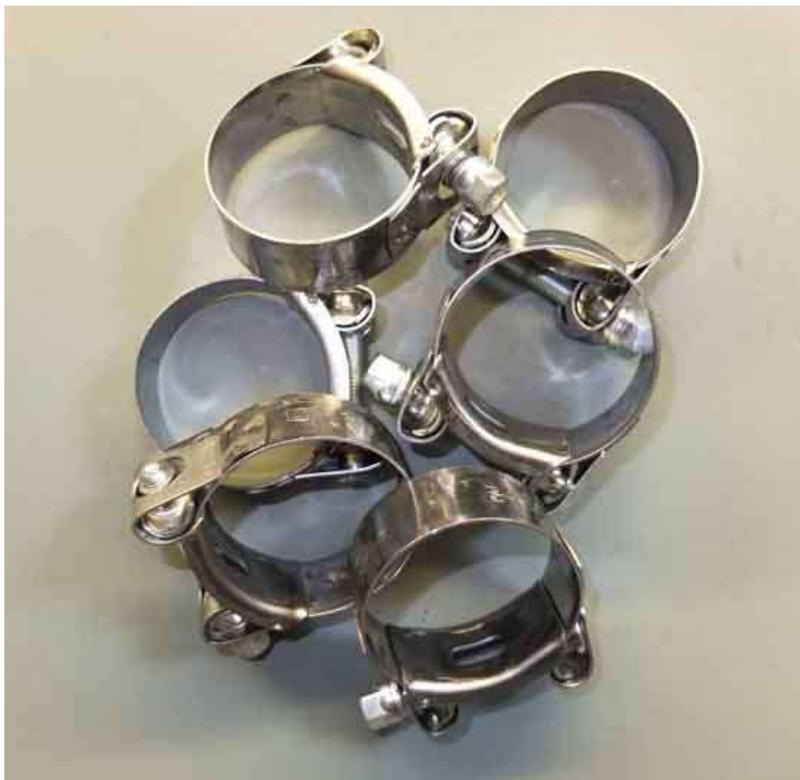
However [Clive Wheatley is now showing this type in stainless](#), £3.60 inc VAT each complete.

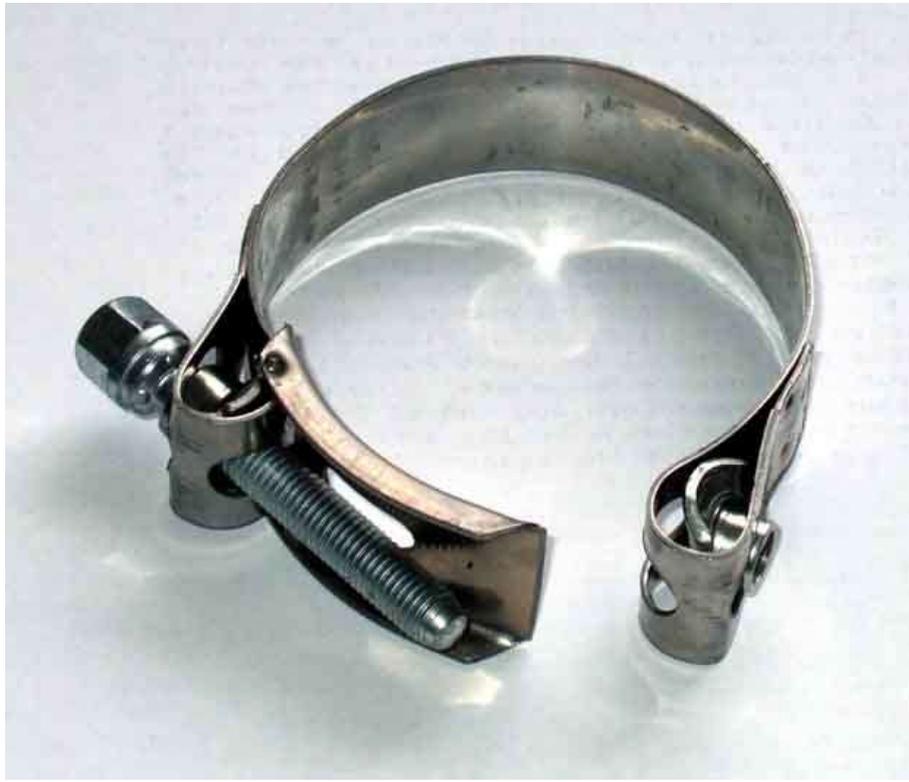
Even better, with the screw backed right off they spring apart and can be fitted round the pipes in-situ, unlike the original type where the main exhaust pipe has to be pulled back to get the Y-connector off the down-pipes so the clip can be slid over the open end.

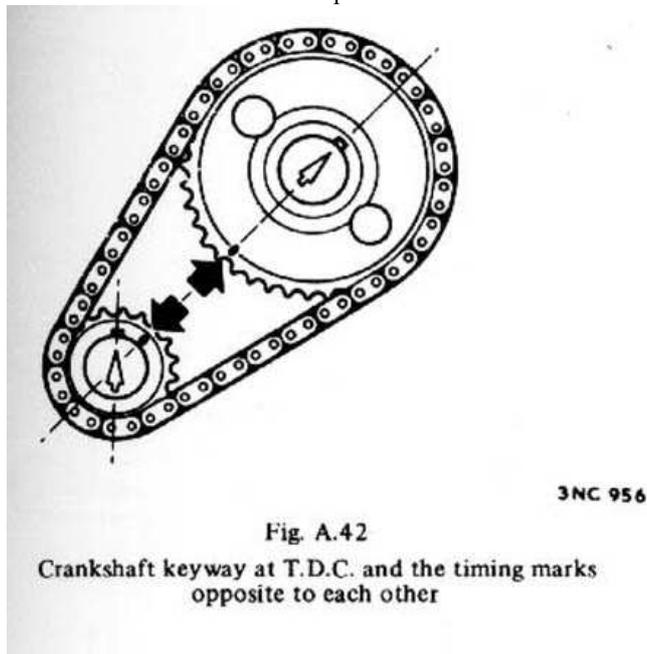
Leyland Workshop Manual image, white arrows showing the positions of the keyways and black arrows showing the position of the dimples.

Both images show the correct orientation of shafts and gears in preparation for fitting the chain and gears to the shafts. Note that this installs the cam such that No.4 piston is at TDC on its compression stroke, not No.1 piston.

To install the distributor drive dog correctly, using the instructions contained within the manuals which state that No.1 piston must be at TDC on its compression stroke, the crank must be turned one full turn i.e. 360 degrees. This puts the camshaft **keyway** adjacent to the crank gear, and the cam gear dimple at top-right. Then follow the instructions for [inserting the drive gear](#).

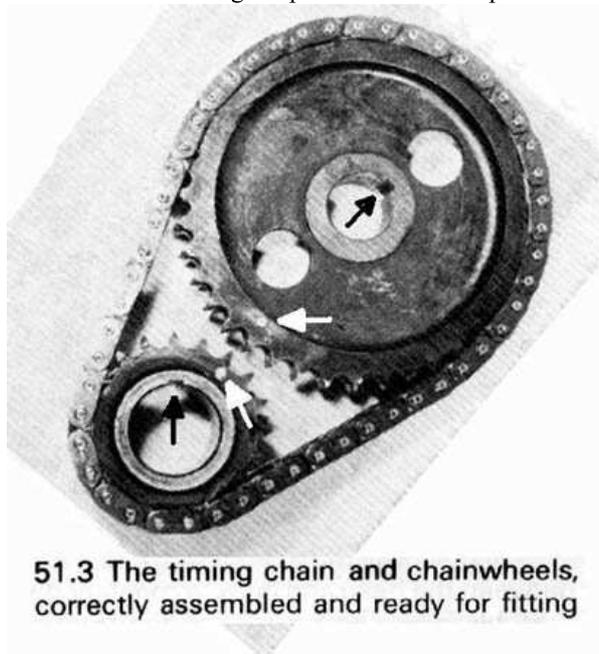
Haynes Manual image, rotated for comparison with the Leyland image, black arrows showing the position of the key-ways and white arrows showing the position of the dimples.

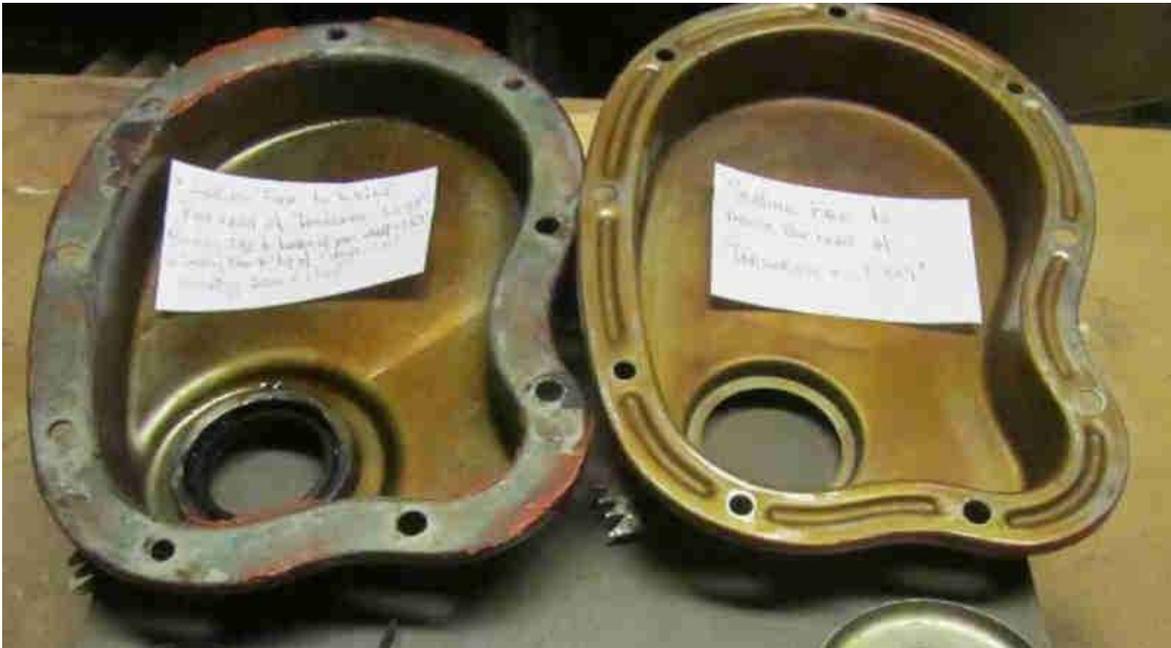
Timing covers - flat flange on MGA (left), ribbed on (most if not all) MGB: [MGAGuru](#)

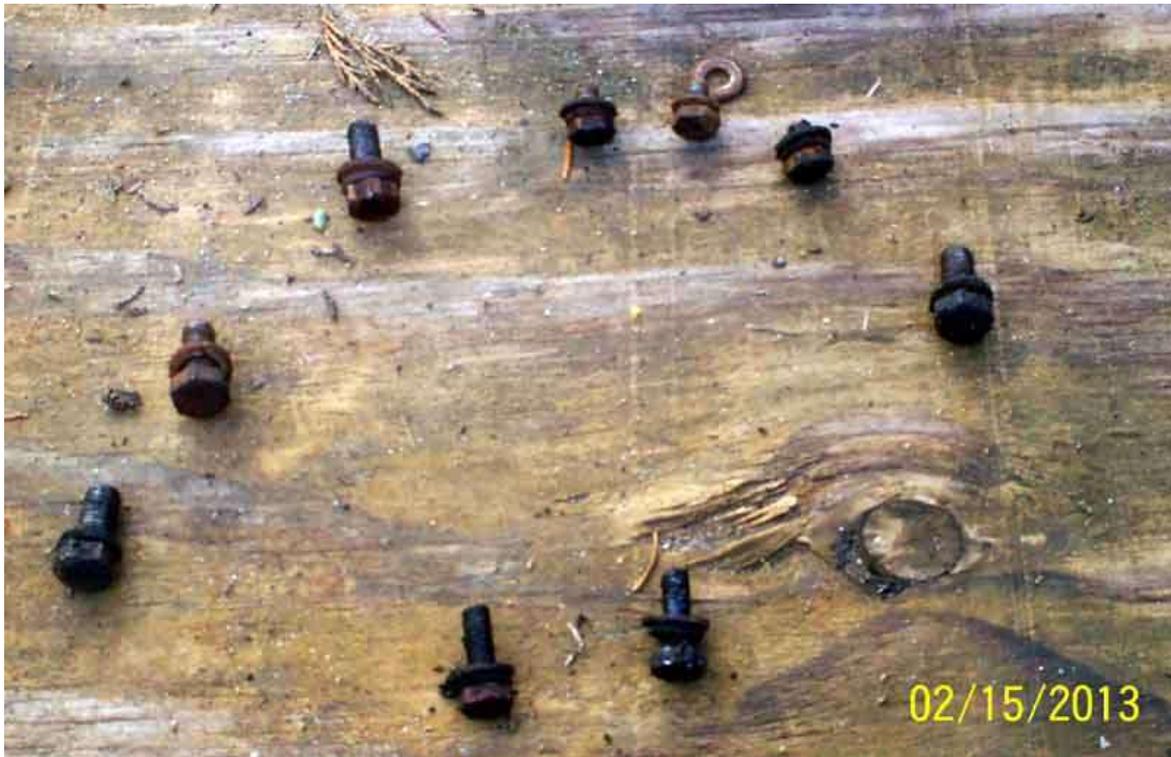
Timing cover bolts: It's fairly self-explanatory where the bolts go. It's obvious the four 5/16" bolts will only go in the appropriate holes, the three shorter 1/4" bolts go at the top into the engine front plate where there is no block behind it, and the two longer ones go at the bottom through the front plate into the block. Torque to 6 ft lb for 1/4" and 14 ft lb for 5/16". (Photo: Chris Wilson)

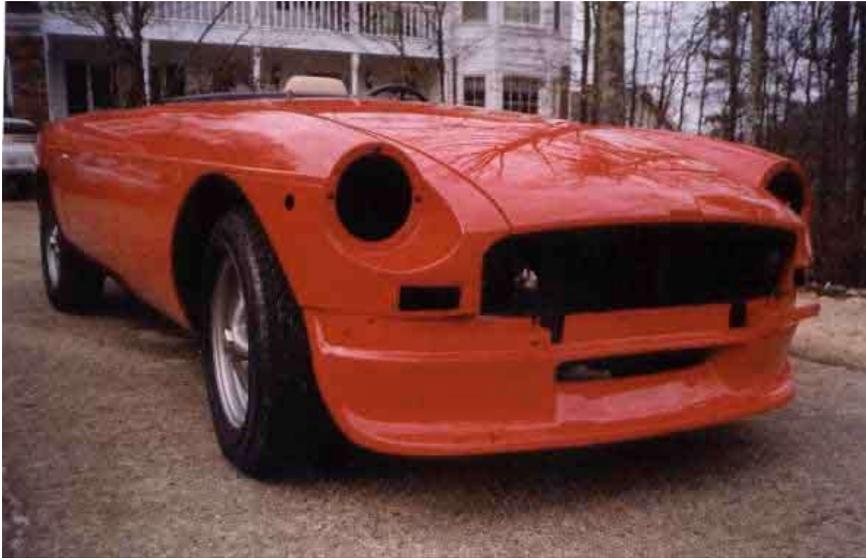
The air-dam, showing how it scoops air into the slot for the oil cooler and lower half of the radiator and will do so even when the bumper and hanging number plate is fitted: (MG-Cars.org.uk)

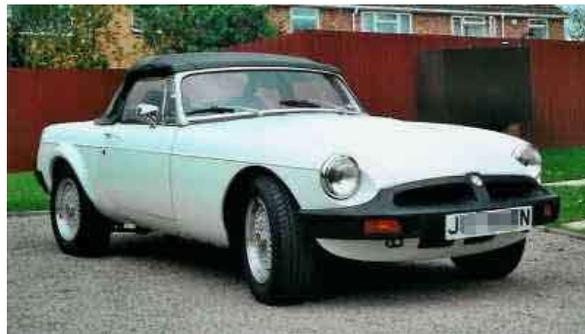
Raised number-plate opens up the slots in the standard apron: (V8 Register)

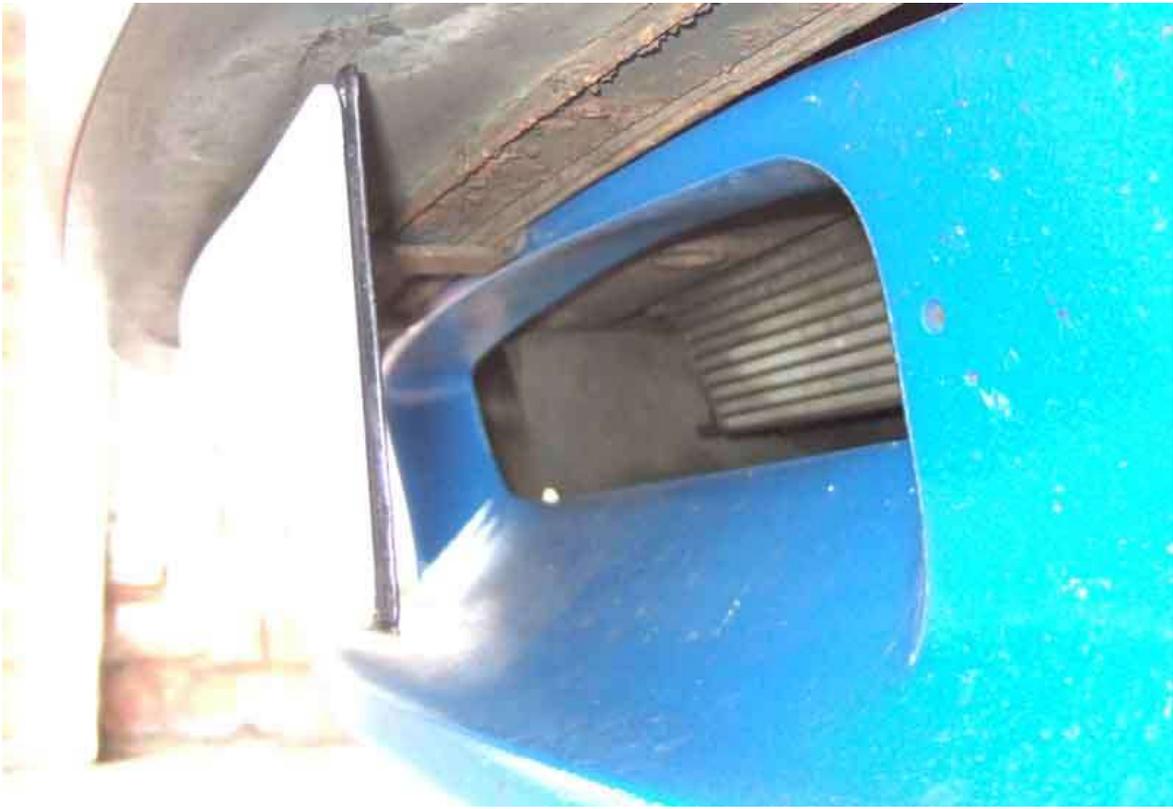
Special-tuning air-dam slot:

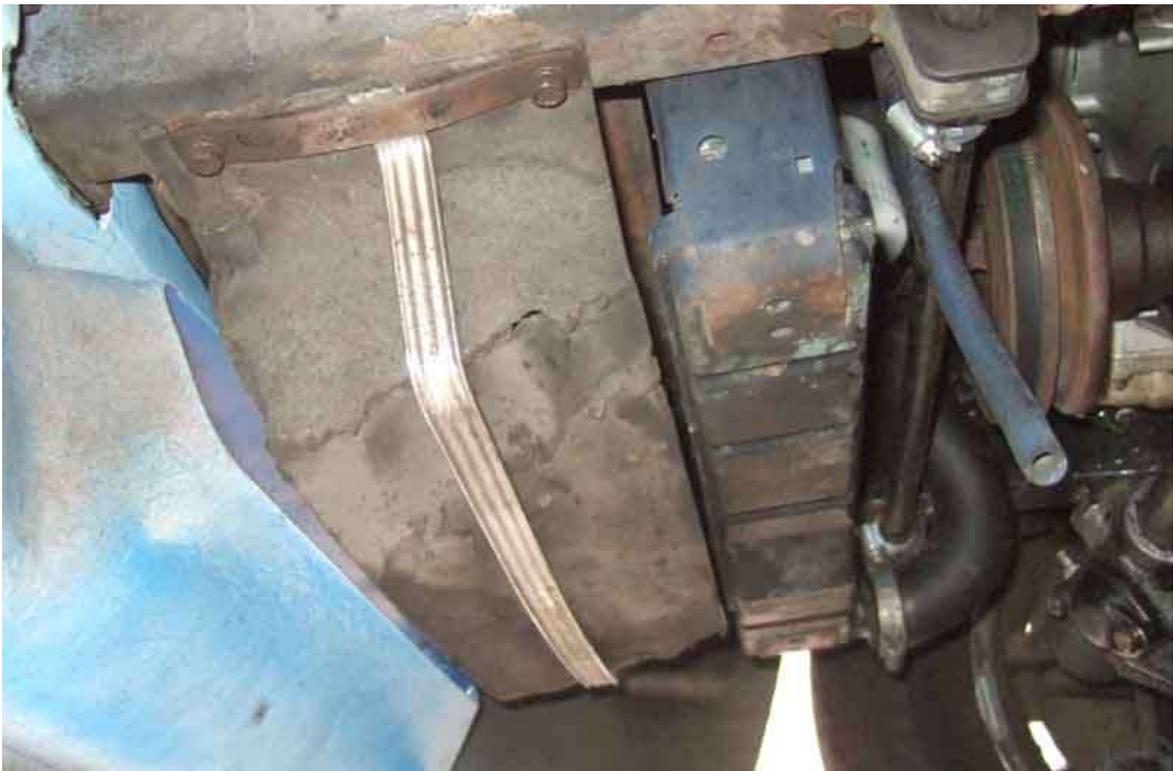
Duct BHH1614 directs air through the under-slung oil cooler and back to the lower part of the V8 and 77 and later 4-cylinder radiators, which extend below the chassis rails. This original flat fibre-board had taken up a curved shape allowing a lot of air to bypass the cooler and radiator, I added the metal strip to force it into the correct rectangular shape:

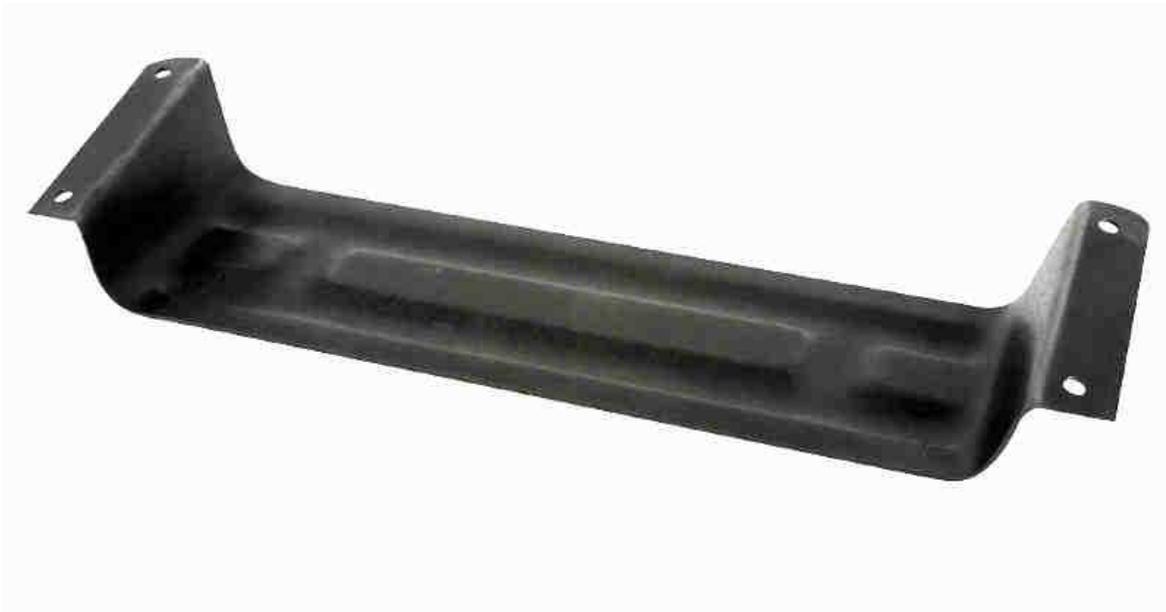
Current stock is pre-formed plastic which should hold its shape better: ([Moss Europe](#))

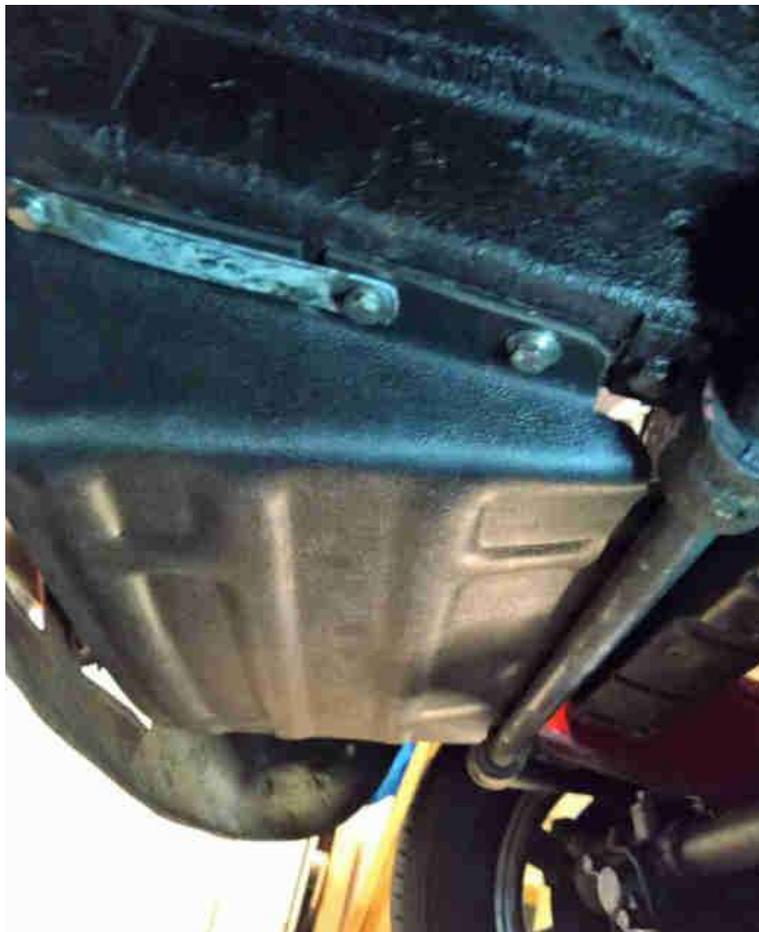
Duct BHH1622 (moulded plastic) on pre-77 4-cylinder rubber-bumper cars, directing the air-flow up to the radiator which doesn't extend below the chassis rails: ([MGB Tips](#))

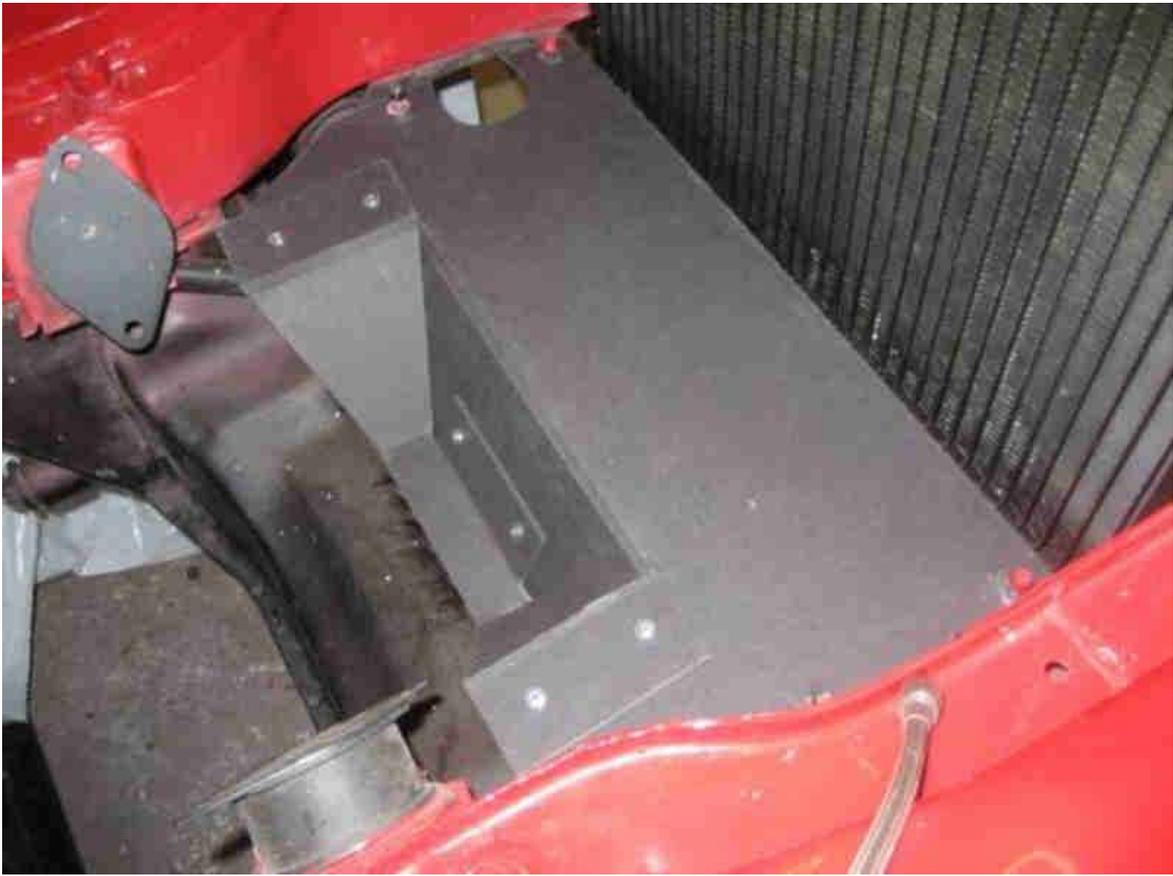
77 and later used a deeper radiator like the V8 and so used the V8 duct, as well as this mud/acoustic shield BHH2127 behind the radiator sitting on top of the chassis rails. The bottom hose passes through the shield at the top of the picture: ([MGB Experience](#))

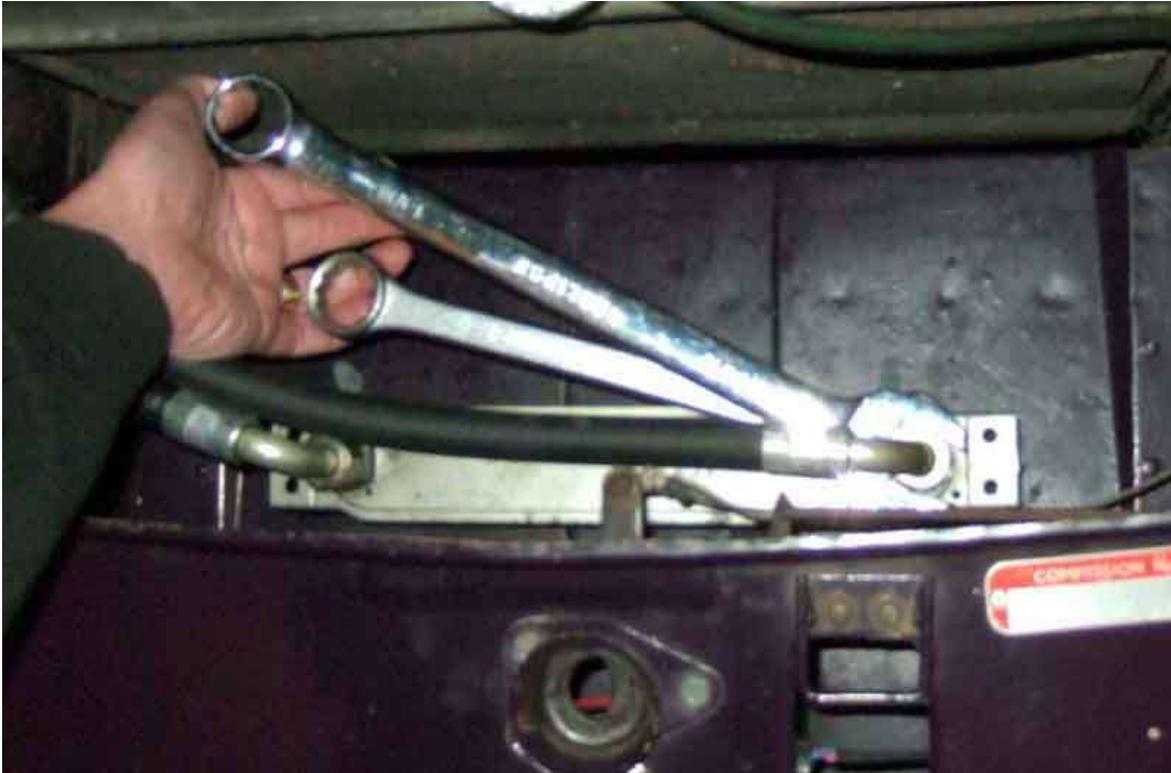
For undoing the hoses, the hose union spanner (above) must be clockwise relative to the cooler spanner, positioned such that the spanners can be squeezed together with one hand - although both may be needed for old fittings. When squeezing no rotational force must be applied to the cooler spanner, only the hose union spanner must move - anti-clockwise as you look down on it.

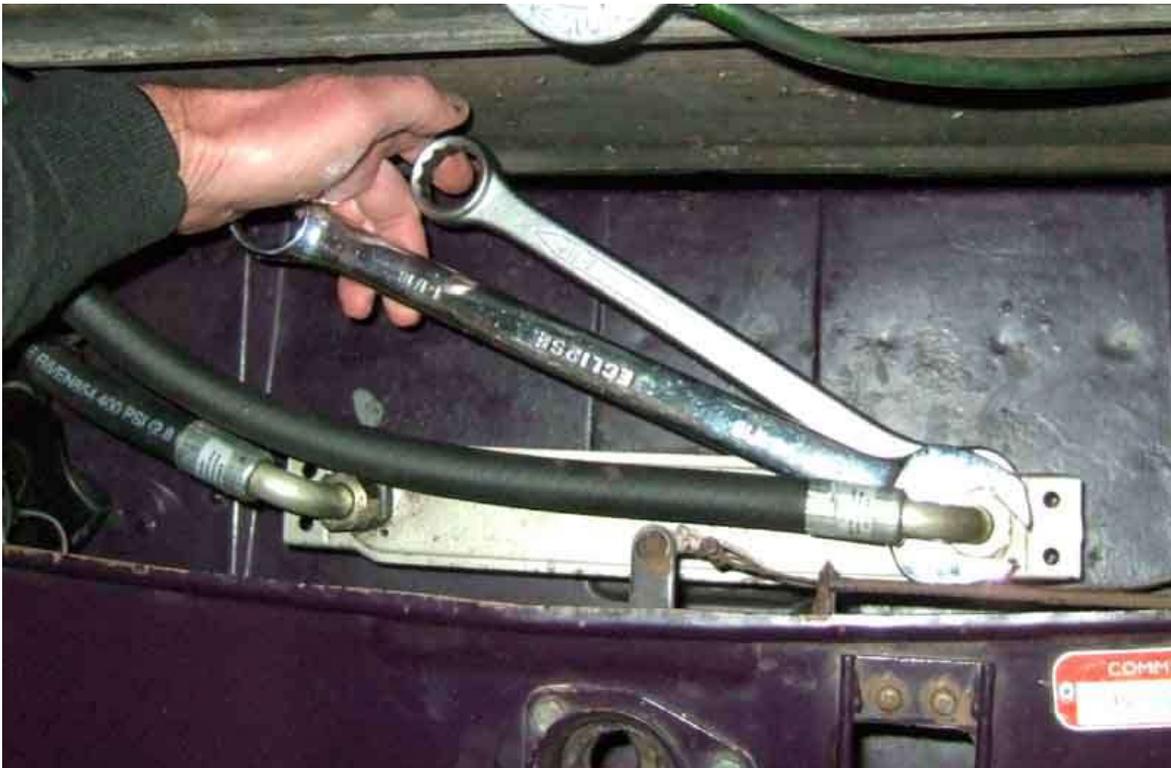
For tightening, the hose union spanner must be anti-clockwise relative to the cooler spanner, and when squeezing only the hose union spanner must move - clockwise as you look down on it.

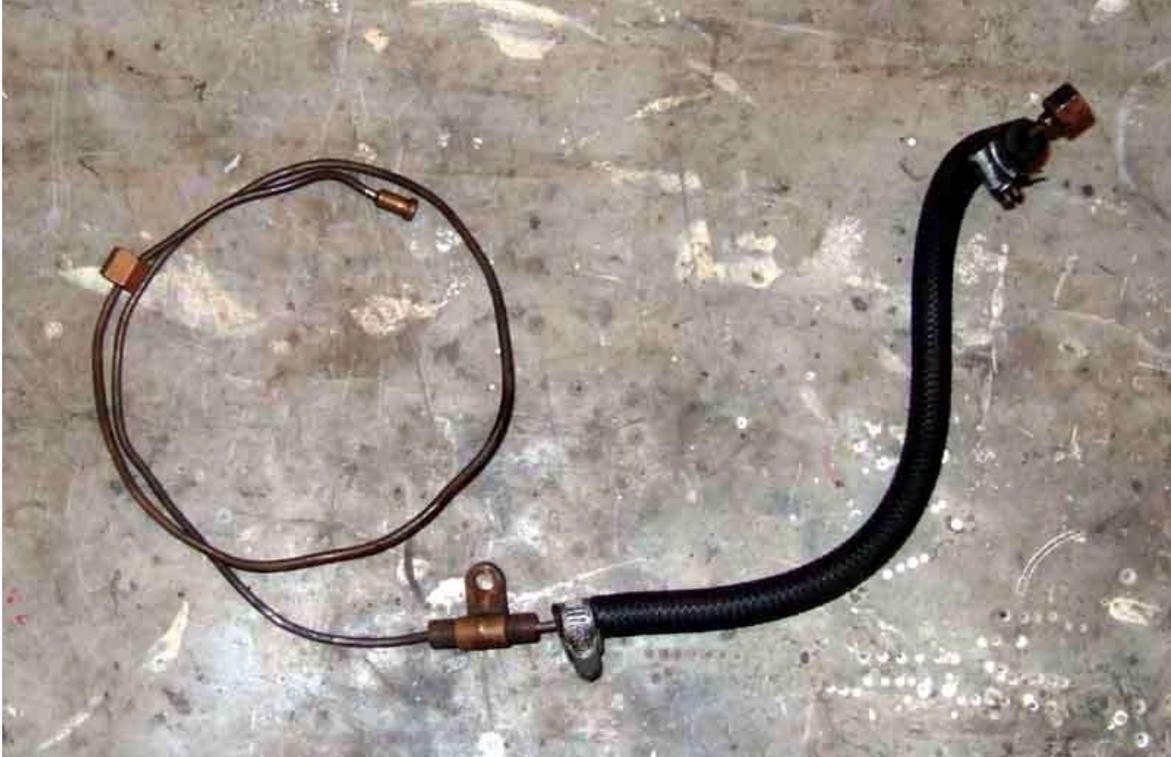
4-cylinder: Bee's original connector as I found it - the gauge pipe has had the fitting cut off and the end of the pipe fed through the connector direct into the hose and secured with a hose clamp. Originally there would have been a short length of pipe with a fitting at this end of the pipe as there is at the block end. Presumably one of the pipes fractured at the connector, hence this cheap 'fix':

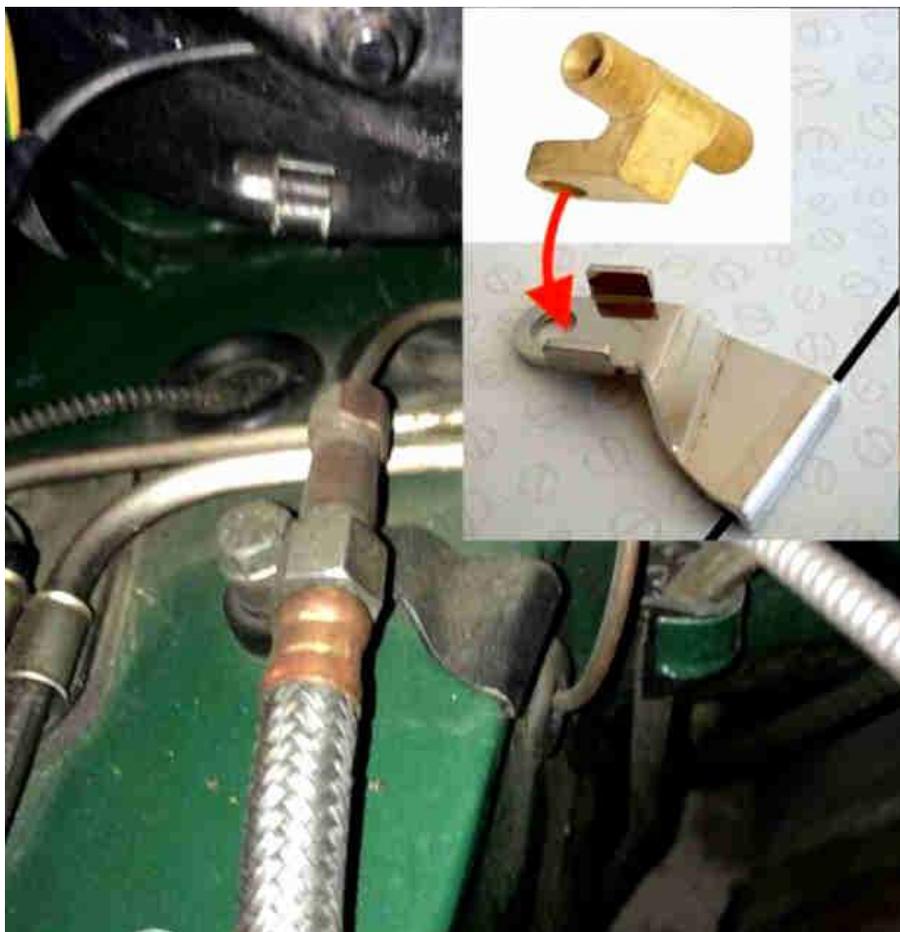
The connector has support bracket AHH6938 with spacer AHH6247 underneath. The bracket prevents the connector twisting as the hose and pipe nuts are slackened/tightened. However that does make for quite a convoluted route to go through the hole in the side of the tunnel when there is a grommeted hole almost immediately behind the connector, used for the heat control here: ([MGE](#))

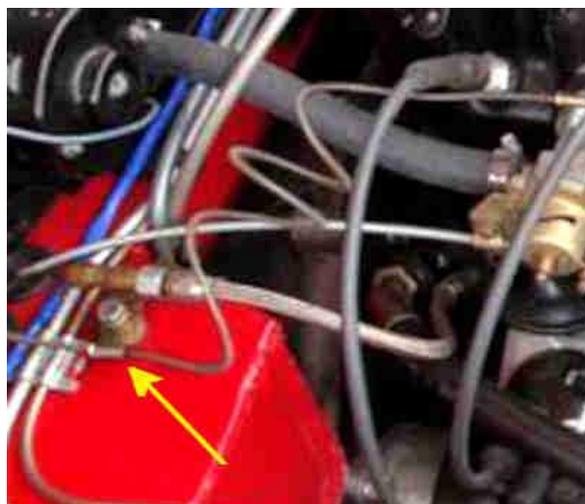
Unlike mine that shows the connector on the heater side of the screw, but other pictures including several in Clausager show the same with another P-clip for the temp gauge capillary on the master-cylinder side of the screw. This looks neat and lines up both for the grommets holes in the heater shelf. In this image it's not clear but the oil pipe may be going through the same grommet as the heater cable: ([MGE](#))

I was only aware of one P-clip on the capillary and that goes on the [lower heat valve screw](#) (not the upper one as in the same image). Also yet more pictures show the [speedo cable](#) using that side hole, although there is one for that in yet another position in the tunnel.

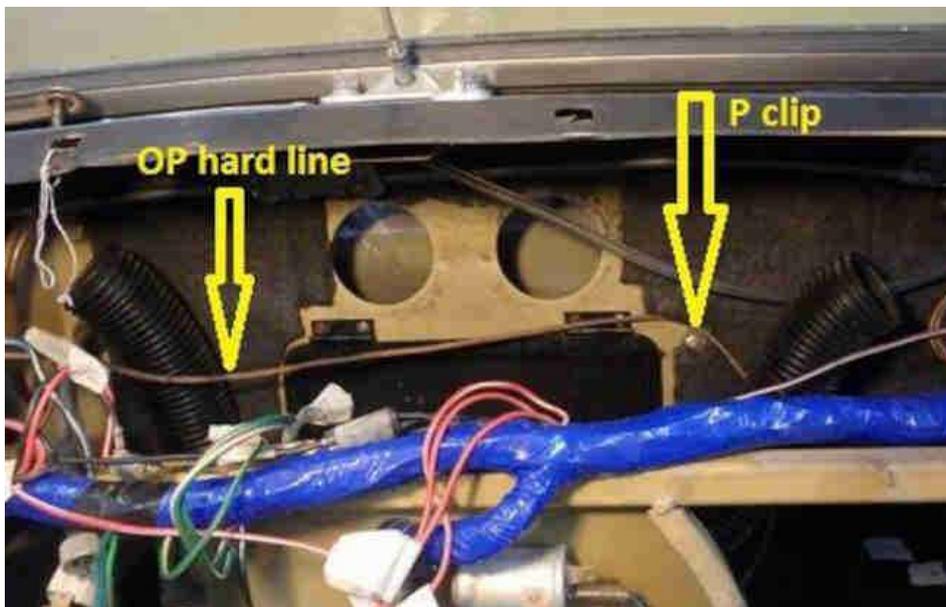
On 4-cylinder cars the oil gauge pipe has a P-clip in the cabin, on CB cars near the top right-hand corner of the cold-air flap as shown here: ([MG Experience](#))

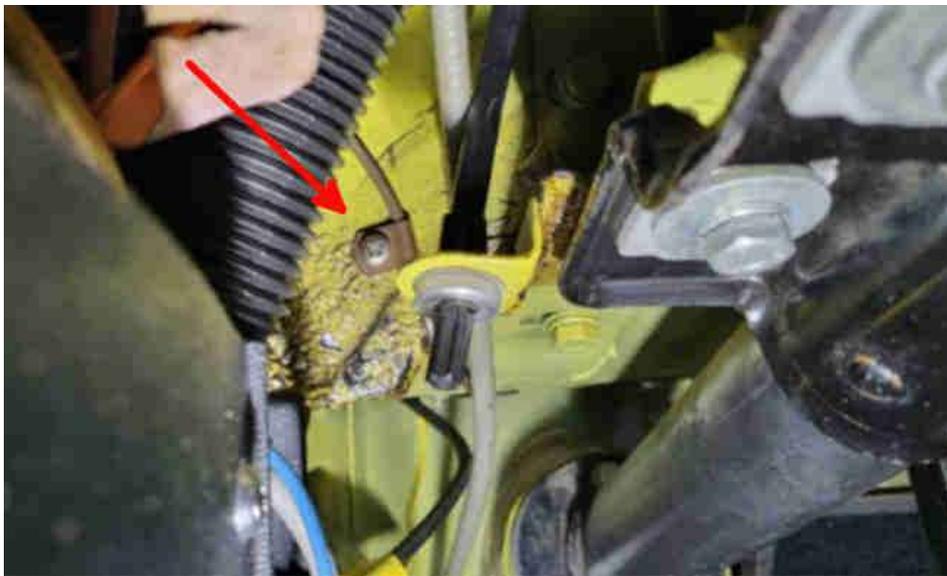
And on RB lower down and further to the right as here: ([Charles9, mg-cars.org.uk](#))

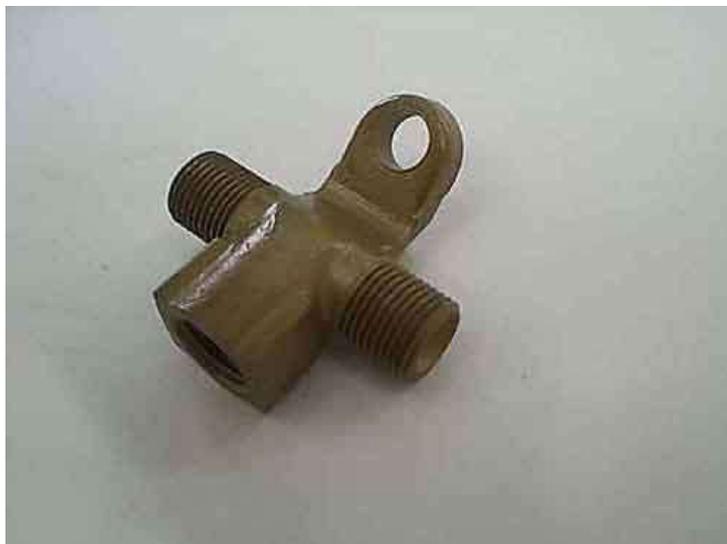
The North American connector with the tapping for an oil pressure switch:

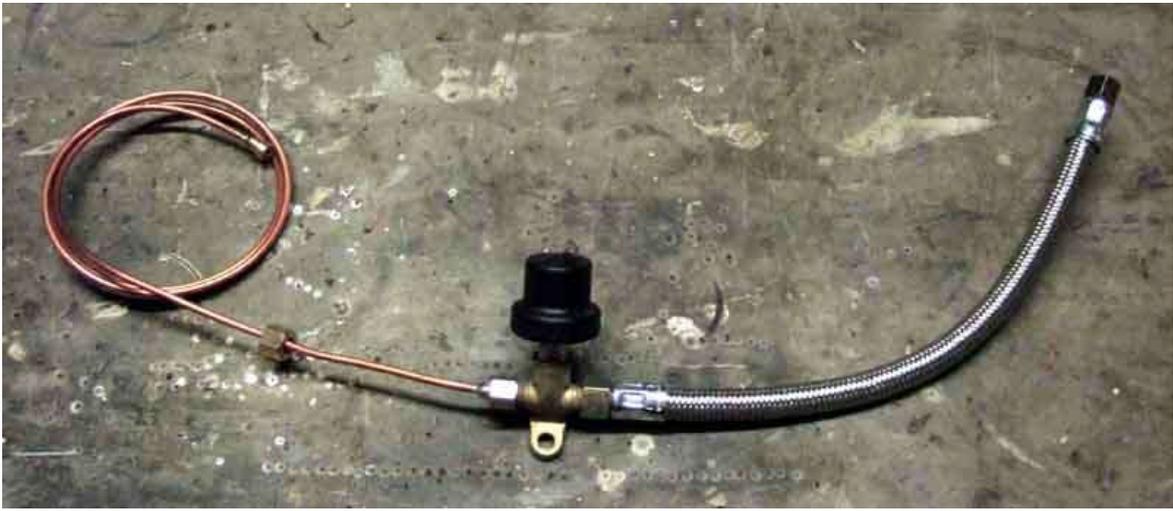
New Teflon-cored hose, North American connector with pressure switch fitted, and new gauge pipe:

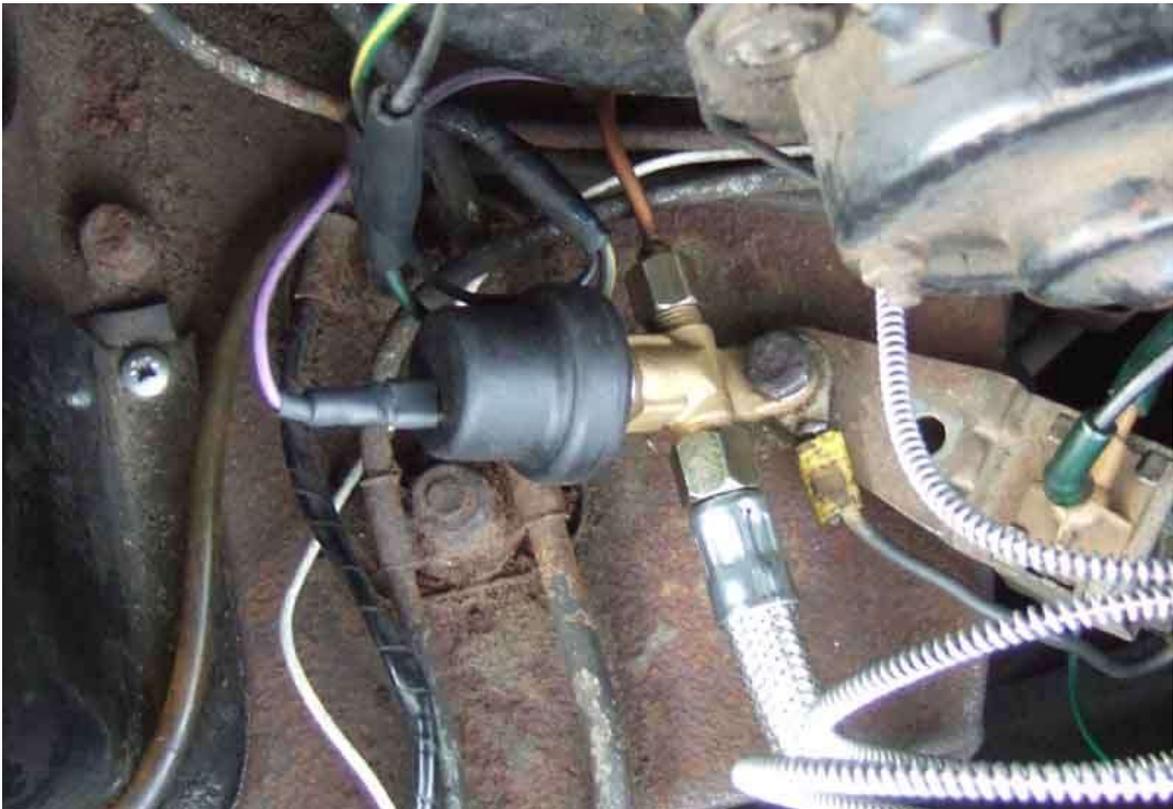
Installed:

Note the original connector support bracket is not fitted as I have something else mounted using the same screw.

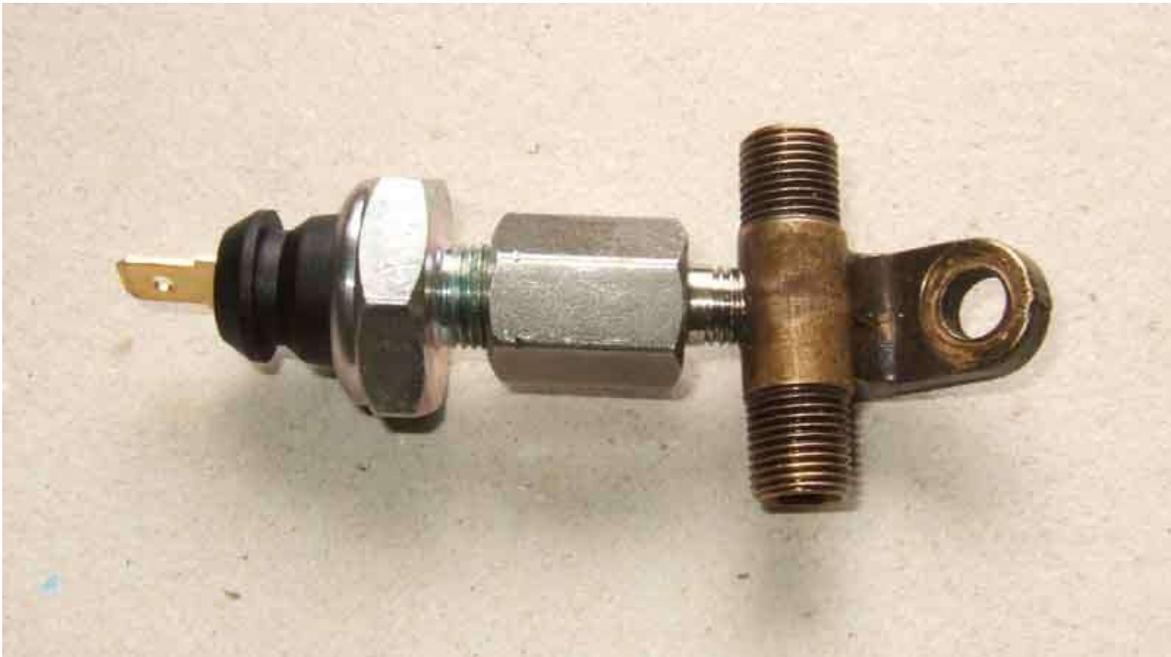
Standard connector modified to take a switch:

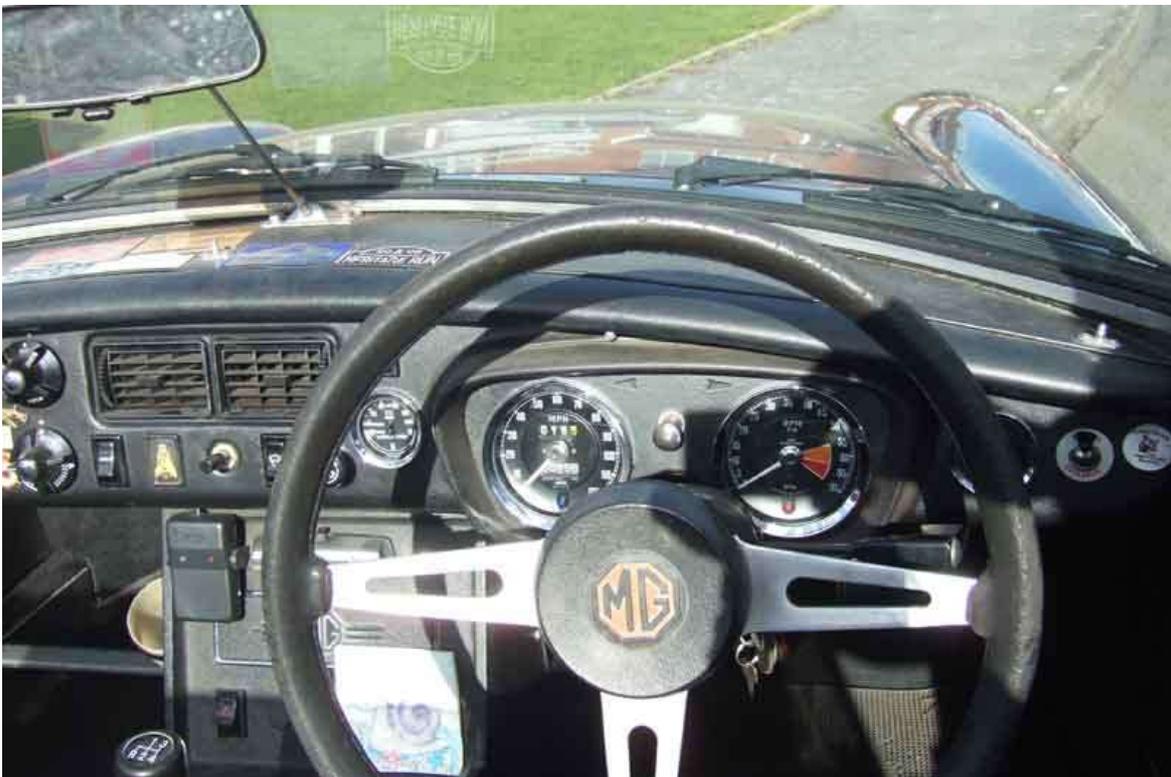
Warning light unobtrusive ordinarily ...

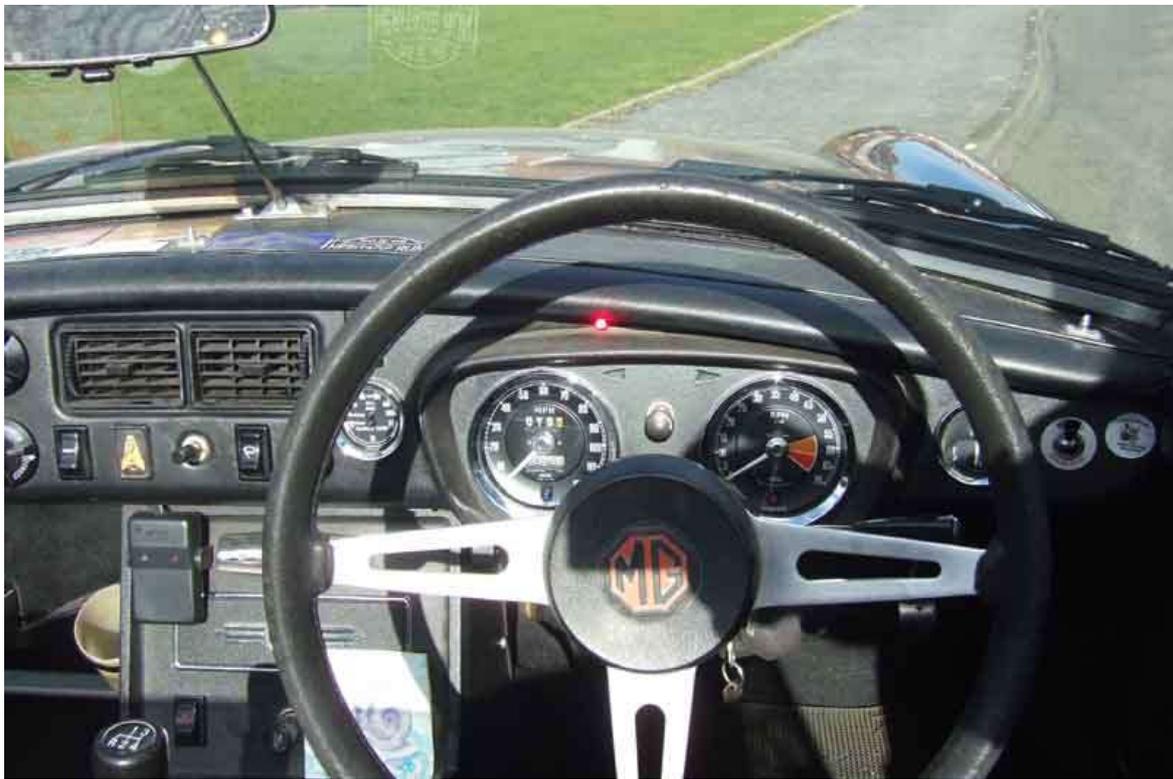
... but very obvious when illuminated, compare it to the ignition warning light which is also on. I did intend to fit the orange version, my local Maplin were showing two so ordered one and trooped down there to be told they couldn't find them! I'm not paying postage on a 99p item, and happened to have a red one to hand, so that's what went in. Subsequently bought one and they are indistinguishable from red!
