Crankcase Breathing

Cylinder Block

Engine Numbers

Dating the Block

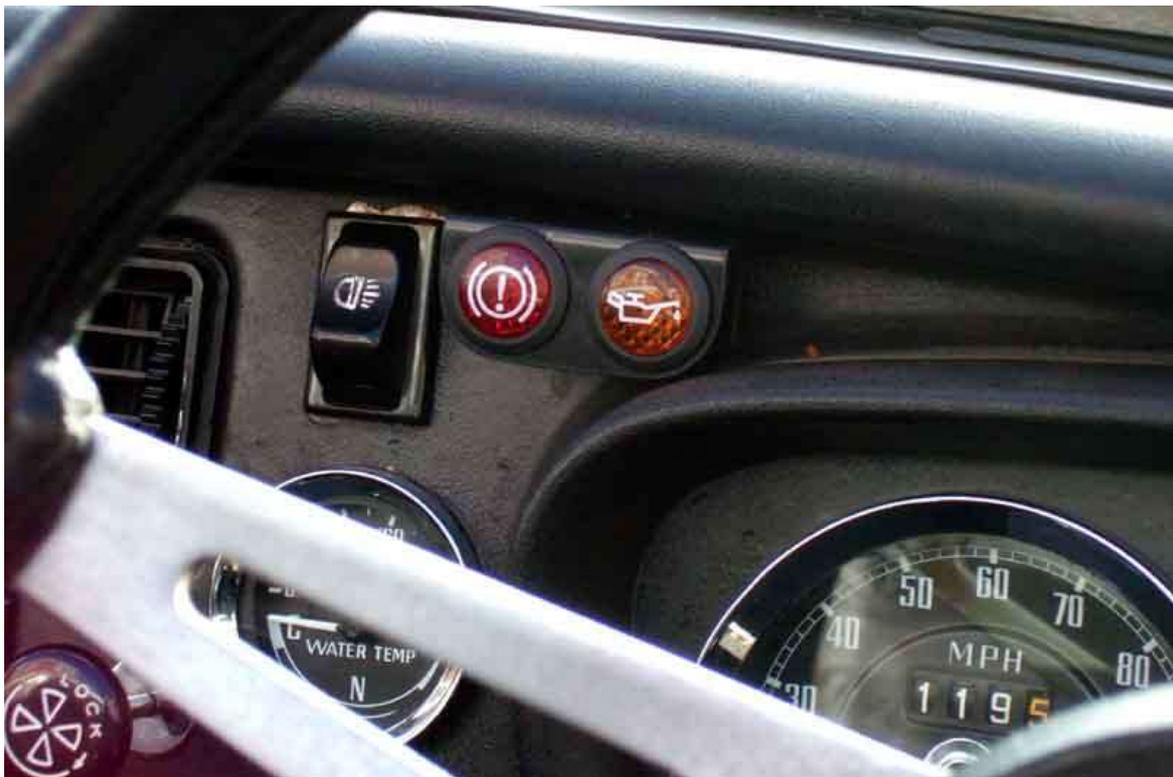
After-market warning lights modified with superbright LEDs: Visible from the driving seat, off ...

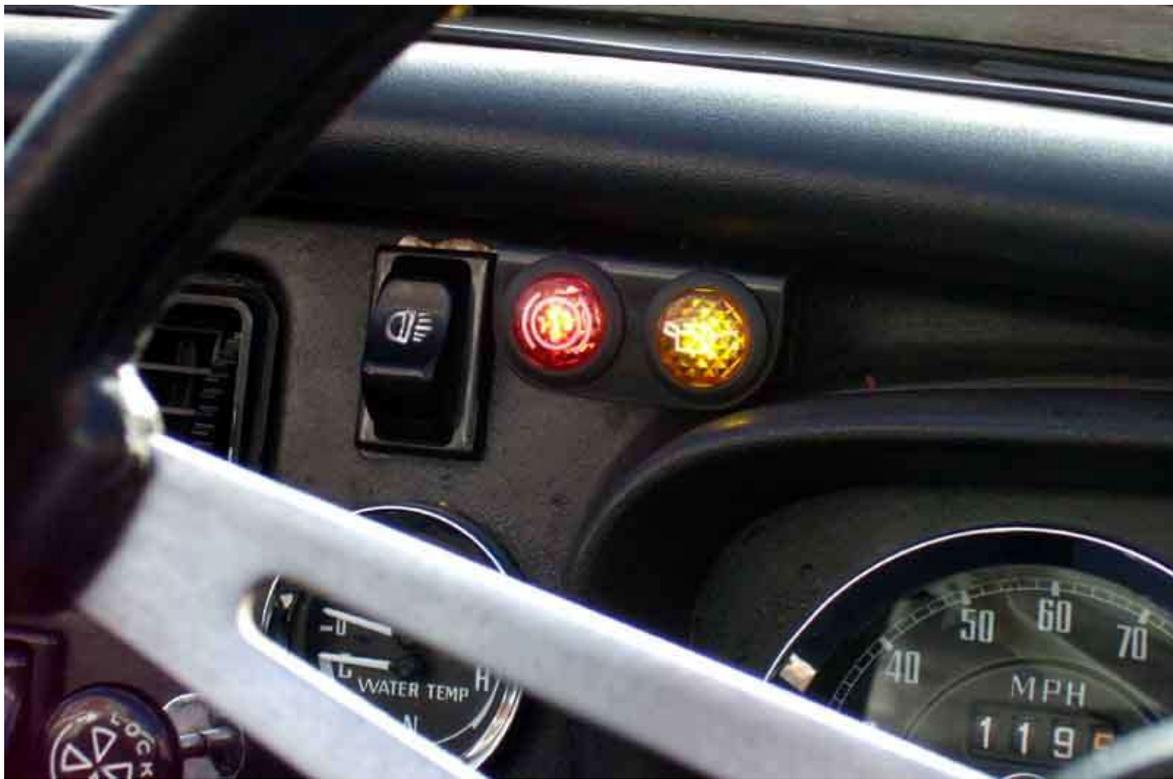
... and on in bright but not direct sunlight:

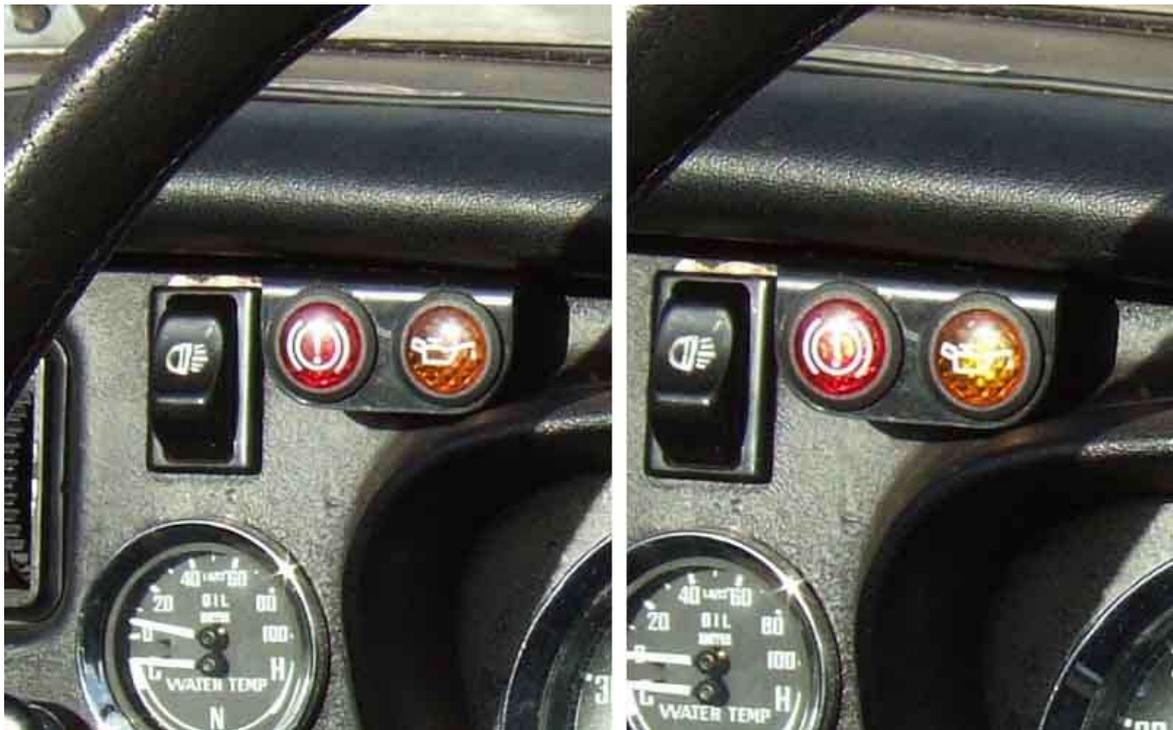
However less visible in low direct winter sun - off on the left, illuminated on the right. Maybe a cow! They are angled towards the driving position:

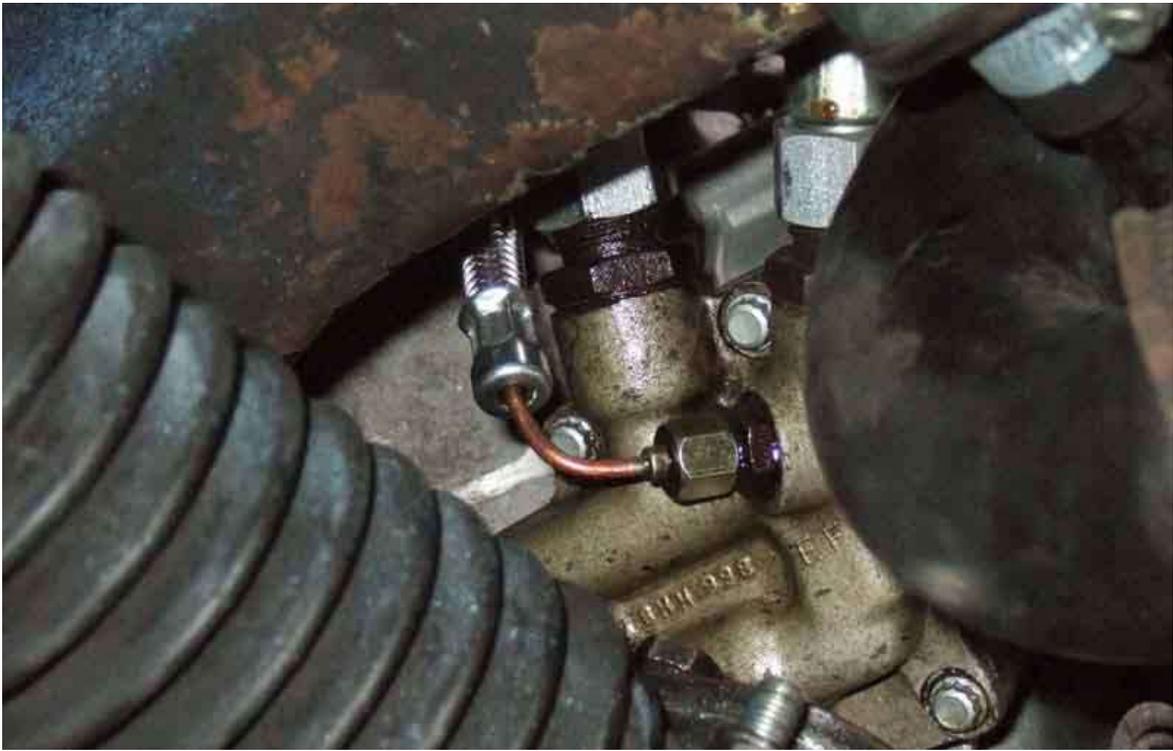
V8: Hose to oil pump at the front of the engine:

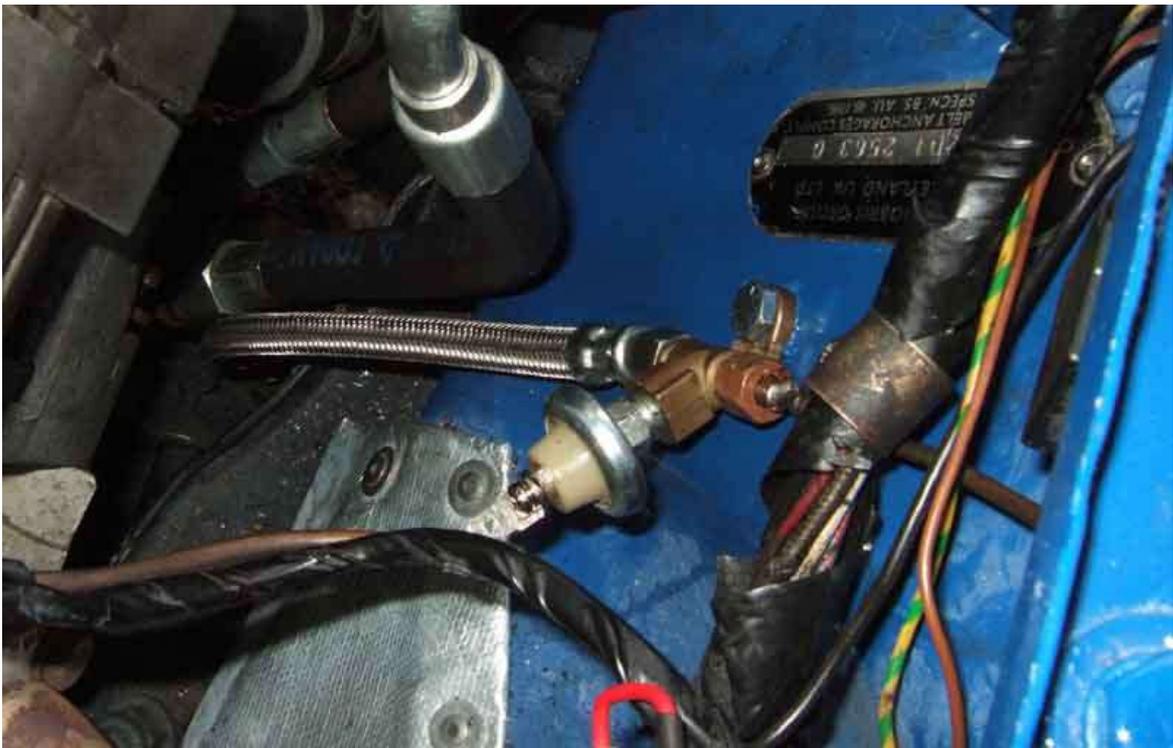
3-port connector and oil switch on the inner wing:

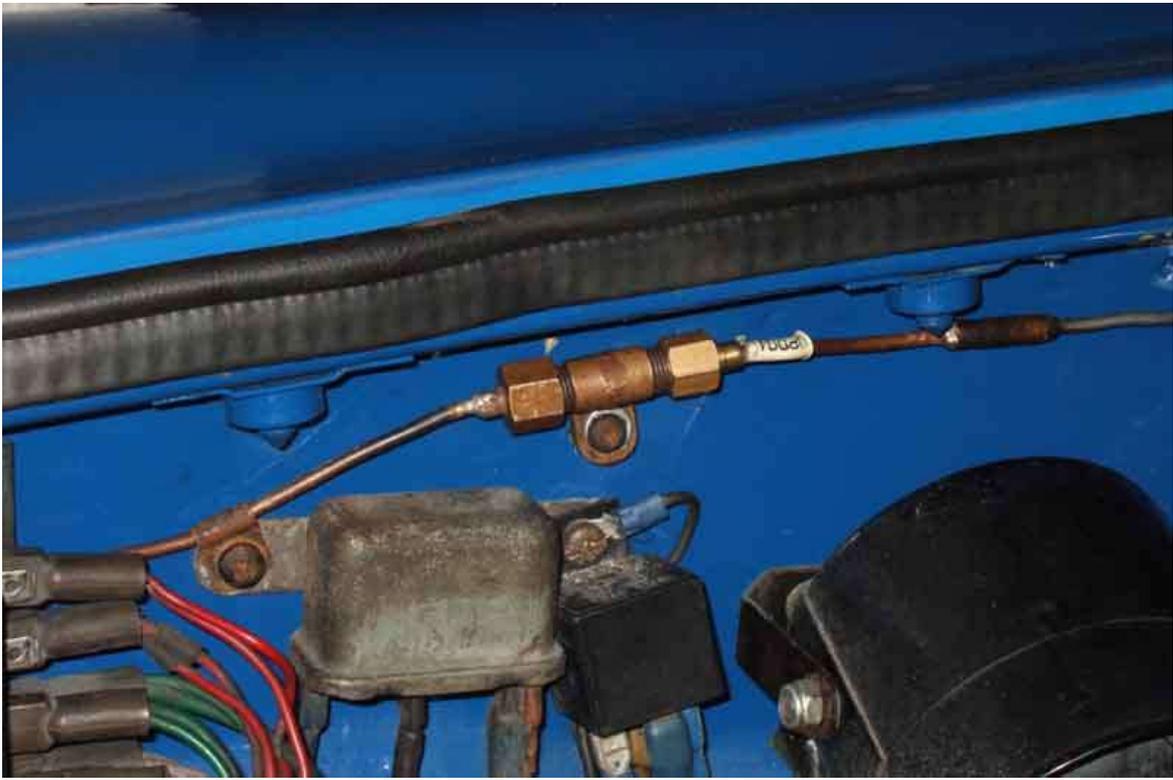
2-port connector by the starter relay to eliminate the original short section of hose between two pipes. This needed a blind fixing as it goes into the box-section behind the panel:

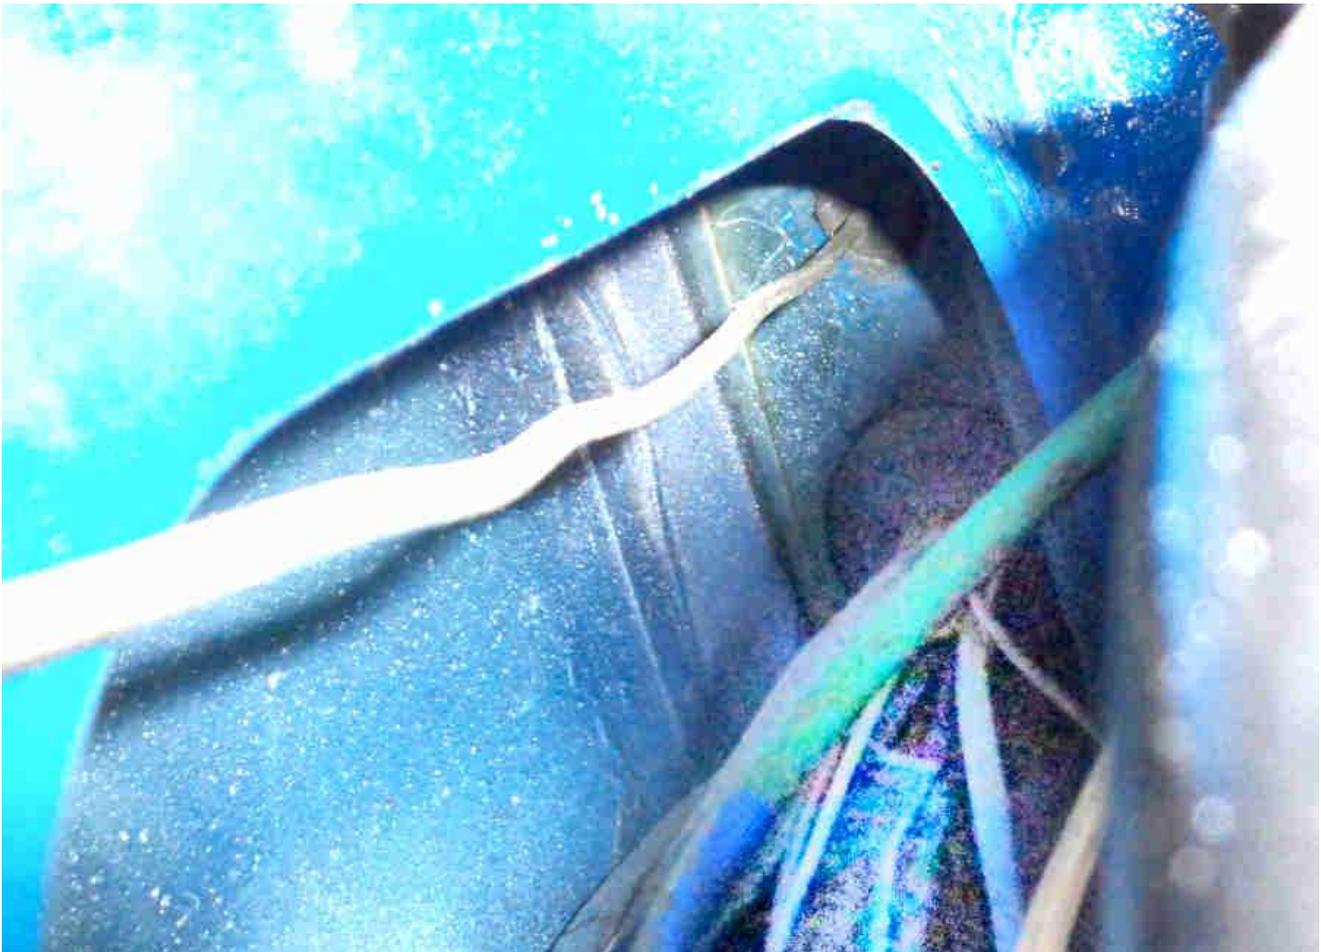
The pipe goes through the bulkhead above the main harness:

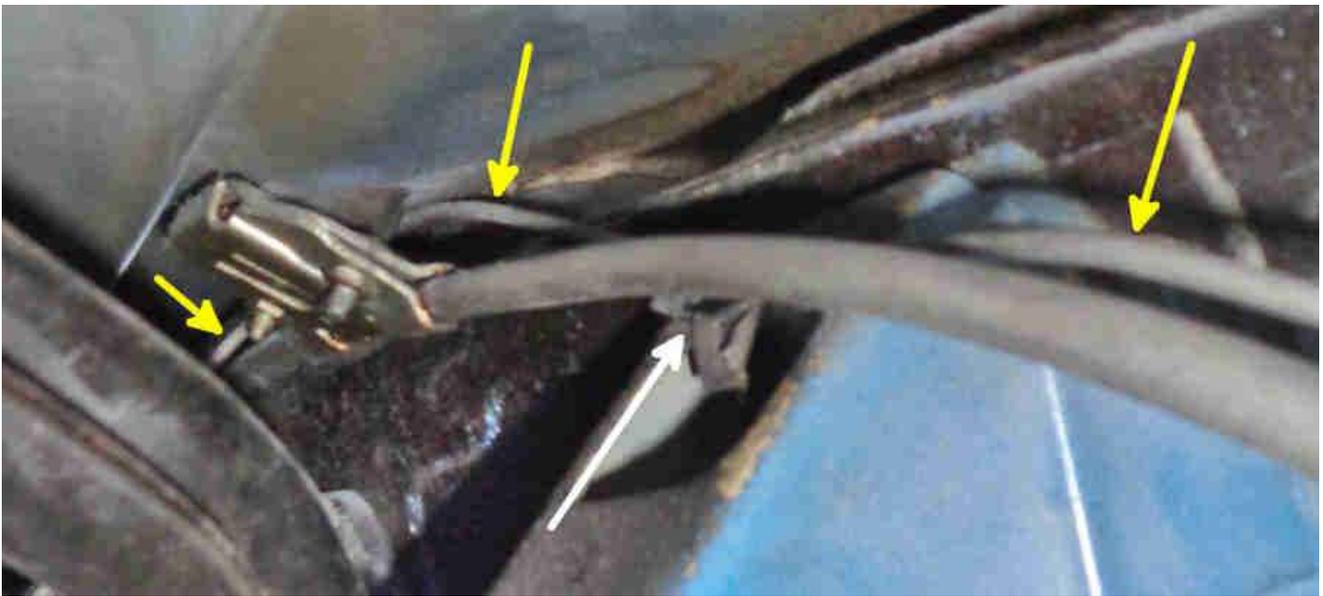
Then across behind the dash and over the wiper box (yellow arrows). There may be a P-clip above the steering column (white arrow):

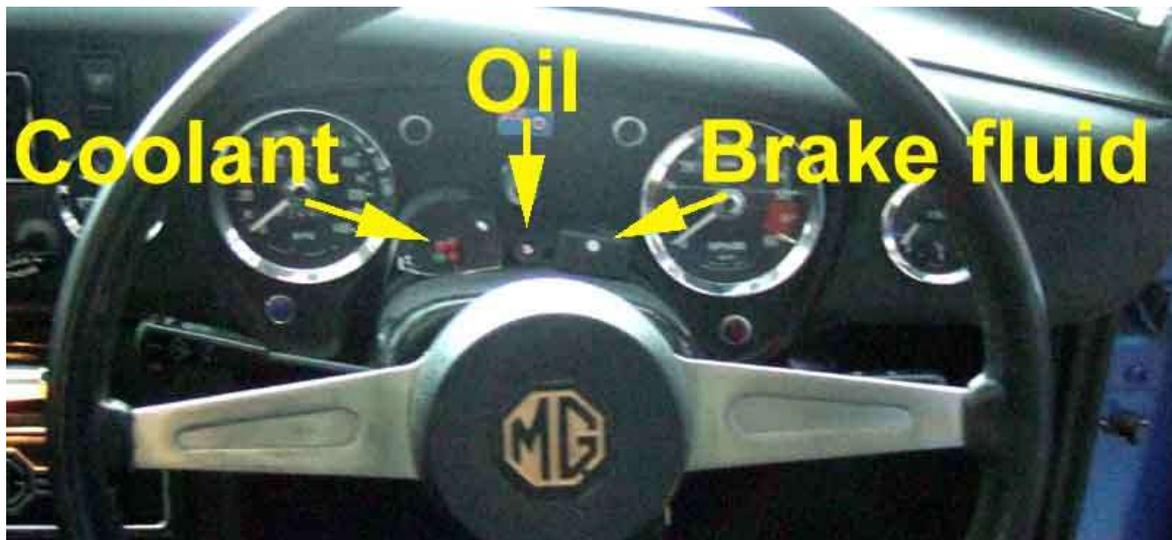
As sunlight masking it is not such an issue in the GT, and I happened to have a high-brightness orange LED to hand, I fitted that in the same position as the original 'OD inhibited' warning light on the roadster, between the coolant and brake fluid level warning systems, rather than messing about getting a pukka 'oil warning' warning light and swapping the LED as I had for Bee. Not terribly elegant, really all three could do with being pukka warning lights in a mini console, but that's quite a big job. If I could have got a coolant level warning to match the brake and oil warning versions that are available, I'd have been tempted:

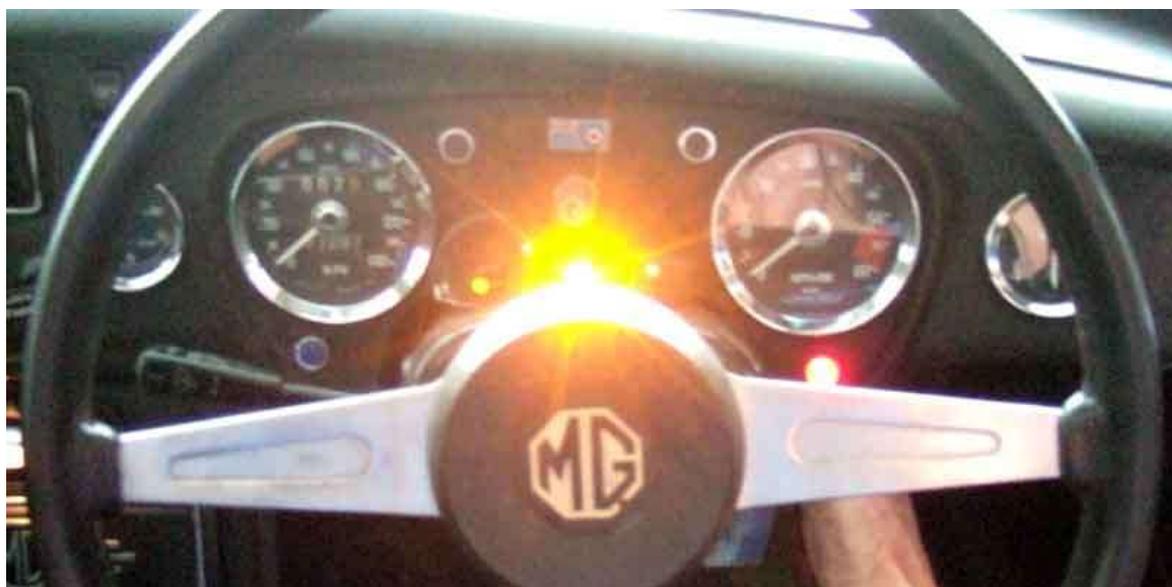
Hopefully won't miss that, the ignition warning light is lower right, and the 'coolant OK' green LED immediately to the left:

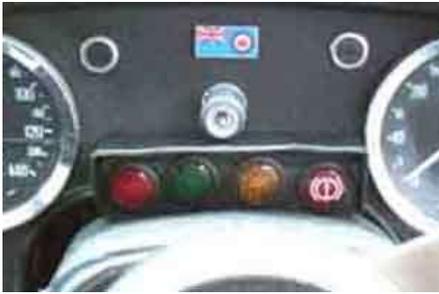
All off ...

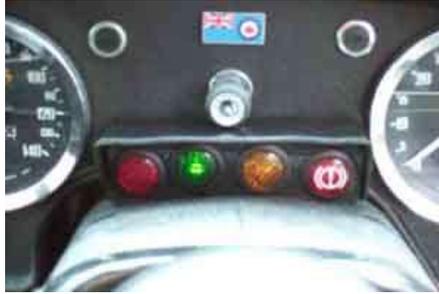
Normal running:

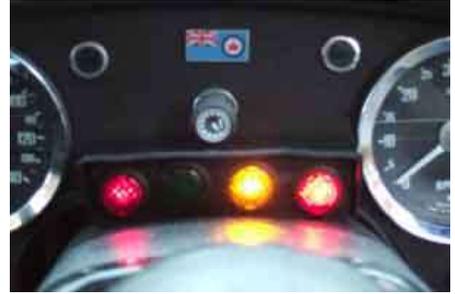
Full son et lumiere:

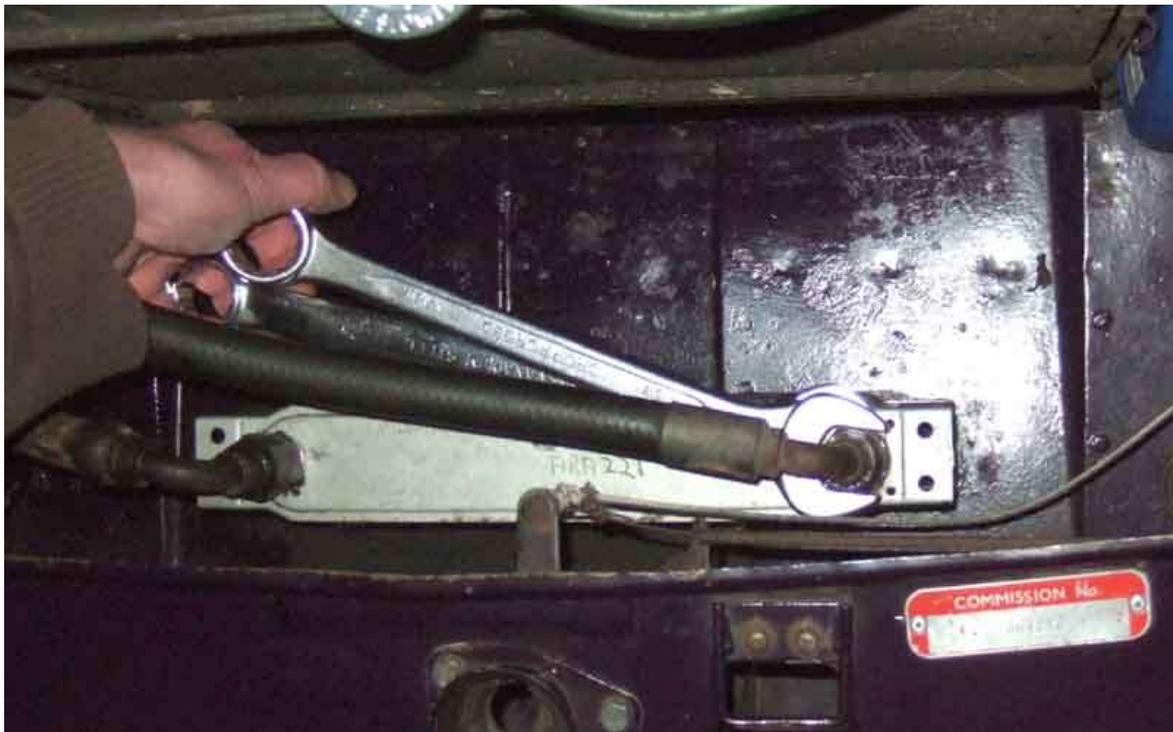
Undoing the cooler hose fitting: Spanners on both the cooler hex and the hose fitting hex, in such a way that squeezing the two spanners towards each other applies all the force to the hose fitting in the 'undo' direction, and little if any to the cooler port itself.

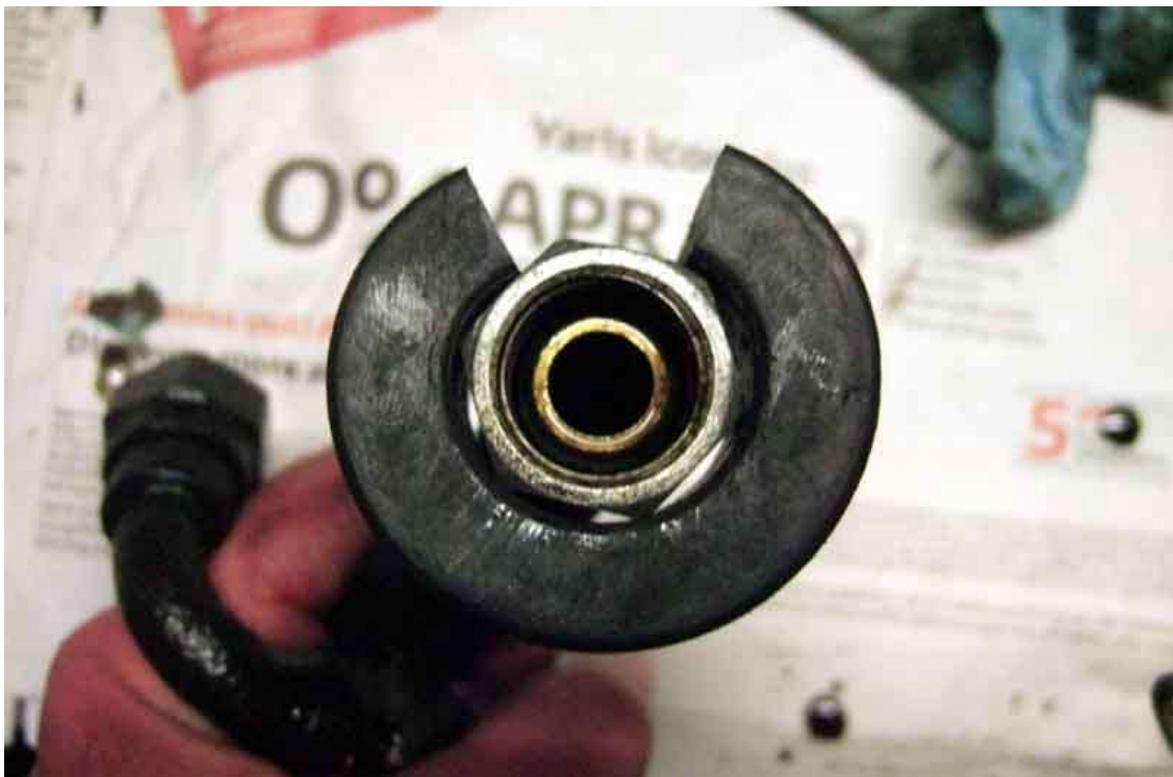
Despite claims to the contrary there is no way these hoses could be pushed through the grommets AHA8401 if the grommets had been pre-fitted to the radiator diaphragm panel. Even split they are very difficult to fit and remove with the hose already in the panel, although the new hoses being smaller make it slightly easier.

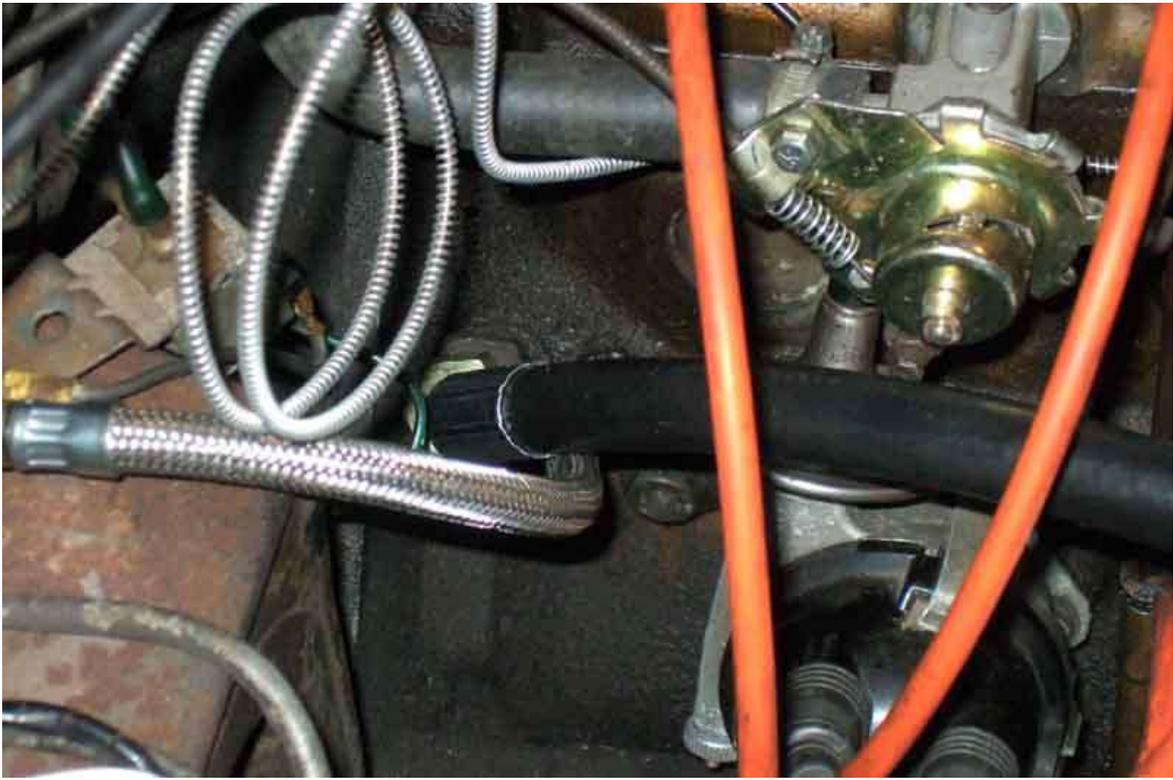
Cooler hose routed above the gauge hose, giving better access to the distributor cap ...

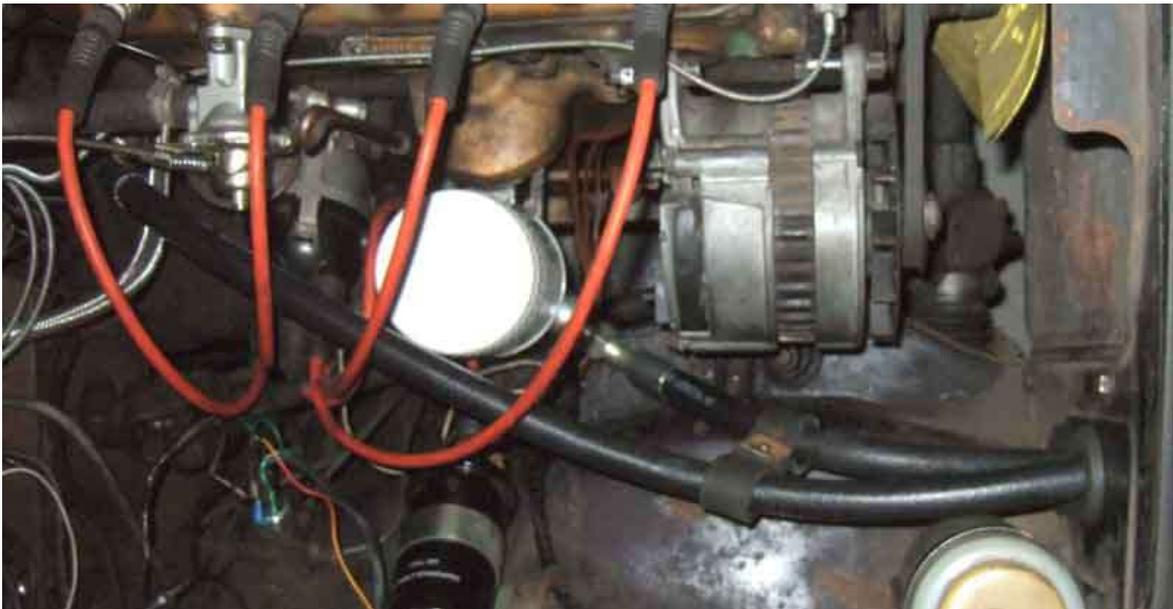
... albeit closer to the filter than before.

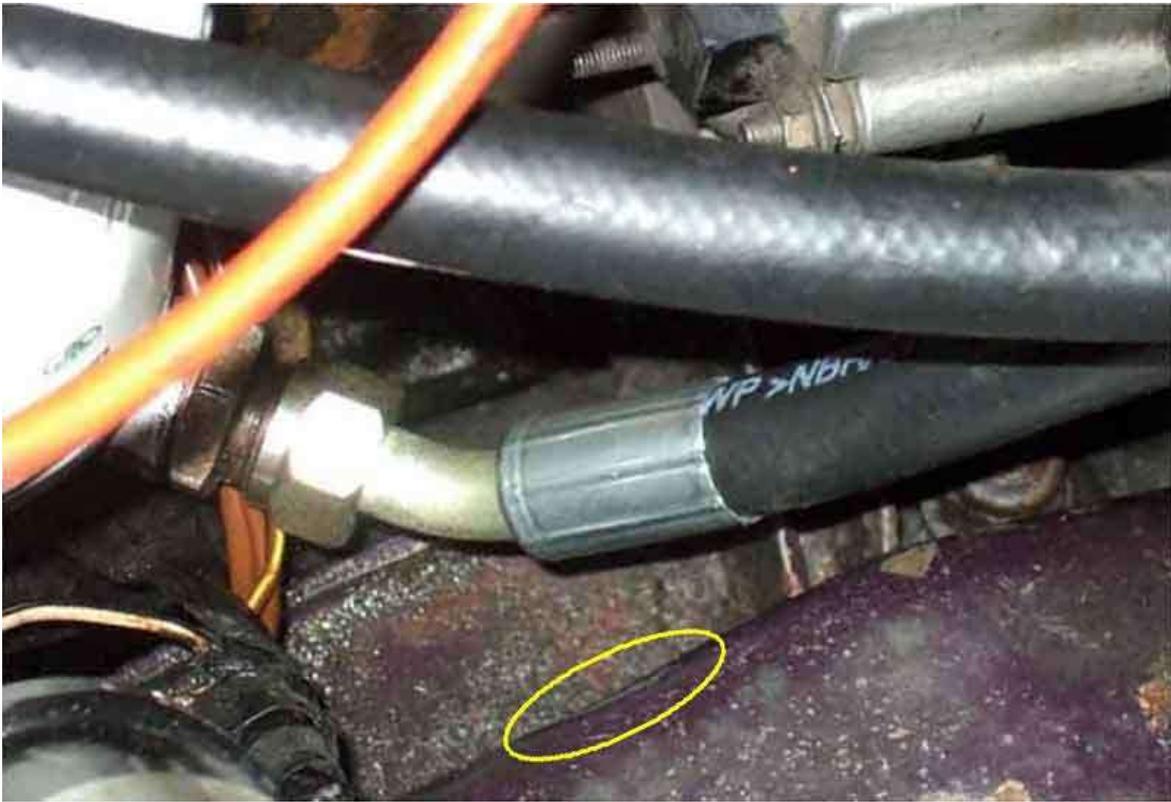
Plenty of clearance to the inner wing though, lack of which caused the problem with the original filter adapter, and had dented the panel (circled) on a bend, which is a lot stronger than a flat panel.

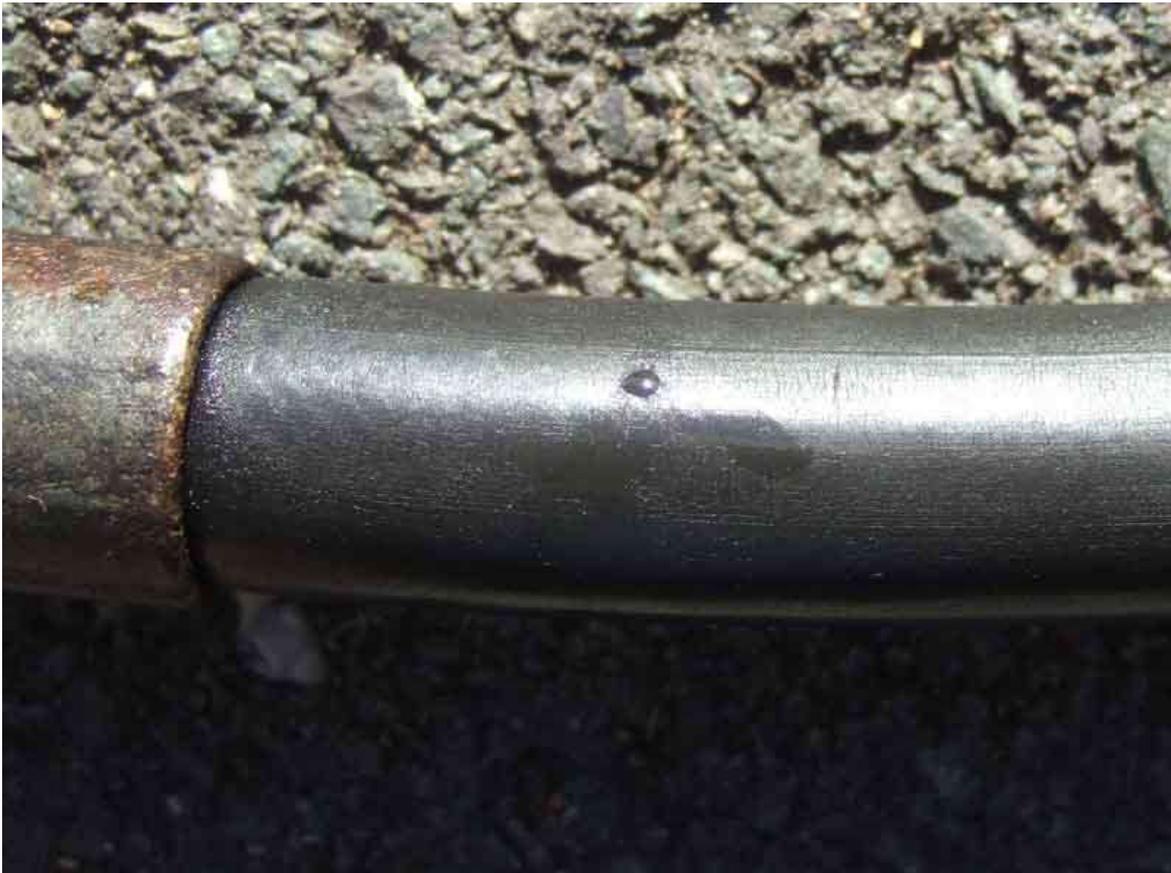
Bead of oil from the source of the leak ...

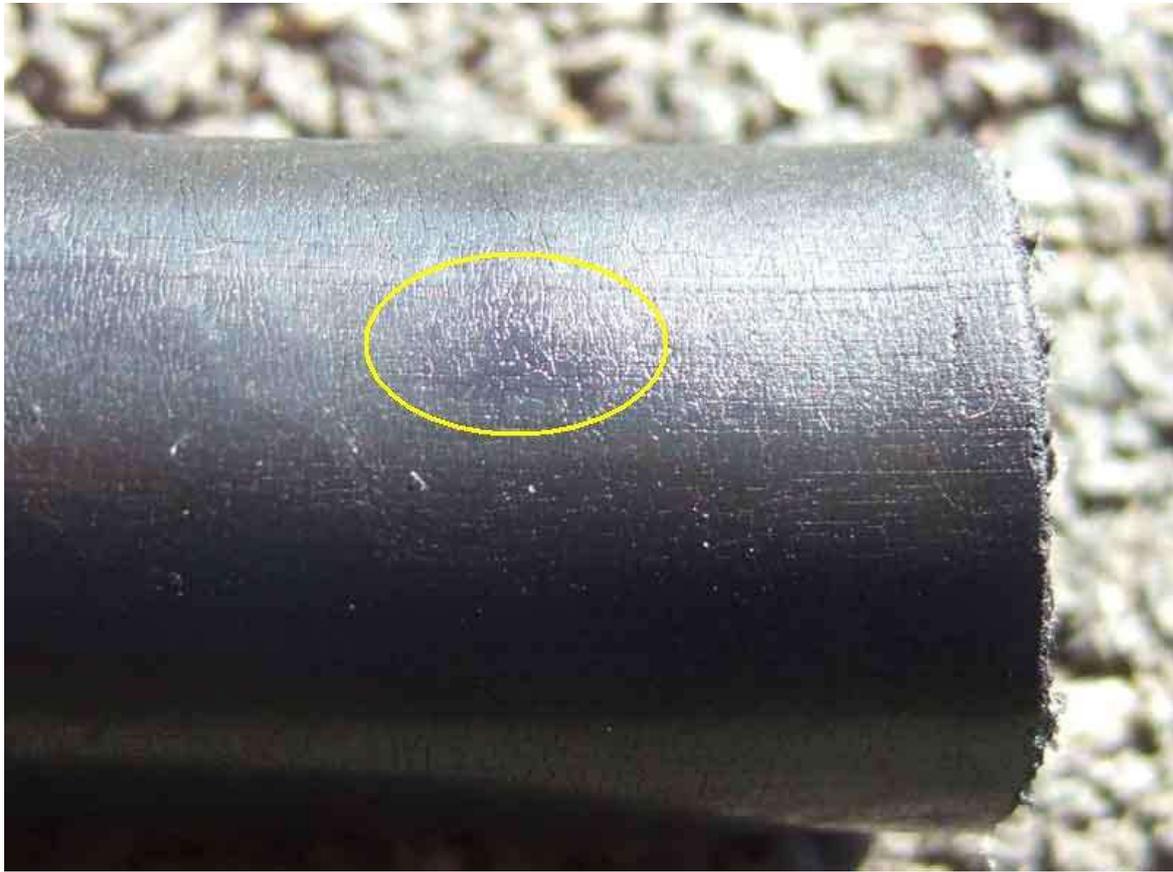
... which when wiped away is indistinguishable from the very fine crazing over the general area.

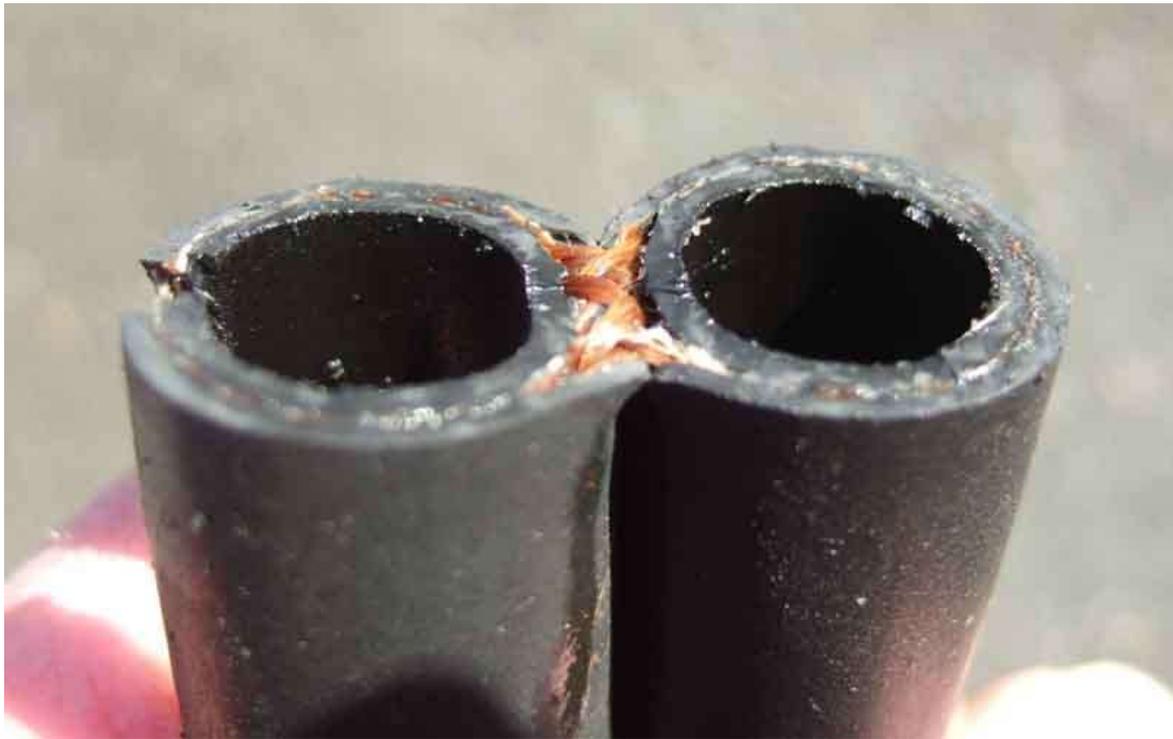
Internally looks ok ...

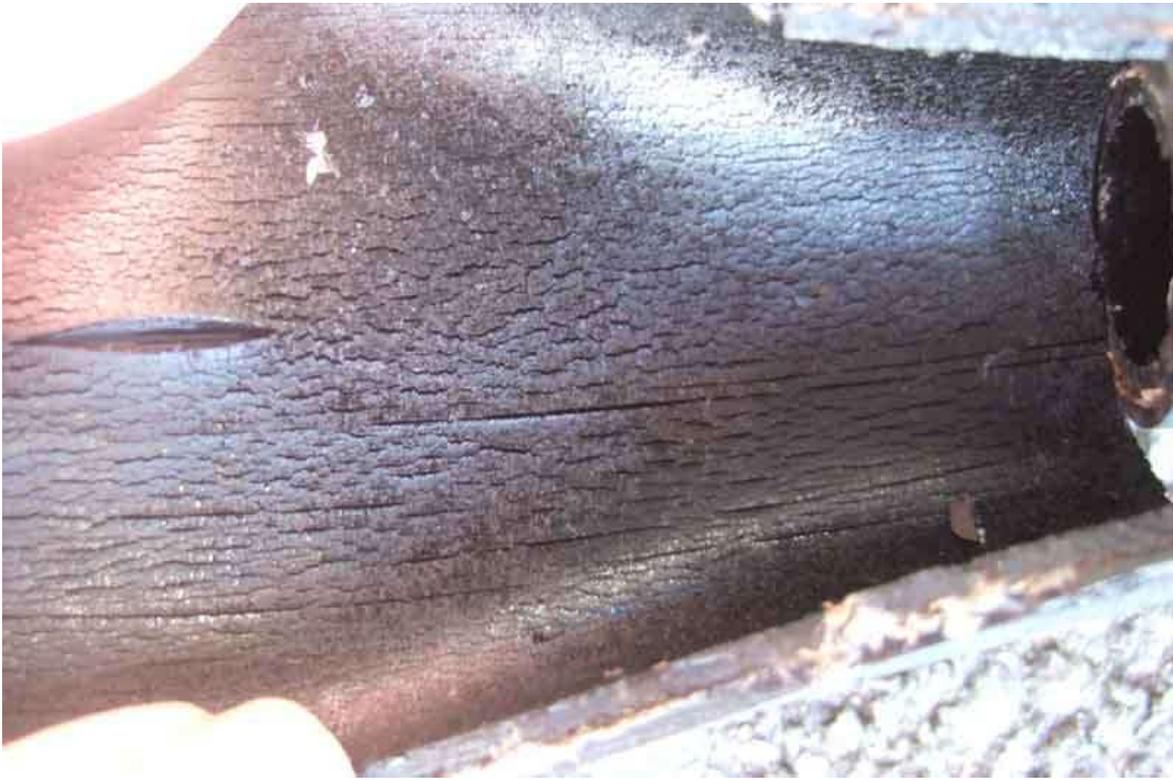
.. until slit lengthwise and opened out, then a lot of fine cracking (the long cut is from the blade I used to slit it) - worse than the external crazing.

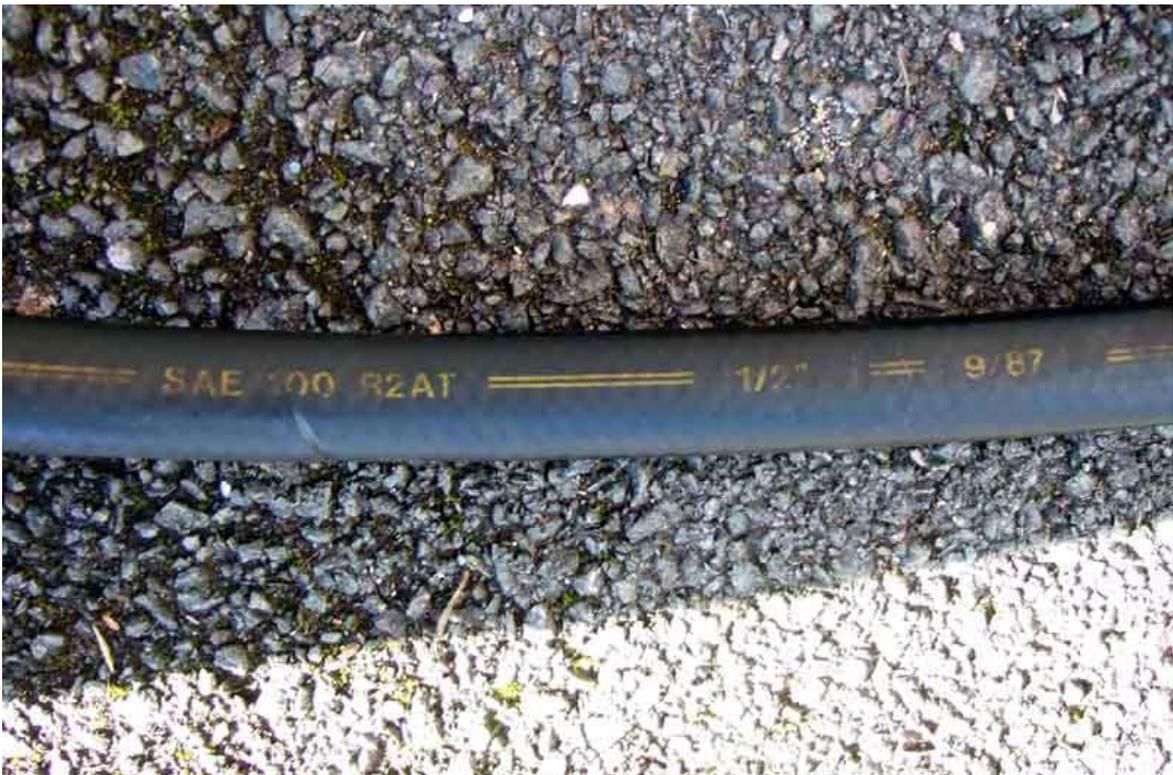
Markings on the long hose (not the failure), indicating it had perhaps already been replaced. No markings on the failed hose, perhaps original.

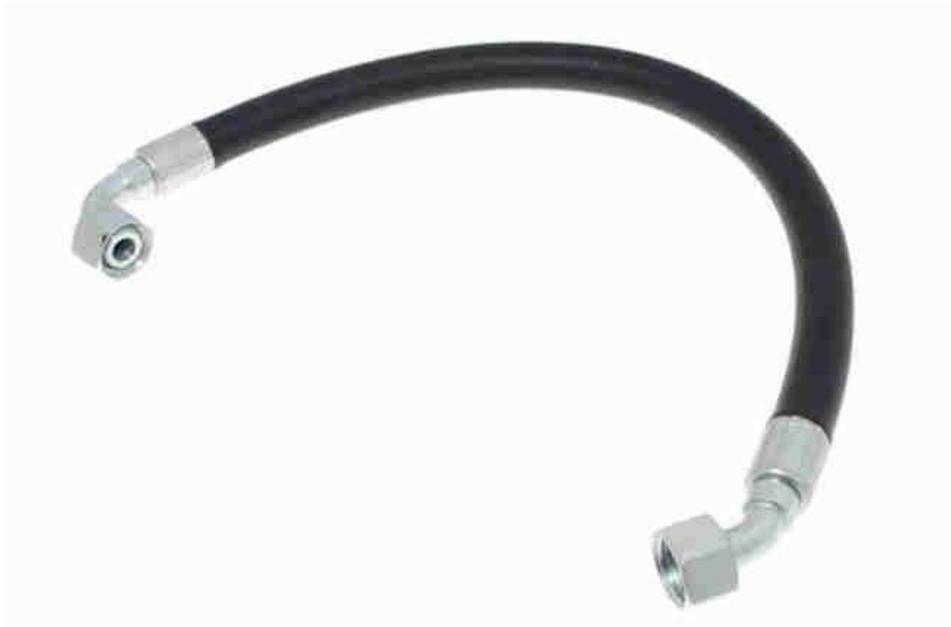
Oil cooler bypass hose [from Rimmer](#) (also [Moss Europe](#) and [Mossmotors.com](#)):

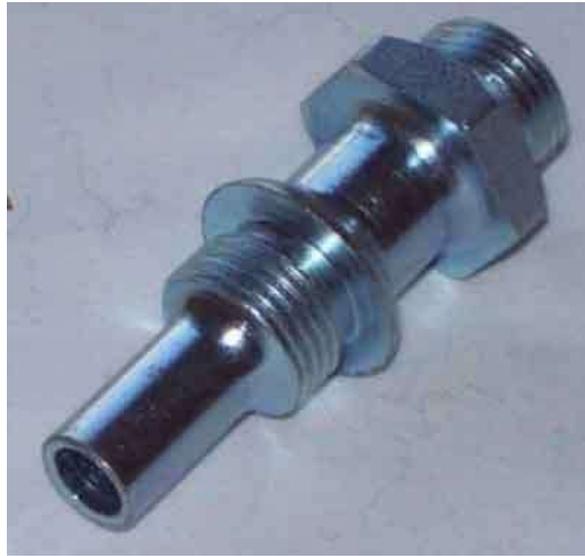
'Full-flow' oil pipe adapter 1H922 as pictured by a number of suppliers. Note this type stands the cooler hose thread away from the block by about an inch: (*Motaclan/Leacy*)

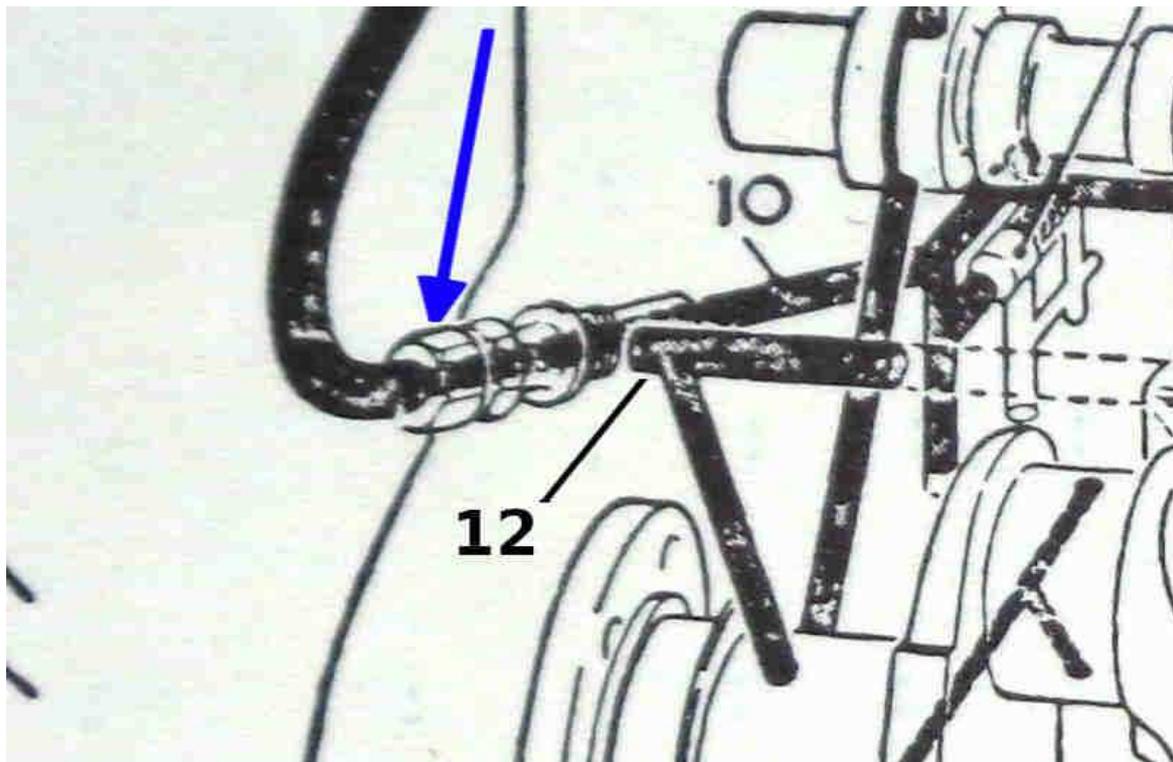
Adapter 1H922 (arrowed) screwed into the block with the spigot projecting into the oil pump gallery (10), isolating it from the main bearing and oil gauge gallery (12) ensuring the oil flows through the filter and cooler (where fitted) before it reaches the bearings:

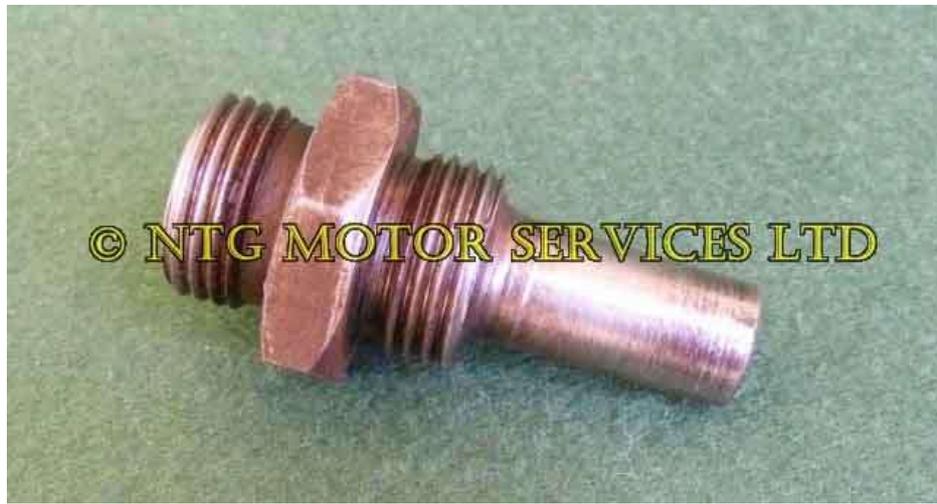
An alternative adapter pictured by NTG for the MGA (and others) and found when Googling 1H922, although NTG list it as 'B034'. This one has the cooler thread close to the block. Also the [identical photograph is shown on another NTG page](#) found by Googling 1H1291, but unlike 1H922 that part number is not referenced anywhere else: (*NTG Motor Services*).

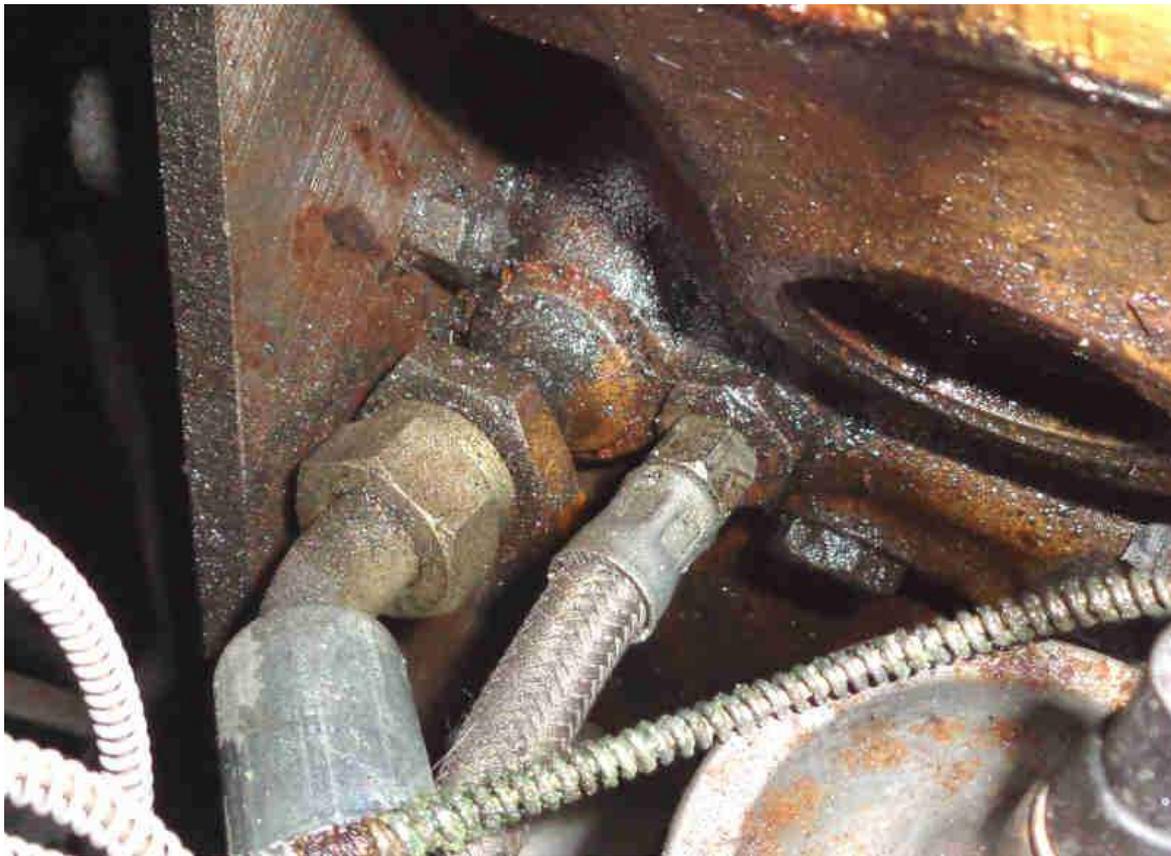
The 'stand-off' type allows a spanner (and maybe a socket) to be used on the adapter without fouling the back-plate nut that is close by, or the oil gauge adapter (it's amazing how oily an engine seems to get even when it doesn't drip ...):

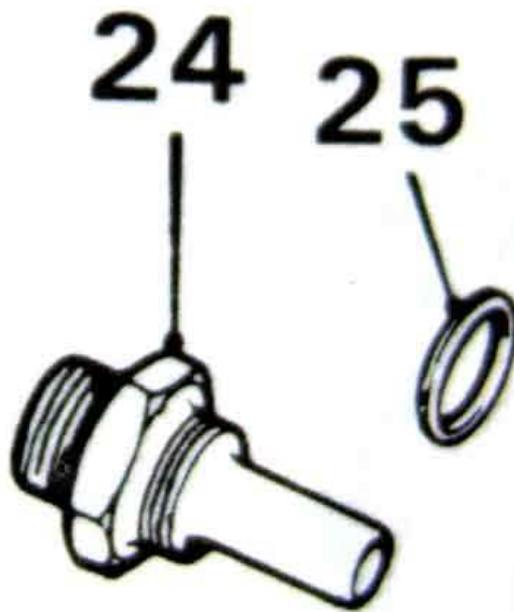
The drawing in Parts Catalogue shows the same shape as the NTG item, and with the 1H922 part number. However drawings are only representative and are often carried forward from a previous version without being redrawn even though the part number has changed: (*Parts Catalogue*)
