Crankcase Breathing

Cylinder Block

Engine Numbers

Dating the Block

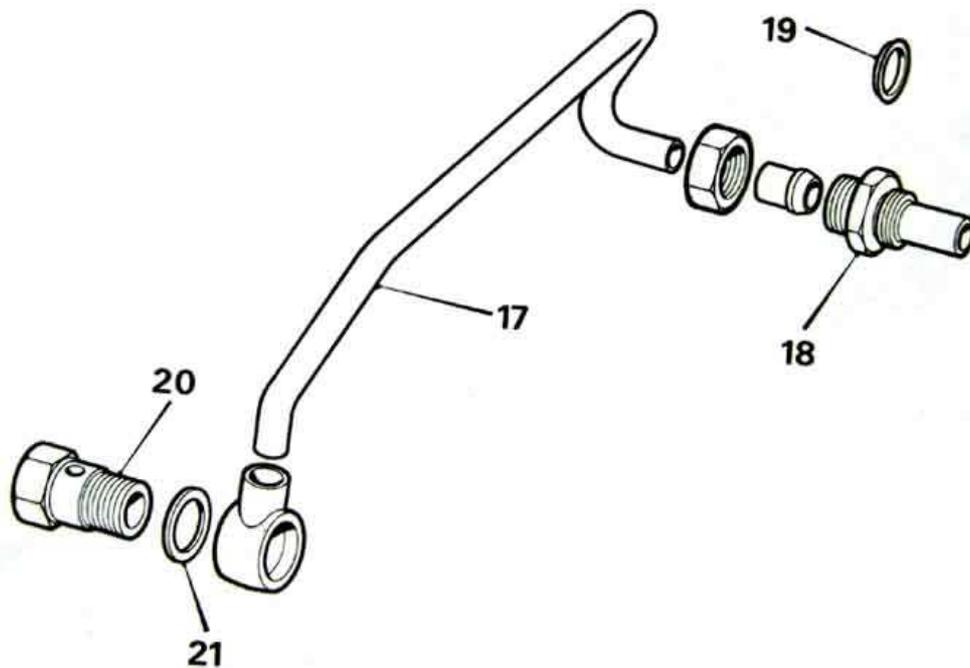
Parts catalogue drawing of direct pipe 1H1056 showing a separate ferrule of 'olive' that could be soldered further back from the end of the pipe to leave a spigot that would project into the rear gallery to largely seal that off from the main-bearing gallery. This would need plain adapter AHH6701, although a 'full flow' adapter is shown with it:

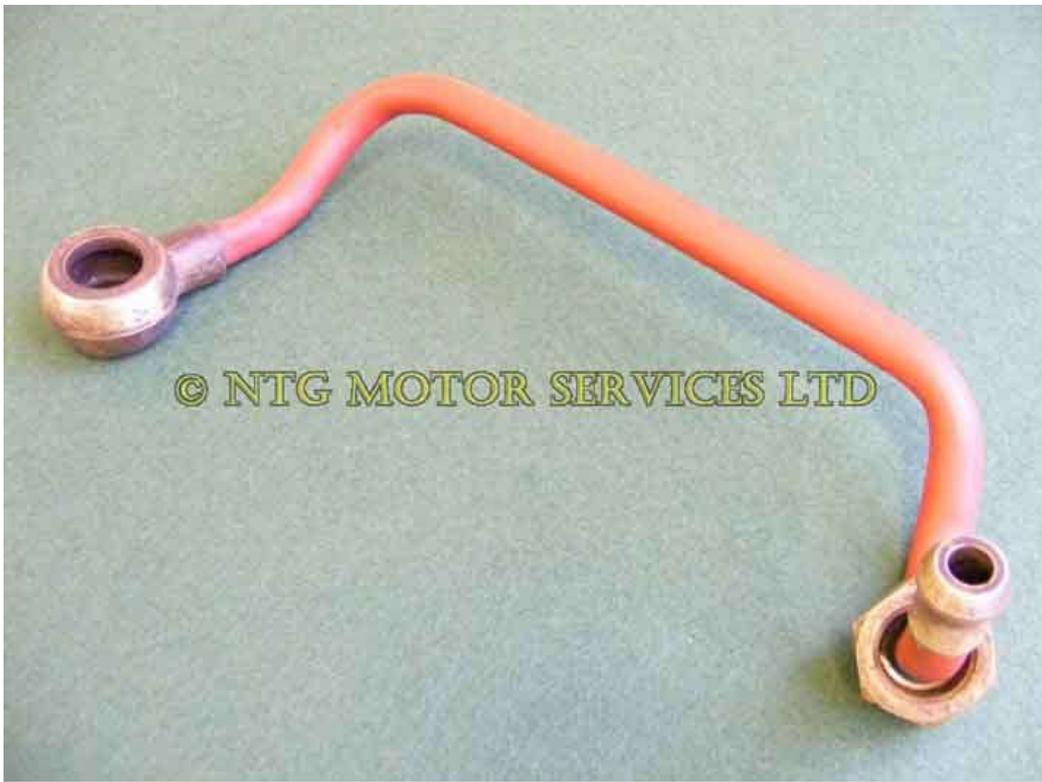
'Direct' pipe 1H1056 with the fitting right on the end of the pipe, requiring a 'full flow' adapter: ([NTG Motor Services](#))

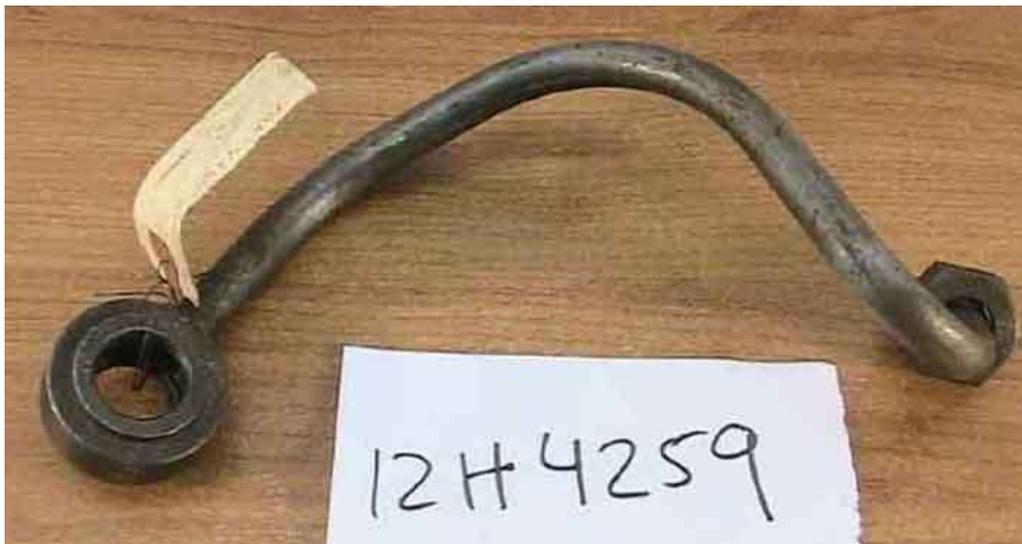
'Direct' pipe 12H4259 ditto: ([MGE](#))

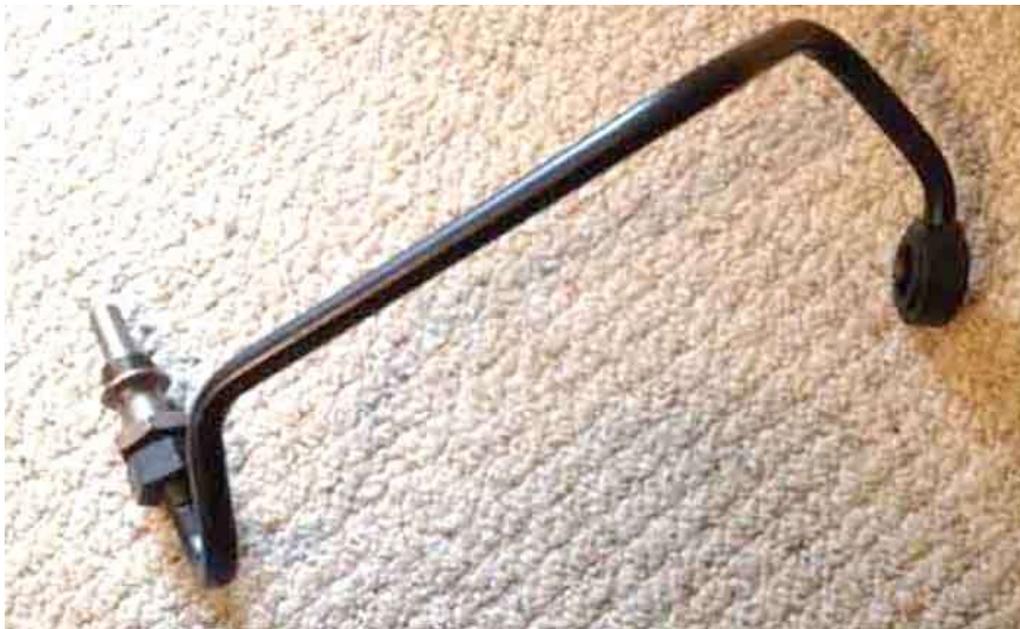
'Direct' pipe 1H1056 with adapter 1H922 attached: ([MGE](#))

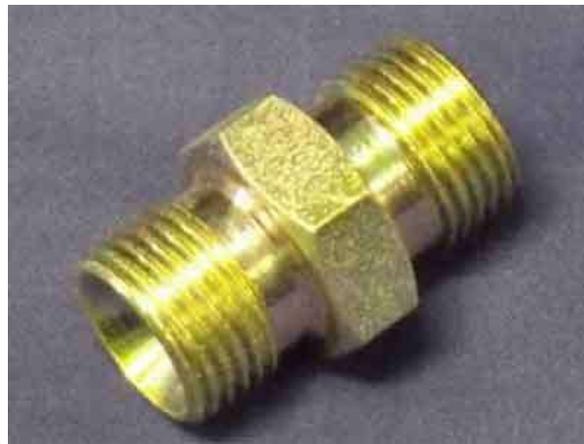
'Plain' adapter AHH6701, used at the filter adapter for the return hose from the cooler. However Motaclan/Leacy show a quantity of 2 which is incorrect, if this is used in the block with a cooler hose then the majority of the oil will bypass the filter:

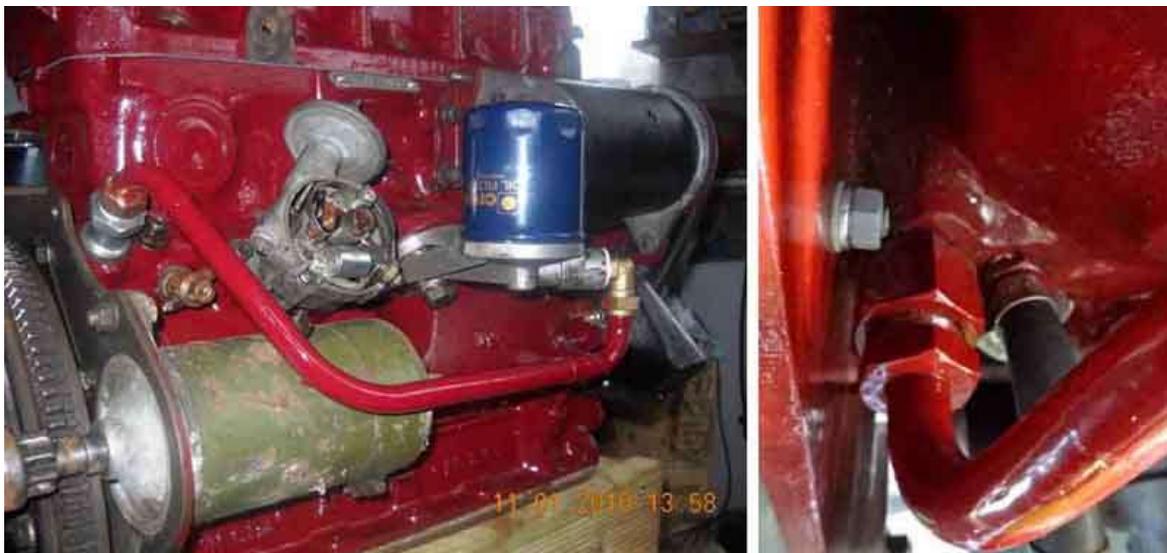
The picture on the left could be showing a stand-off 'full flow' adapter, the one on the right does not seem to be a 'full flow' adapter of either type. Both pipe unions appear to screw into the adapter, rather than on to it which would be the case with either of the 'full flow' adapters pictured above. Unless there is a spigot projecting into the oil pump gallery the majority of the oil will bypass the filter. The left image is of a 'homebrew' fitting of a [spin-on filter adapter to an MGA from Barney Gaylord's pages](#). The right image is from Willy Revit in Tasmania and is said to be of an engine from a UK 1976, in which case someone has removed the oil cooler fitting (according to Clausager all five-bearing MGB engines had the cooler) and substituted a direct pipe using an unknown adapter:

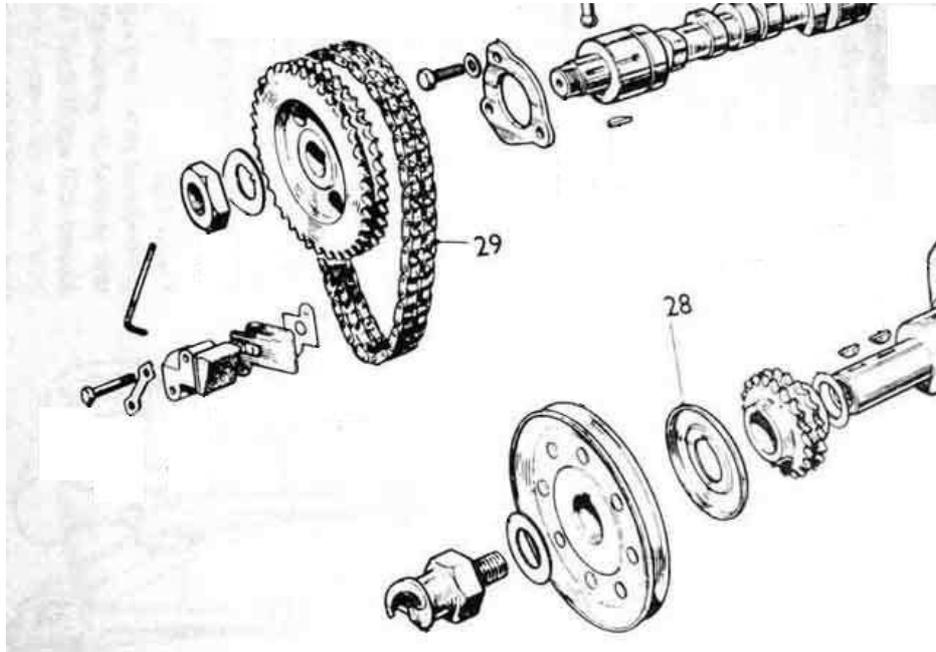
The early double-row timing chain (29) with the concave side of the thrower (28) facing away from the engine (these and the following images from Leyland Workshop Manuals).

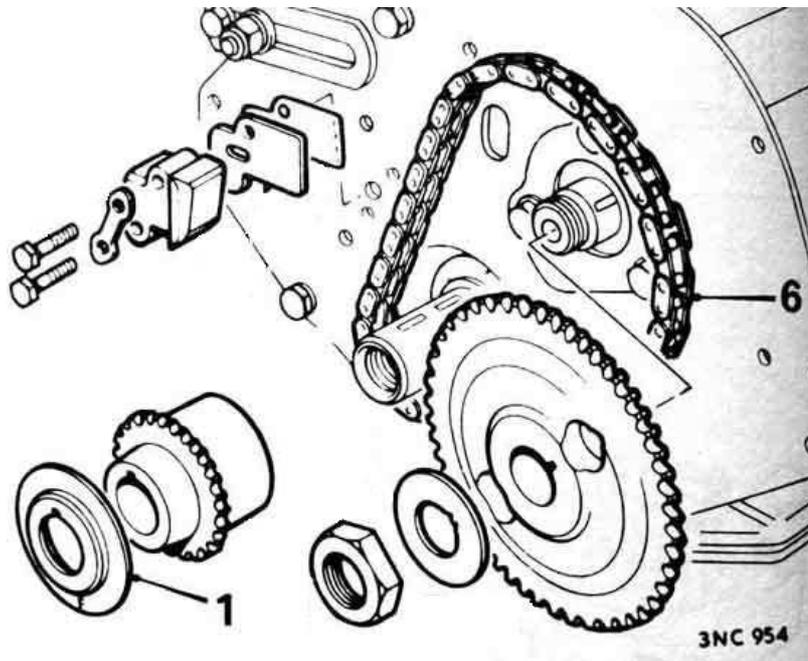
The later single-row chain (6) with the thrower (1) facing towards the engine.

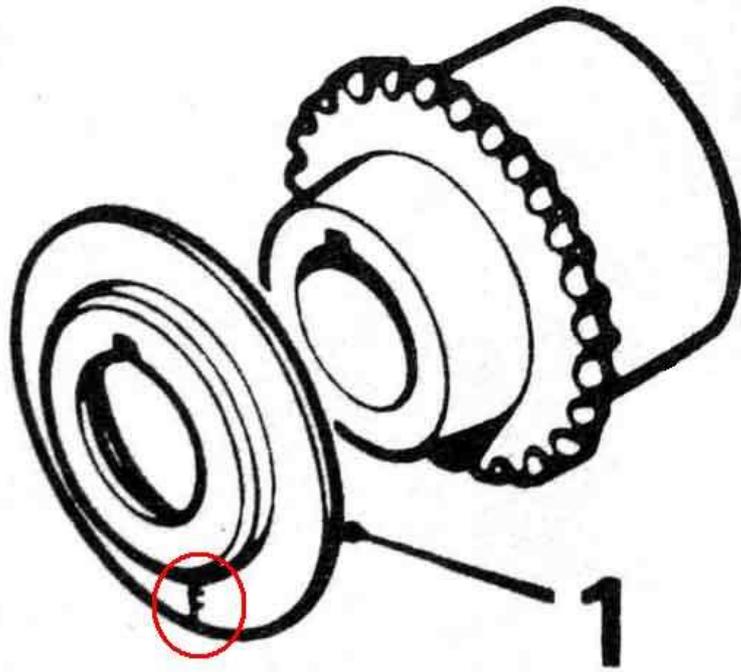
Detail of the thrower showing the 'F' (circled) stamped on the side that faces away from the engine, reputedly on the appropriate side of the earlier thrower as well.

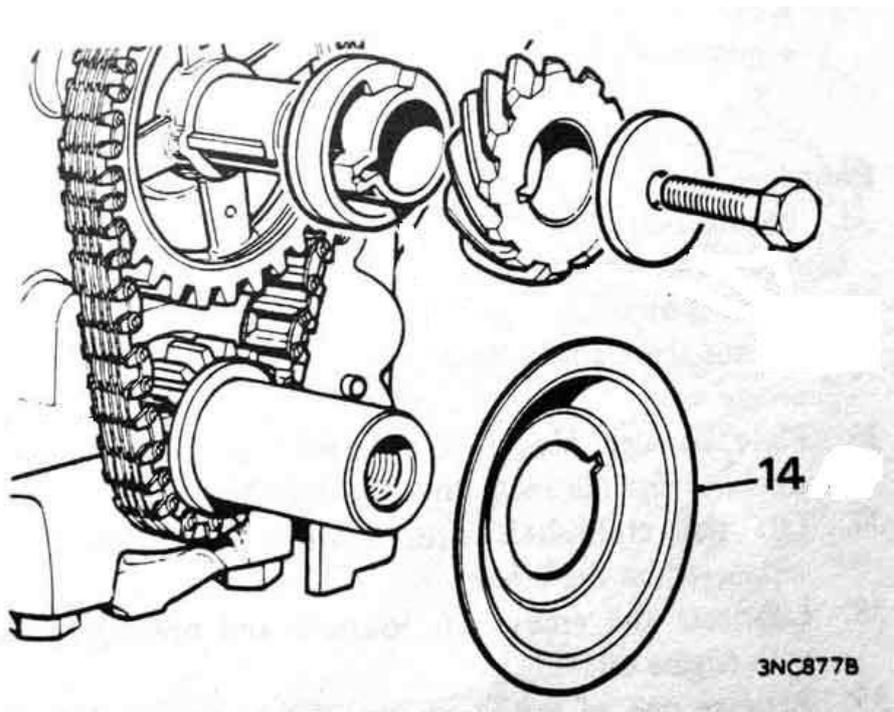
The V8 thrower (14) facing away from the engine, I can't recall if this is stamped with an 'F' or not, the text of the manual doesn't mention it.

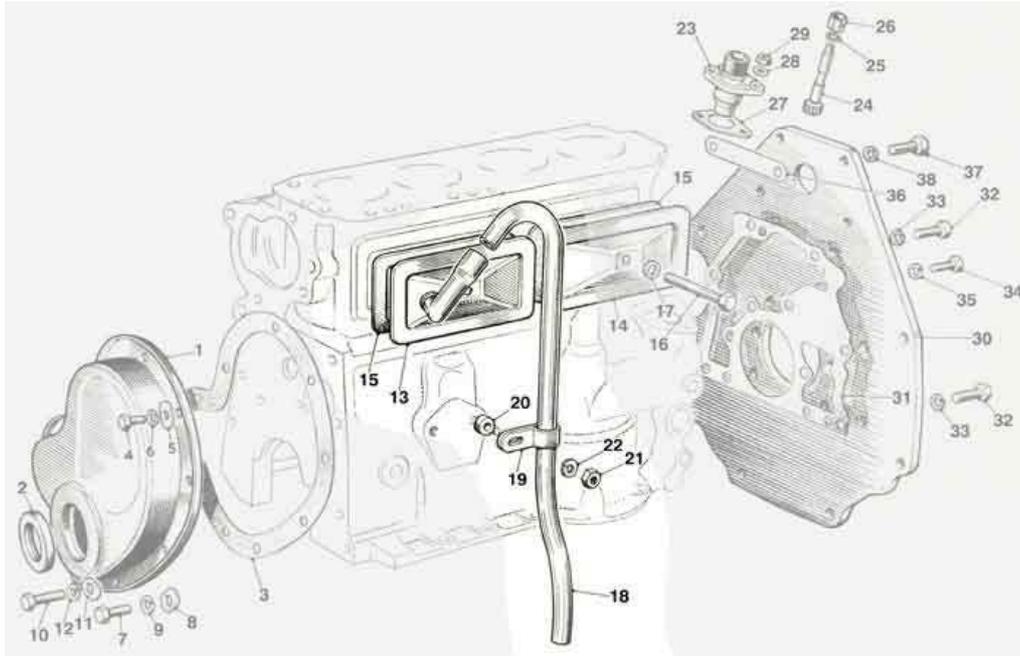
Early unrestricted and unfiltered cover 12H950 for the 'road draught tube' used on non-positive ventilation systems. ([Auto-Part.com](#))

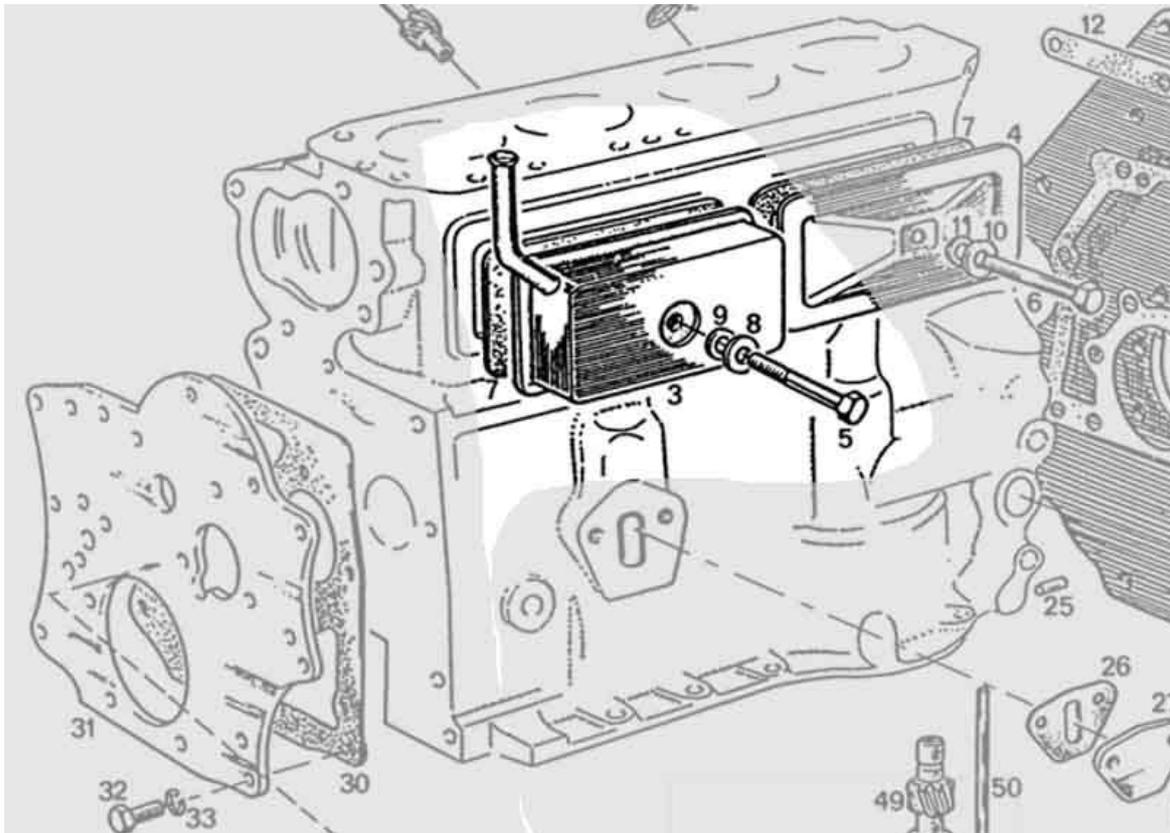
Cover with internal filter and oil separator 12H1399 for PCV-ventilated systems. ([Moss Europe](#)) However despite the drawing showing it as being box-shaped one corner was flattened as per [the top one here](#).

Cover 12H1399 (above) with internal filtering and oil separation, used with the PCV valve: *(Chris Howells)*

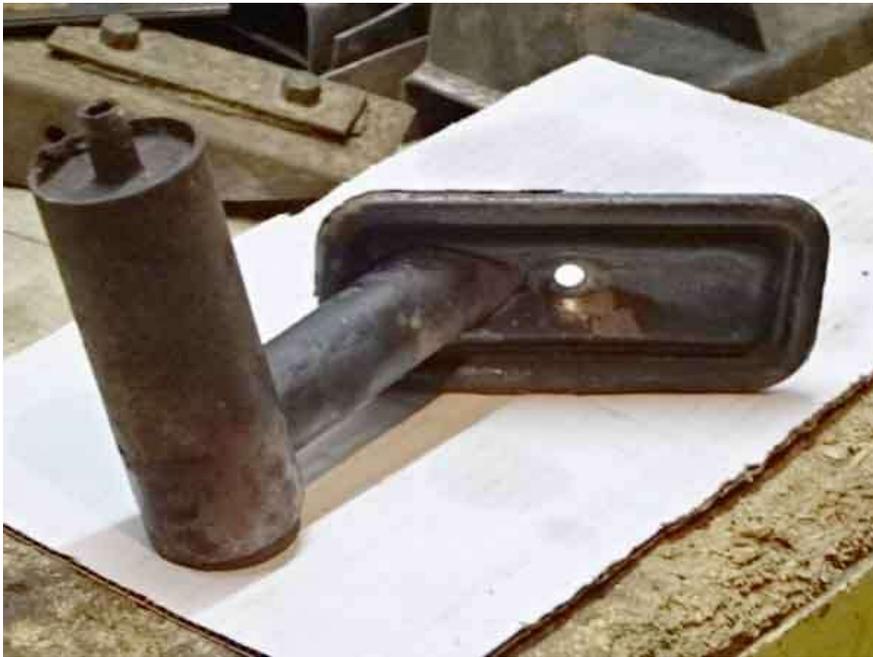
Cover with external filter and separator 12H3684 used when carburettor ventilation was introduced with 18GG engines (69 model year), and used until the 18V779/780 engines were introduced during the 74 model year. However the Parts Catalogue states that rebuilt engines used the cover below, as is the case on Bee's Gold Seal engine. *Image from William Revit in Tasmania via the MG Enthusiasts forum.*

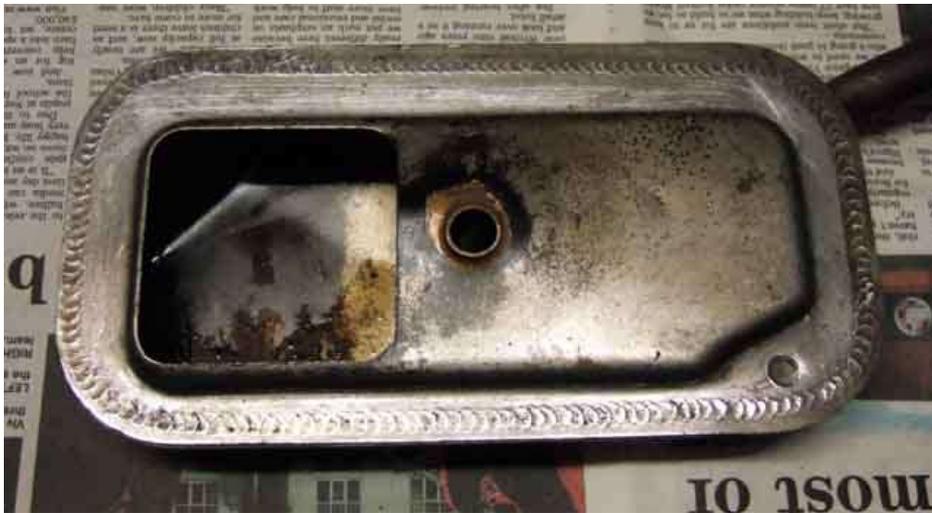
The later front cover 12H4395 ...

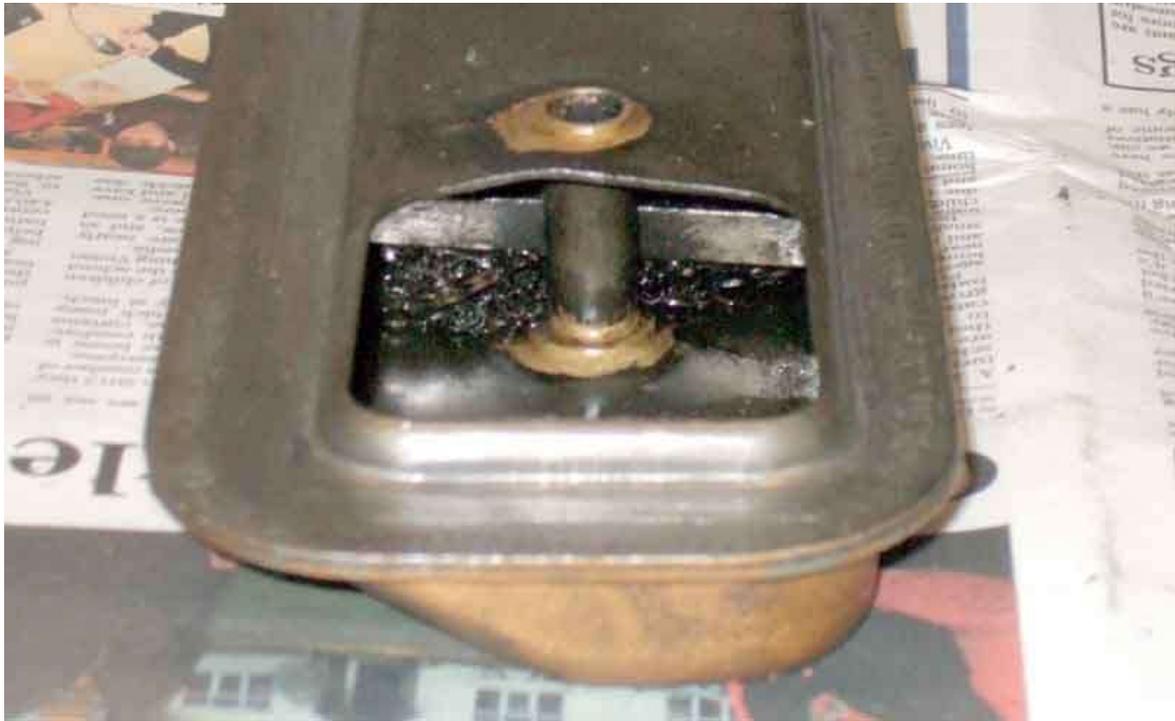
... with internal oil separator/flame trap steel 'pan scourer'. However [at least one person](#) has found this resulted in excessive oil burning via the cover and replaced it with the earlier PCV version 12H1399. With one corner flattened and the opposite corner changed in shape as per [the lower one here](#).

Oil burning via the breather: Adam's original (12H4395) and replacement (12H1399) covers. The strip of metal near the top left corner of the replacement cover is positioned over another set of holes. I suspect these are nominally the inlet, with the strip of metal acting as a shield preventing oil running down the walls from trickling in. The holes at the bottom draining any oil mist converted to liquid drops by the wire wool.

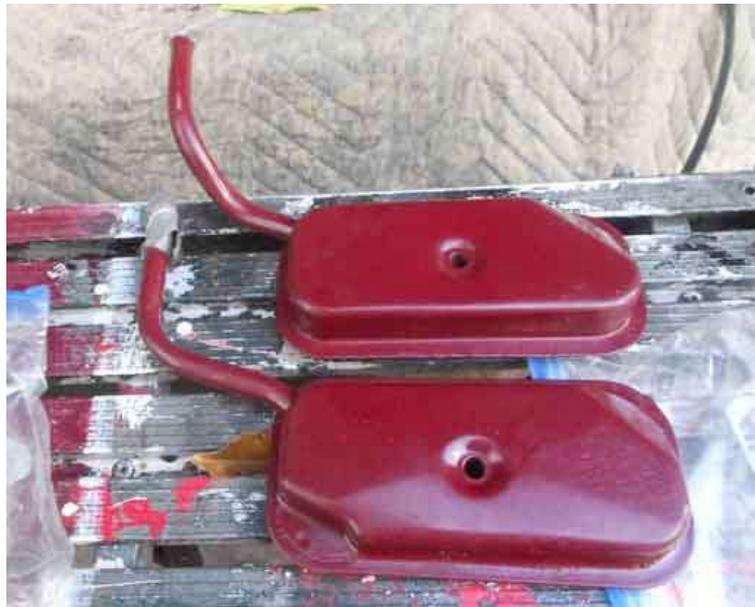
12H1399 above, 12H4395 below. (Chris Howells)

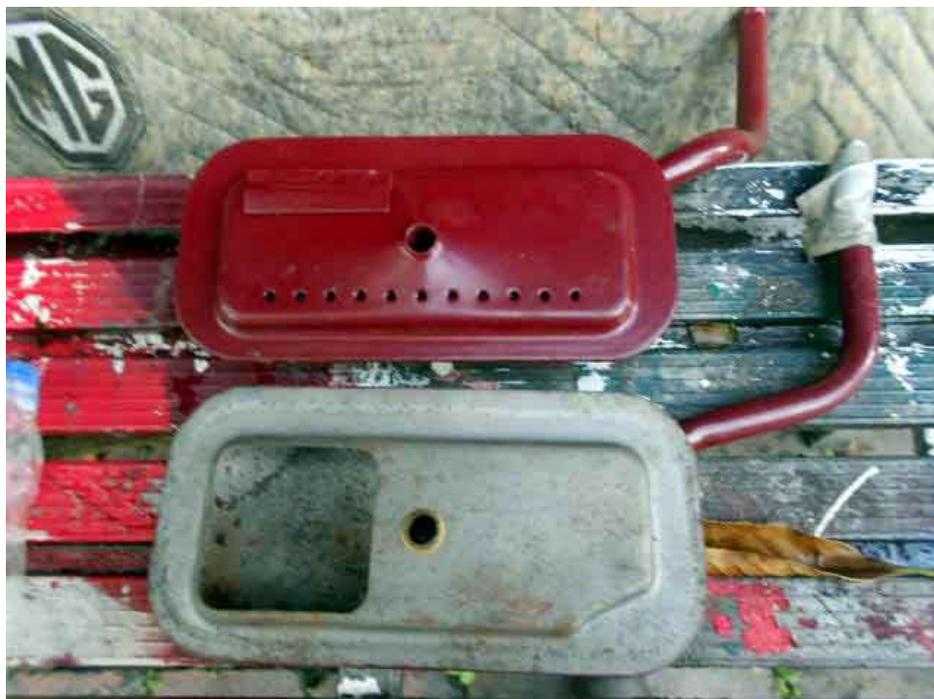
12H1399 above, 12H4395 below. (Chris Howells)

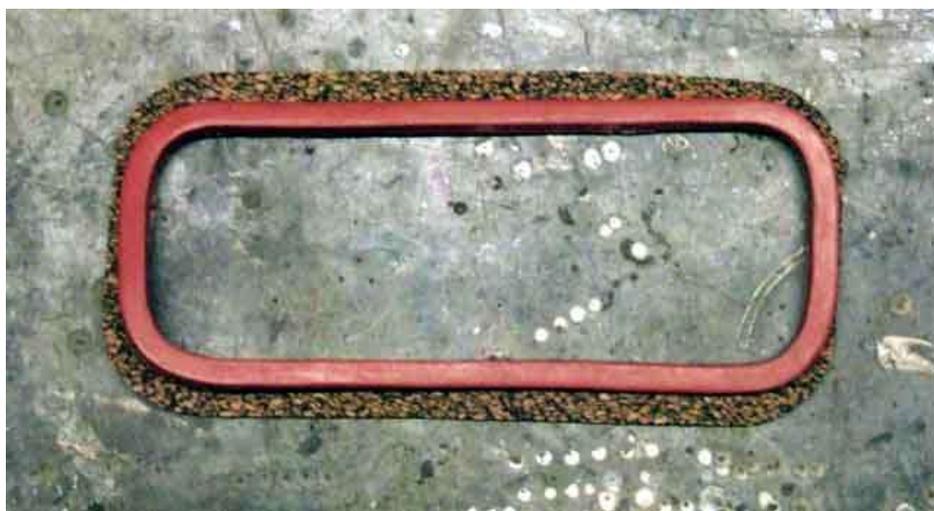
Rubber gasket quite a bit smaller than cork

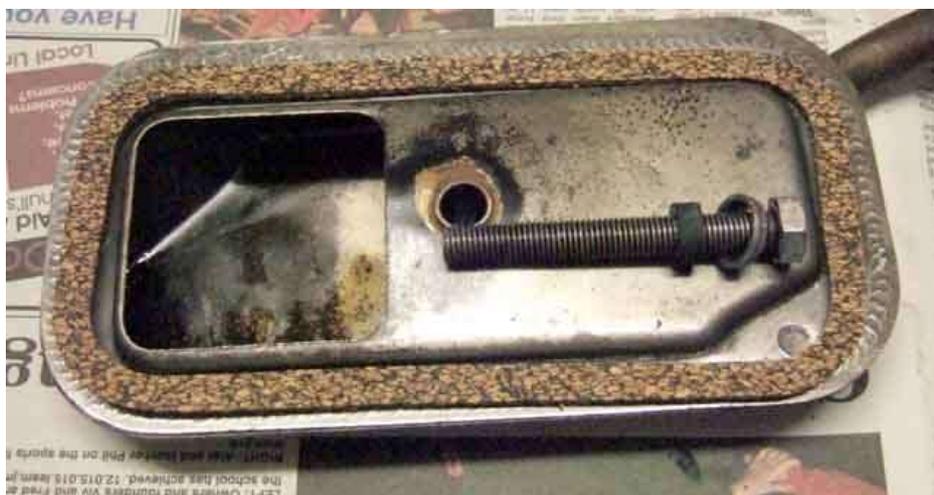
It's possible the rubber would stretch to fit the front cover, but it would be very difficult to keep it in place. The cork is an easy fit, but note how it has to seal against a 'rippled' surface where the inner and outer plates have been attached together. Note also the very long bolt, cup washer and rubber bush. The pre-September 76 Parts Catalogue indicates a copper washer (or two) was used here with only this cup and bush on the rear cover, the September 76 on catalogue shows cup and bush being used on both covers. My 1973-spec Gold Seal engine had them on both.

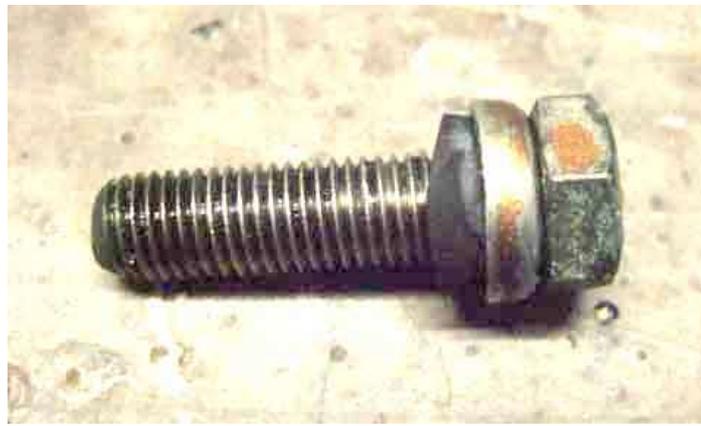
When fitted the bush is pushed into the cup washer, and compressed as the bolt is tightened. The bush wants to squeeze outwards, but is constrained by the cup, so squeezes onto the bolt threads instead, as well as being pressed onto the face of the cover.

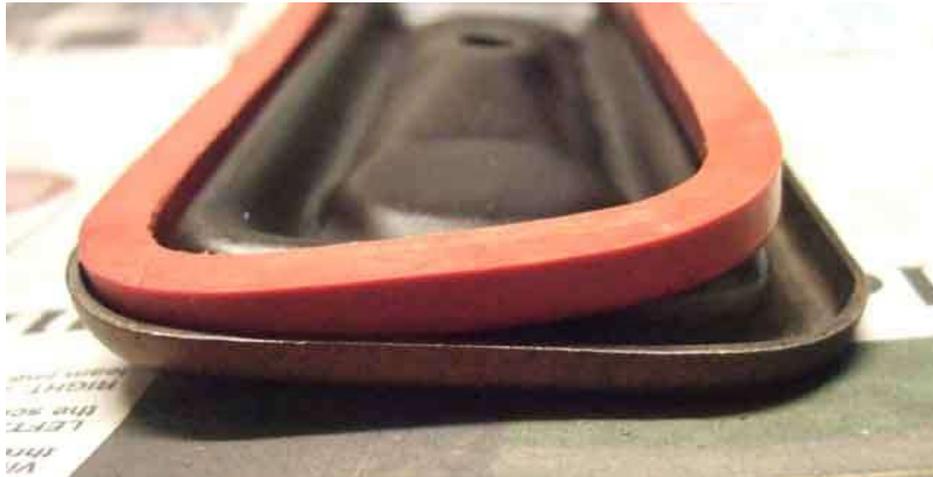
The cork gasket would never fit the rear cover, being too large and thin to fit in the channel. As it is the rubber gasket is slightly too small. This has a flat face and a slightly rounded face, the rounded face fits in the channel.

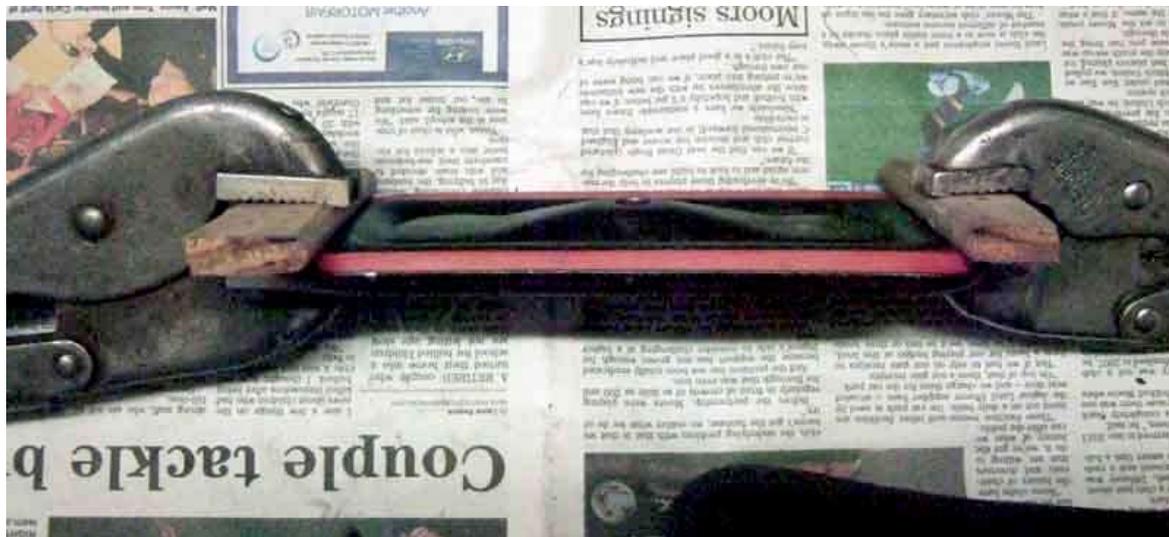
Lightly clamping it in place overnight stretches it. Note the round-edged pieces of wood so the face of the gasket isn't distorted.

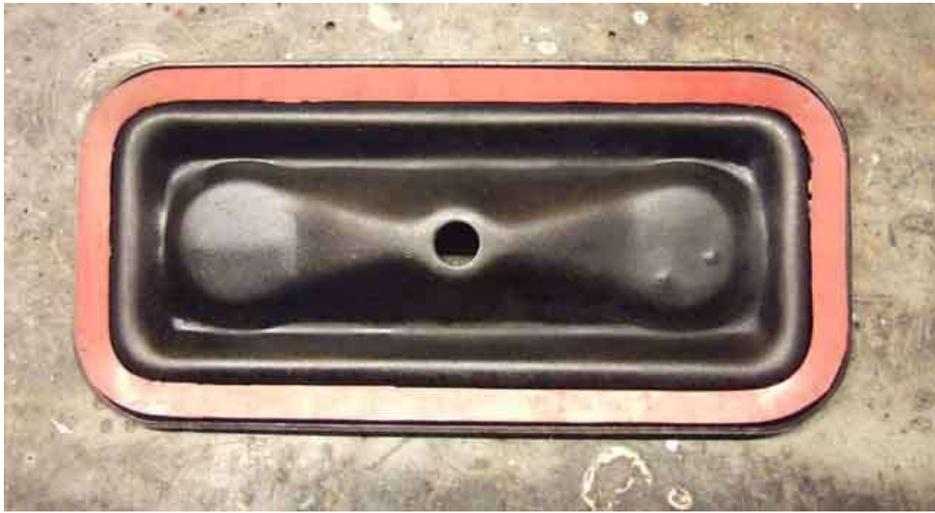
When the clamps were released the gasket stayed in place, but leaving it unclamped for a while allowed it to regain its former size and pop back out.

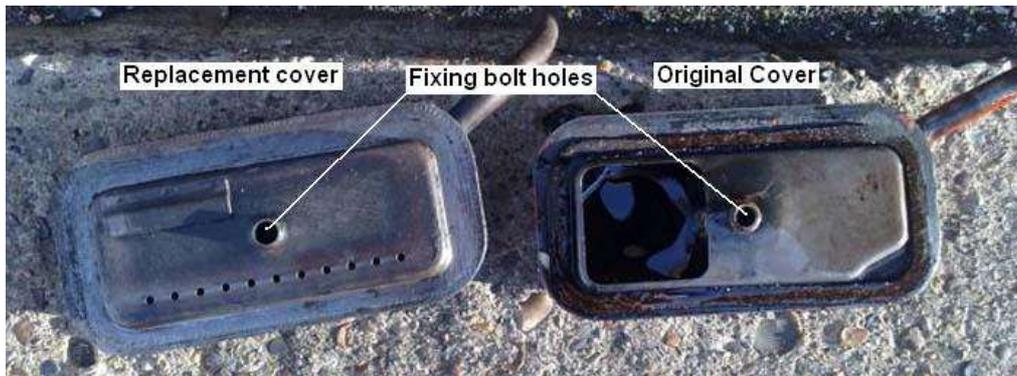
If you have the problem and can't lay your hands on one of these alternative covers it seems to me you could weld a plate over the hole and drill your own holes along the bottom, although I'd remove the wire wool first, drill the holes in the right-hand half of the cover and be sure I had got all the swarf out, replace the wire wool, cut the plate to size, drill that before welding (to keep swarf out of the cover), then weld it to the cover. Or maybe weld a plate over the hole leaving just a narrow slot at the bottom.

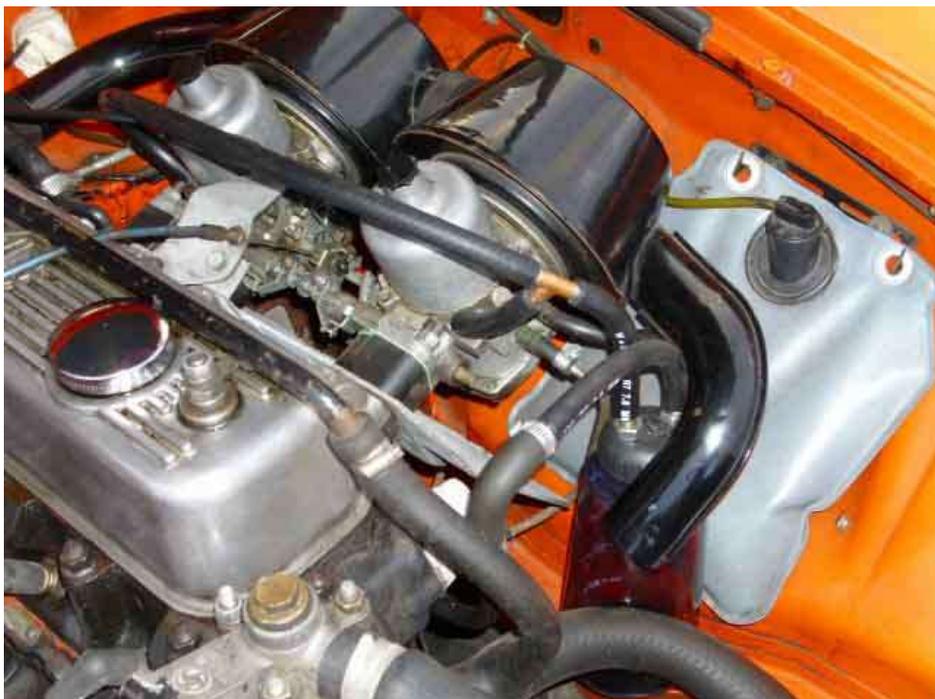
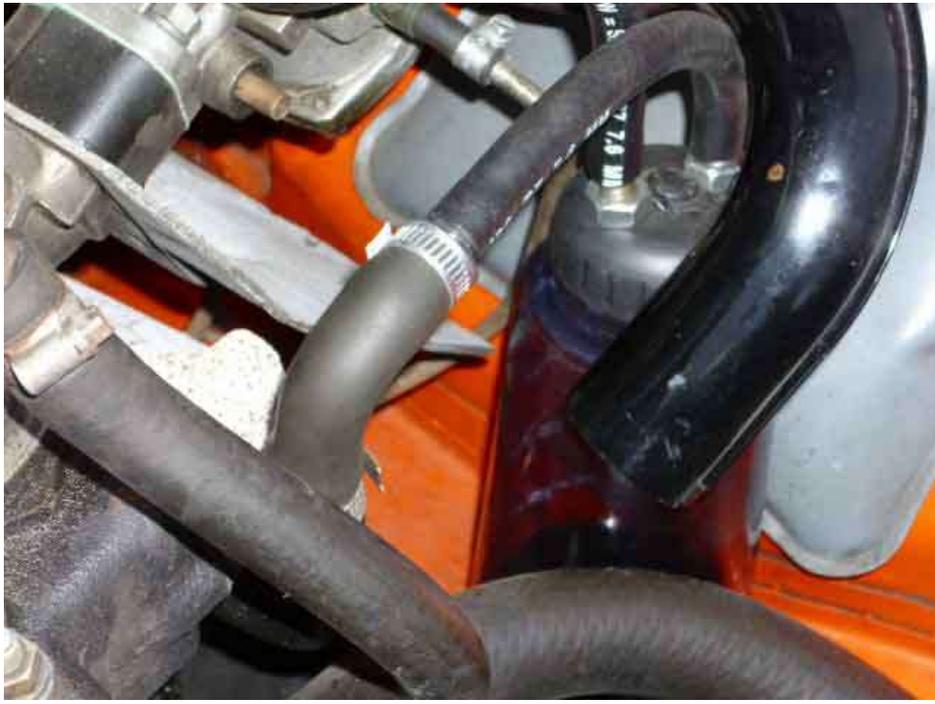
Peter Donlan's neat catch-bottle installation

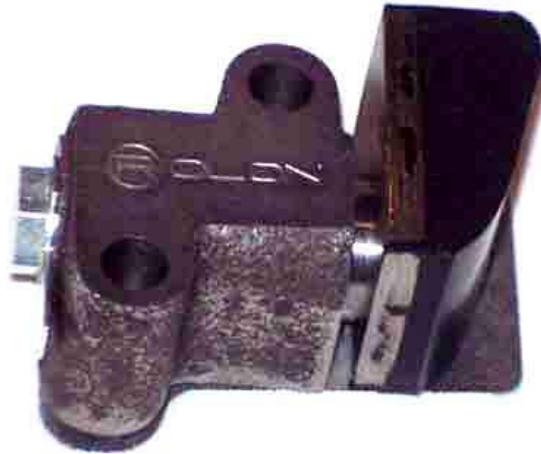
The Rolon item with the Allen key bolt, and the slipper pad the same size as the slipper base:

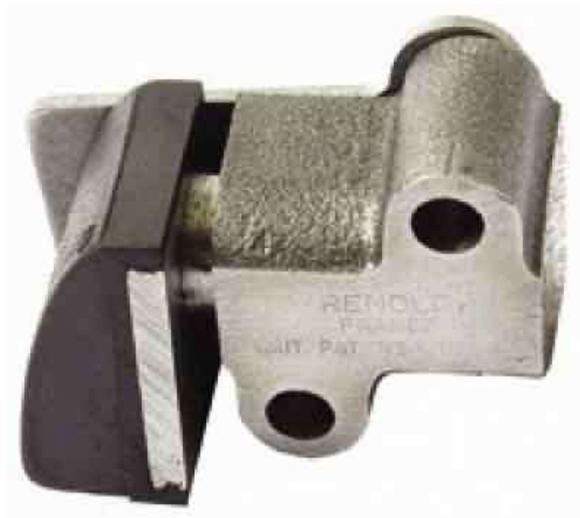
The Renold item - no Allen key bolt, and the slipper pad goes over the ends of the slipper base. However the Renold name is stamped in the reverse direction to mine and would be upside down when fitted:

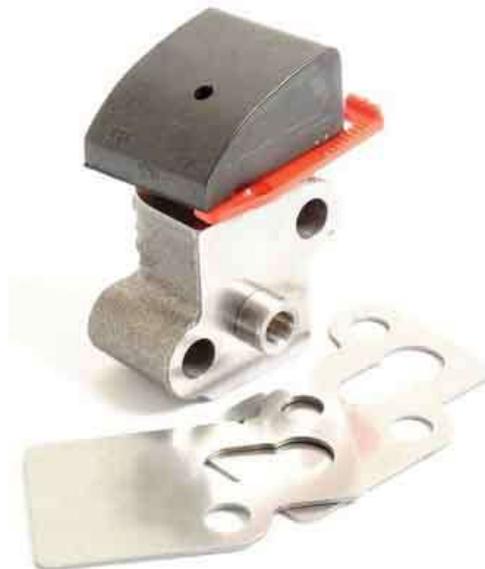
Another Renold item with a location dowel in the oil supply port, and plastic shipping spacer which is removed once installed with the chain. Also showing the spacer plate for use with single-row chains, and the gasket, which all tensioners should be supplied with:

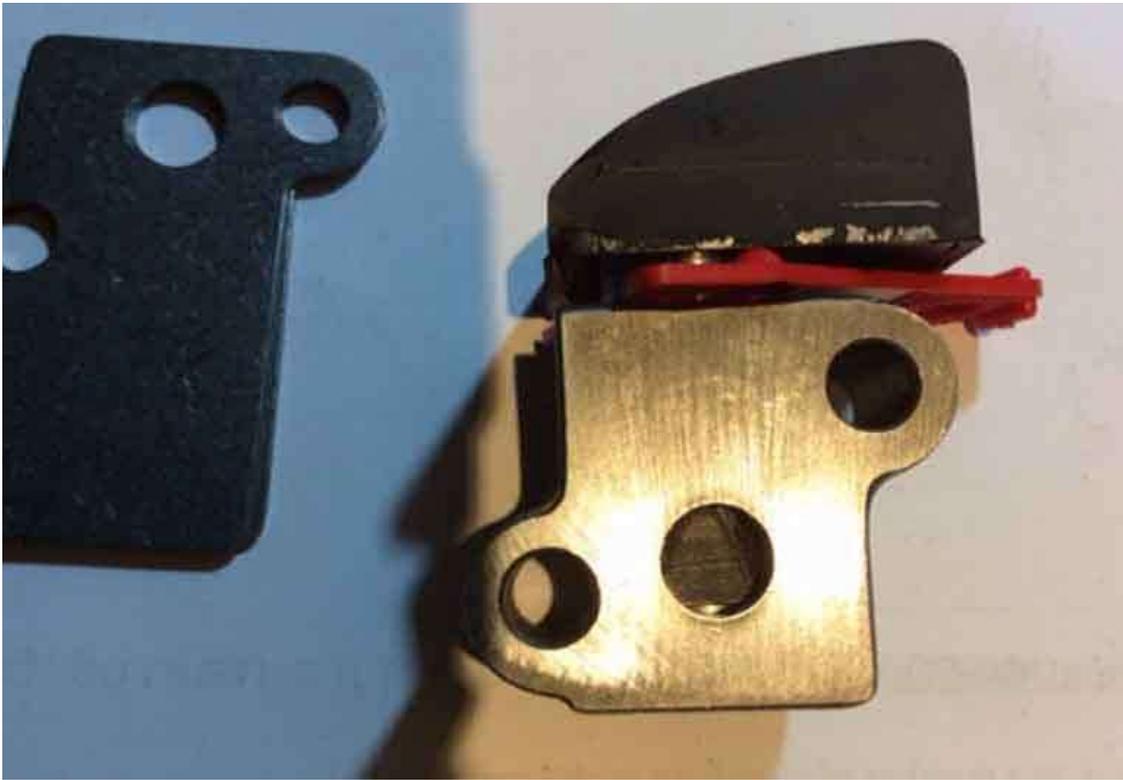
Peter King's advertised as 'Not Rolon', but with the large oil feed hole instead of the drilled dowel:

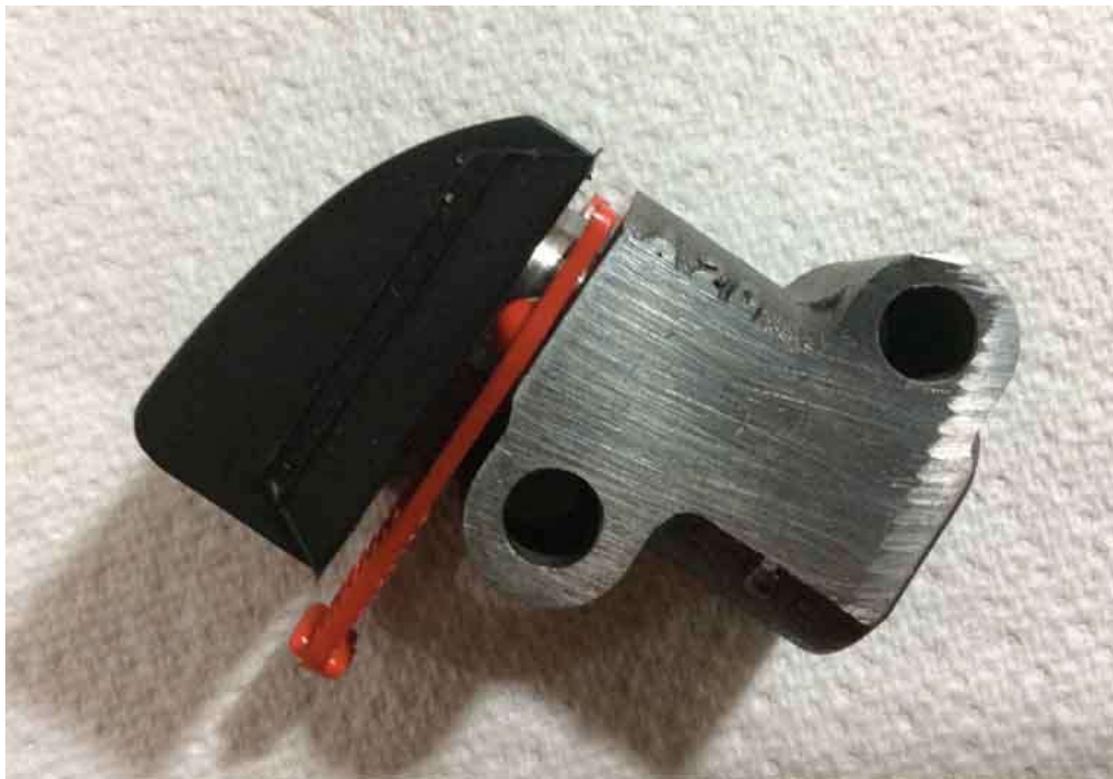
More worryingly (despite the plastic shipping spacer) no makers name at all, and the face showing it may have been ground off:

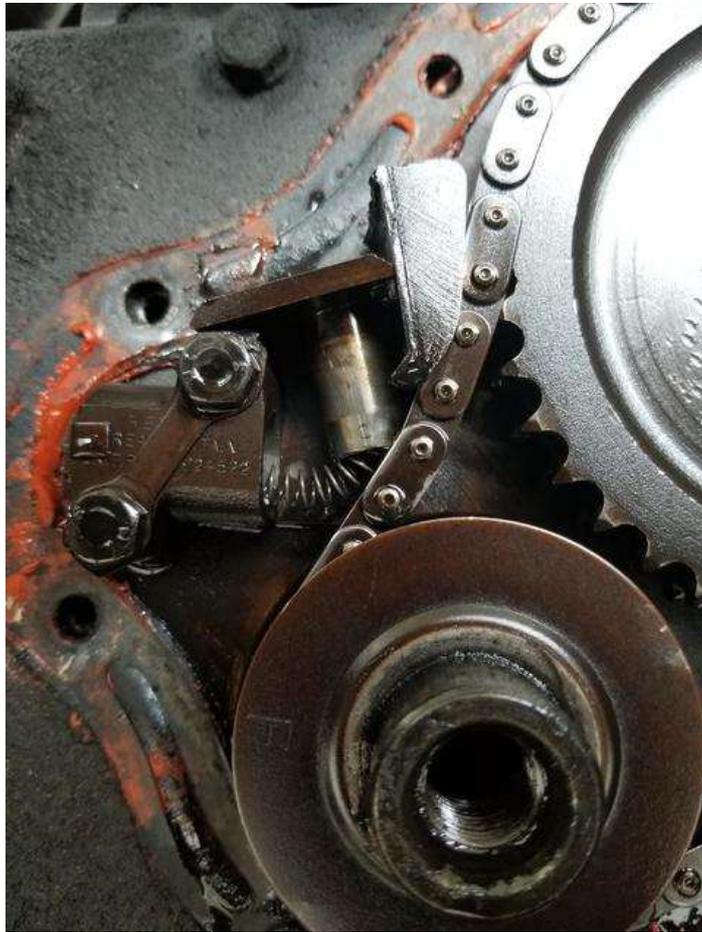
This looks like a failed Renold item from the part of the name that is visible, and the slipper pad overlapping the ends of the backing. The slipper pad has come off the backing and allowed the backing plunger to come out of the body, potentially very damaging if it happens at speed. However the identification marks are upside down and the overlap is triangular rather than rectangular as with the [Renold item above](#):

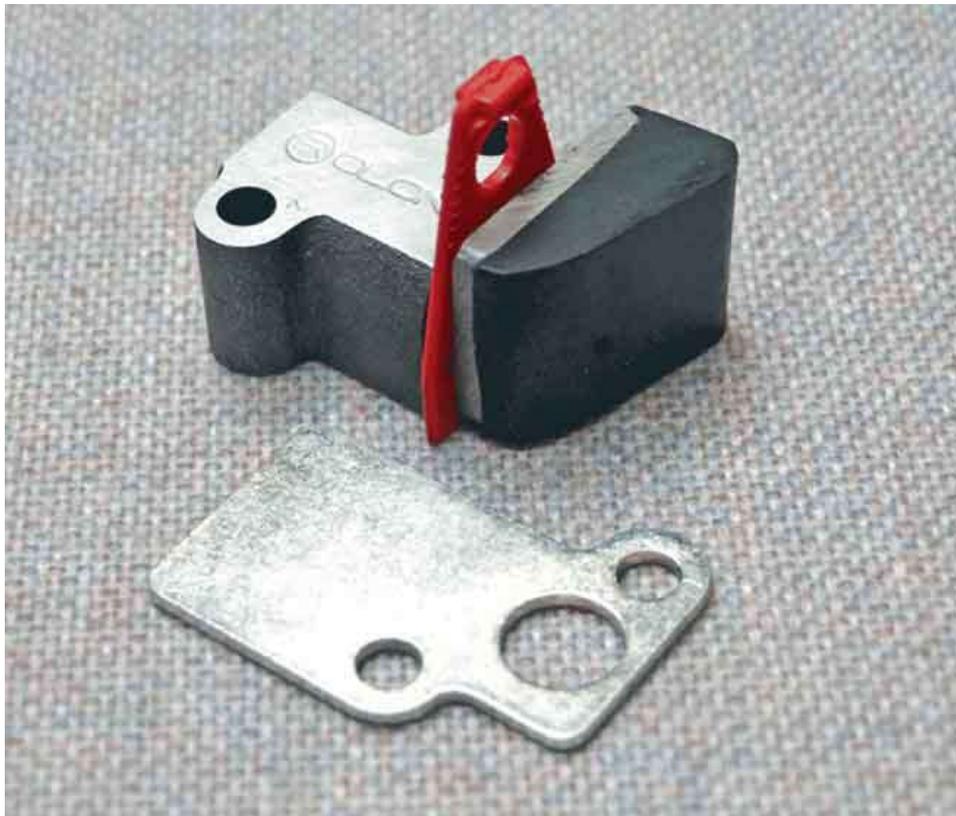
A Rolon item with the plastic shipping spacer, same length slipper pad as slipper base, and obviously no dowel on the back:

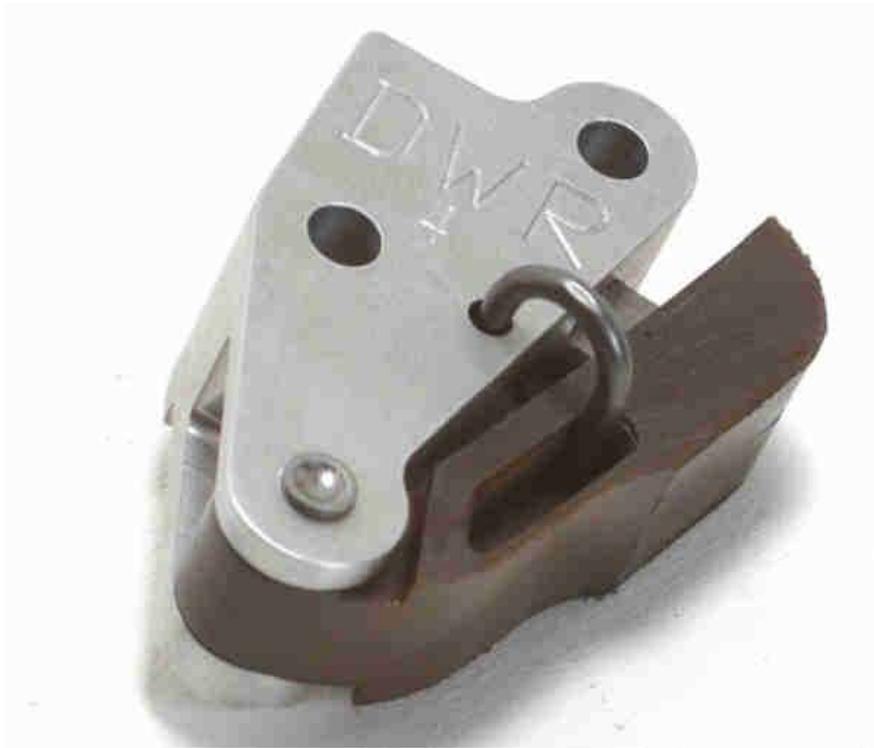
An alternative design, this from [Denis Welch Motorsport](#) at Â£130, even more expensive from [SNG Barratt](#) and [SC Parts](#):

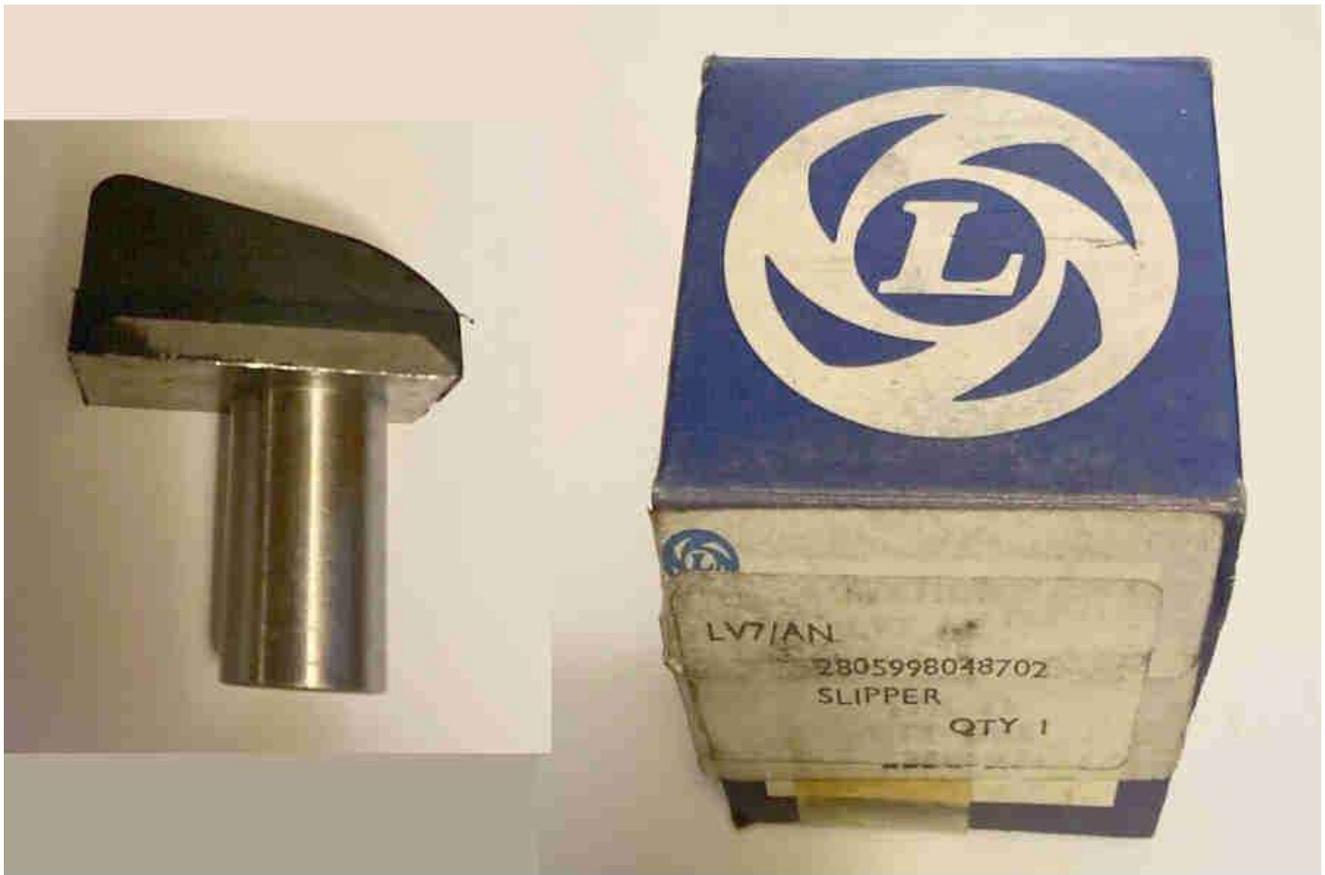
[NOS BL slippers](#) can be substituted for those that come with Rolon tensioners:
