Crankcase Breathing

Cylinder Block

Engine Numbers

Dating the Block

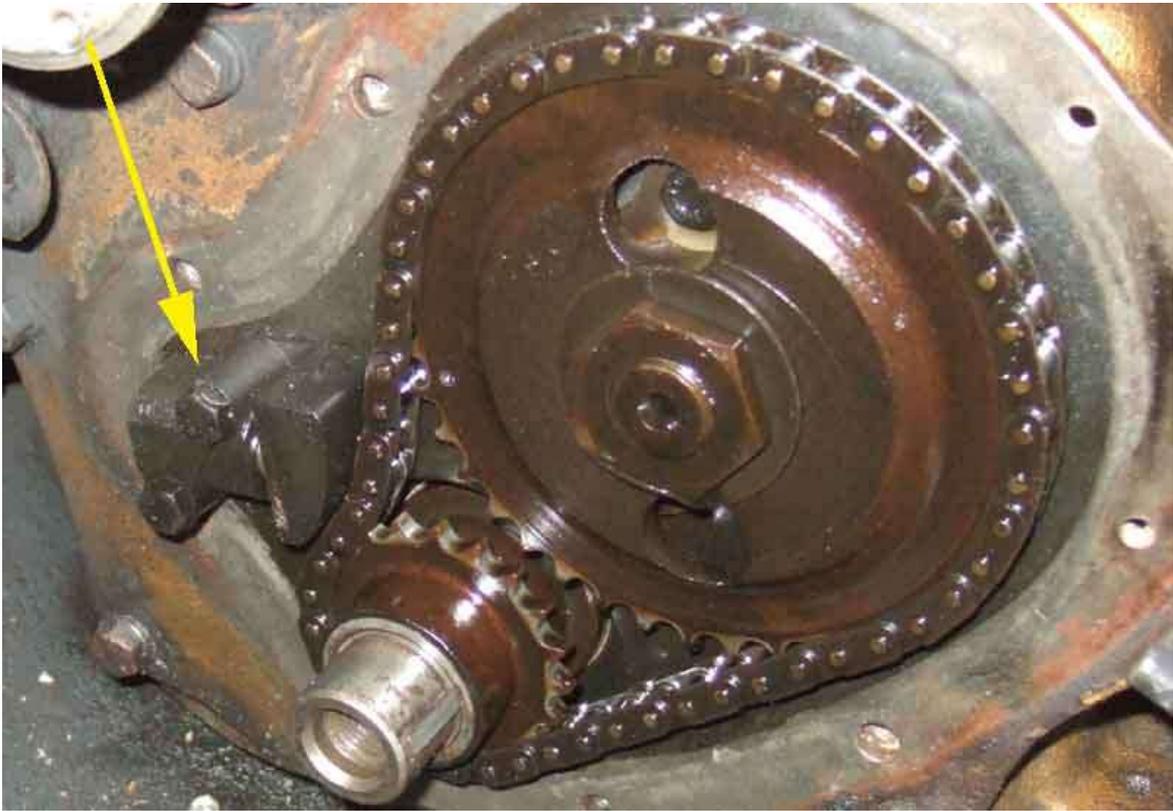
Bee's tensioner before removal ...

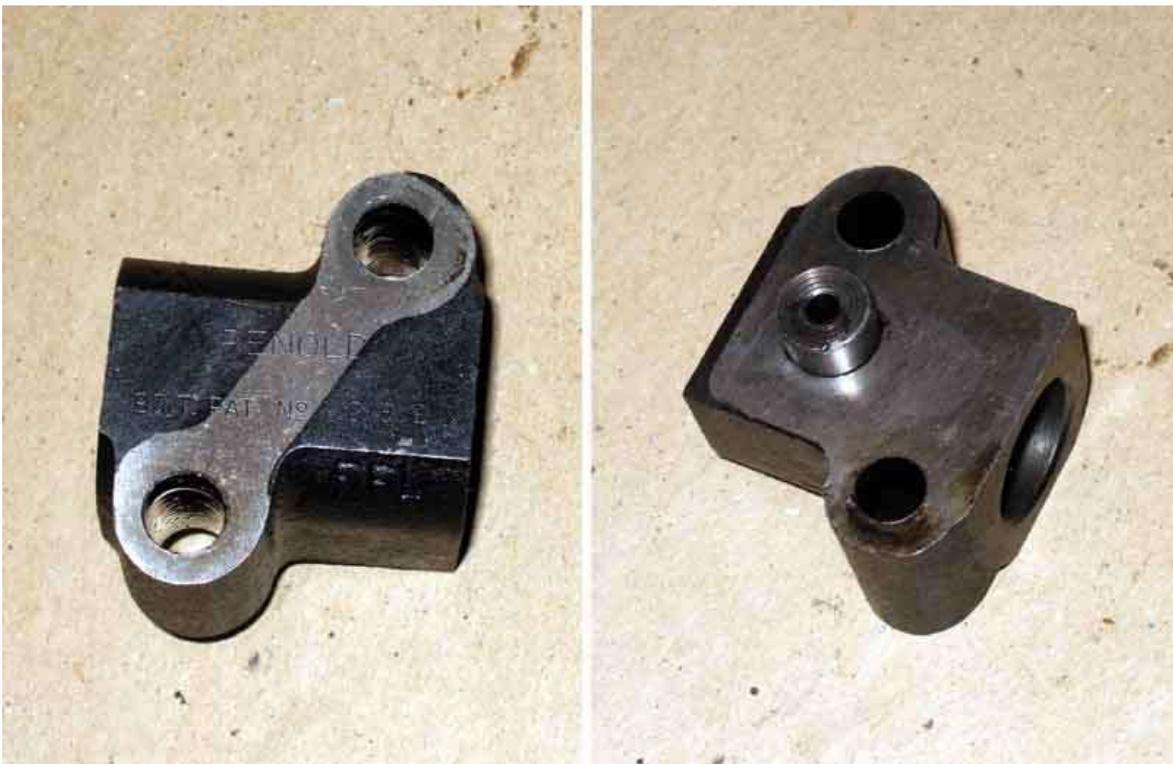
... Renold type - name under the lock-tab strip, no Allen key bolt, oil-way dowel on the back but with a smaller hole [than above](#):

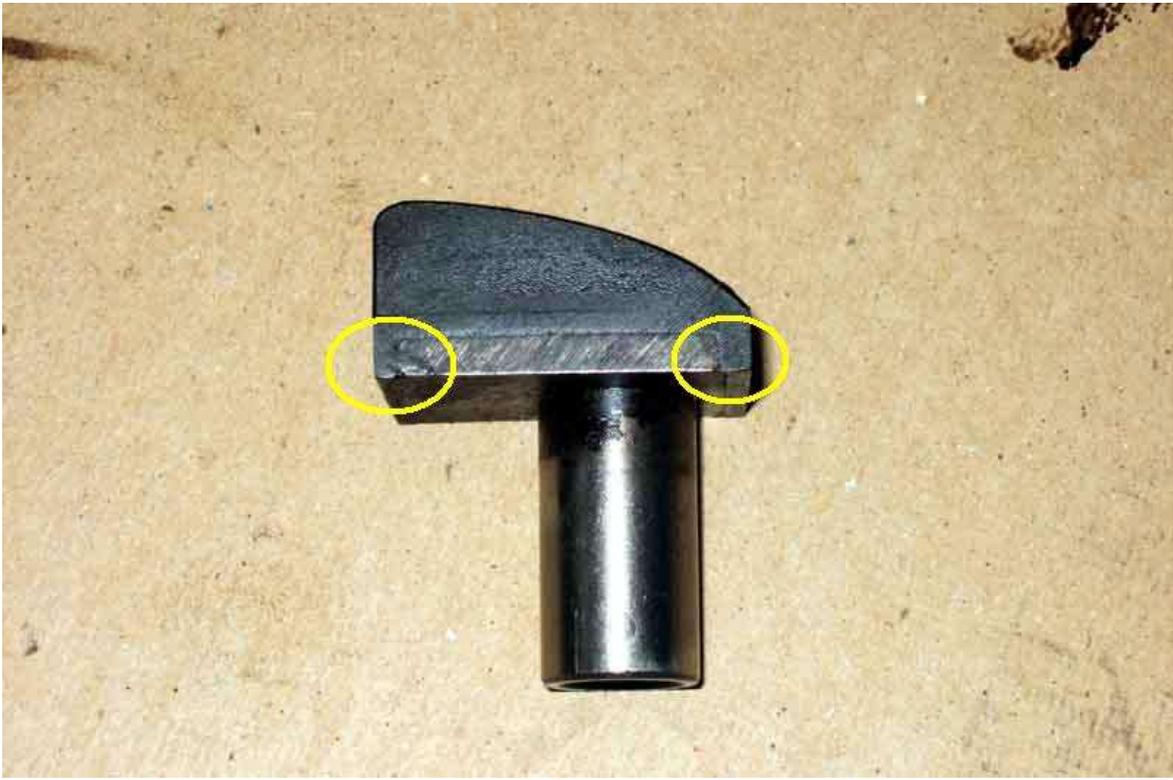
Slipper pad fully overlapping the ends of the slipper base:

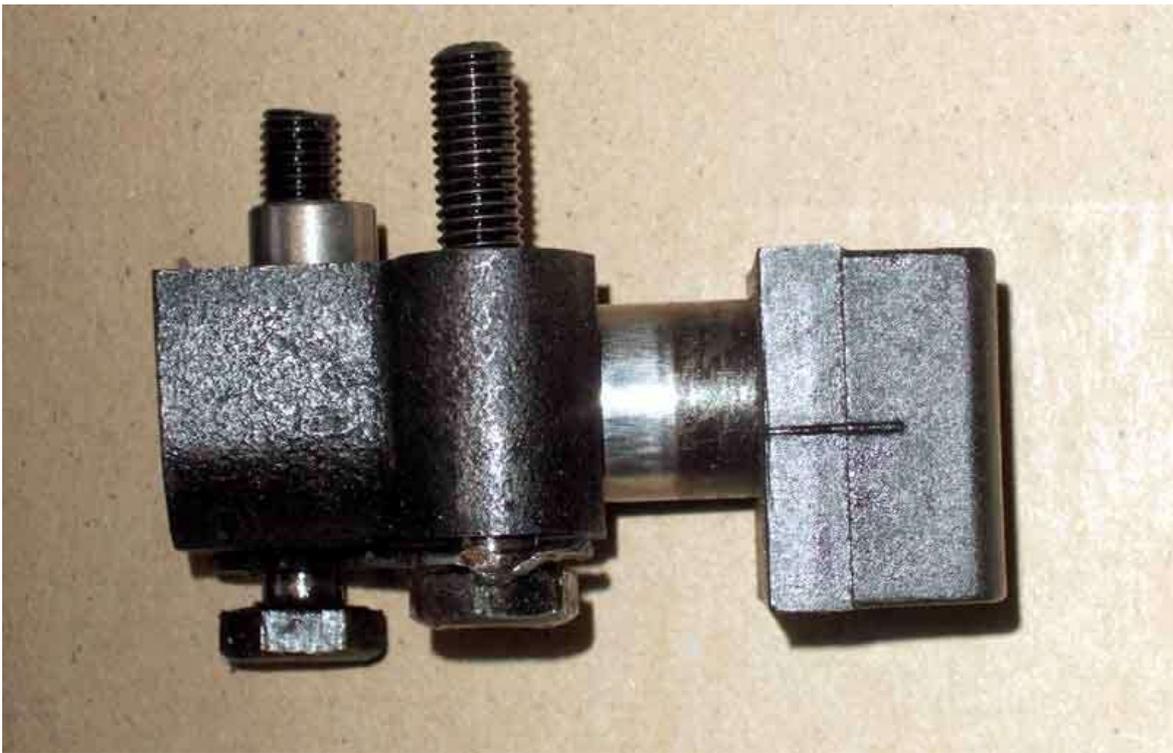
Note the piston is offset behind the slipper pad, which puts it slightly offset one way to the single chain and slightly the other way to the duplex, so only one tensioner is needed for both types of chain:

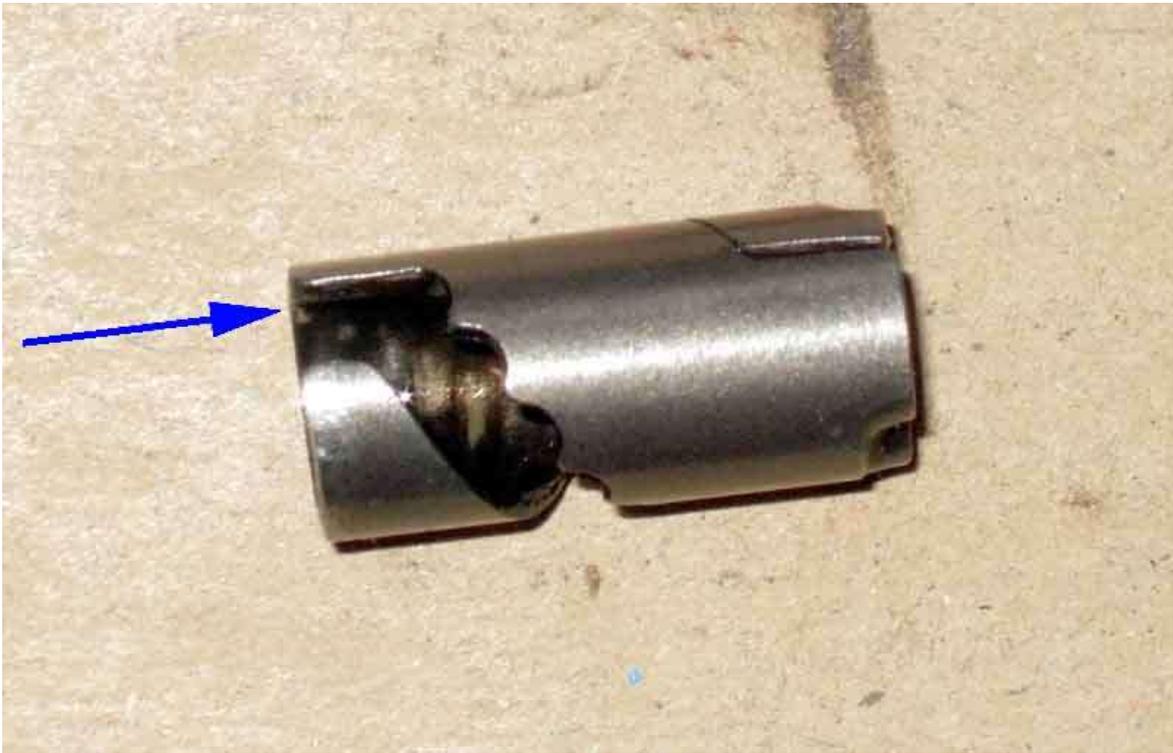
Stepper mechanism with entry slot arrowed ...

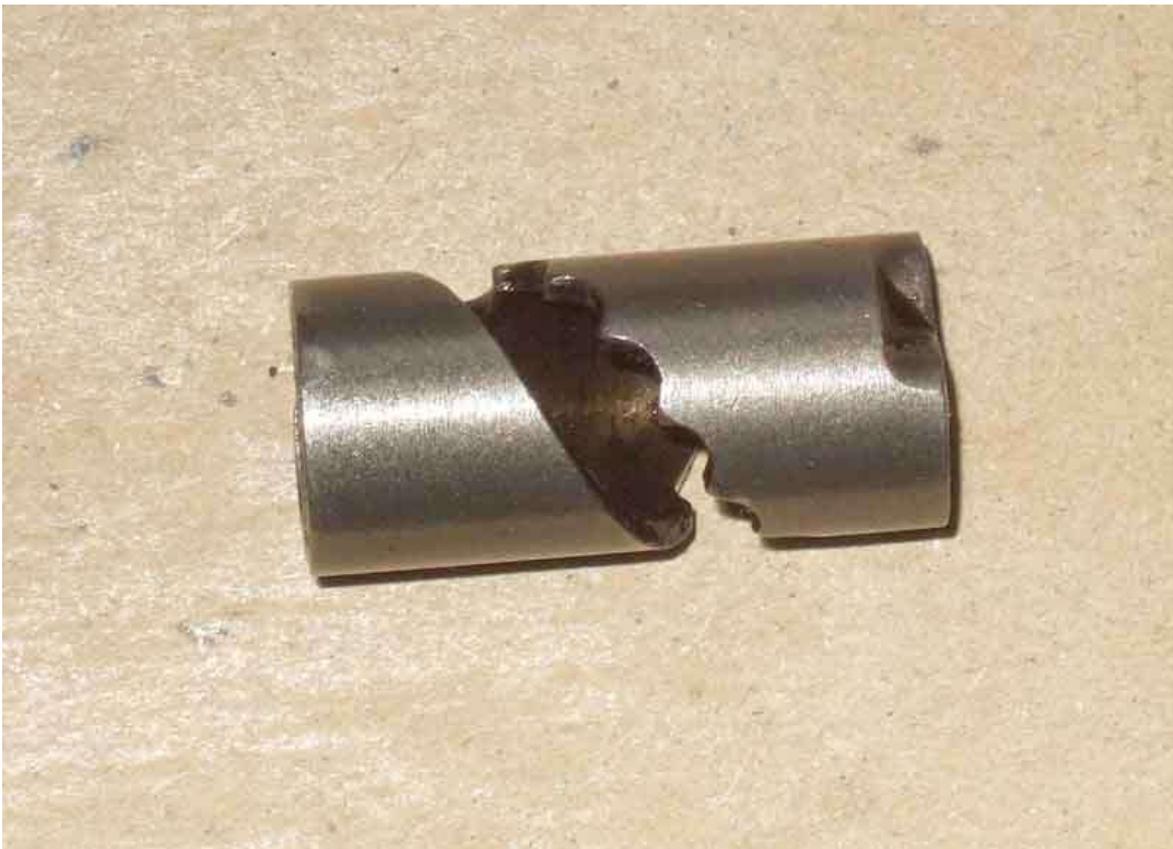
... limit teeth along the helix ...

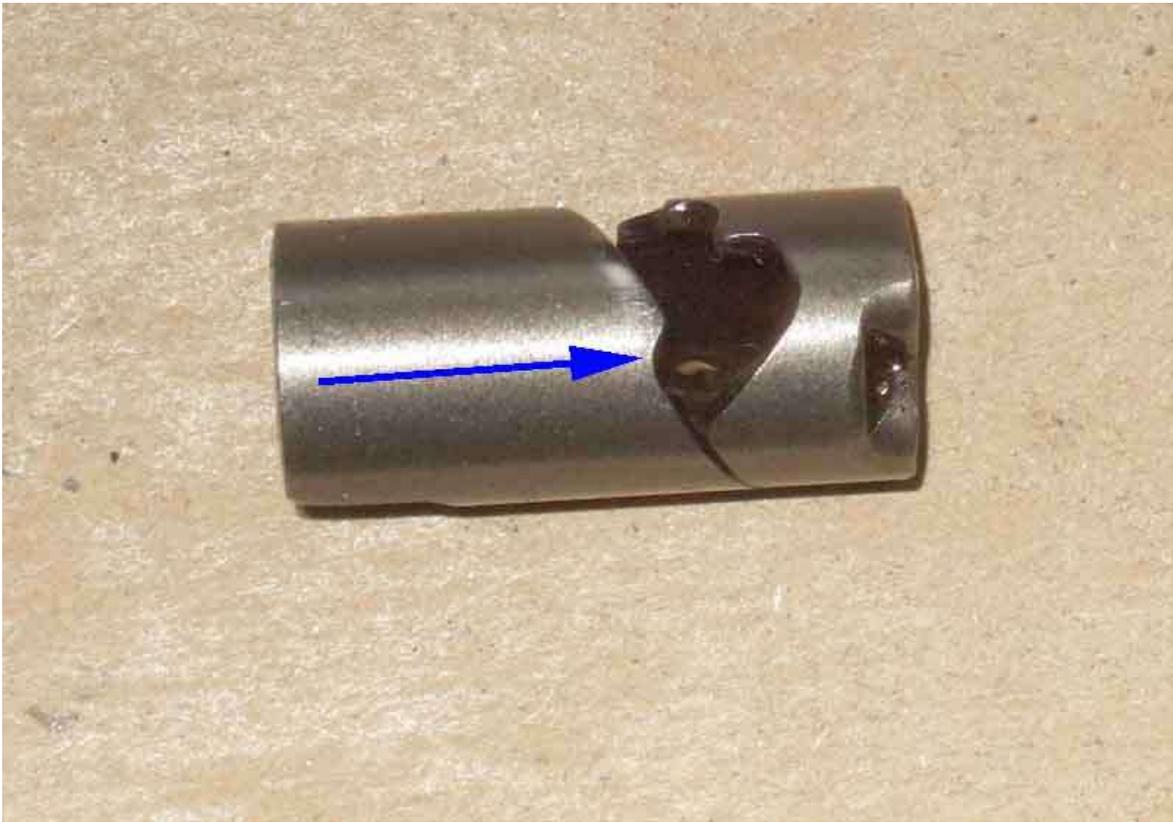
... recess to lock the mechanism in position for installation ...

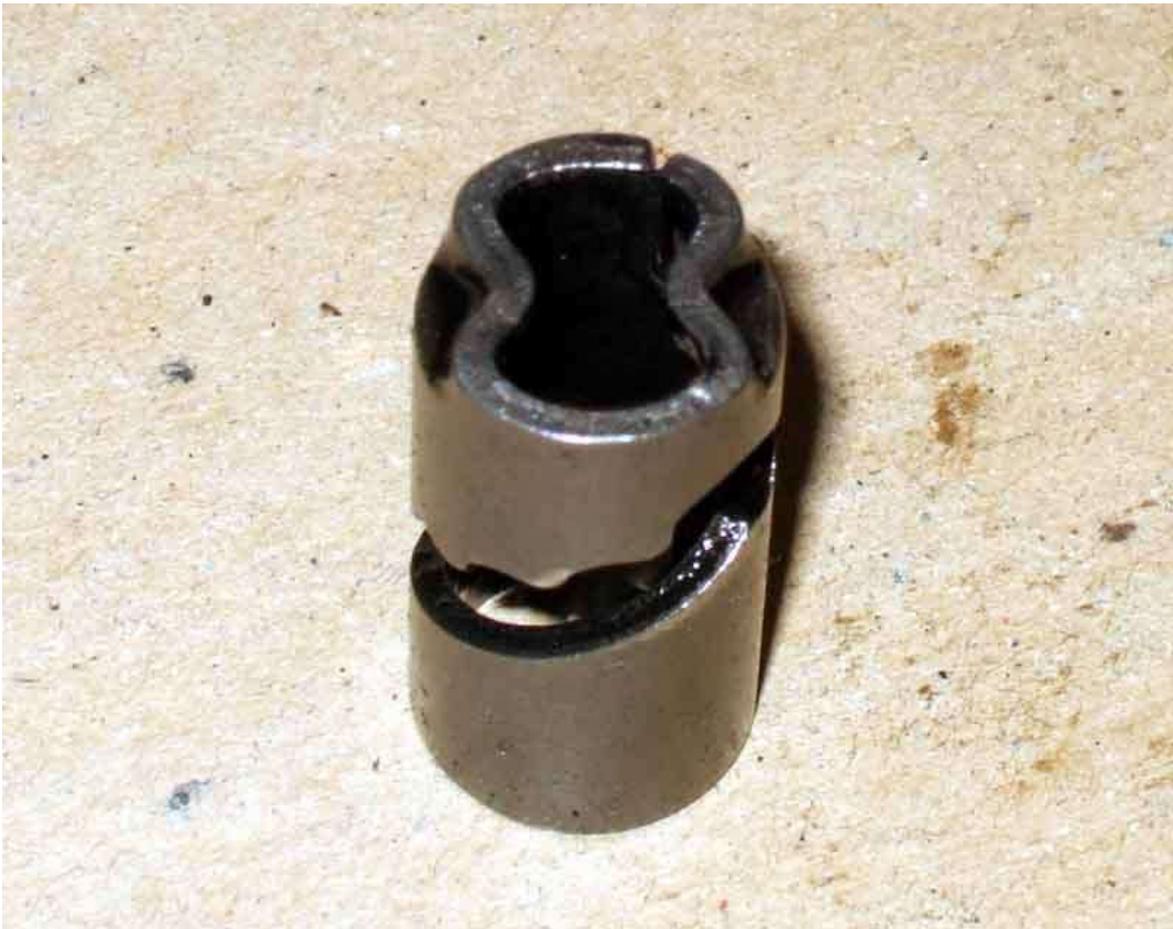
... and slot so the mechanism can be pushed and twisted into place with a screwdriver against spring pressure.

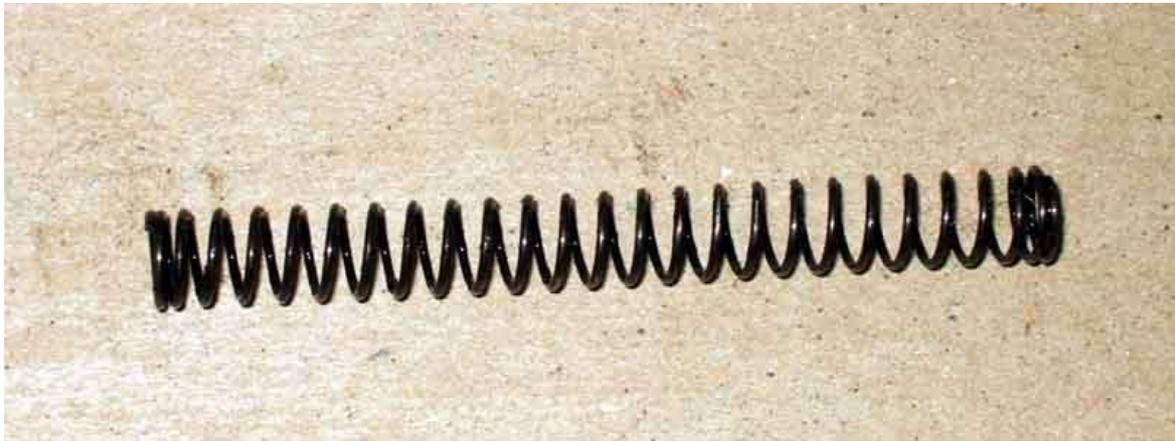
Spring ...

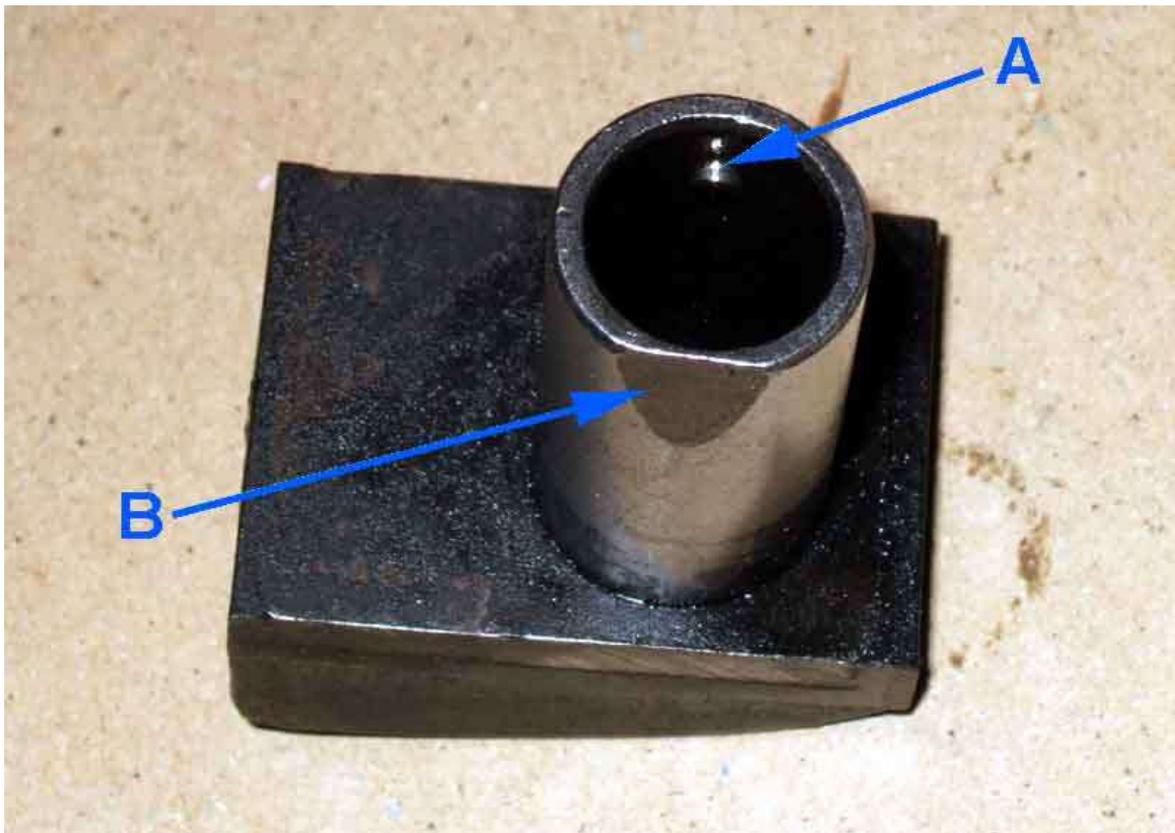
... peg (A) that passes through the entry slot and latches behind each tooth, and chamfer (B) to direct oil from the inlet to the open end of the tube on the slipper:

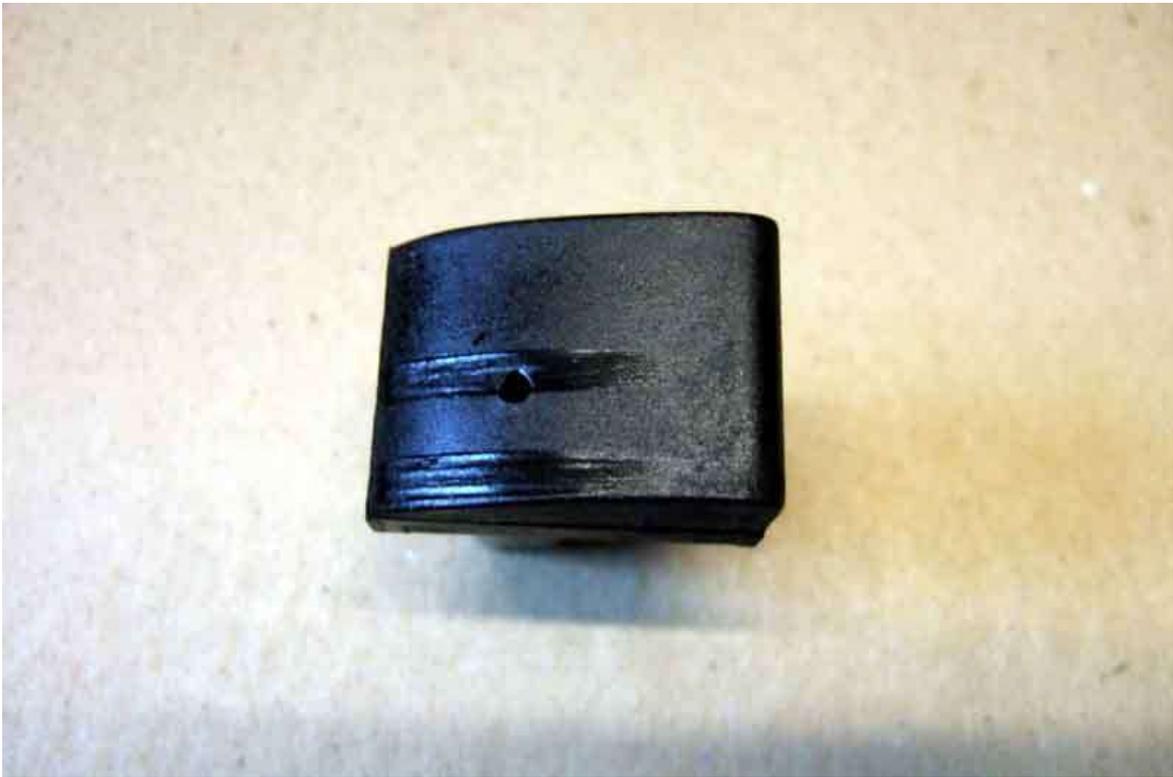
Slipper pad barely worn, with hole through from piston to lubricate the chain:

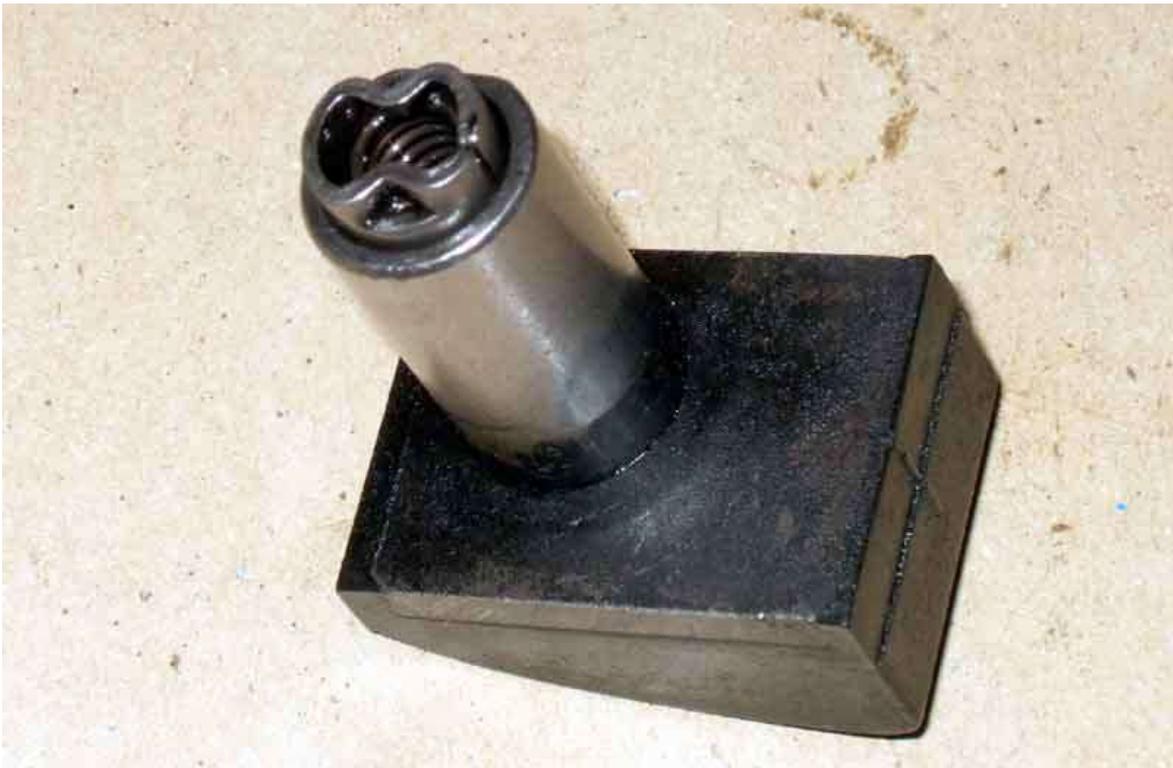
Reassembled - mechanism and spring fitted ready for insertion to body ...

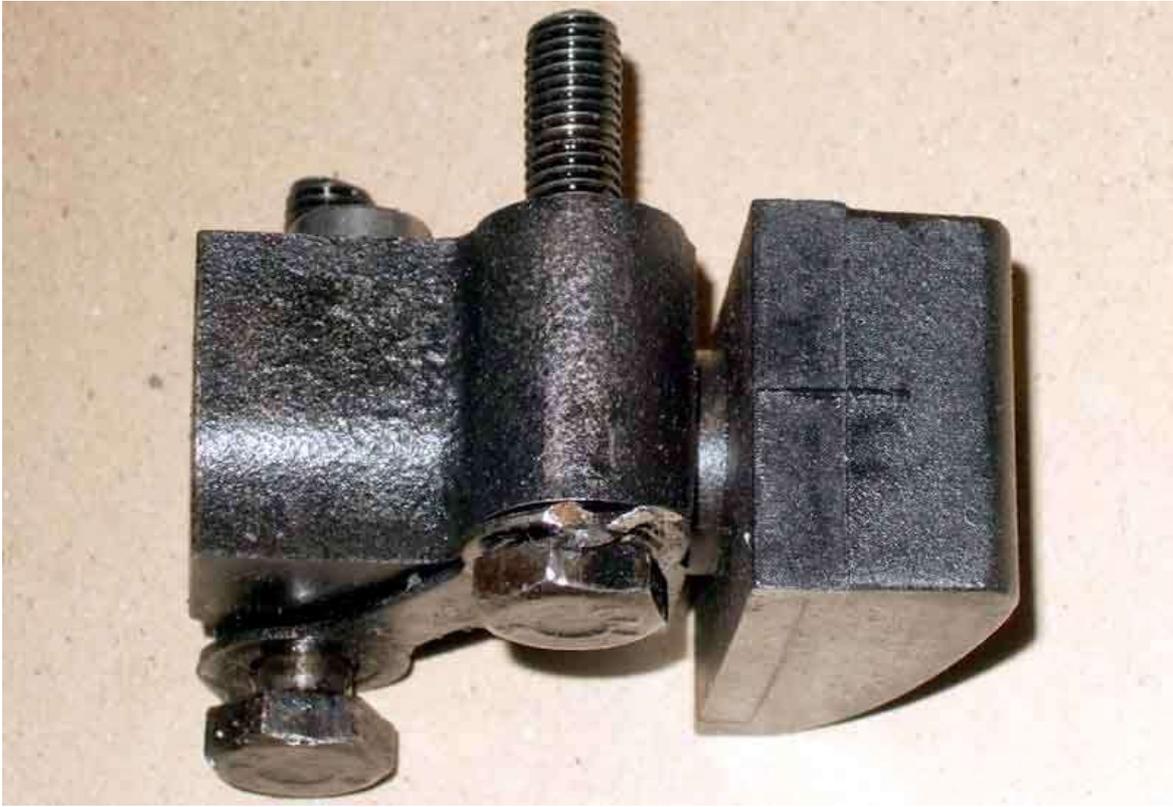
... and slipper fully inserted ready for fitting to engine. Once mounted push the slipper back the remaining amount and it will pop forward to tension the chain. If you push the slipper back any further **before** mounting, the mechanism will rotate and the peg move from the locking position into the helix, and the slipper, mechanism and spring will fly out:

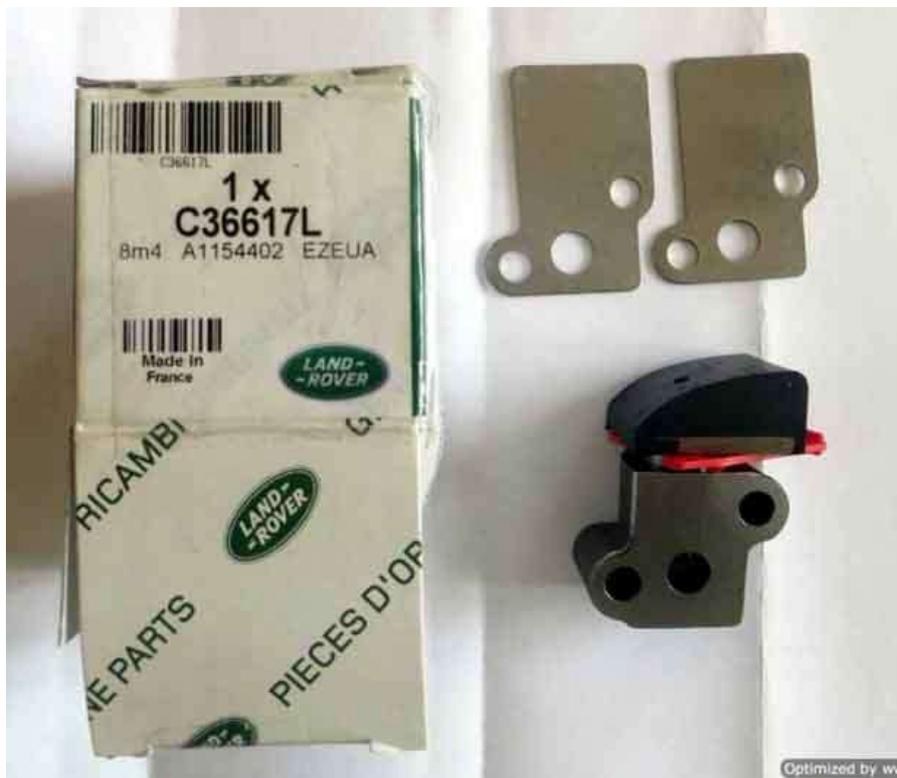
- 5 ..Just out of curiosity I ordered the EAC3629 one from BritishParts and this is what came, they show the part number as superseded (to C37717LG). Its flat on the back with no dowel. Doesn't look too bad though and its says Made in France on the box:

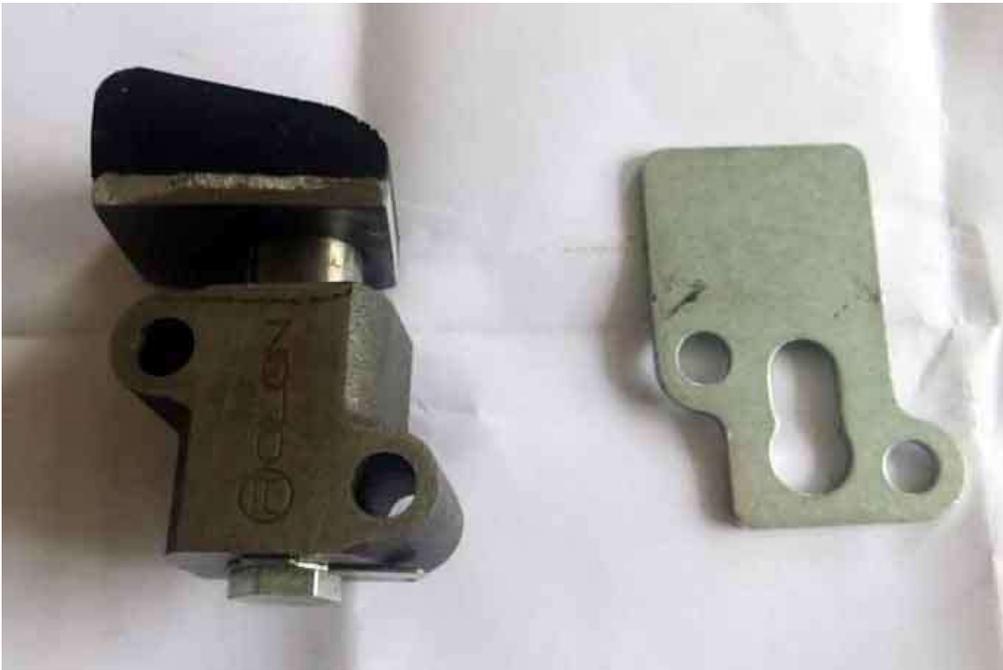
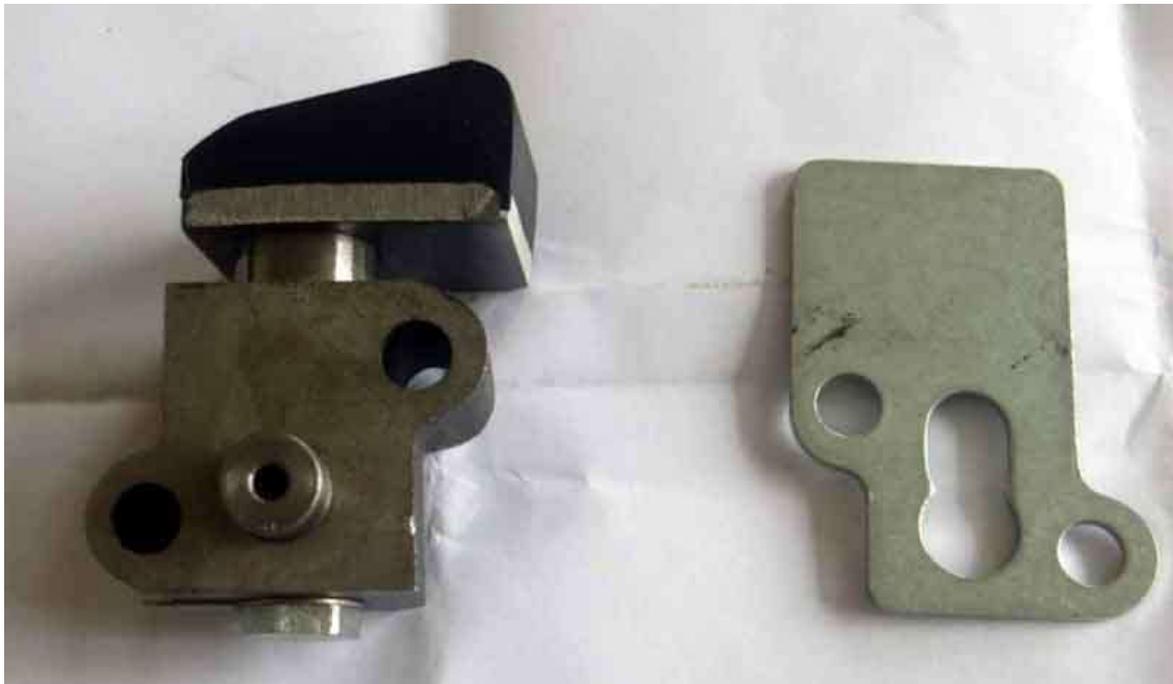
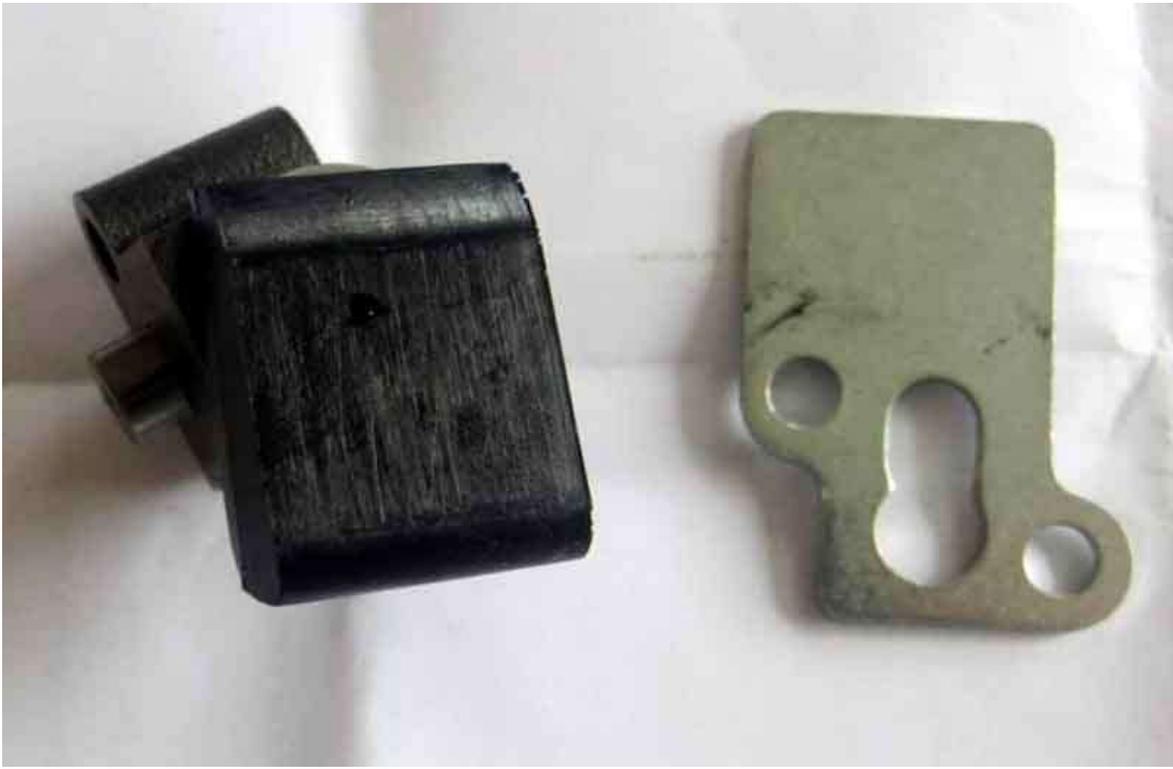
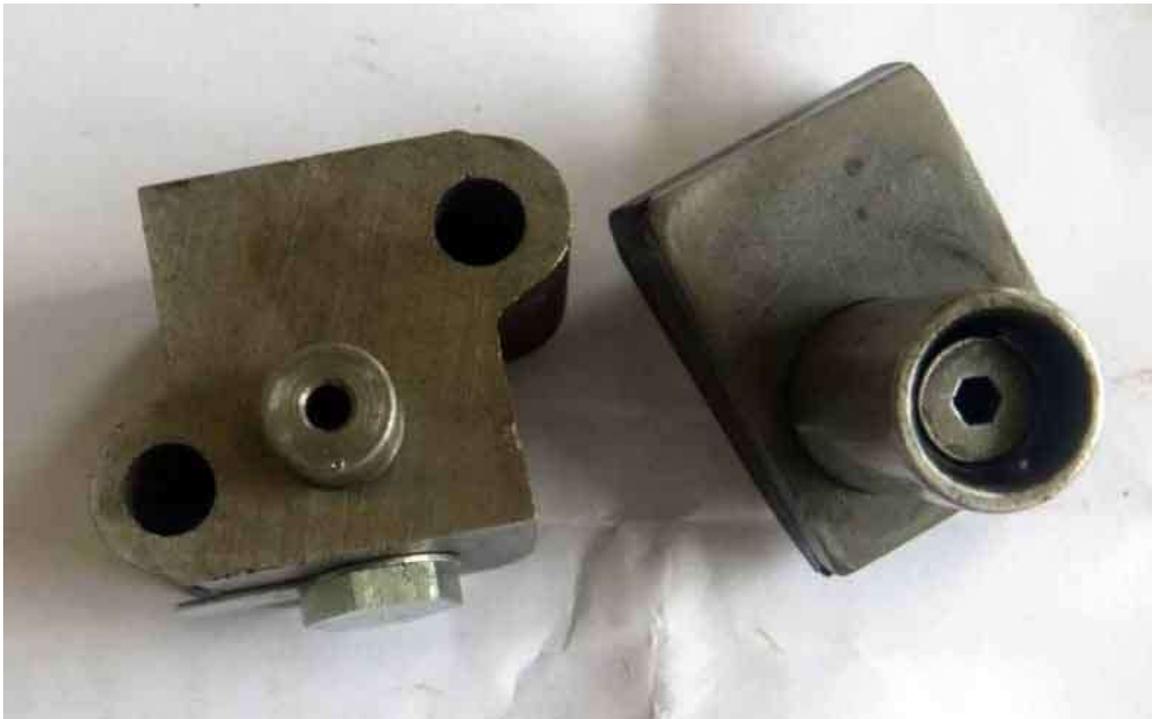
6. Update: Leacy Classics 12H3292 just arrived:

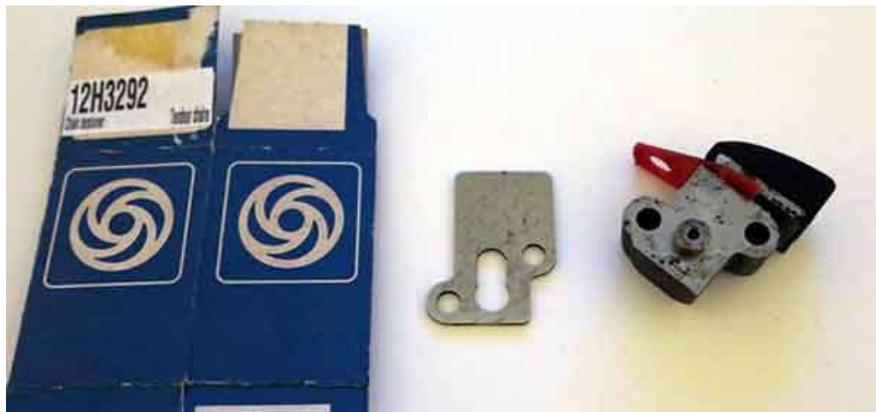
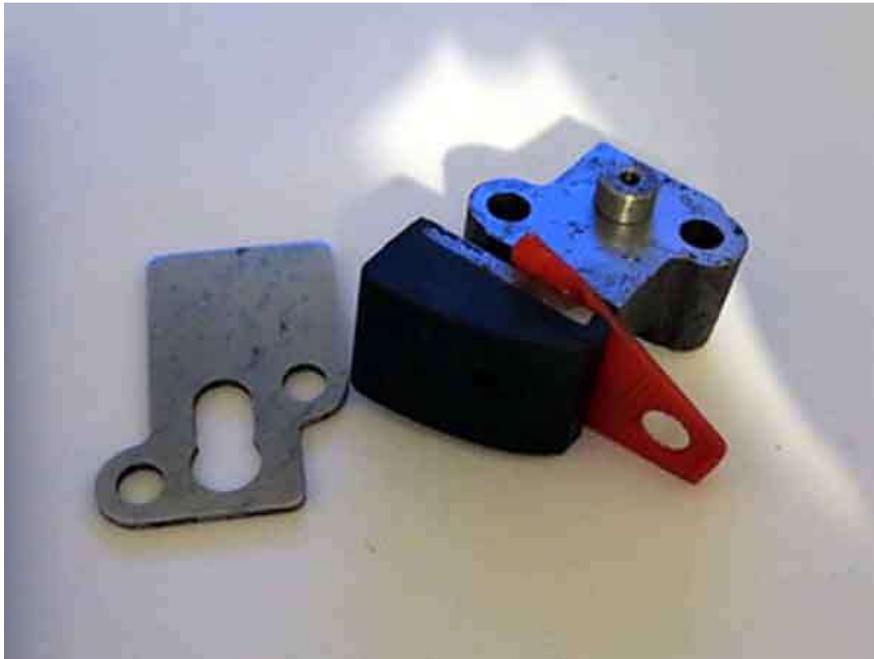
7. Here you go, this is an original 12H3292 it has a dowel and hole in the slipper pad:

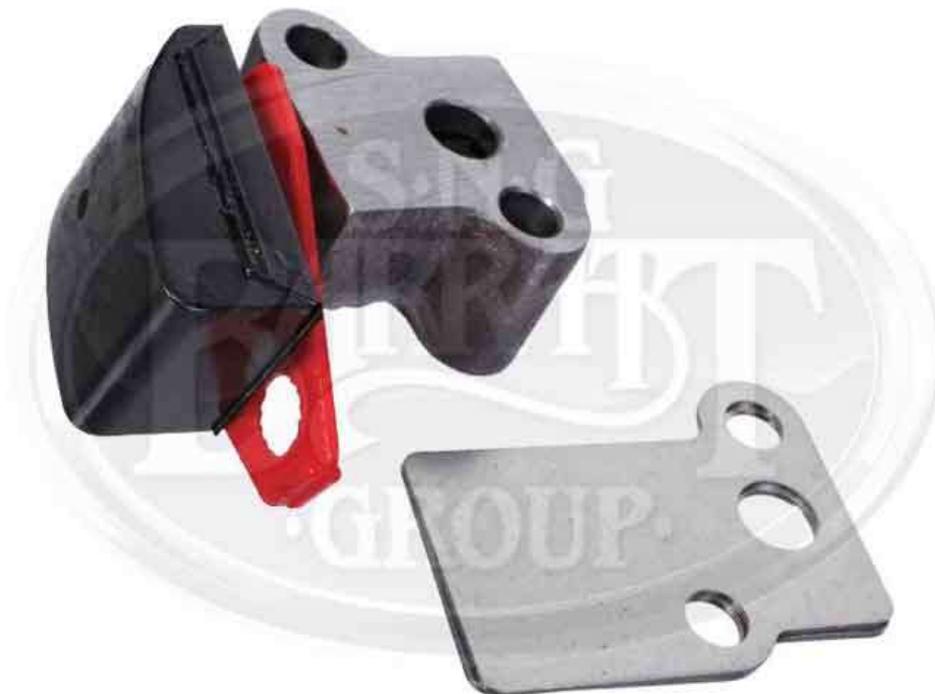
9. I purchased a genuine Jaguar tensioner, EAC3629 (Land Rover box, made in France) from SNG, strangely the manufacturer data looks like it's been machined off. Like others that have posted, I found it had no dowel and a large oil feed hole at the back, I was worried this could starve the head of oil so I pulled it apart to look at it's guts. I was very disappointed to find a very small pin hole oil bypass in the shaft, just like the later Renold ones. The 'lube' hole that goes through the rubber pad does not go all the way through the metal at the back. I'm glad I checked this as I'm sure many people buy these tensioners in the hope that their chains would get a direct oil feed, instead it just dumps the oil to the sump. Why on earth would they manufacture it like this, makes no sense to me. I did email SNG but they didn't bother replying. As if I wasn't in a bad enough mood after loosing a valve shim somewhere down my new engine:

10 Thanks. I looked at my options today and bench tested with the front cover off, it's surprising how much oil comes out of that tiny hole in the tensioner shaft. I'm going to use my old Renold tr7 tensioner body (with dowel) and fit the pad from my Renold sprint tensioner. I think the oil will squirt on the chain when it stretches a bit and the slipper moves out, so a hole in the pad isn't essential. At least I have confidence in the Renolds unlike the thing SNG sent me. At least the missing shim didn't make an appearance and cause damage, I'll worry about that later.
