Gearbox and Overdrive

Last updated 23-Dec-2023

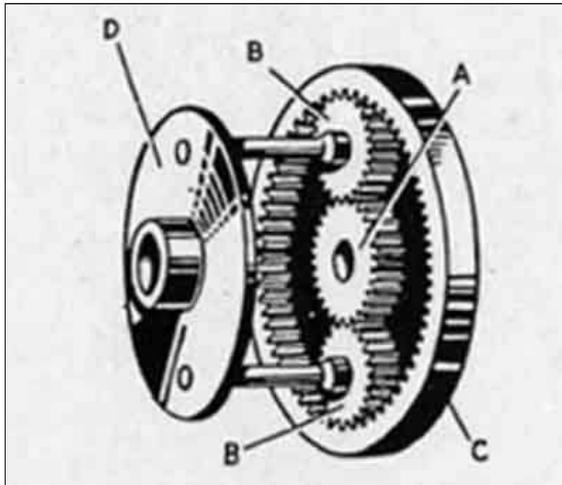
The gear train consists of a sun wheel (A), planet wheels (B), planet wheel carrier (D), and annulus or ring gear (C). The input is via the planet carrier, and when the sun gear is locked to the ring gear the whole unit rotates as a single unit to give direct drive. But if the sun wheel is locked to the casing so it cannot rotate, when the planet carrier is rotated the ring gear is 'overdriven' at a higher speed than the planet carrier to give the overdrive ratio. Believe it or not this is exactly the principle used by the Sturmey Archer 3-speed hub dating from 1902 that many of us will have been familiar with when we were in short trousers. How does that give three gears? The Laycock unit always applies the input to one of them (the planet carrier), and either locks the sun wheel to the ring gear or to the casing to give either direct drive or the overdrive ratio. The Sturmey Archer does basically the same, but can reverse the input and output so that the ratio difference can either be used to gear the output down i.e. for first gear, or to gear it up for 3rd gear, with direct drive for second gear. Lots of videos and descriptions online, with varying degrees of complexity and confusion!

Also complex is understanding what determines the OD ratio, and comparing the drawing above with endless descriptions of epicyclic gearing is no help. The ratio for the simple

system drawn above is determined by the number of teeth in the ring gear, divided the number in the ring gear plus the number in the sun gear. The number of teeth in the planet gears has no effect. But the Laycock planet gears have two diameters - the larger engaged with the sun wheel and the smaller with the ring gear and now the planet gear tooth count **does** have an effect ... and makes the calculation a lot more complex!
