## Engine

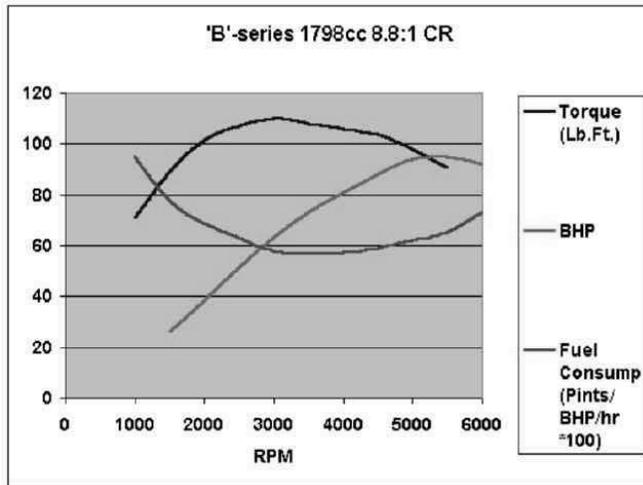
Data for the following BHP, Torque and fuel consumption curves cropped up on the MG mailing list recently, makes interesting reading. Originally published in 'The Motor' September 26th 1962, subsequently reprinted in a 'Brooklands' book - "MG Cars 1959-1962" - and posted to the mailing list by Blake (aka [Bullwinkle](#)). Note these figures were taken at full throttle with an engine brake to obtain the required rpm. The fuel consumption figures have been multiplied by 100 to fit the vertical axis.

RPM	Torque (Lb.Ft.)	BHP	Fuel Consumption	
			Pints/BHP/hr	Pints/min.
1000	71			0.95
1500	89	26	0.78	0.338
2000	101	38	0.69	0.437
2500	107	51	0.63	0.536
3000	110	63	0.58	0.609
3500	108	73	0.57	0.694
4000	106	81	0.575	0.776
4500	104	88	0.59	0.865
5000	98	94	0.62	0.971
5500	91	95	0.65	1.029
6000		92	0.73	1.119
