Gearbox and Overdrive

Last updated 17-Dec-2019

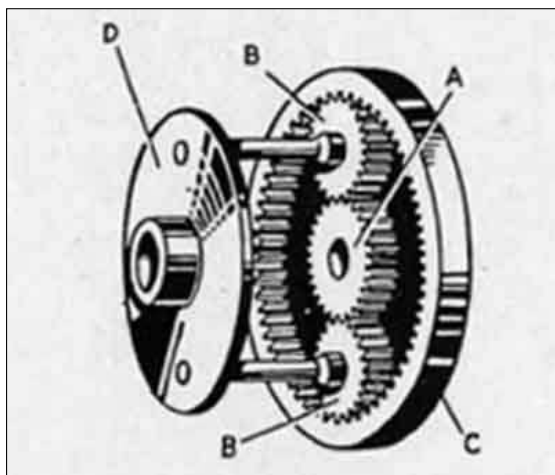
The gear train consists of a sun wheel (A), planet wheels (B), planet wheel carrier (D), and annulus or ring gear (C). The input is via the planet carrier, and when the sun gear is locked to the ring gear the whole unit rotates as a single unit to give direct drive. But if the sun wheel is locked to the casing so it cannot rotate, when the planet carrier is rotated the ring gear is 'overdriven' at a higher speed than the

planet carrier to give the overdrive ratio. Believe it or not this is exactly the principle used by the Sturmev Archer 3-speed hub dating from 1902 that many of us will have been familiar with when we were in short trousers. How does that give three gears? The Laycock unit always applies the input to one of them (the planet carrier), and either locks the sun wheel to the ring gear or to the casing to give either direct drive

Although specific to the D-type OD the above document contains this very clear description of how the Laycock overdrive switches ratios, which also applies to the LH-type:
