Prop-shaft UJ Lubrication

MGB Propshaft UJ

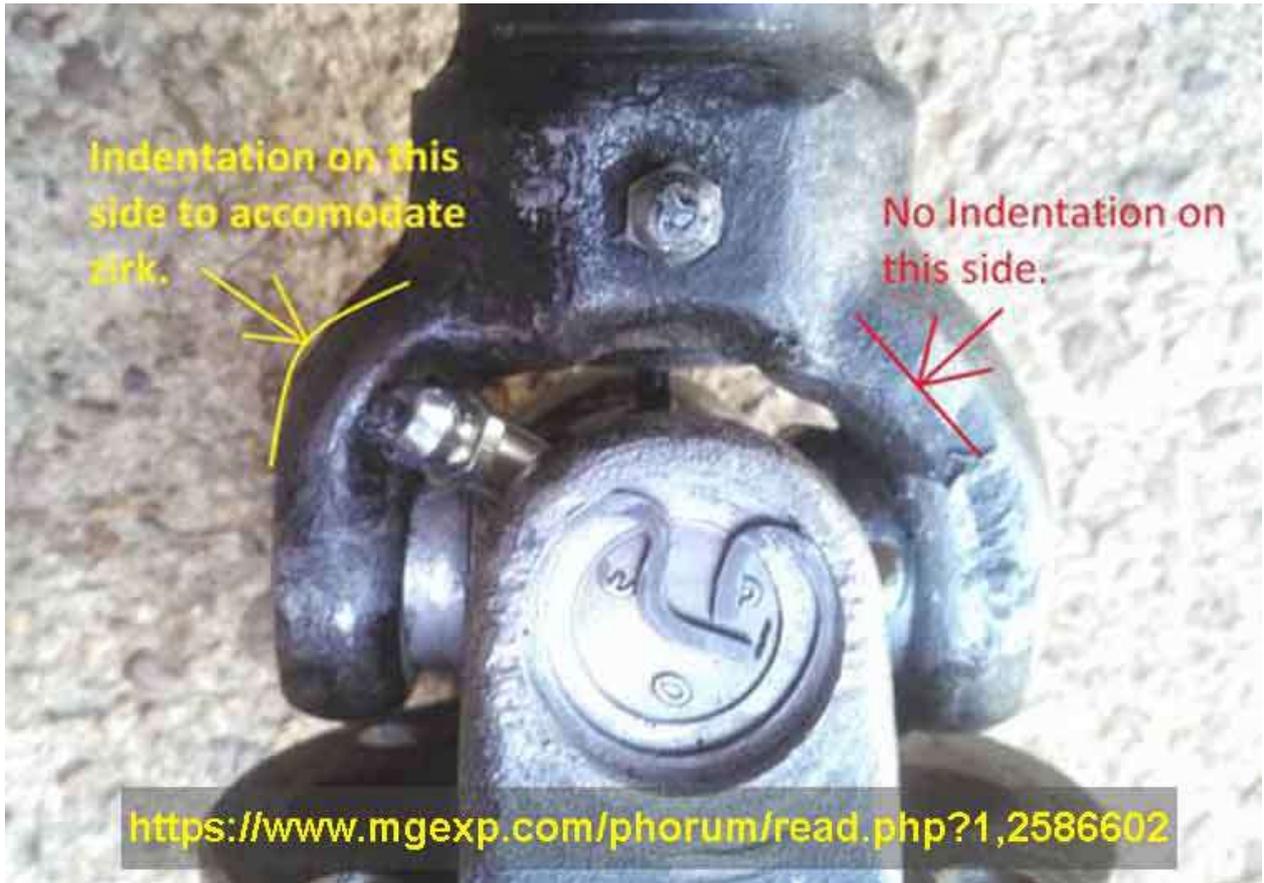
Recess on one part of a sliding joint yoke

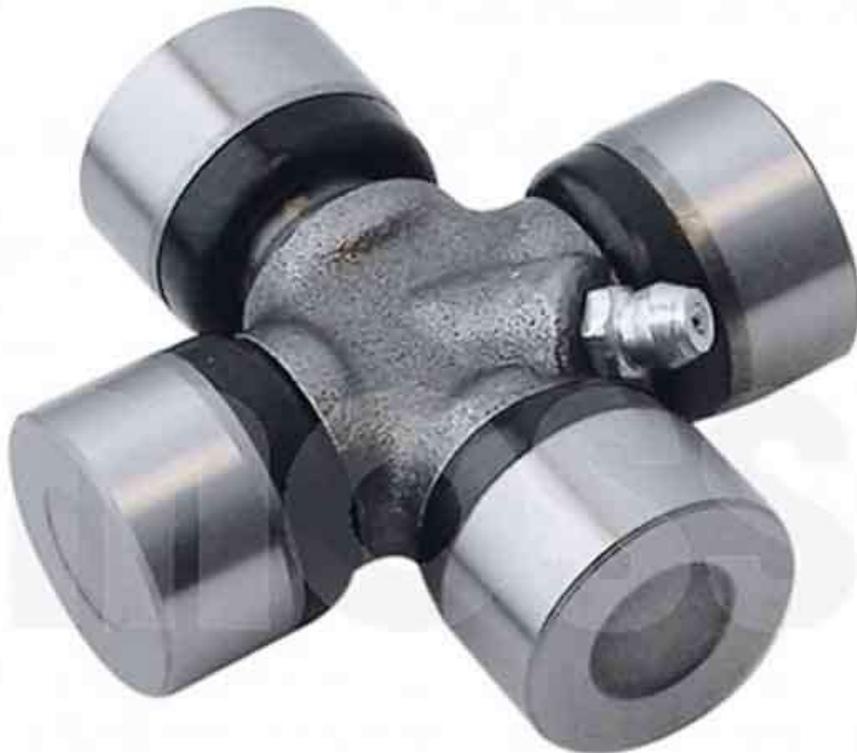
Moss GUJ115 with a short nipple

Looking closely at the bulge in the casting that the nipple screws into in the two above, it's apparent that the Moss is 'shorter', so the nipple will be at a greater angle relative to the line of the arms of the spider, compared to the Olphartz item. It may be that with the greater angle only the short one will fit inside the yokes.

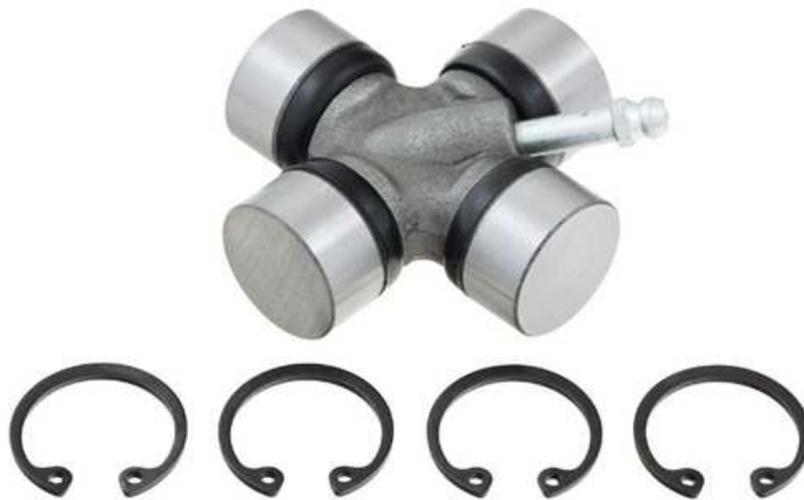
Olphartz GUJ115 with a very long nipple. There are also some suppliers with a 'medium' length nipple.

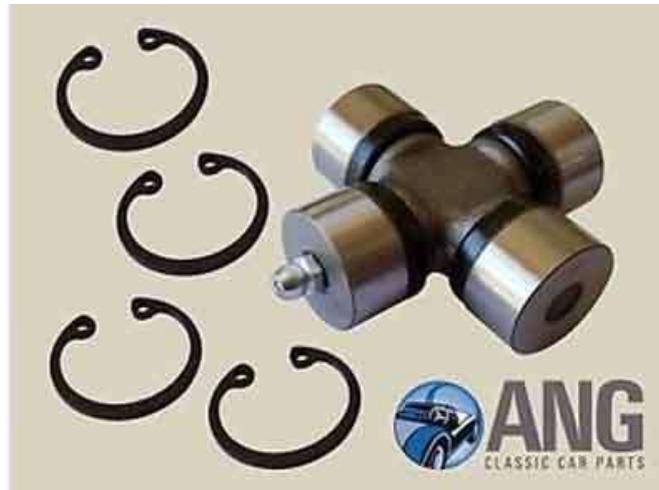
Yet another variation - ANG GUJ115 with a short nipple in one of the cups

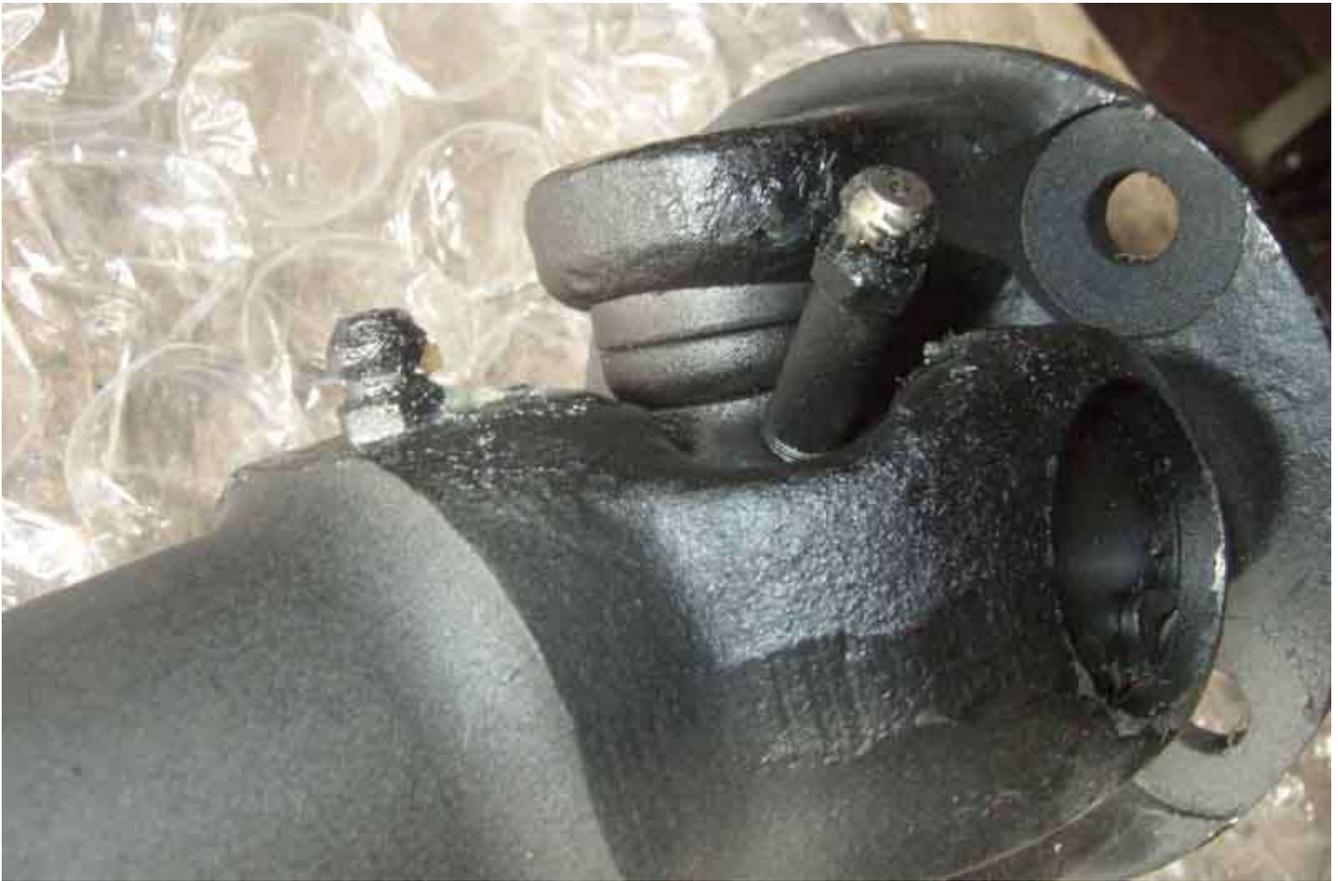
Bee's new shaft, unlike the old shaft grease nipples on the UJs as well as the sliding-joint, but if changing them you would need to fit the same type and nipple or balance could be compromised. Hopefully not required in my lifetime:

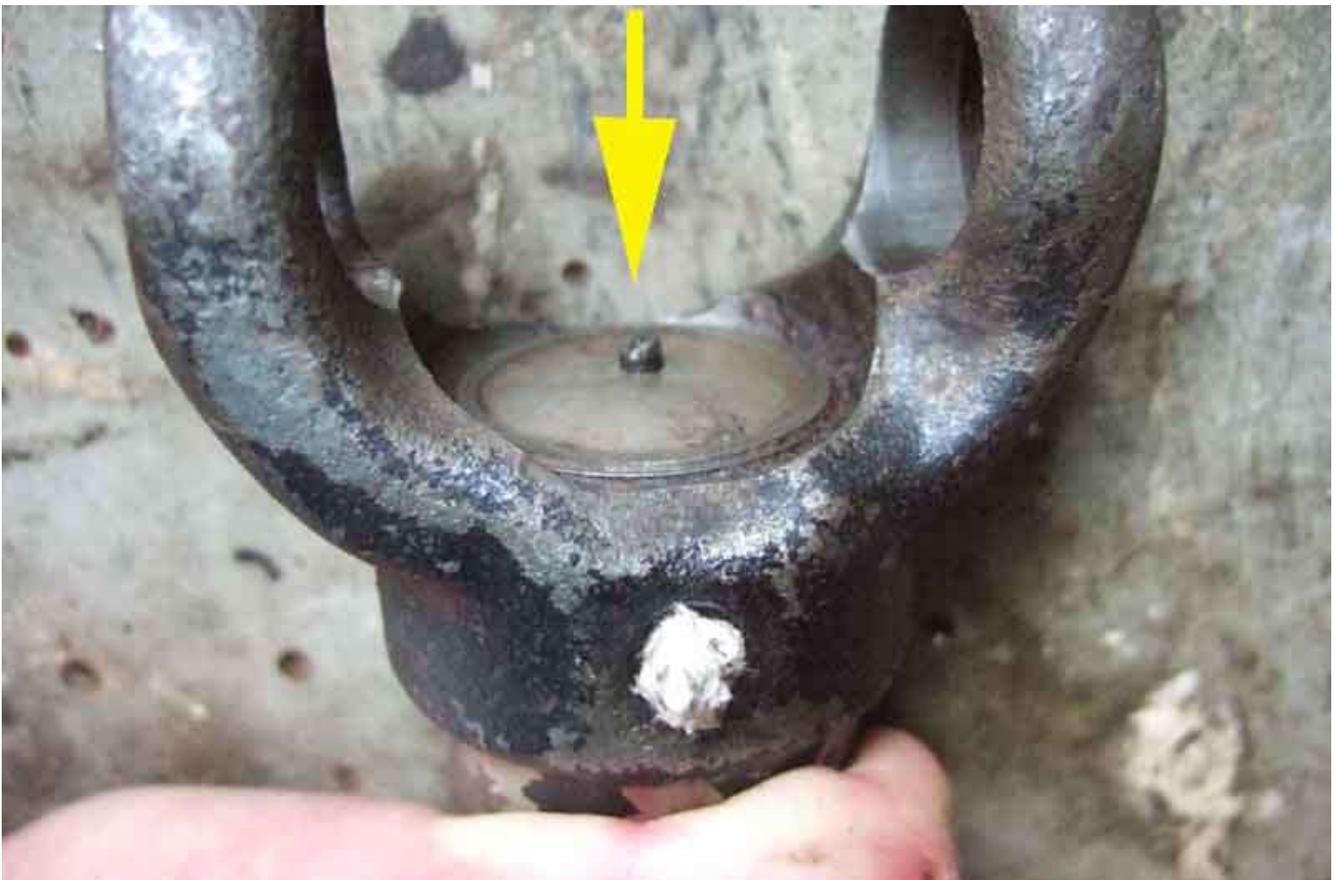
Bee's old shaft has a hole in the end-cap of the sliding joint which means that grease pumped in the nipple comes straight out there:

Said to be necessary to prevent the cap getting blown off if the joint is filled with grease while fully extended. Firstly I can imagine that it would need a lot of force to do that, and one would have to compress it before it could be fitted to a car, and secondly sealed joints (as per my old V8 propshaft) do not have that vent so they obviously 'breathe' some other way.

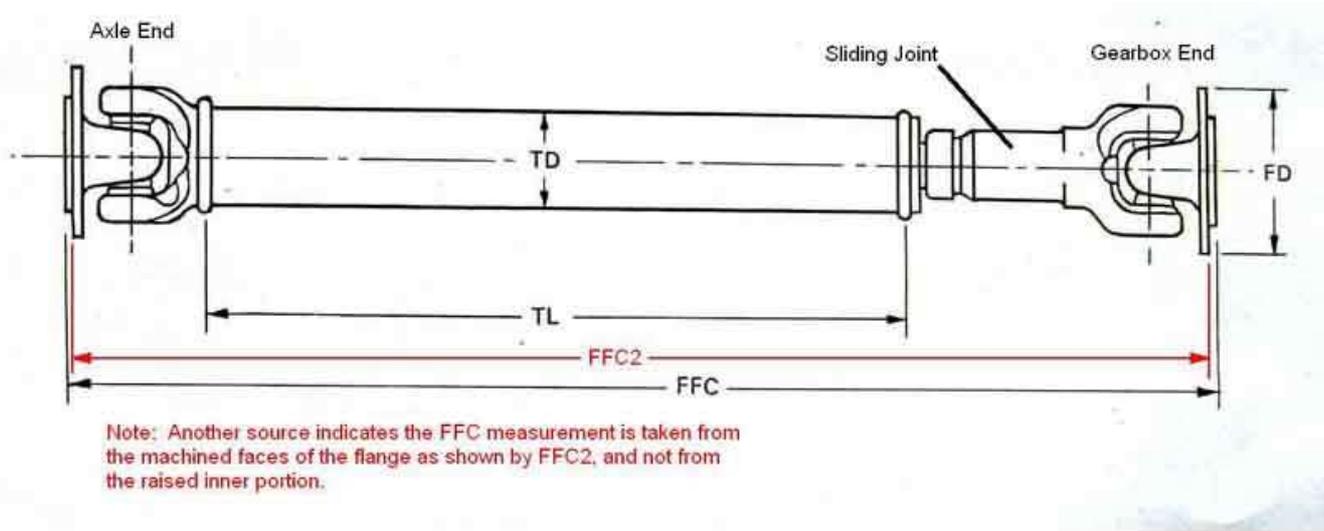
- FD = Flange Diameter
- TD = Tube Diameter
- TL = Tube Length
- FFC = Flange to Flange Closed (i.e. compressed) Length

Plotting the relative lengths of the prop-shafts using the banjo axle flange as a datum point allows us to see the relative positions of the 3-synch non-OD and OD gearbox flanges. Then using those points as datums allows us to plot the relative positions of the Salisbury axle flange. That shows that the prop-shaft for the Salisbury and 3-synch OD option should actually be fractionally longer (circled in red), but the sliding joint is more than adequate to take account of this. It also allows us to measure the length of the prop-shaft required when a 4-synch gearbox is retro-fitted to an early car with a Banjo axle.

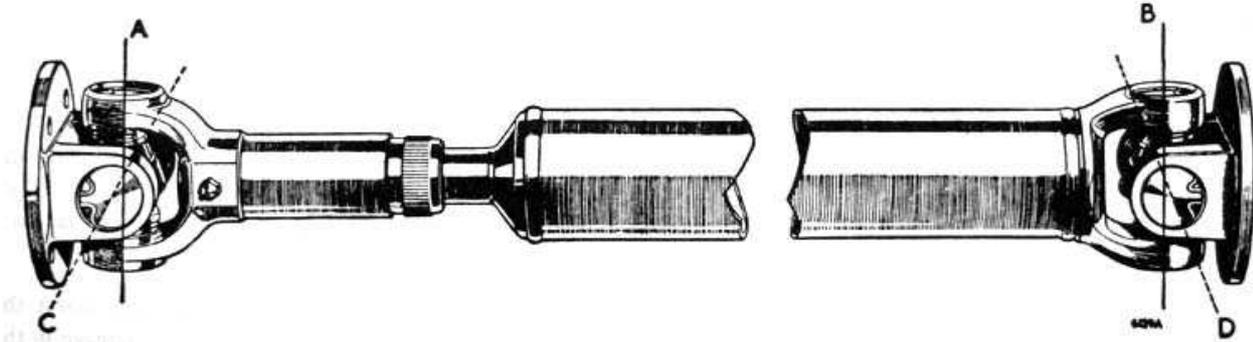
Yoke orientation, or 'phasing'. It's vital that both yokes on the propshaft are in the same orientation as each other, as shown below. This is set by how the sliding joint is assembled, and affects overall balance as well as noise and wear.

When the splined shaft is assembled to the drive shaft it is essential to see that the forked yokes on both shafts have their axes parallel to each other. In other words, the yoke (A) must be in alignment with the yoke (B), and the flange yoke (C) must be in alignment with the flange yoke (D)

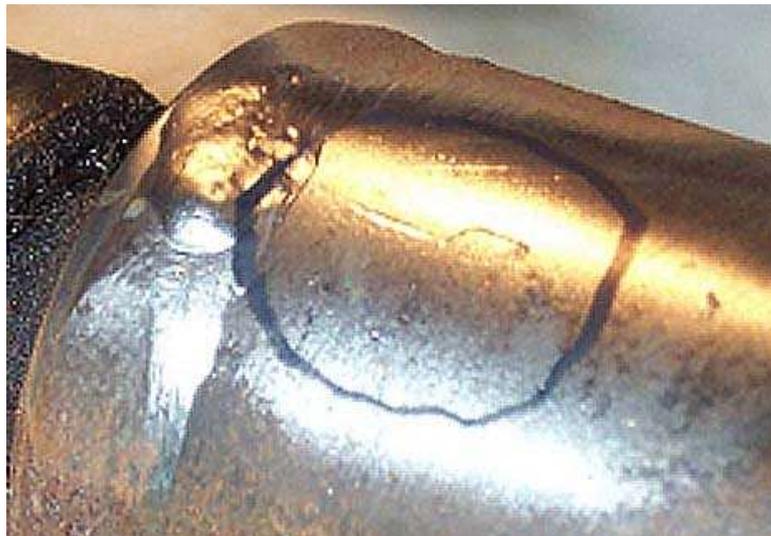
Fletcher's first photo enhanced as best I can. I can just make out an arrow 'shaft' and one half of the 'flight' but no head - a typical mis-stamping.

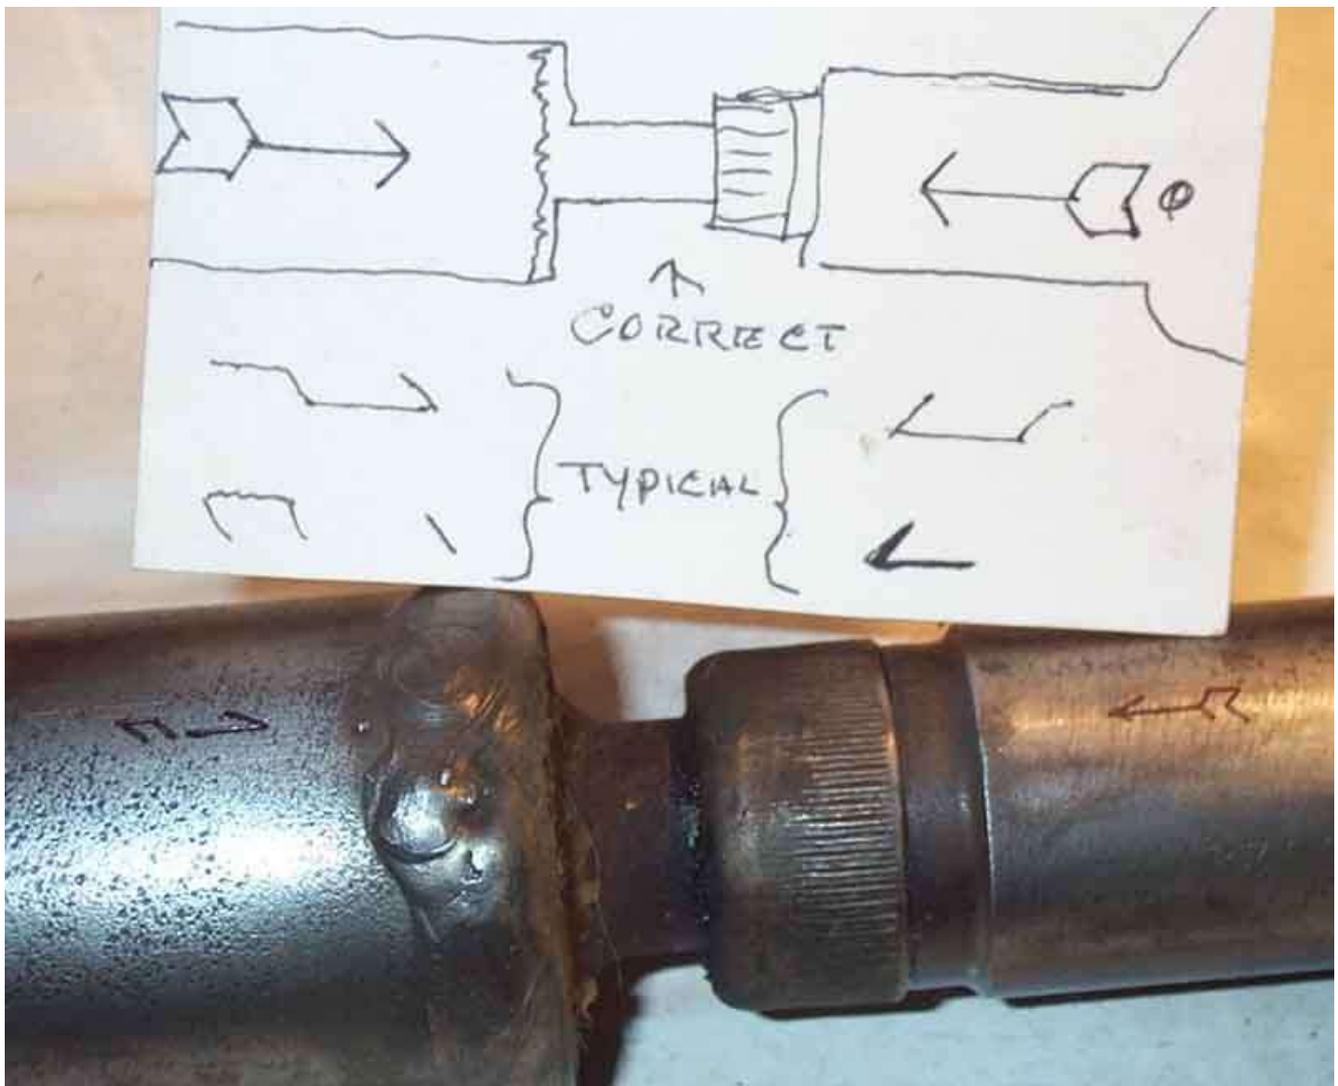
Fletcher's 'best' markings, together with some examples of the poorly stamped markings you are likely to find in practice.

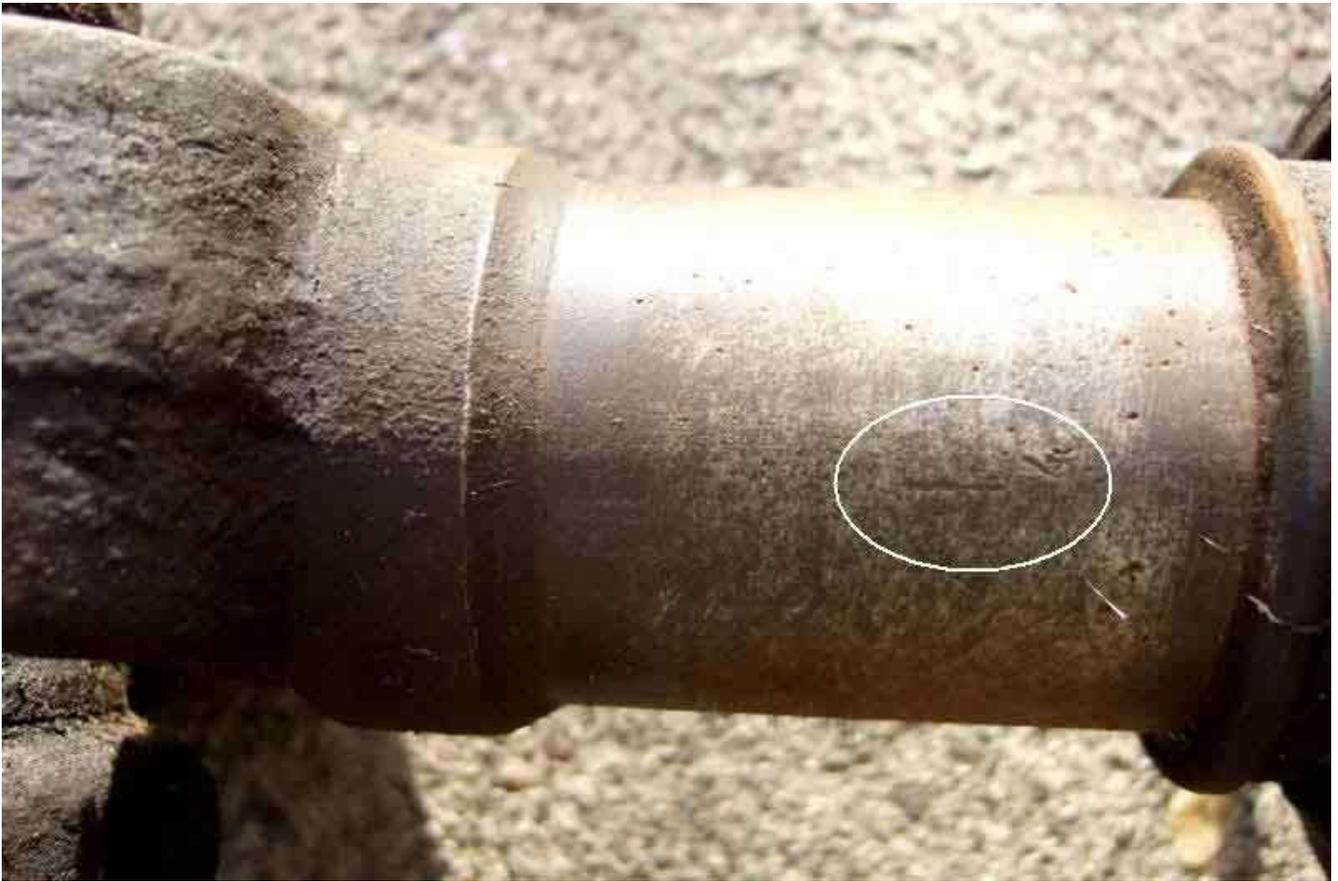
My old V8 shaft, two lines on the yoke, which **could** be the shaft and half of a detached head, but nothing on the tube. These are also sort of but not exactly in-line with one of the arms of the yoke which doesn't have a grease nipple, and not between them and in-line with a grease nipple as on Fletcher's drawing so could be nothing at all, but are similar to one of his drawn examples:

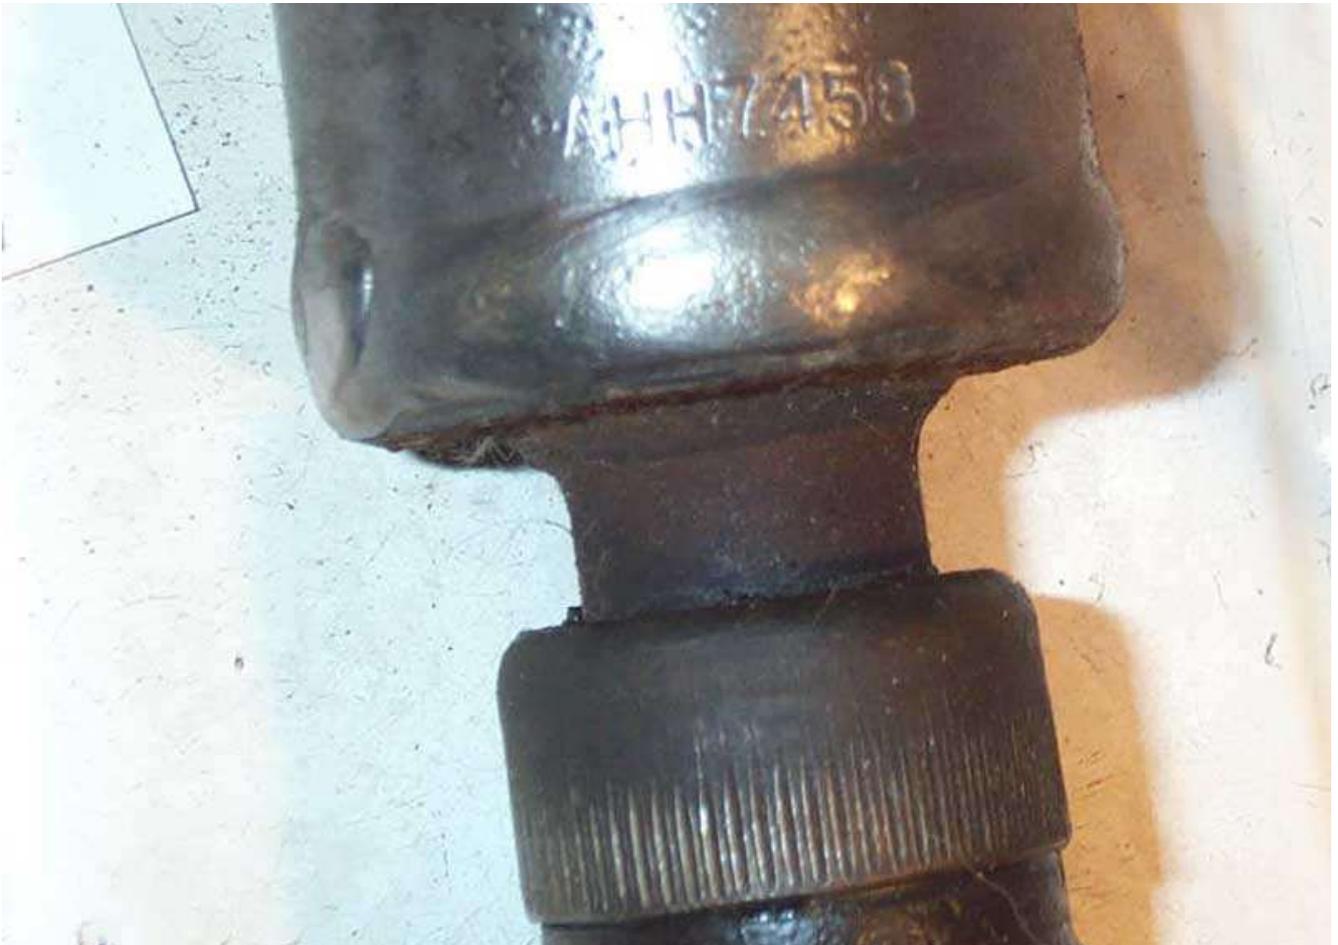
Another of Fletcher's photos this time showing what appears to be a part number stamped into the end of the tube of a banjo axle non-OD shaft. However AHH 7458 is the part number of the little plastic clip that holds the straight end of the sun-visor rod, the correct number for the banjo non-OD shaft from the Parts catalogue is AHH 7488.

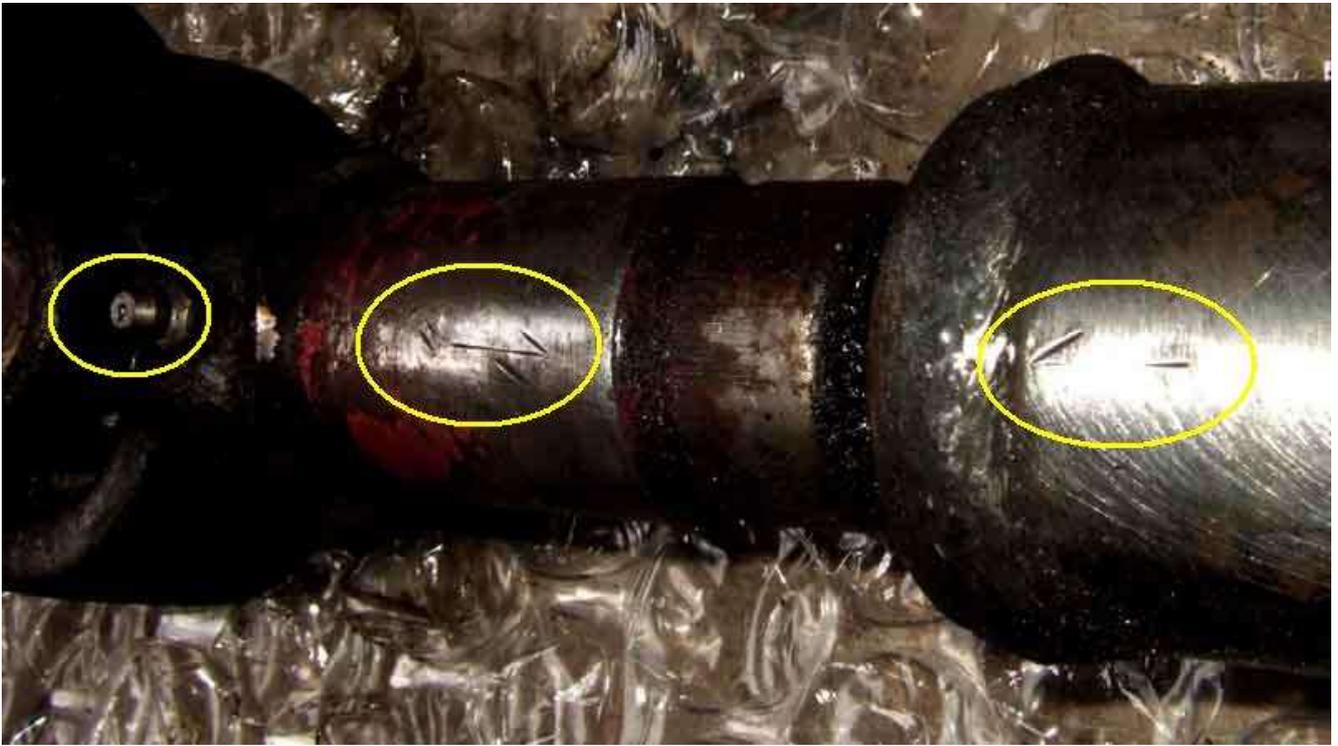
Bee's old shaft, alignment marks in line with the sliding joint grease nipple, better than some:

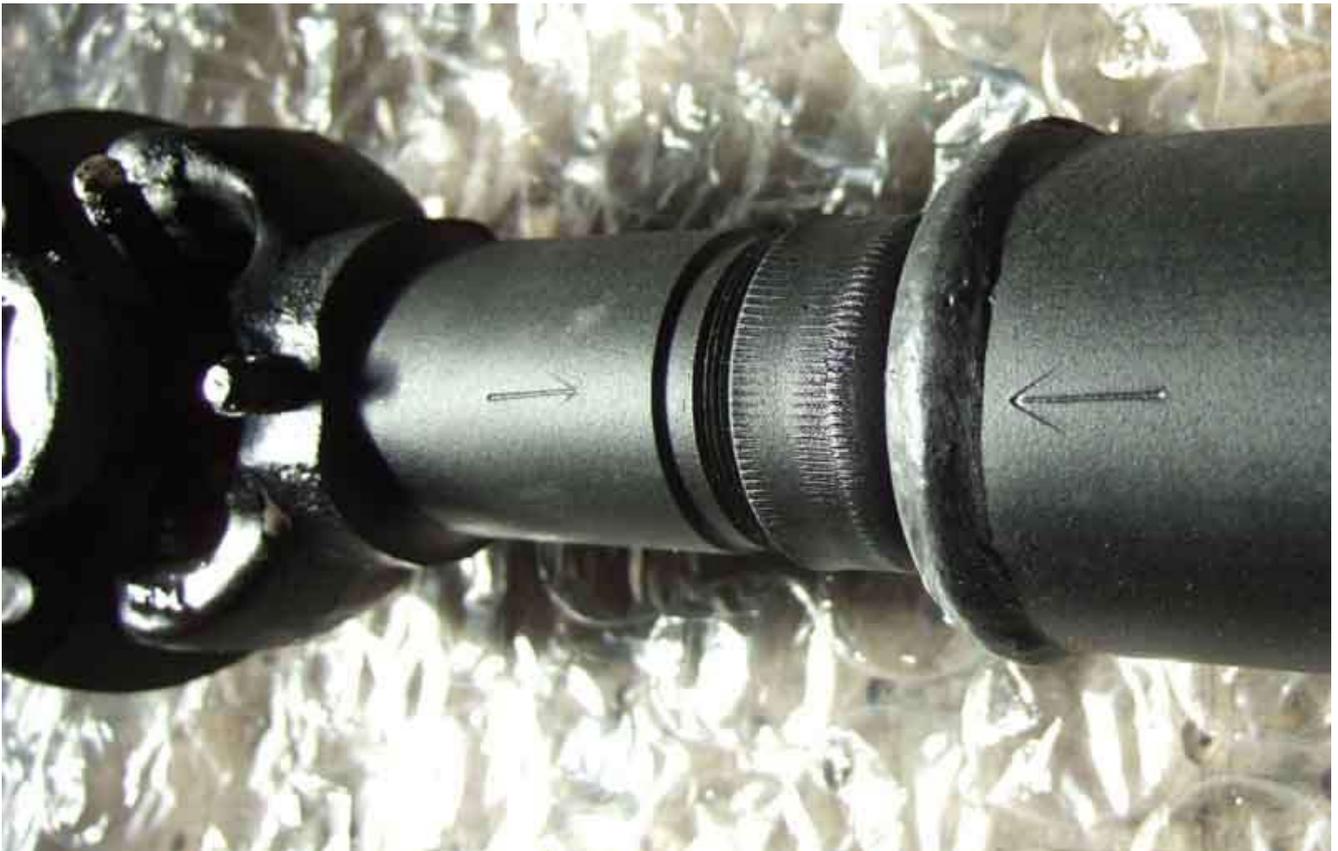
Replacement propshaft from Brown & Gammons. £132 + P&P, but I wasn't going to buy from BHive at £70, nor from anyone else at the same price. Leacy and Rimmer's were showing them at around £100 which I'd have gone for, but no stocks. Very clear alignment markings also in line with the sliding joint grease nipple:

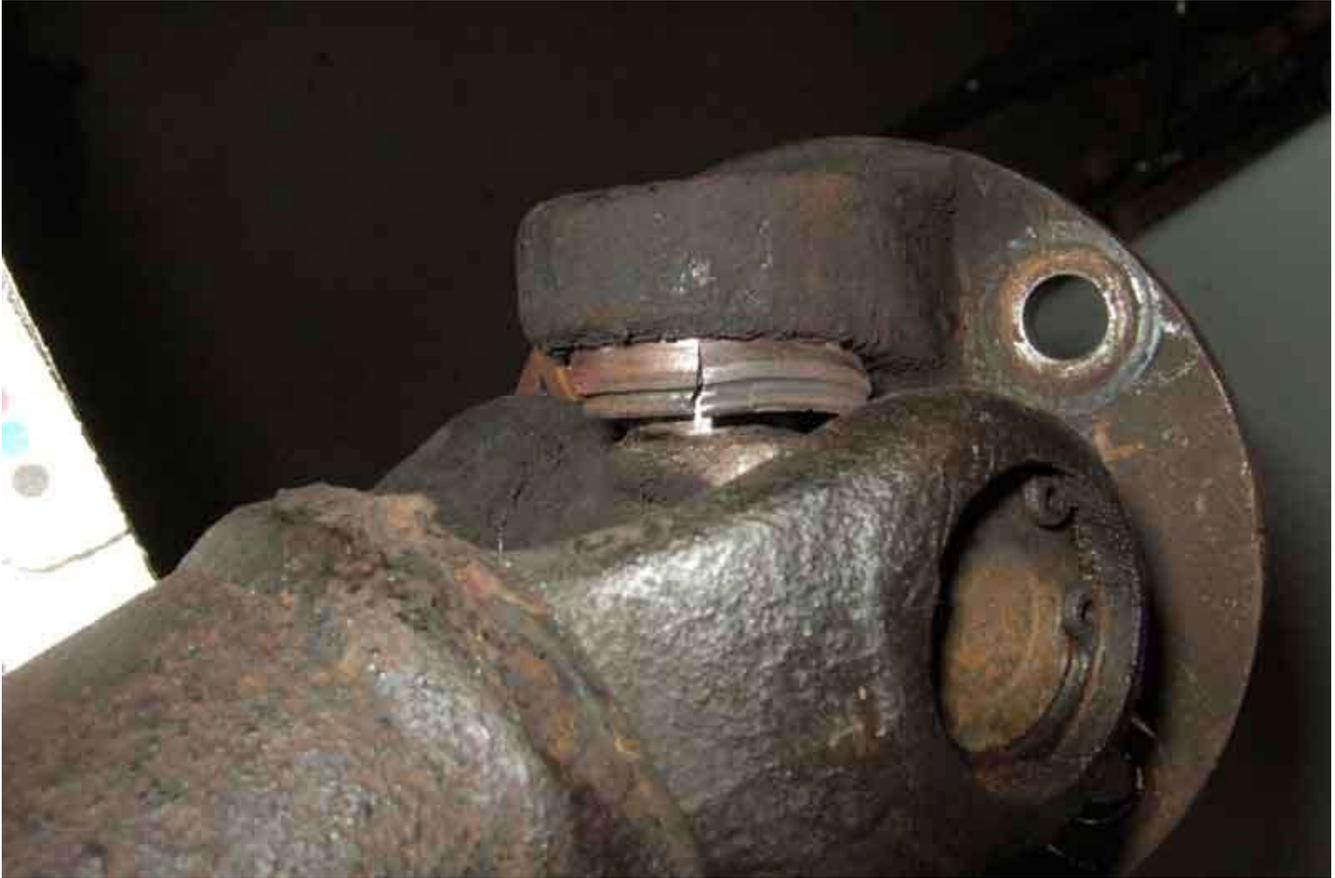
Bee's axle end needle roller housing broken up:

No wonder it caused a vibration:

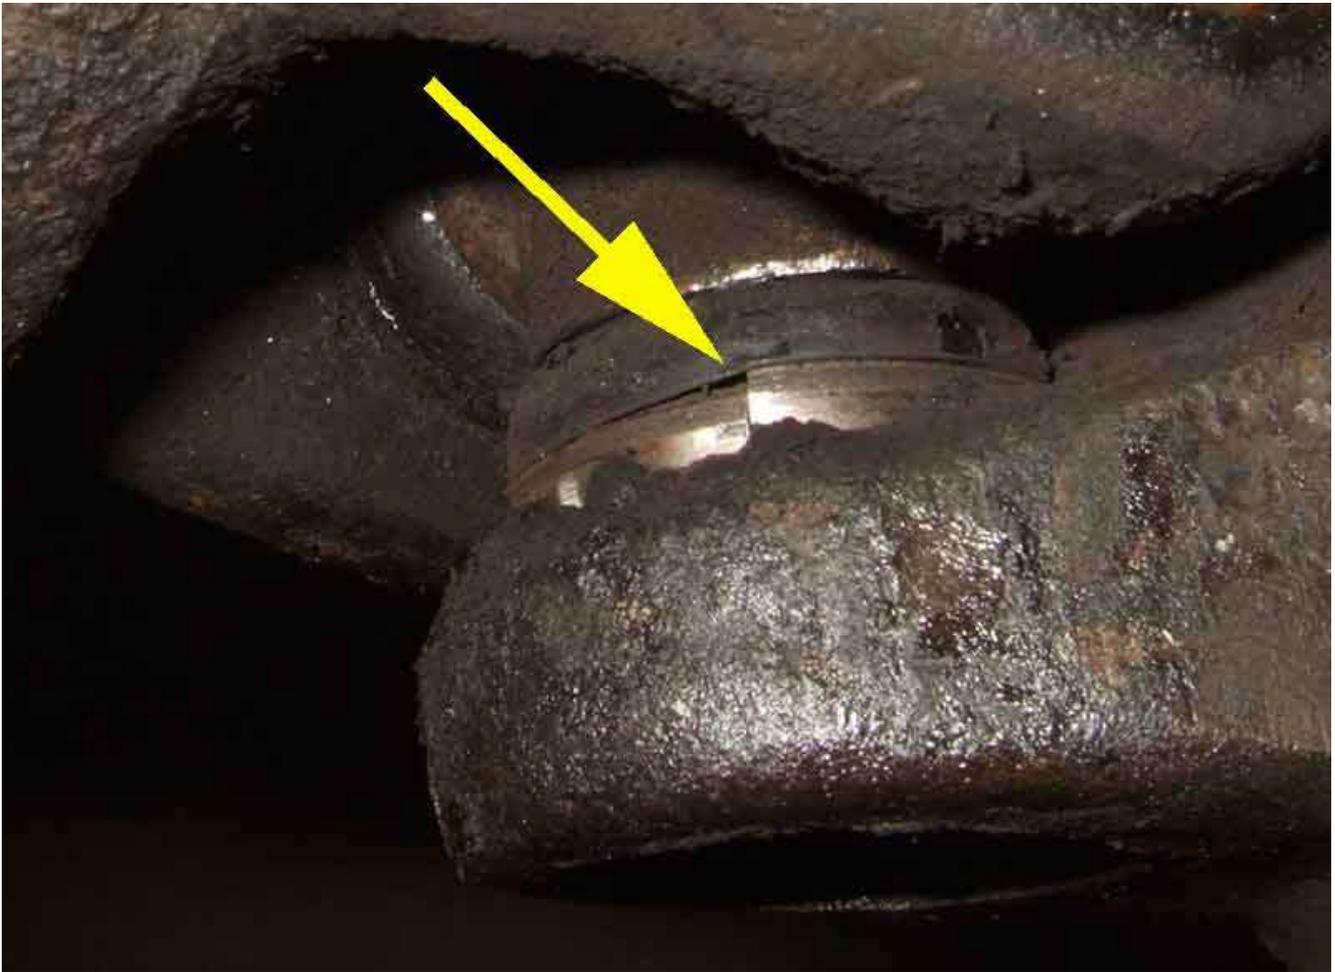
Its opposite number is cracked:

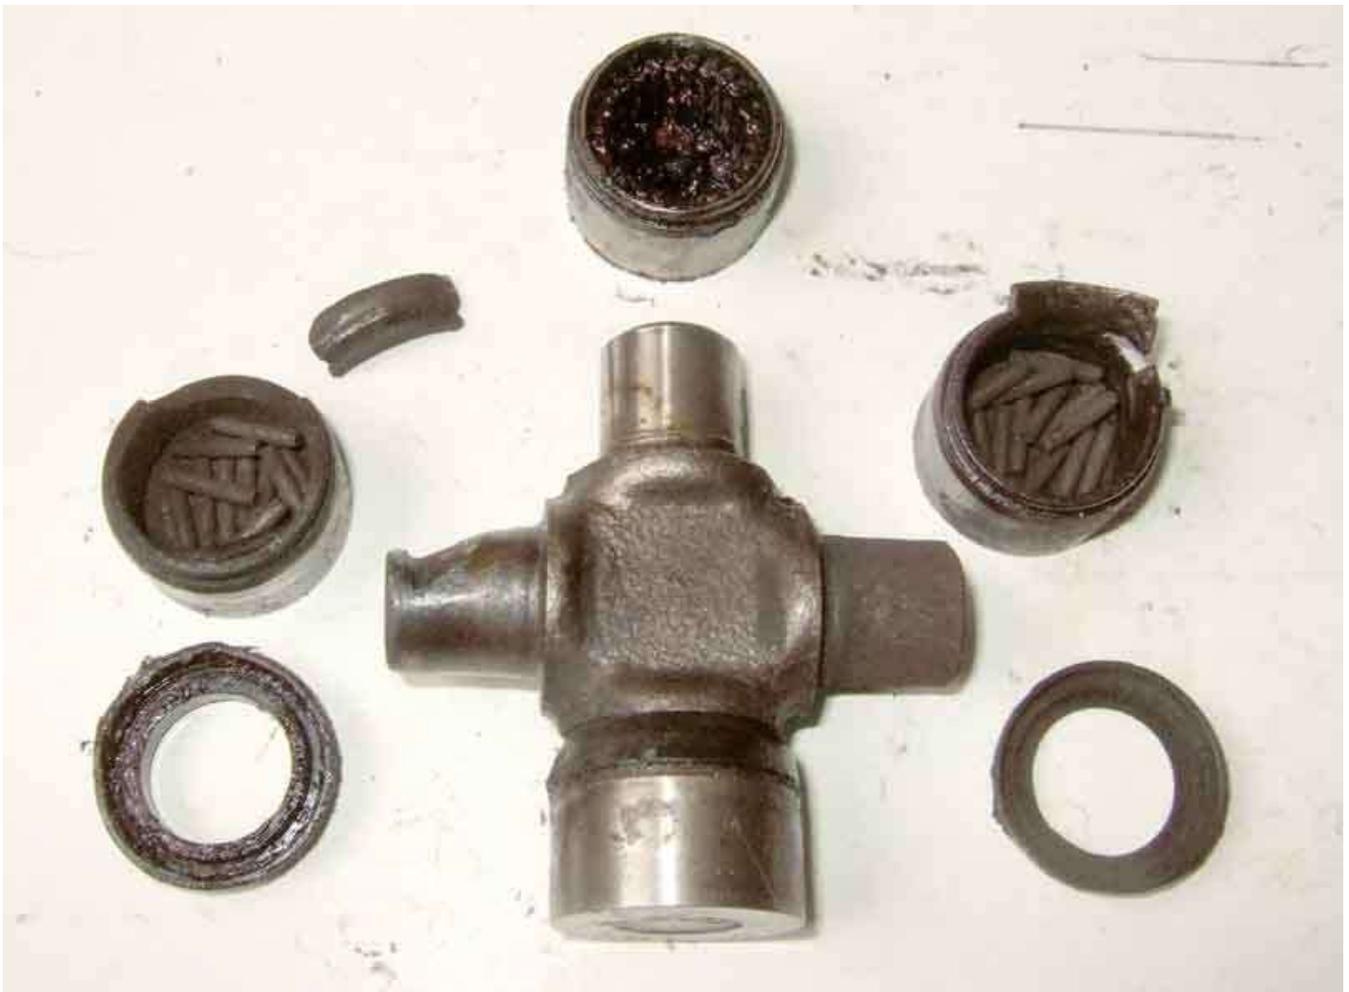
A bit of a fight to remove the UJs from the yokes but I got there in the end. The two damaged bearings are opposite each other, there is no trace of grease, and one side of the spider has been ground away. All four in good condition at the gearbox end and with plenty of grease, one wonders if nipples are really needed - as long as they are adequately greased on assembly! It must have been heading that way for years if not decades, but with no UJ nipples I'd not been messing with that end of the shaft. Obviously one needs to twist and shake each UJ at each service:

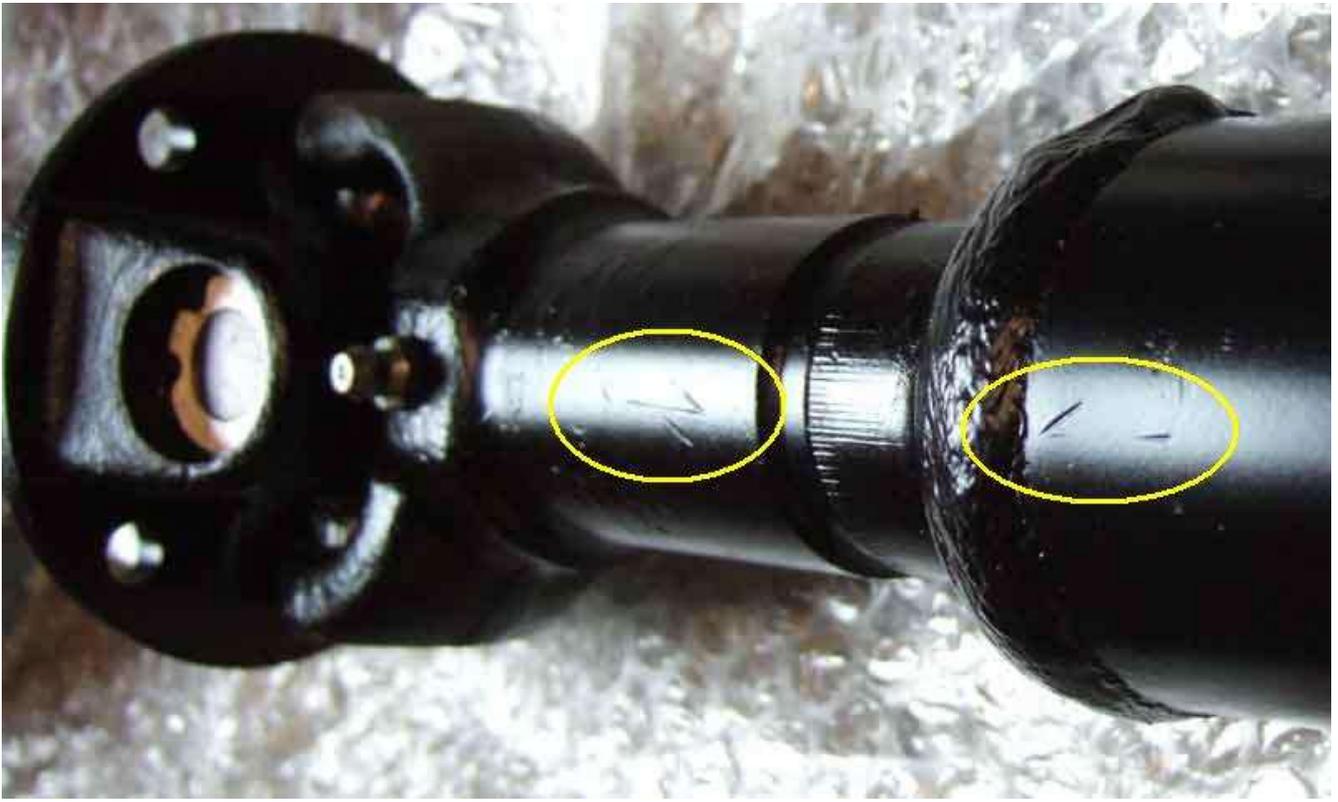
Alignment marks correct:
